Inspection Photos

API: 043-40001

Operator: JAVERNICK OIL

Inspection Date: 4/25/2025

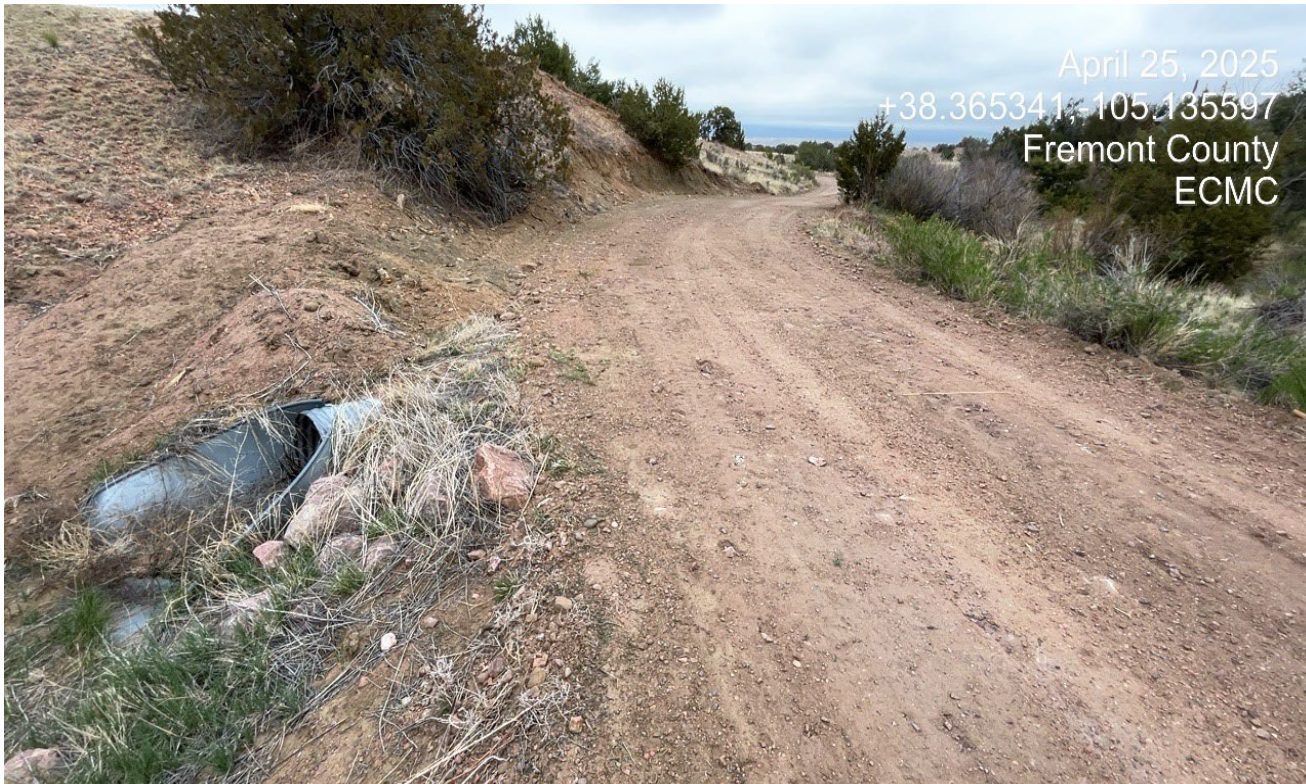
Photo 1. Facing north along the access road. There is an erosion gully along the roadside has been repaired.

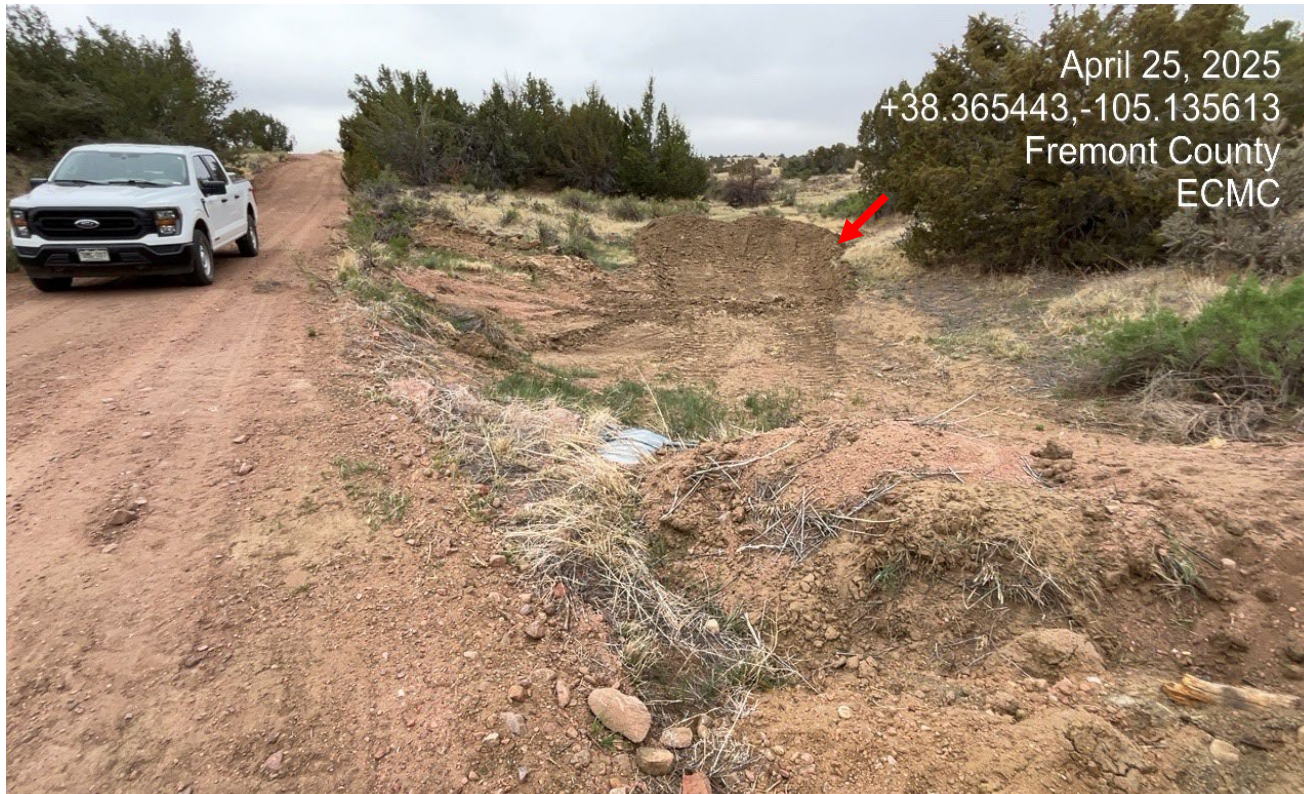
Photo 2. The sediment at the culvert outlet was pushed back in the drainage at red arrow. This material needs to be removed or slope out of the drainage so it does not wash back into the culvert.

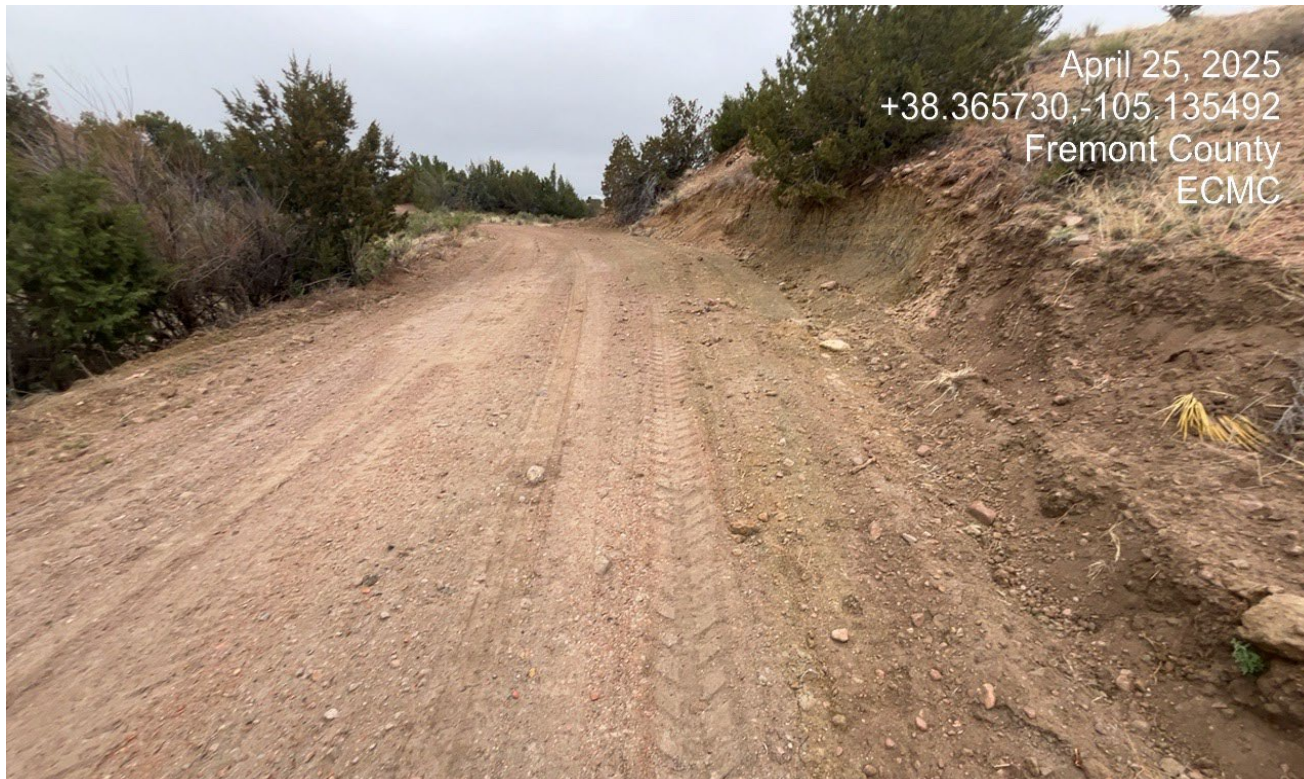
Photo 3. Facing back along the access road. The dozer cut into the embankment to fill in the erosion. The embankment cut now needs to be resloped and stabilized.

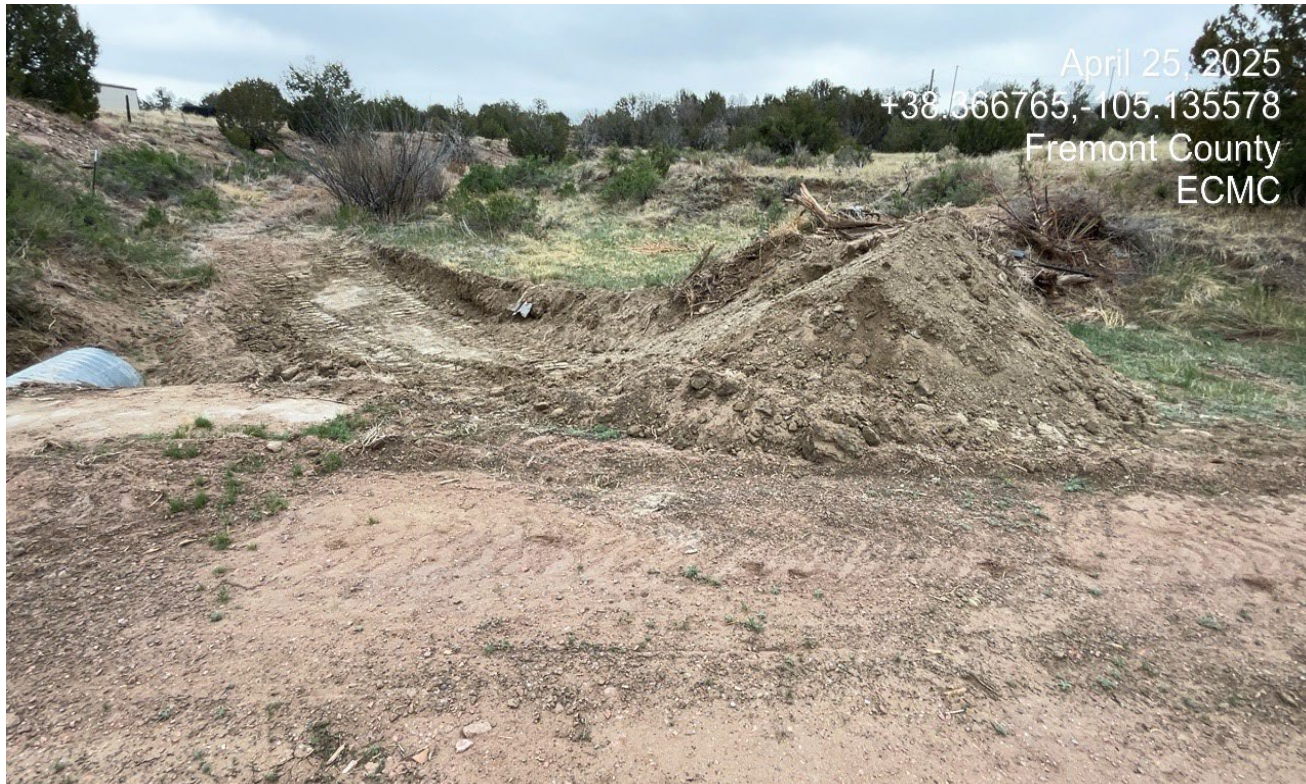
Photo 4. The culvert has been cleaned out and soil and debris is piled up along the side which needs to be removed.

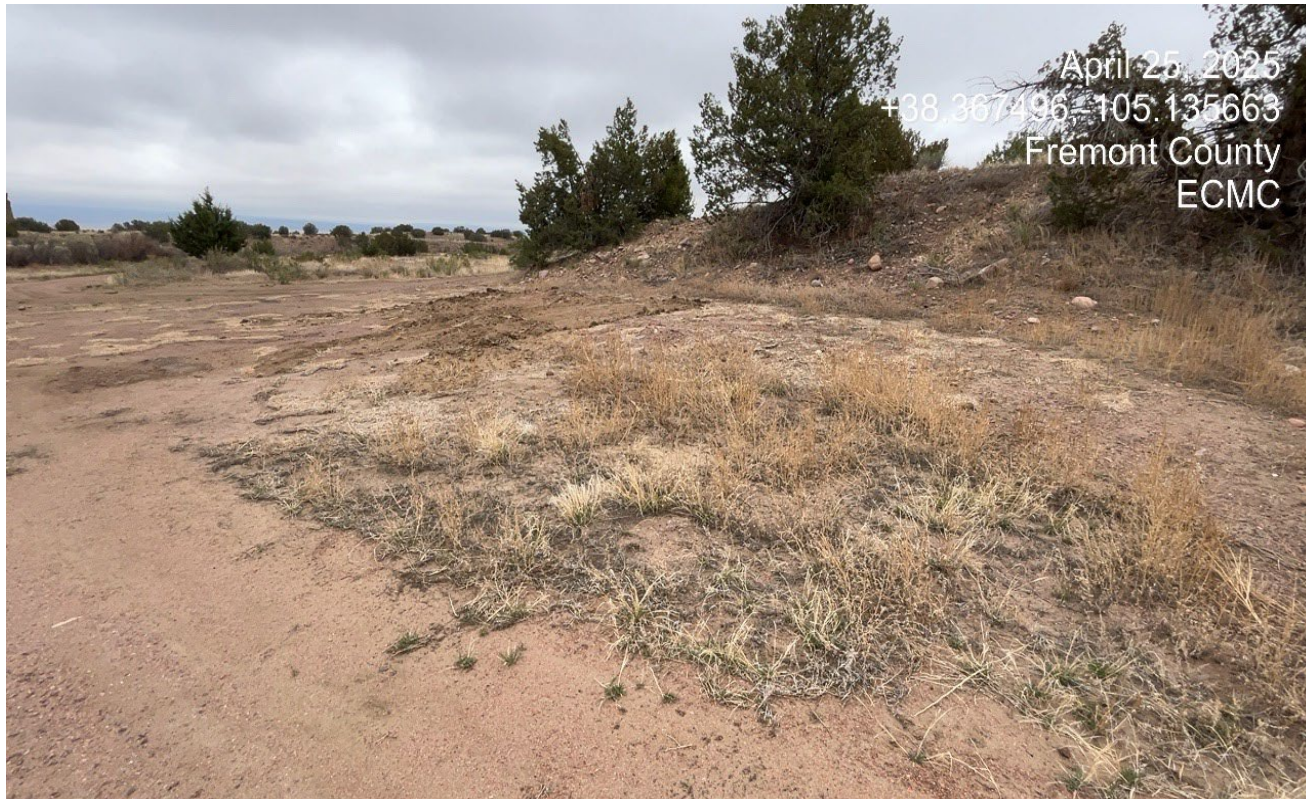
Photo 5. Facing northeast at the locations. Soils need to be cross ripped and reseeded.

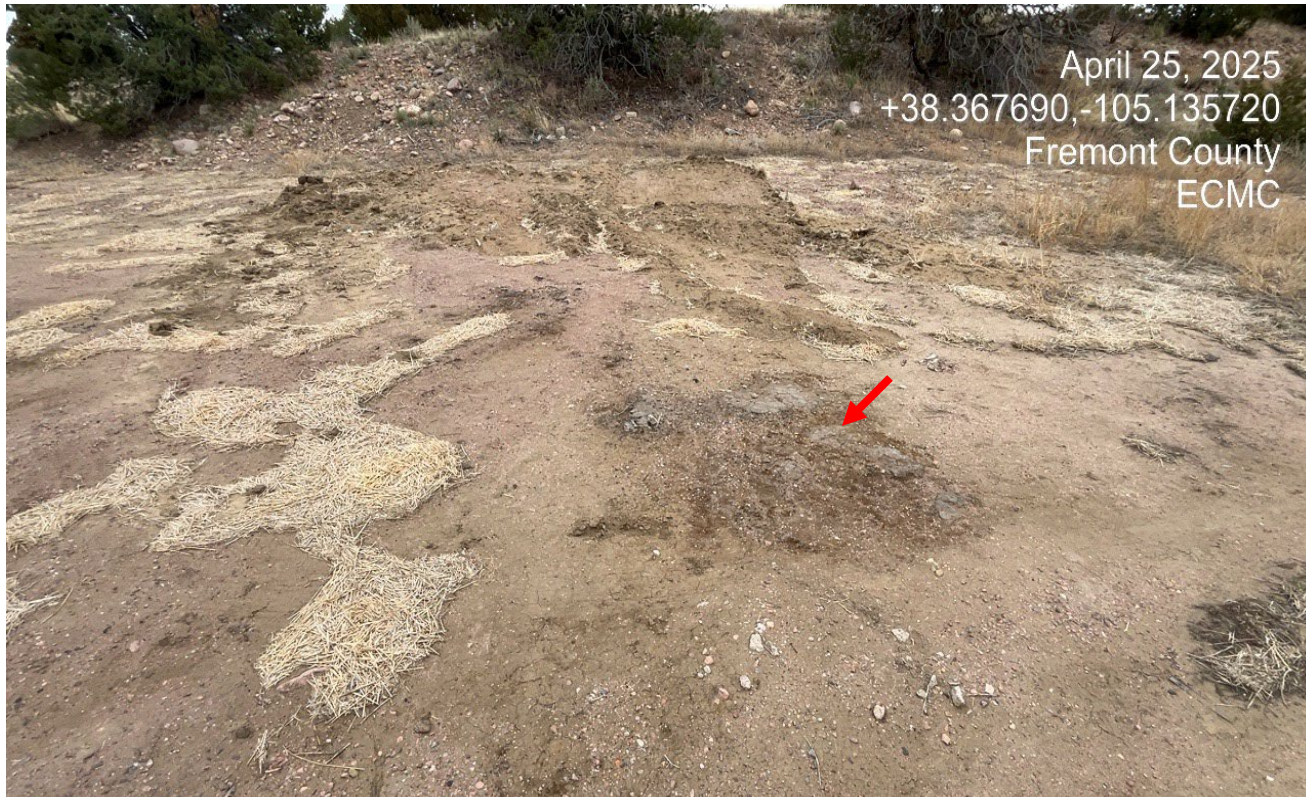
Photo 6. The oil stained soils still remain at the location. Impacted soils need to be excavated and removed.

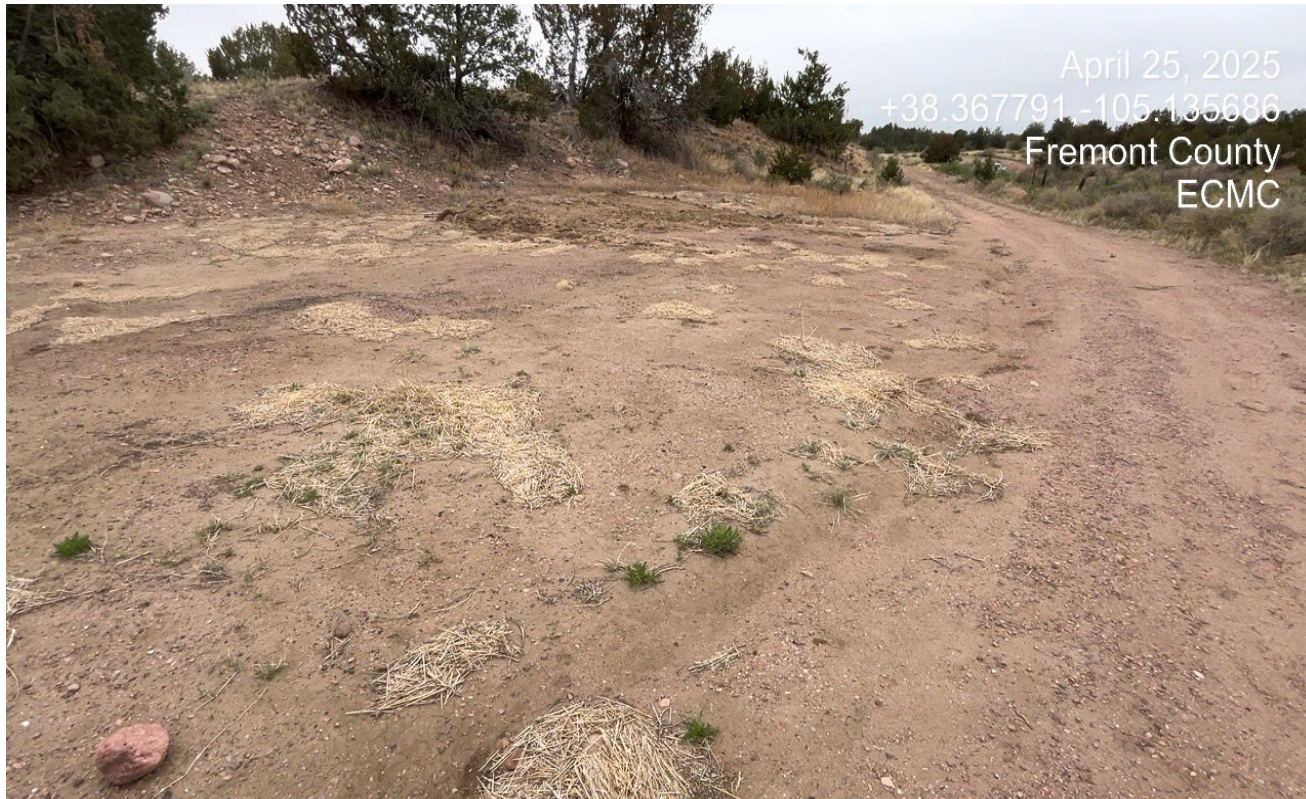
Photo 7. Facing southeast at the locations. Soils need to be cross ripped and reseeded.

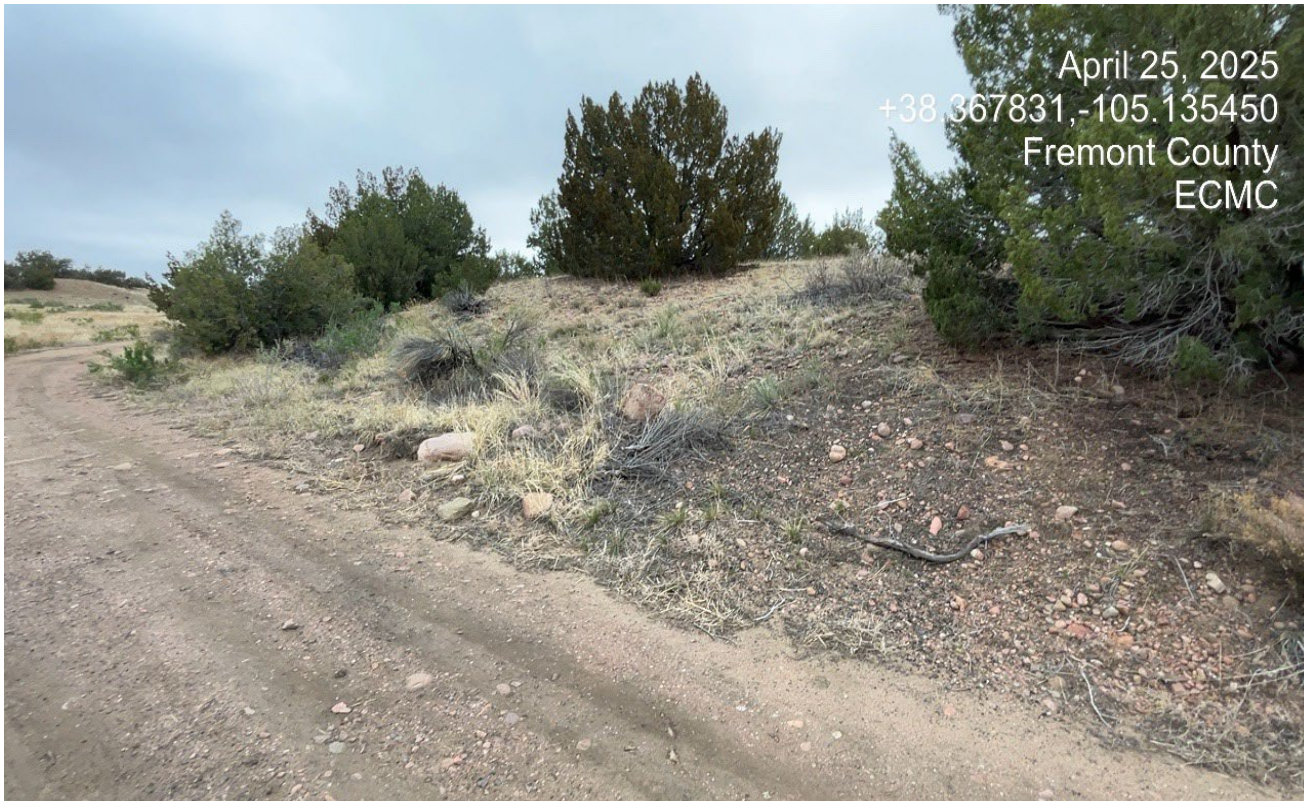
Photo 8. The cement blocks and guy line anchor at this area has been removed.
