Inspection Photos
Location Name: UIV 18-20
Location ID: 306059

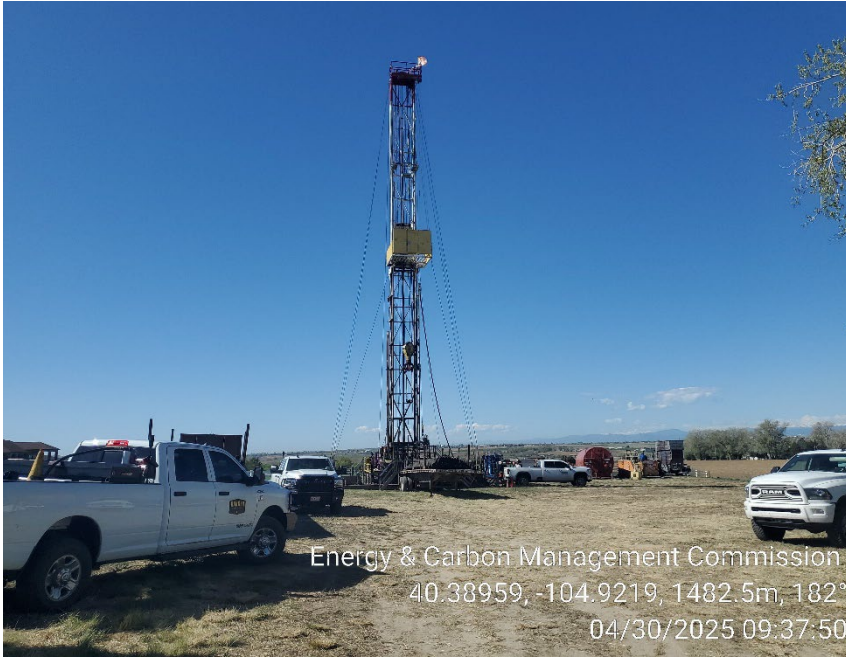
Plugging operations

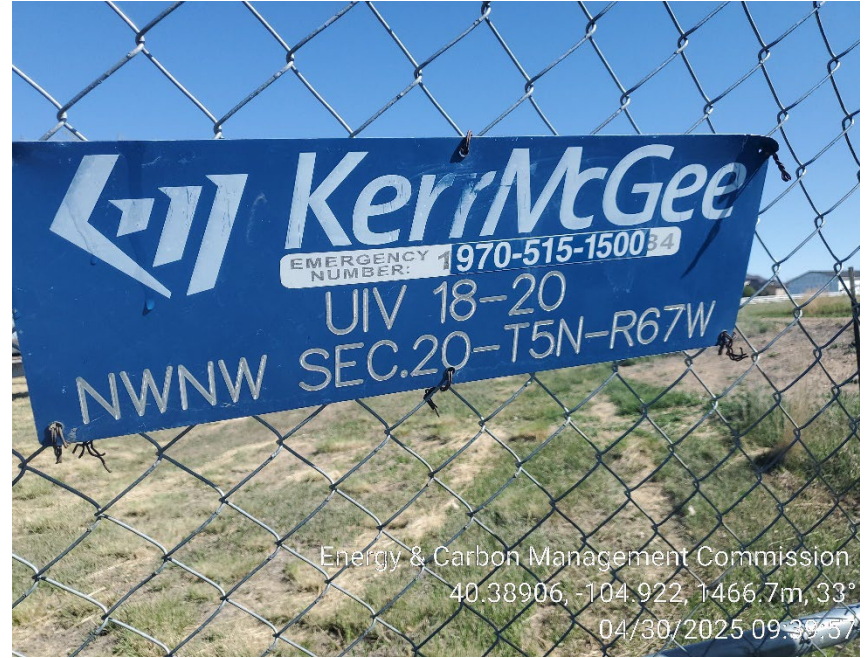
Wellhead sign
