Interim Reclamation and Stormwater Inspection

April 30, 2025

Well Name: JOLLY #D-1

Inspection Document #: 718600551

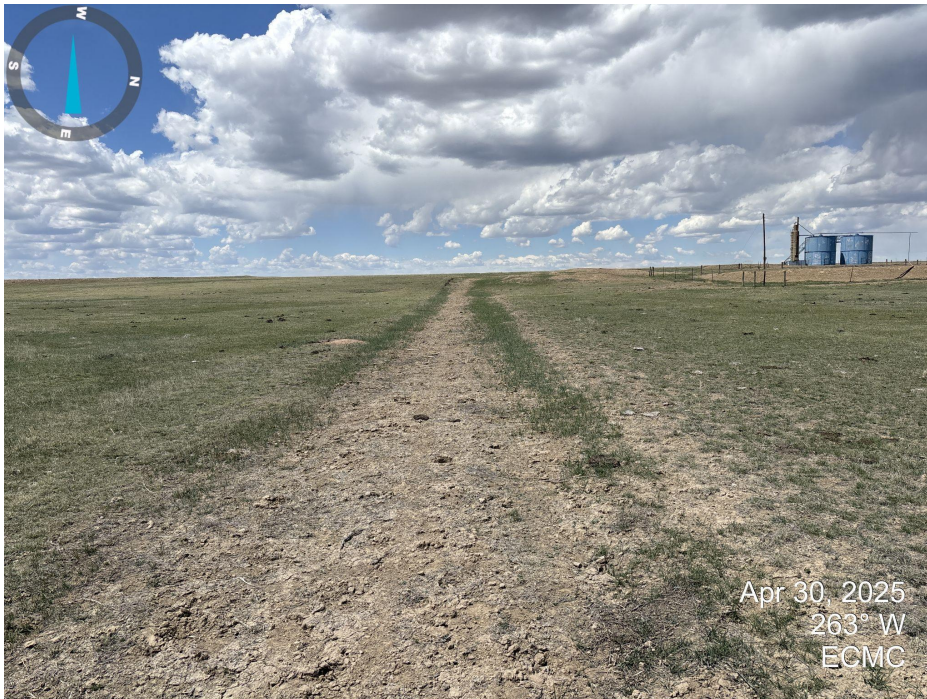
Photo 1. Looking west down access road to tank battery.

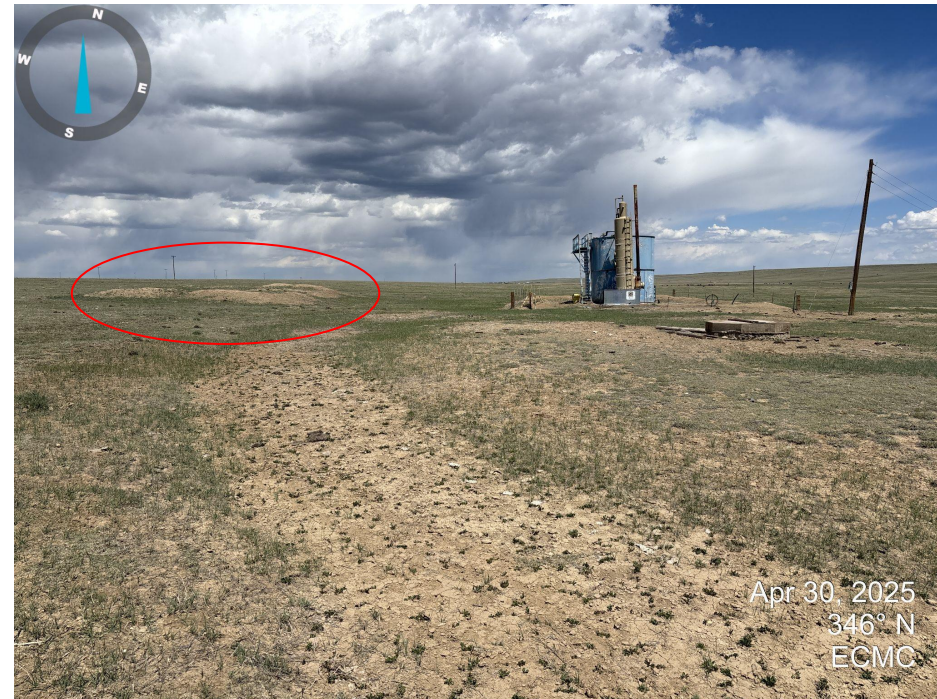
Photo 2. Looking North across the tank battery location. Soil pile on west side of location (red circle). Soil pile has some vegetation growing on it but is largely bare soil.

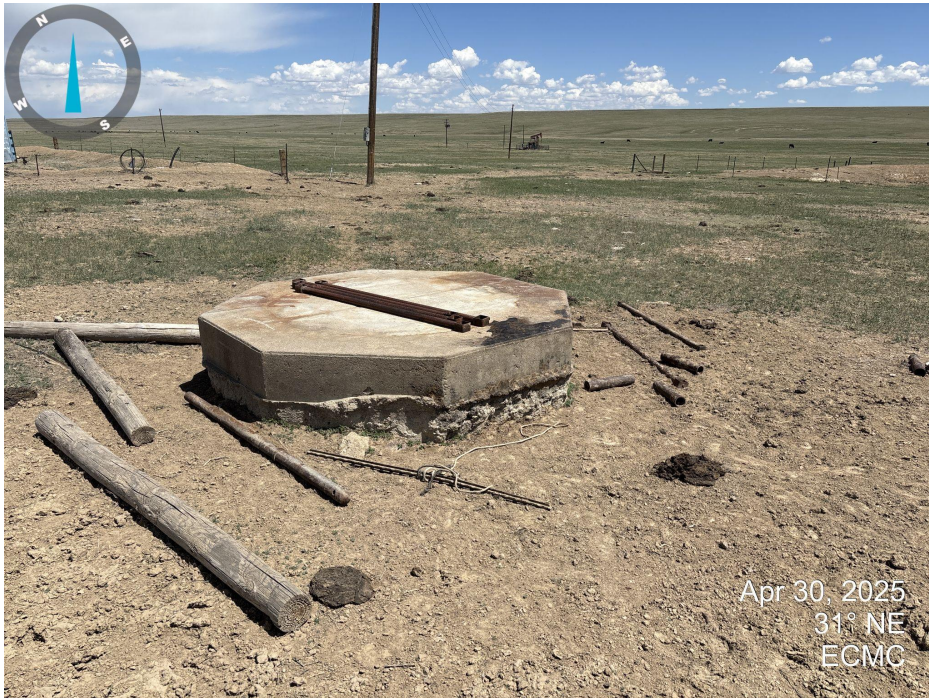
Photo 3. Former separator base to the south of the tank battery. Debris is present around base.

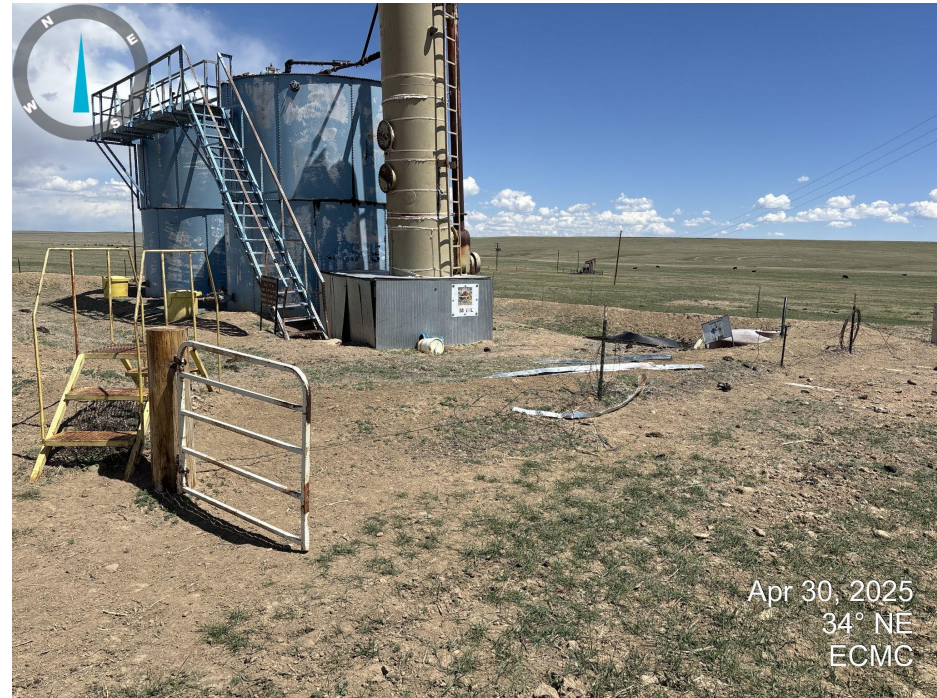
Photo 4. Looking north across the tank battery. Debris is present throughout location (buckets, metal). Fence around tank battery is down and it appears cows have been entering the tank battery.

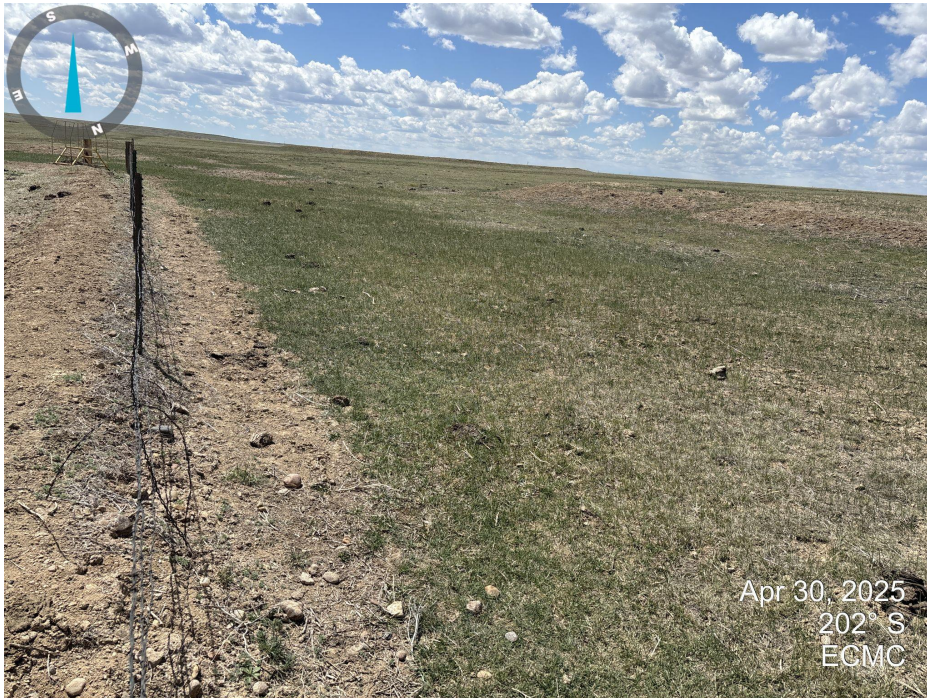
Photo 5. Looking south down the west side of the tank battery. The interim area outside of the tank battery appears to be desirable perennial vegetation.

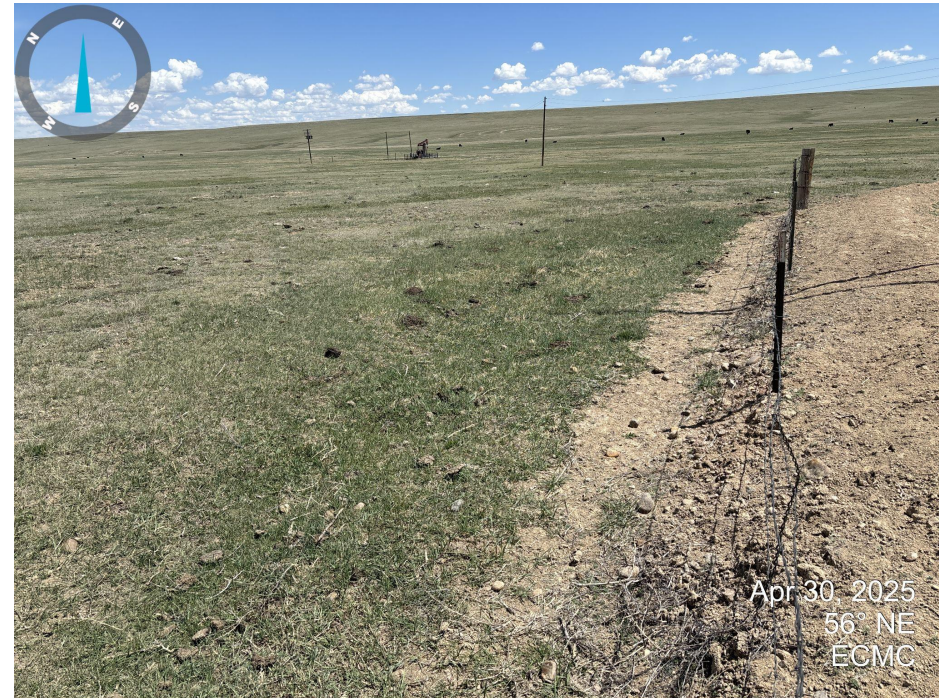
Photo 6. Looking east down the north side of the tank battery. see photo 5 comments.

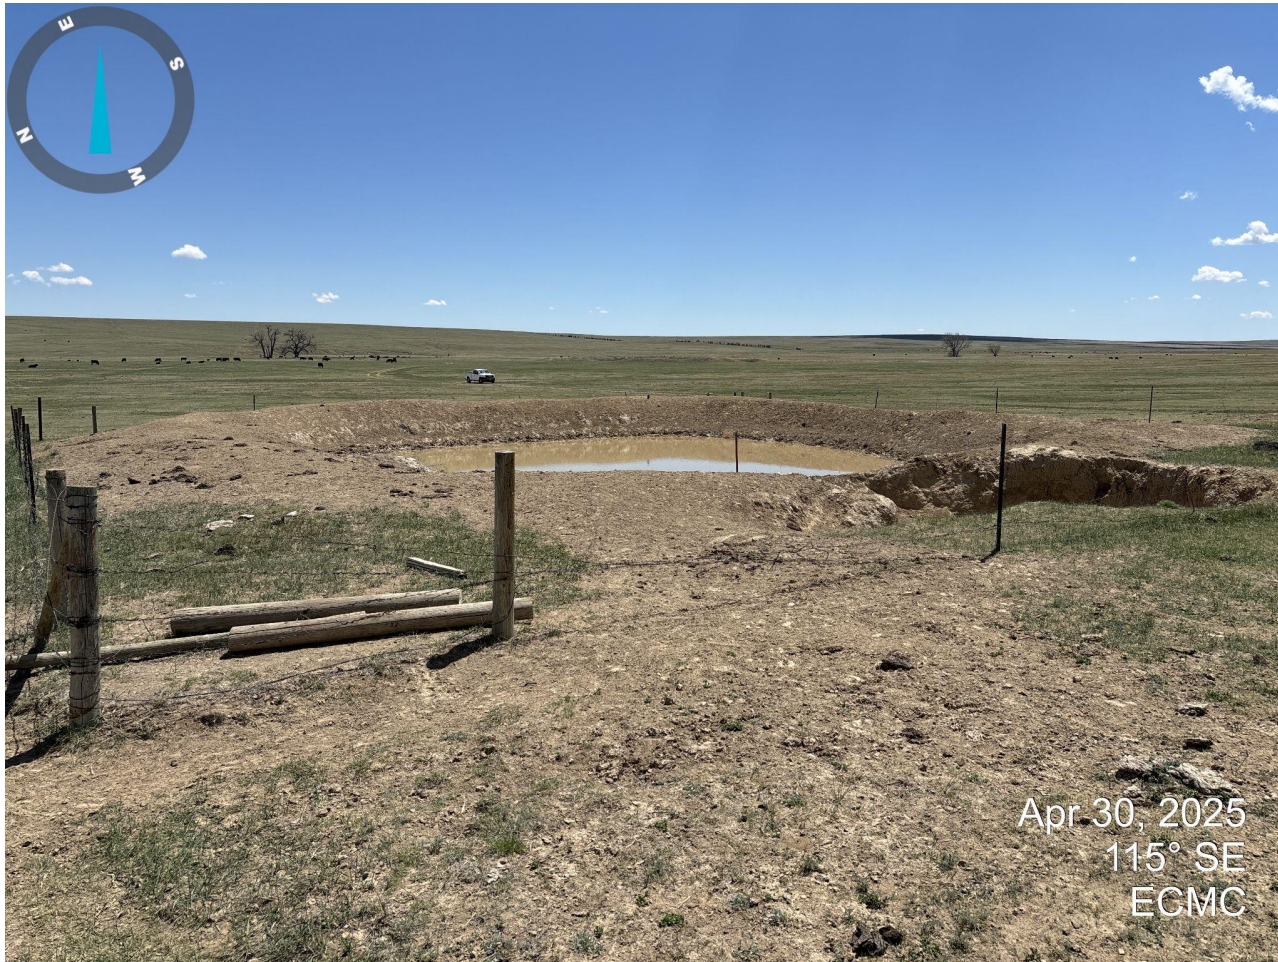
Photo 7. Looking east across the skim pit located to the east of the tank battery. The barbed wire fence around the pit is down and livestock appears to be entering the pit and drinking from standing water in the pit/ evaporation pond.

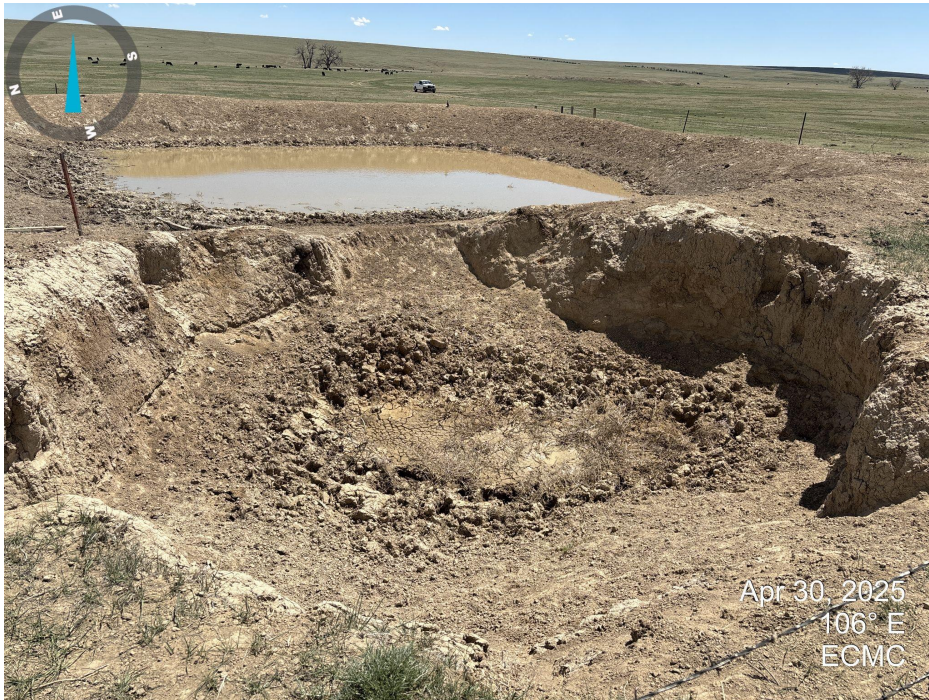
Photo 8. Skim pit on the west side of pond. Cattle prints are present in the mud at bottom.

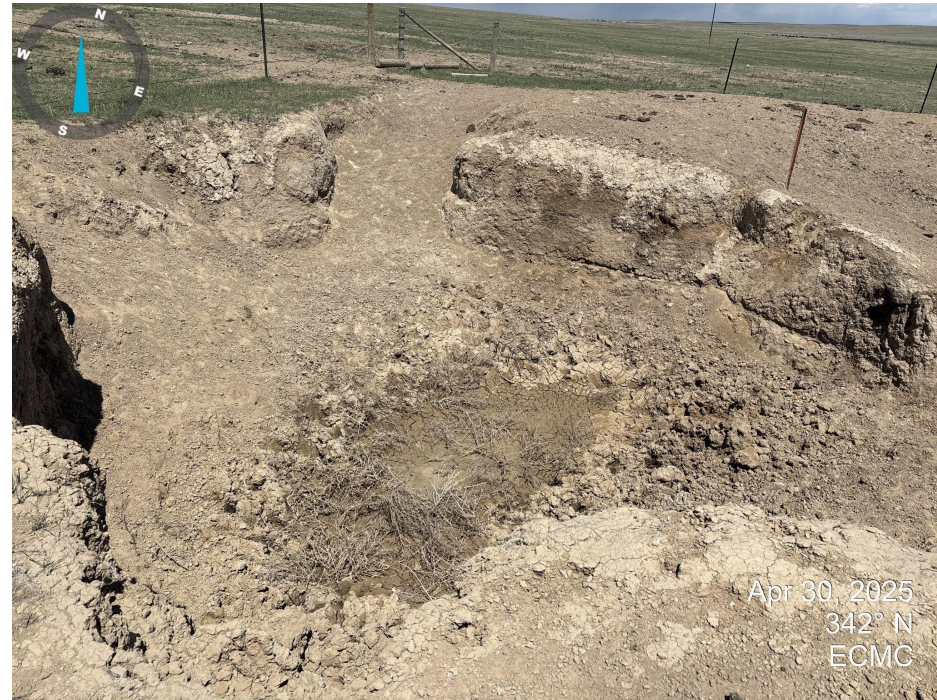
Photo 9. Looking north across skim pit on the west side of the pond.

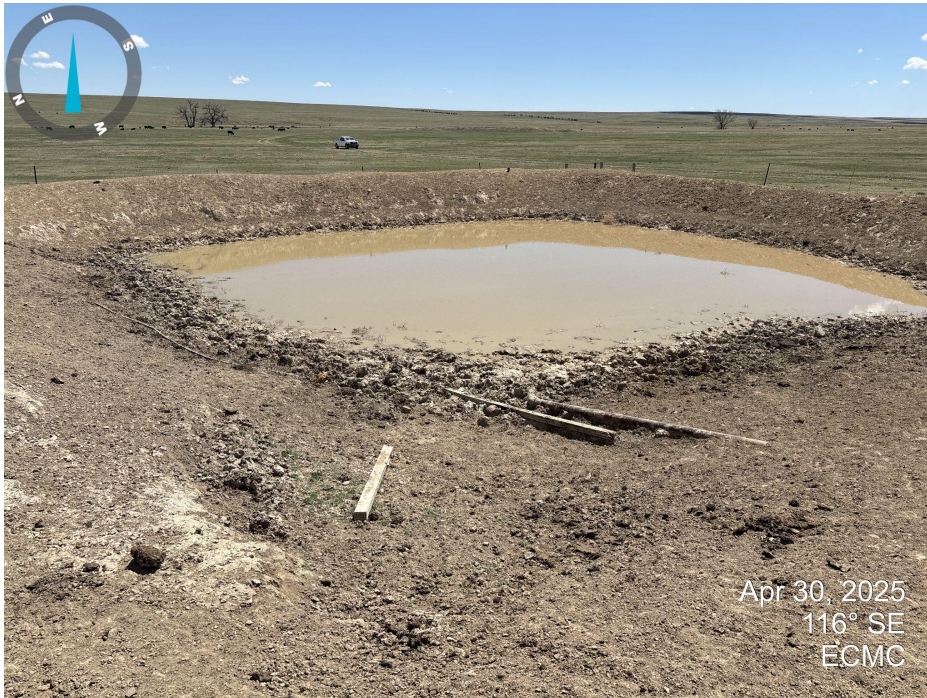
Photo 10. Looking east across the evaporation pond. Debris remains in the pond. Standing water is present in the pond at the time of inspection. Cattle tracks are present at the water's edge.

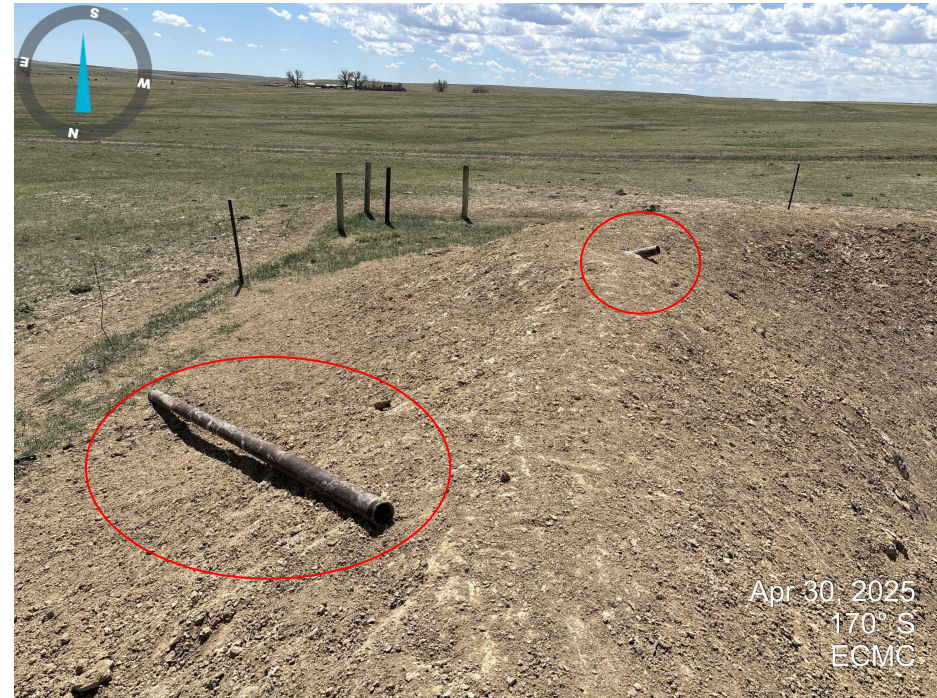
Photo 11. Picture taken on the east side of the evaporation pond looking south. Pipe remains in and around the berm (red circles).

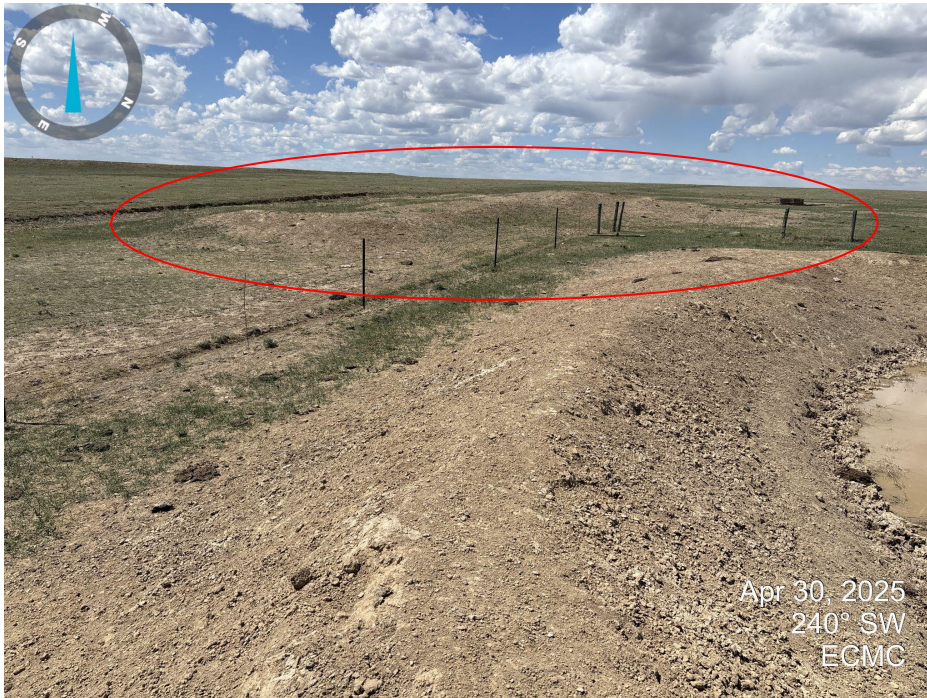
Photo 12. Looking west along the southern edge of the evaporation pond. Soil pile is present on the south side of tank battery (red circle). Soil pile is primarily bare soil with little vegetation coverage.

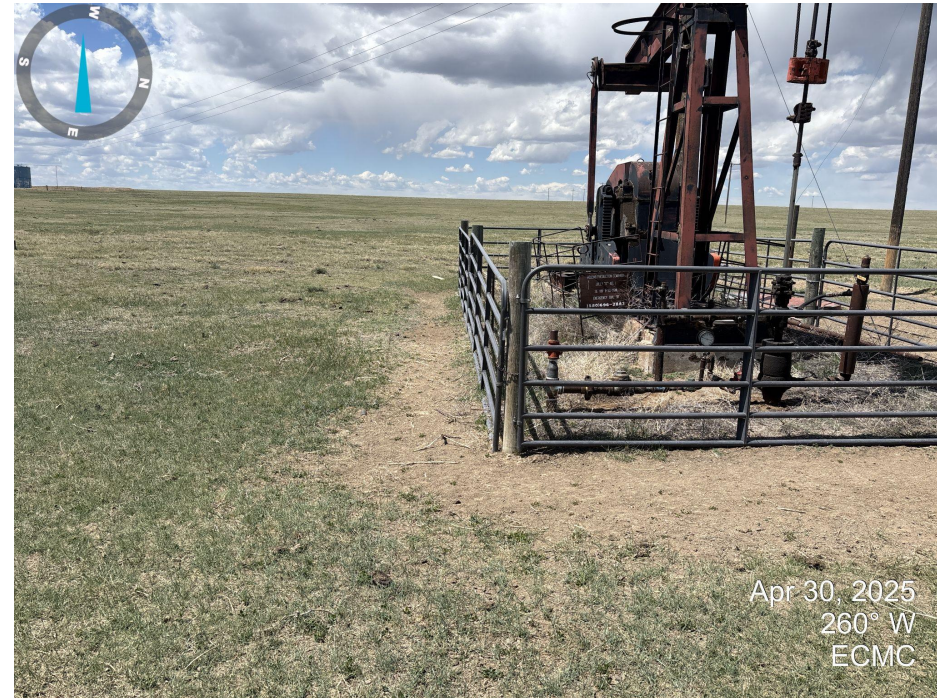
Photo 13. Looking west across the well location. Location size has been reduced and desirable perennial vegetation has established around the location. Undesirable weeds such as Kochia are present inside the fence.

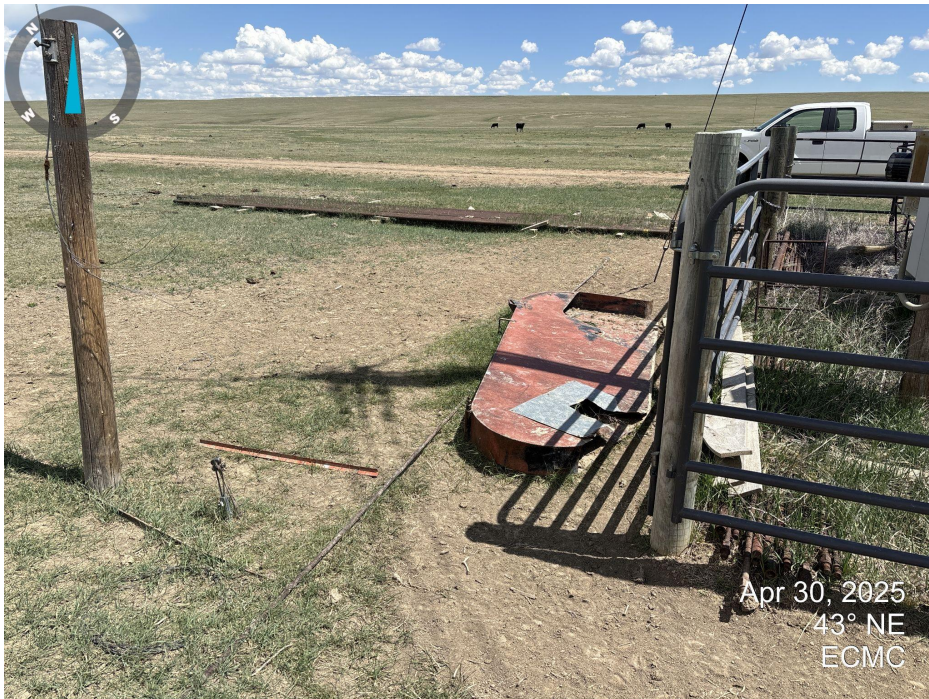
Photo 14. Looking east down the north side of the well location. Debris and unused equipment is present (belt cover, posts, barbed wire, sucker rod, pipe)

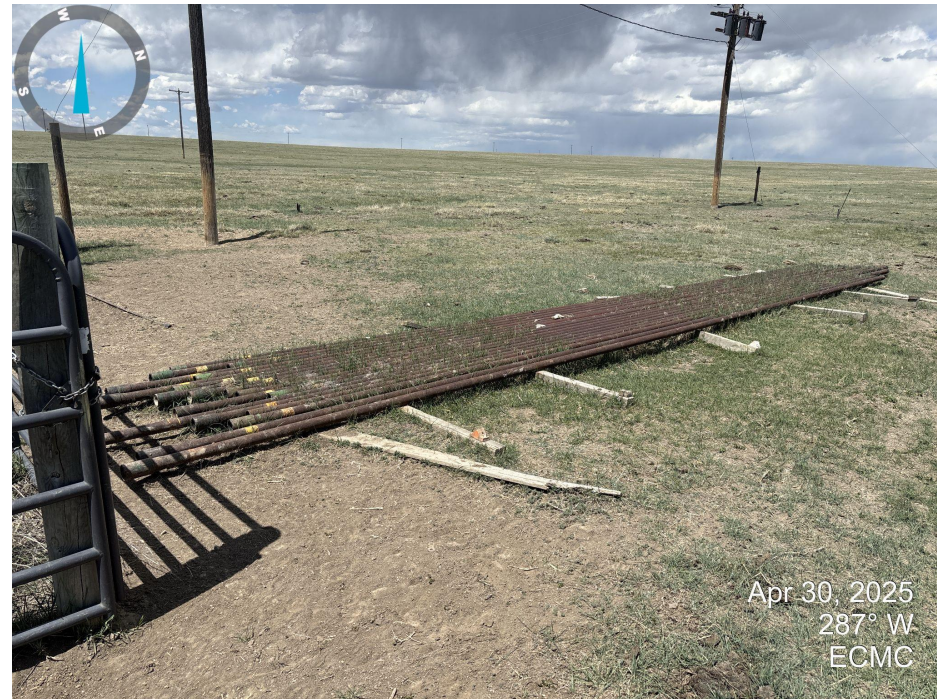
Photo 15. Pipe stored on the north side of location.
