Storm Water Management and Erosion control
Location Name: TEP ROCKY MOUNTAIN LLC DOE 1-W-19
Location ID: 311567

**Location Overview: Location is within High Priority/Density Habitat areas. Location is approximately 140 yards from a creek/drainage that contributes to the Colorado River.
Section/Township/Range: 19 6S94W**

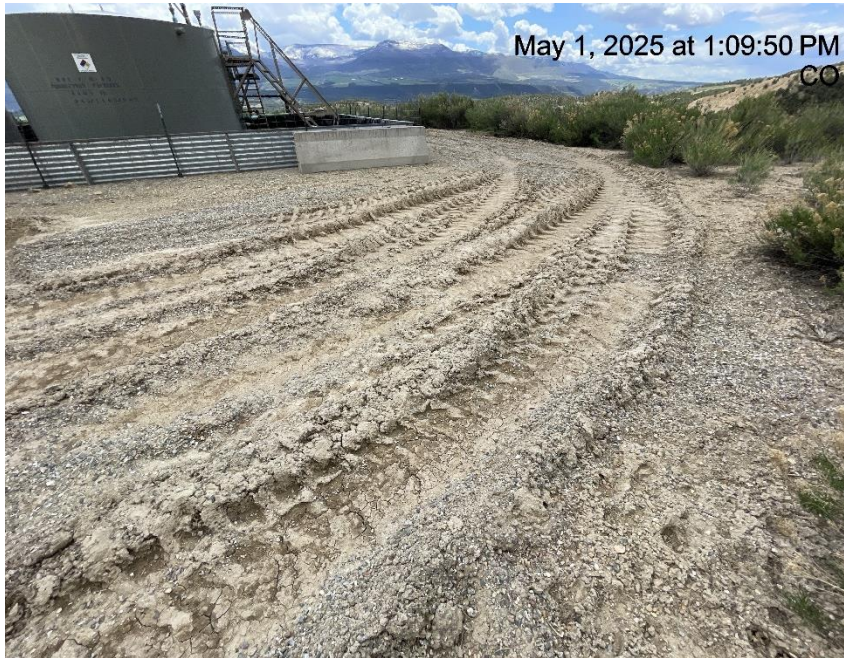
Photo # 7703 Lack of stabilization/compaction

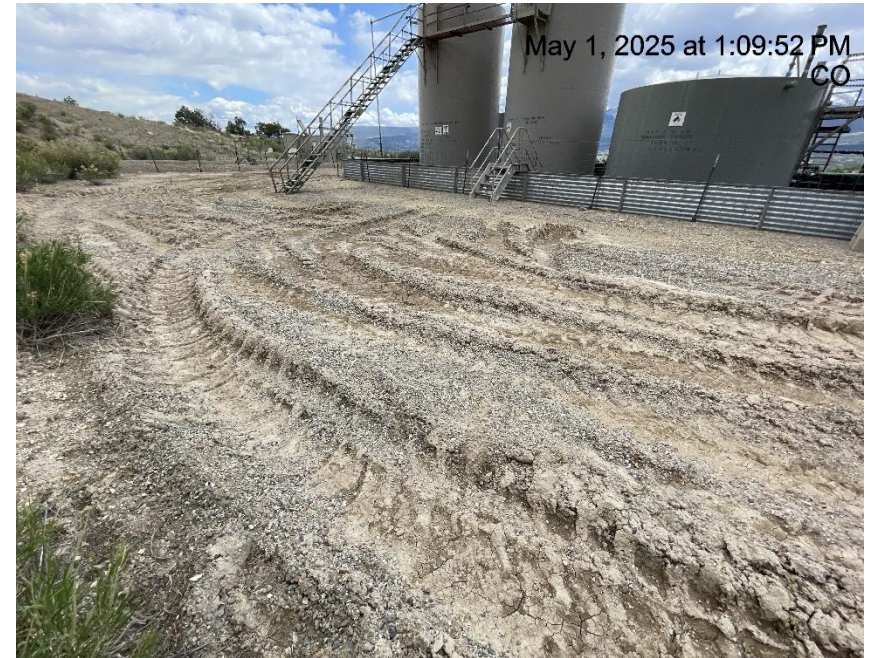
Photo # 7704 Lack of stabilization/compaction

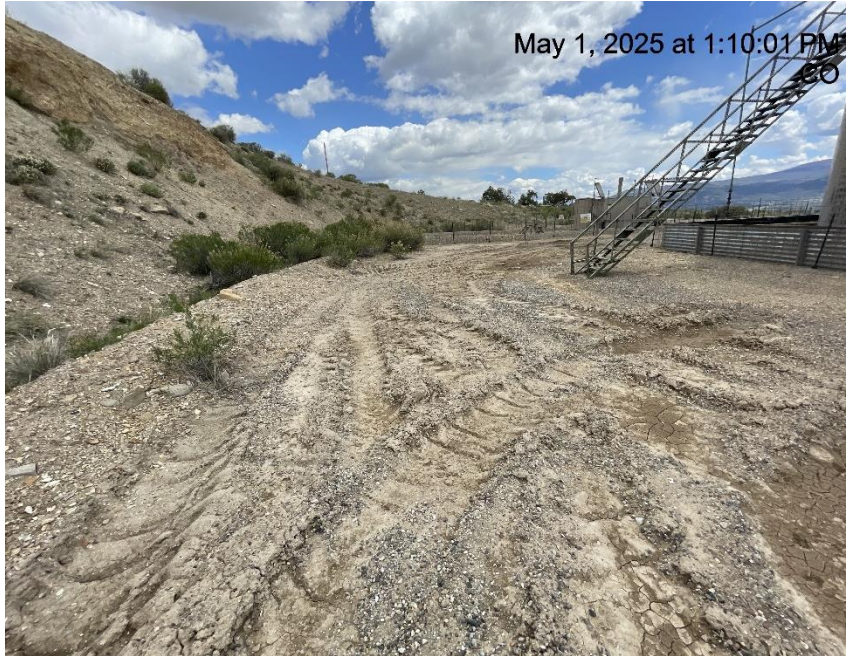
Photo # 7705 Lack of stabilization/compaction

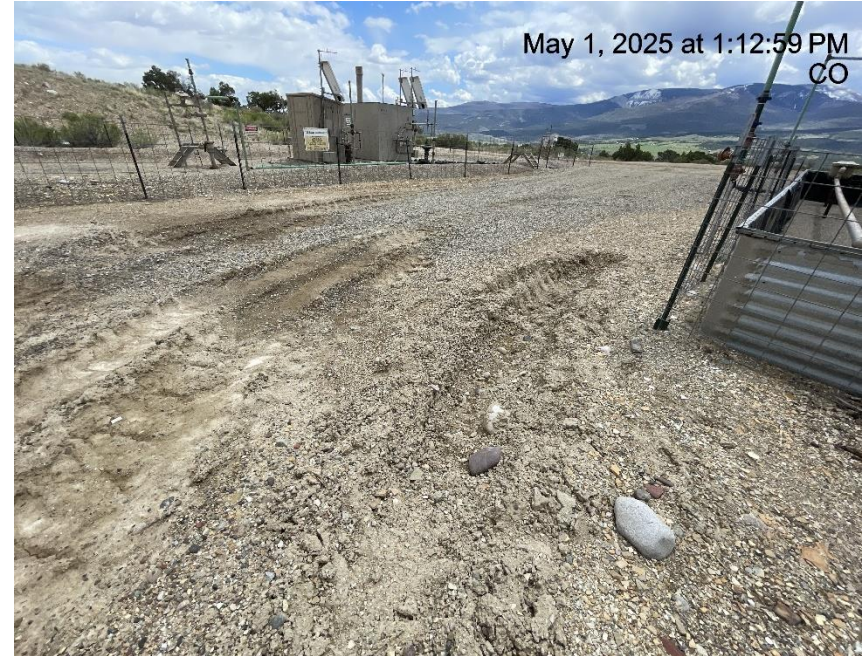
Photo # 7706 Lack of stabilization/compaction

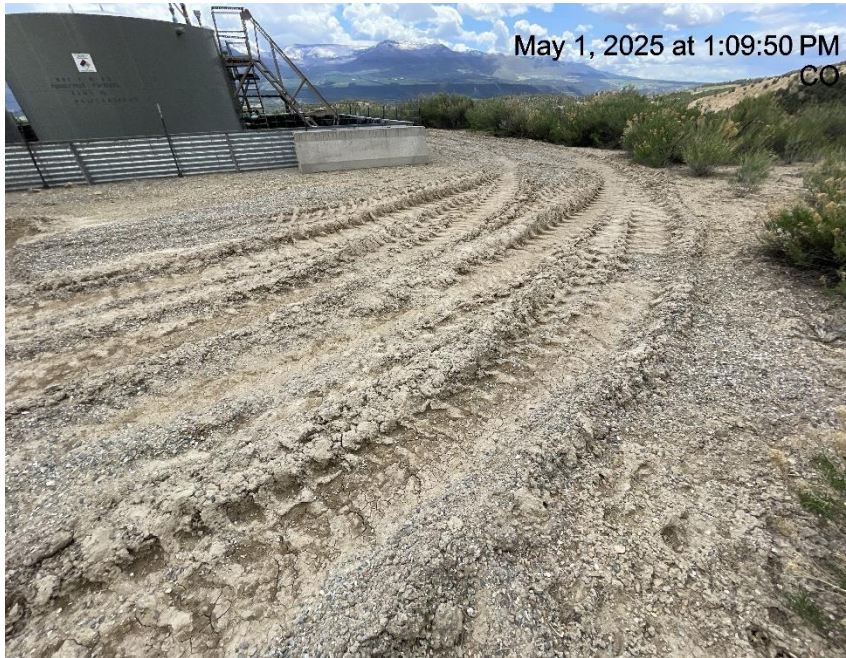
Photo # 7707 Lack of stabilization/compaction

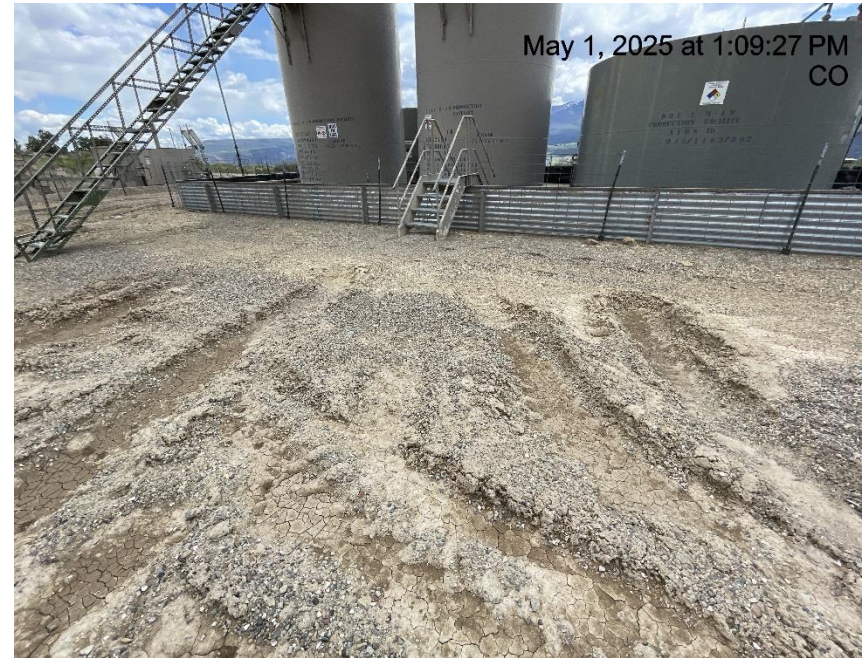
Photo # 7708 Lack of stabilization/compaction
