Inspection/Audit Photos

Location Name: TEP ROCKY MOUNTAIN LLC JOLLEY 31A-20-691 Pad

Location ID: 335173

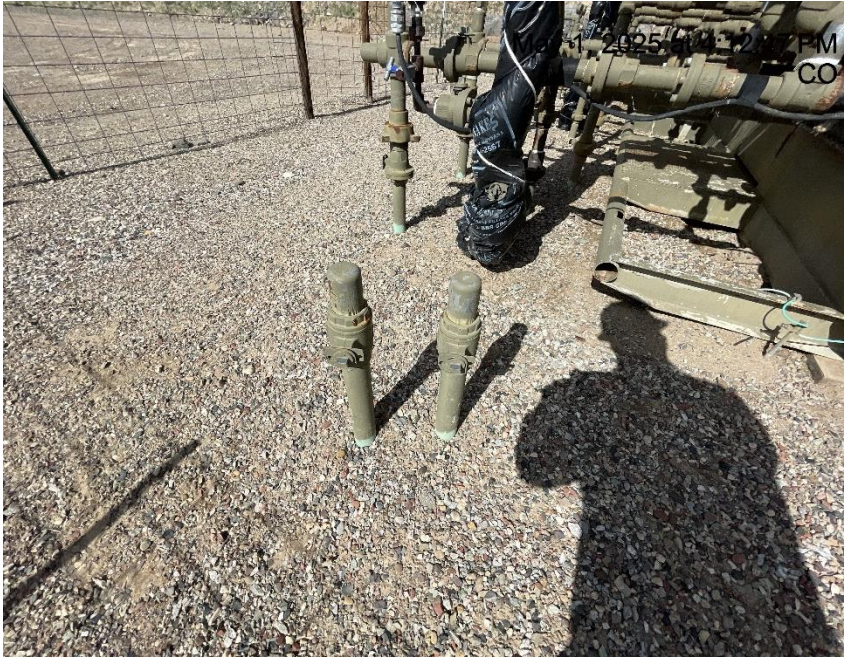
Photo # 8368 Unused flowlines at separators lack lockout tagout (OOSLAT)

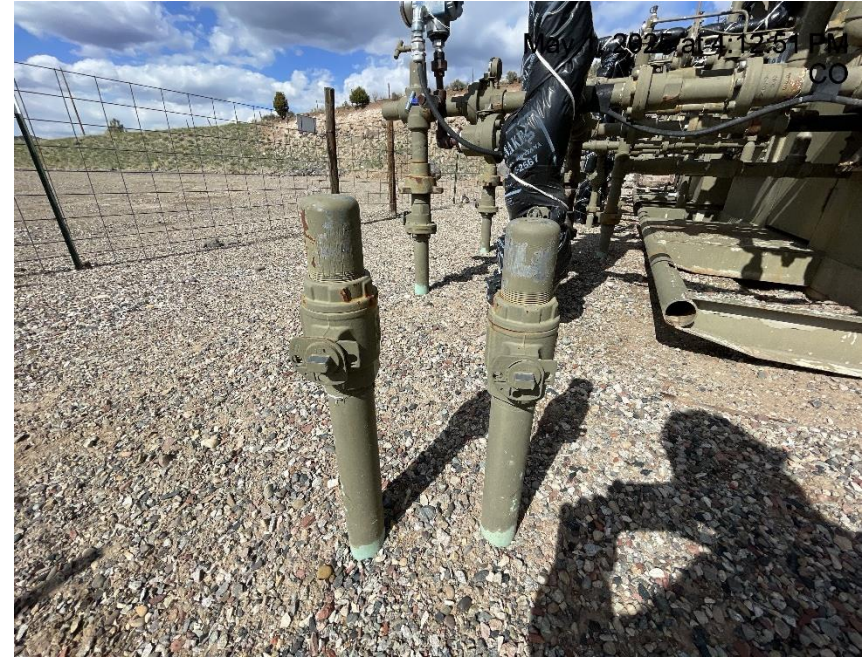
Photo # 8369 Unused flowlines at separators lack lockout tagout (OOSLAT)

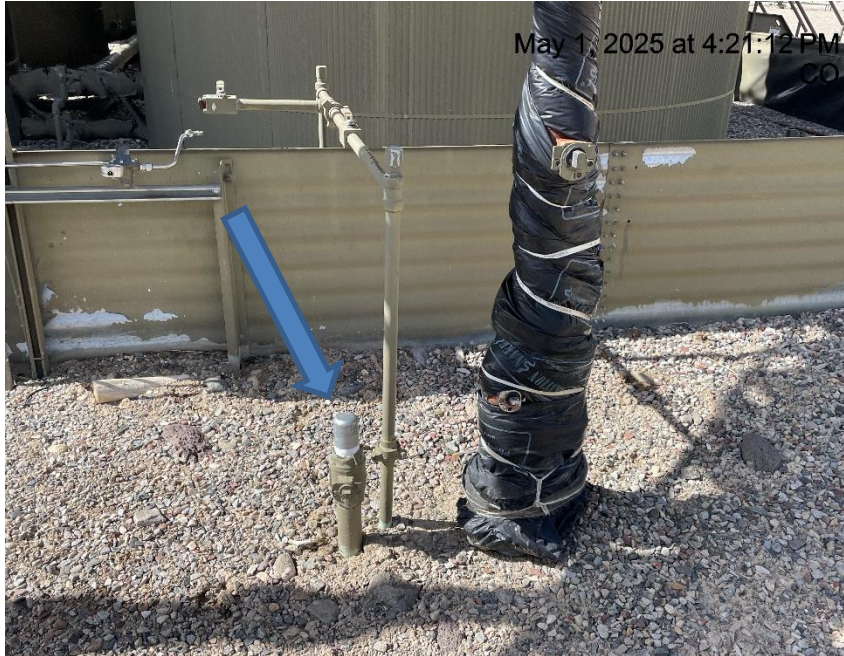
Photo # 8370 Unused flowline at tank battery lacks lockout tagout (OOSLAT)

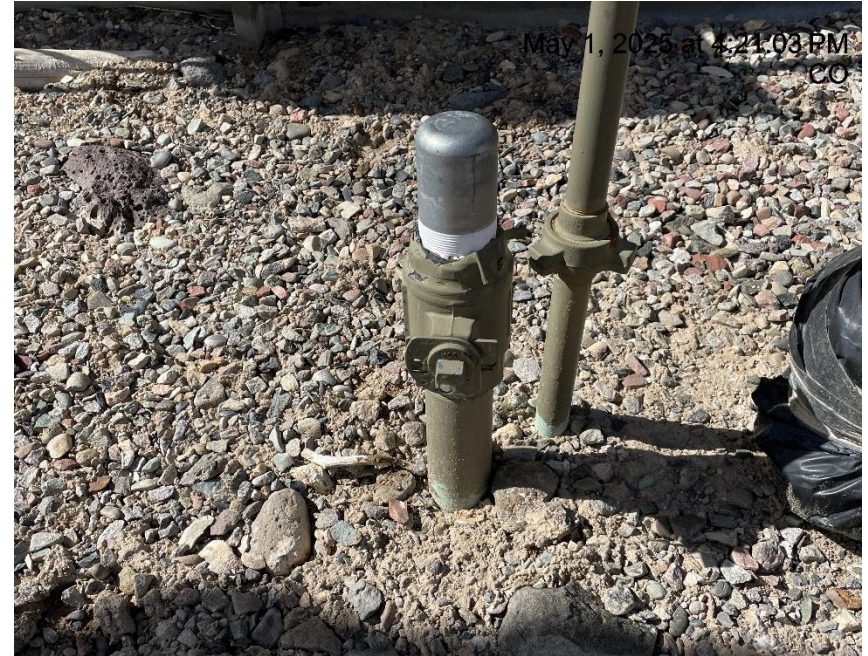
Photo # 8371 Unused flowline at tank battery lacks lockout tagout (OOSLAT)

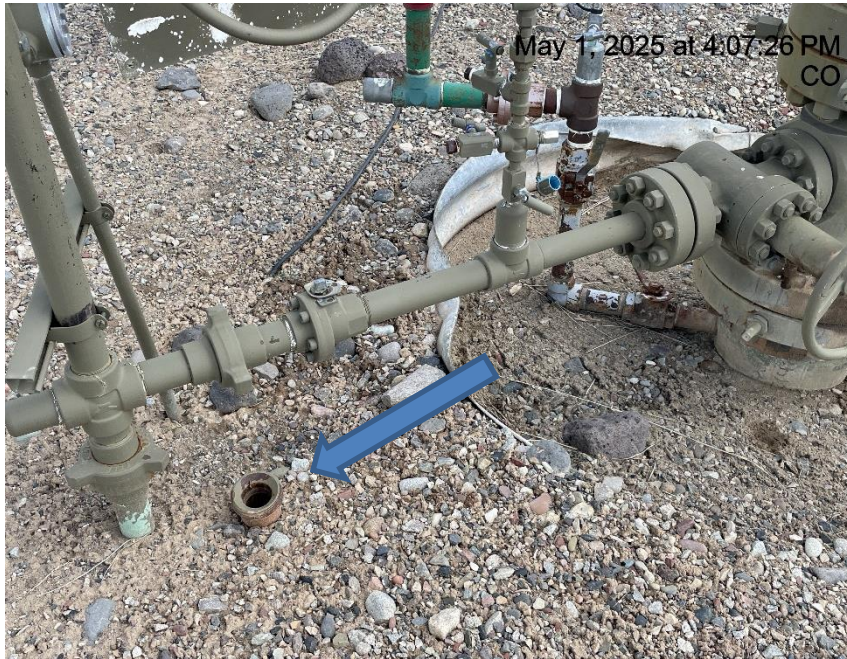
Photo # 8372 Unused flowline at wellhead lacks lockout tagout (OOSLAT) (Additionally the flowline is open ended & constitutes a wildlife hazard - JOLLEY 31A)

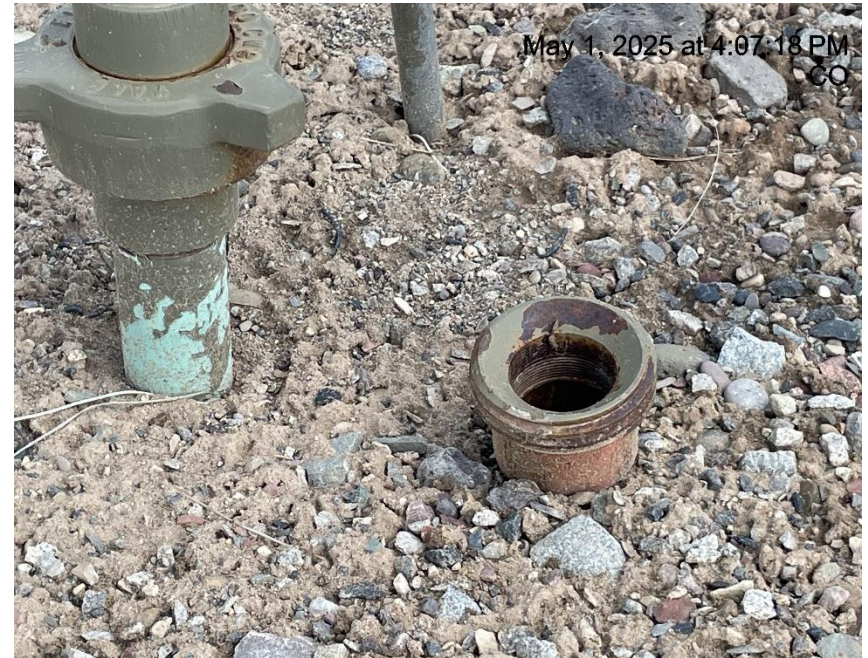
Photo # 8373 Unused flowline at wellhead lacks lockout tagout (OOSLAT) (Additionally the flowline is open ended & constitutes a wildlife hazard - JOLLEY 31A)

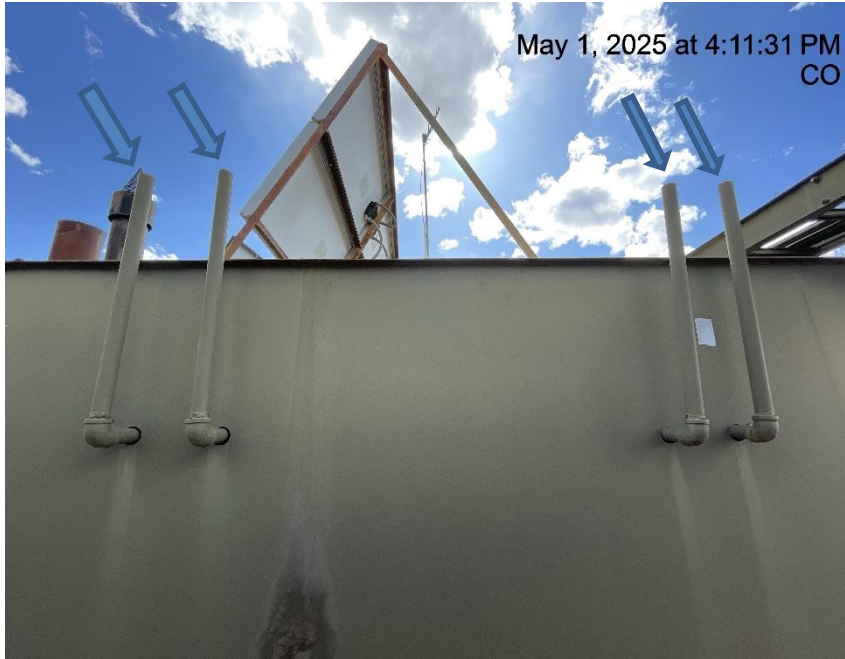
Photo # 8374 PRV & Rupture disc vent lines do not comply with CECMC pressure safety device rules

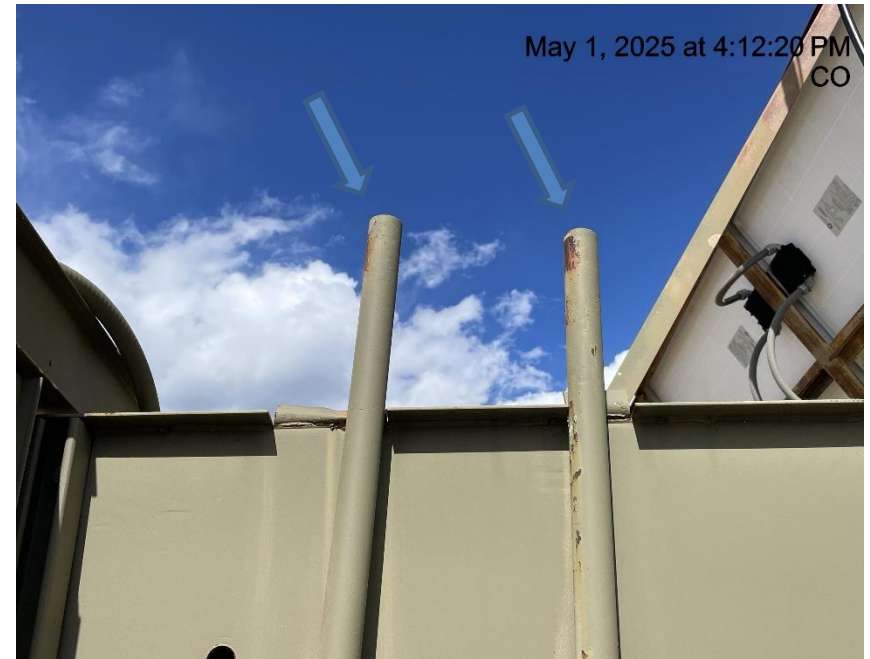
Photo # 8375 PRV & Rupture disc vent lines do not comply with CECMC pressure safety device rules

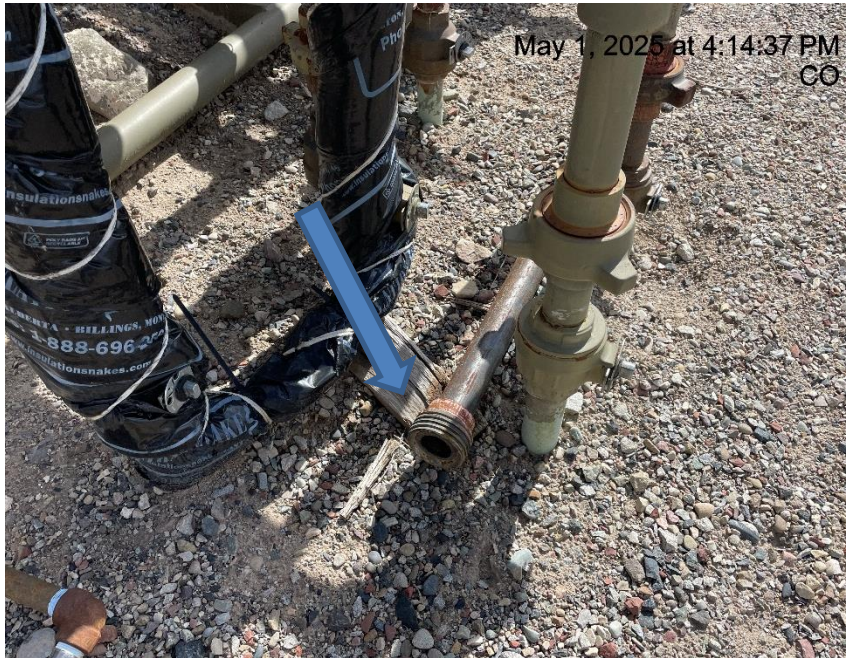
Photo # 8376 Open ended piping/wildlife hazard/available for entry by wildlife

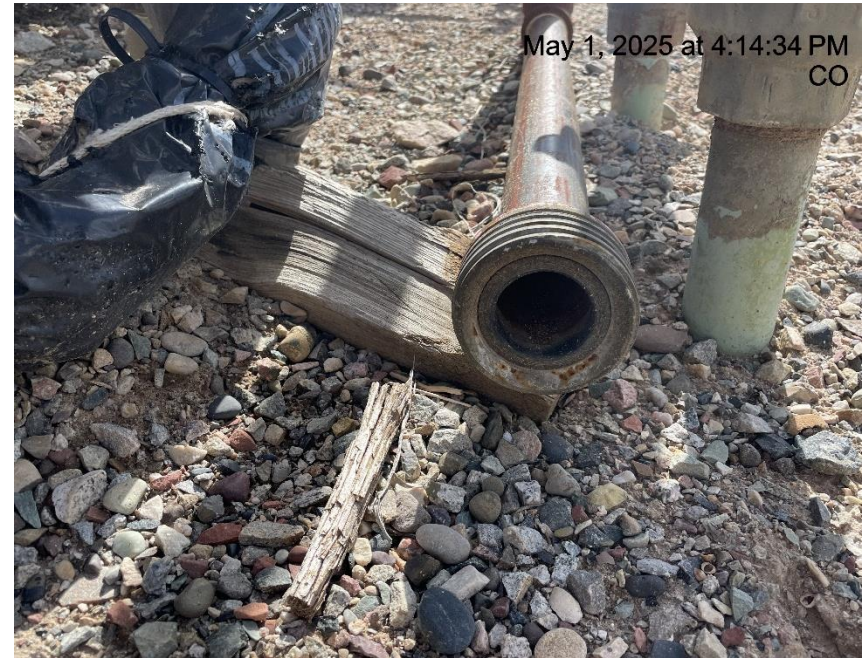
Photo # 8377 Open ended piping/wildlife hazard/available for entry by wildlife

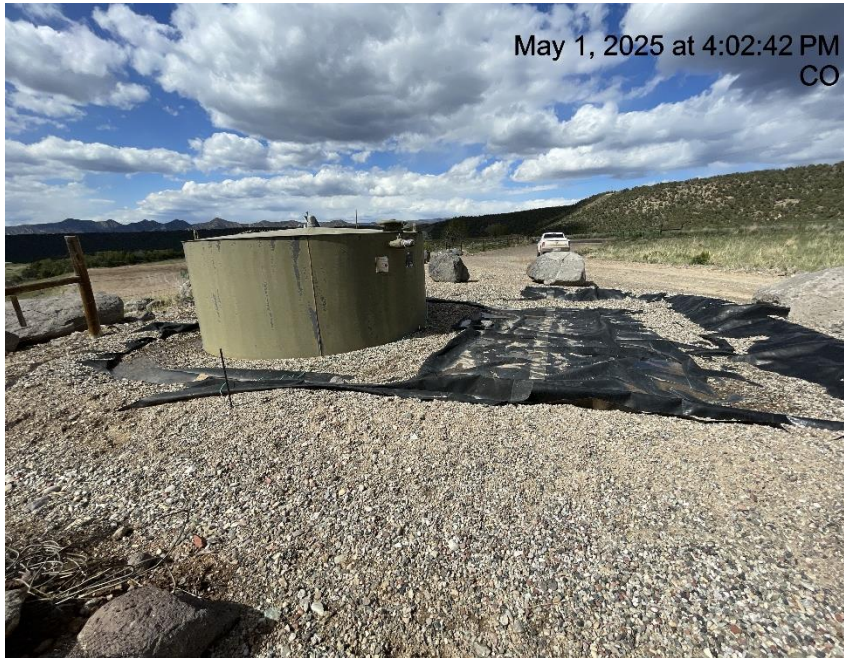
Photo # 8378 Secondary containment insufficient/does not comply with CECMC rules

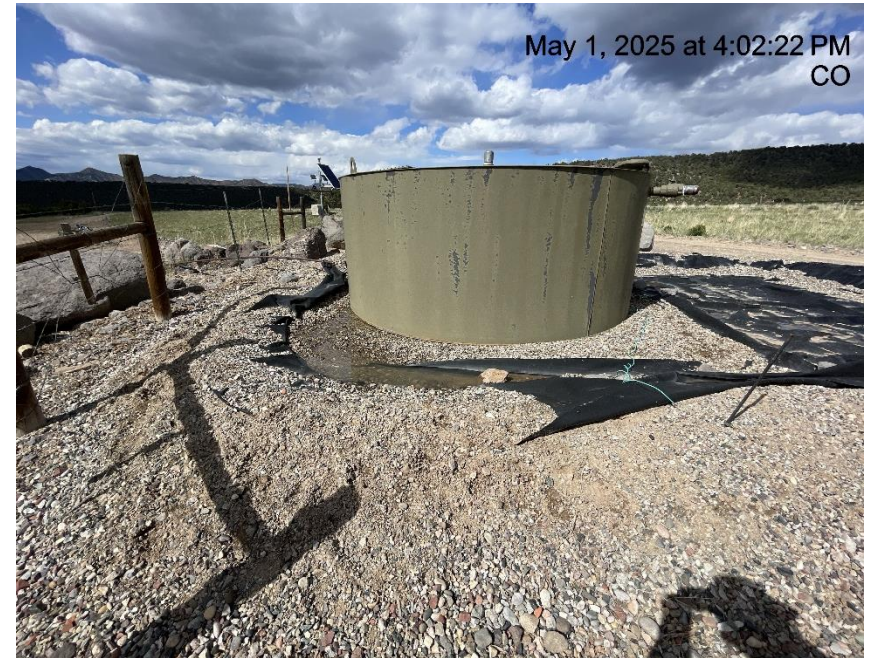
Photo # 8379 Secondary containment insufficient/does not comply with CECMC rules

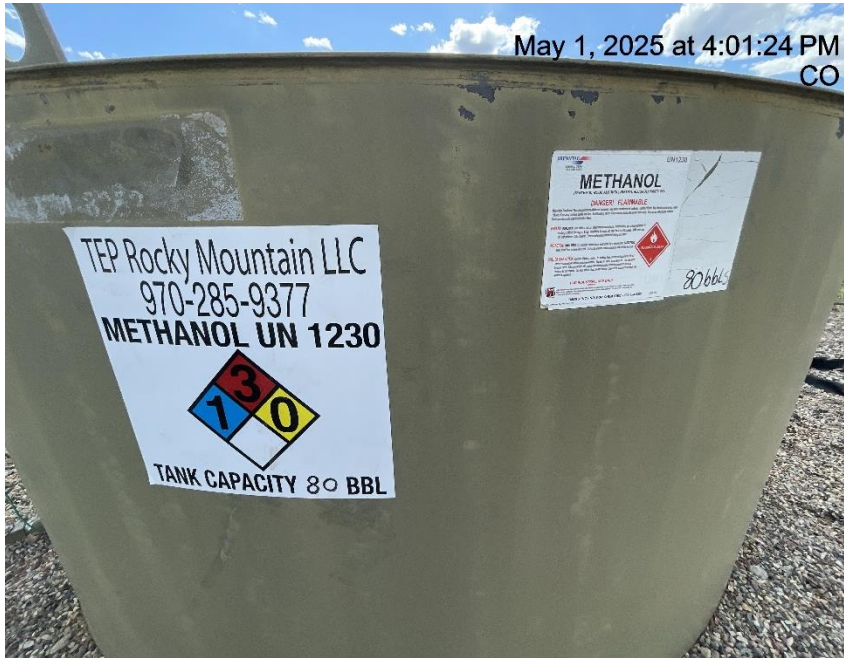
Photo # 8380 Tank capacity incorrect
