Inspection/Audit Photos

Location Name: TEP ROCKY MOUNTAIN LLC JOLLEY 20-6 Pad

Location ID: 335185

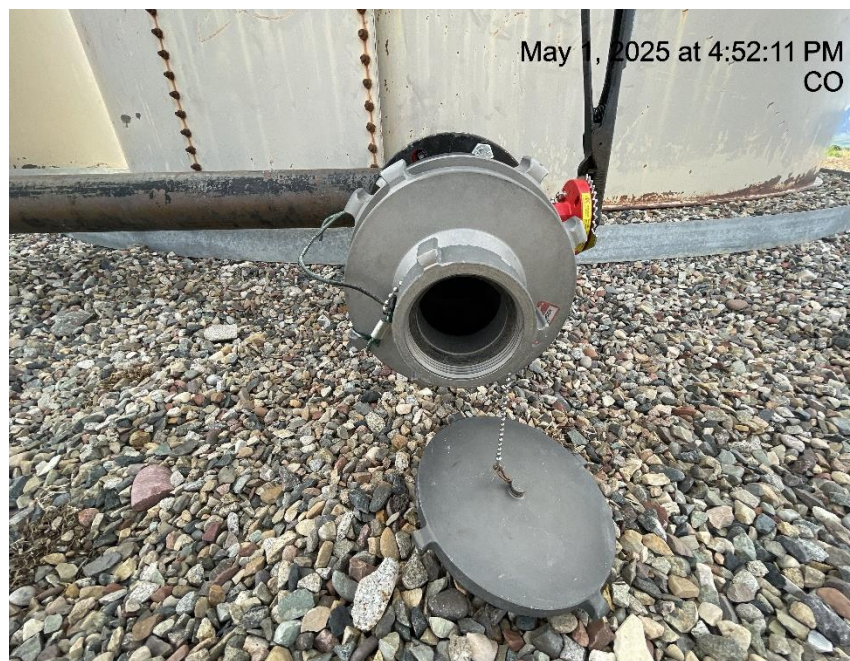
Photo # 8512 Open ended load line

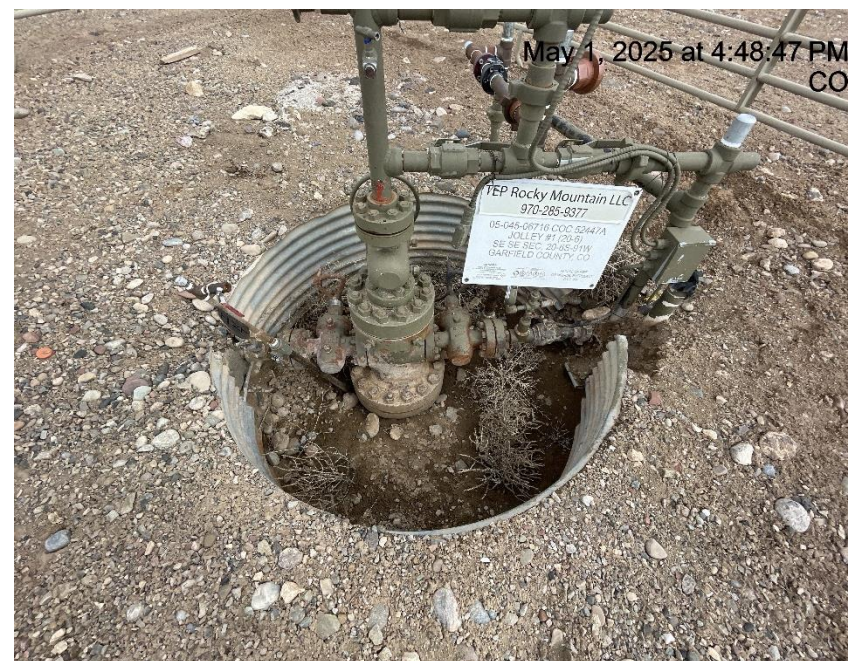
Photo # 8513 Wellhead cellar lacks wildlife egress - JOLLEY #1 (20-6)

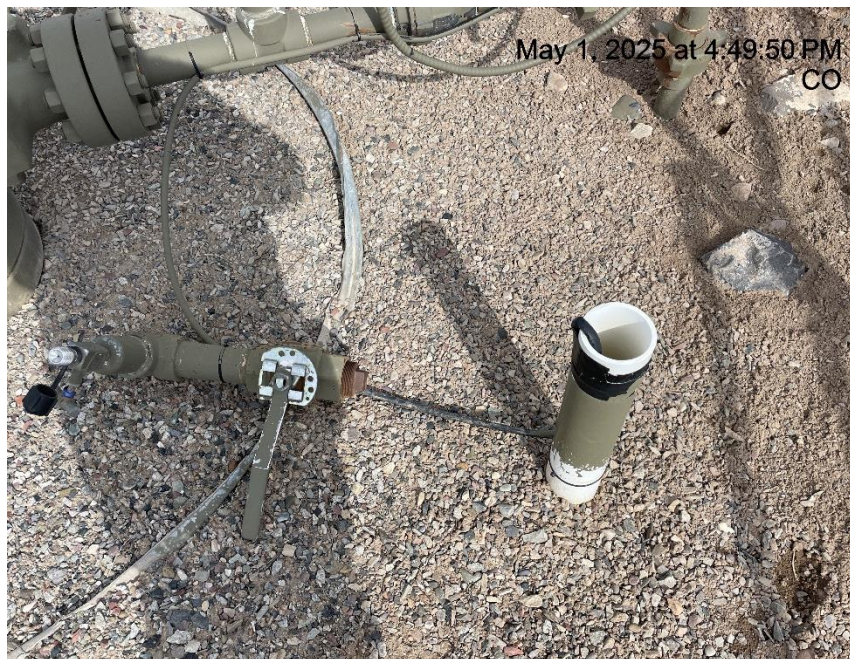
**Photo # 8514 Open ended plastic piping/wildlife hazard
/available for entry by wildlife**

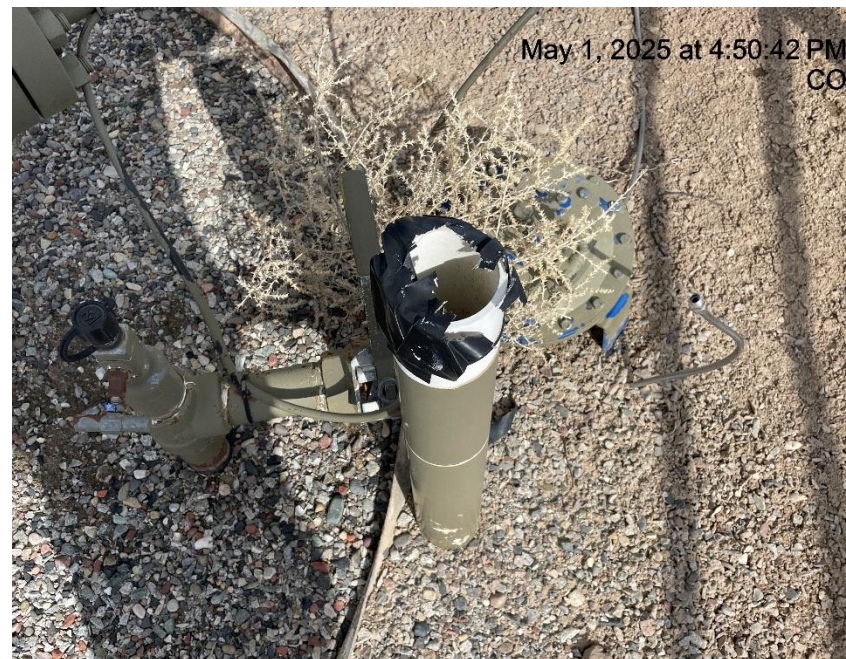
**Photo # 8515 Open ended plastic piping/wildlife hazard
/available for entry by wildlife**

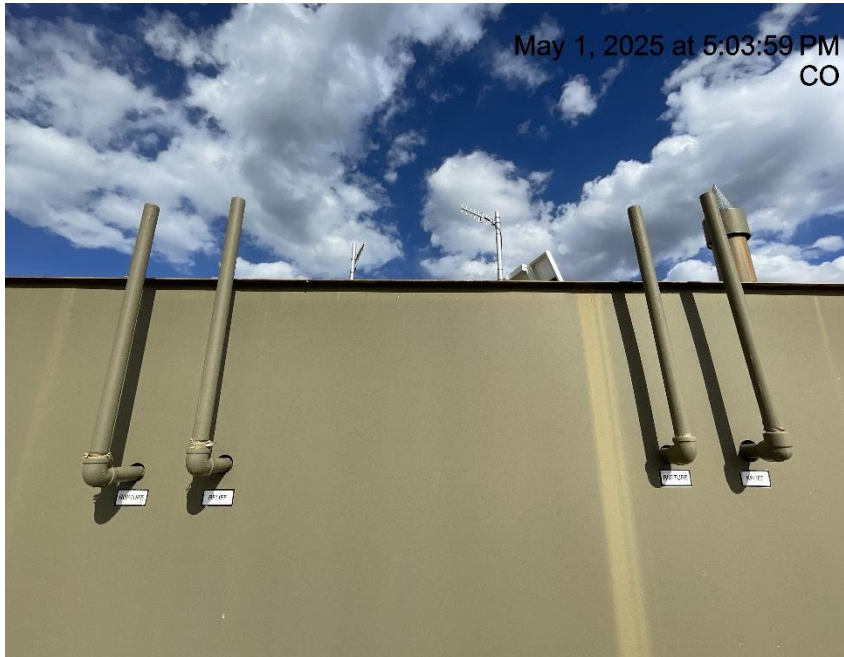
Photo # 8516 PRV & Rupture disc vent lines do not comply with CECMC pressure safety device rules

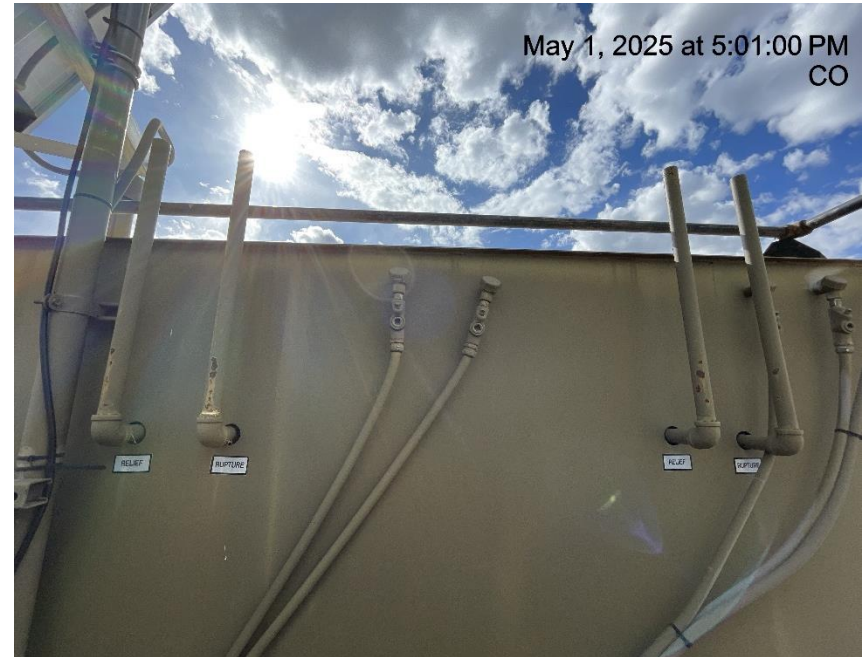
Photo # 8517 PRV & Rupture disc vent lines do not comply with CECMC pressure safety device rules

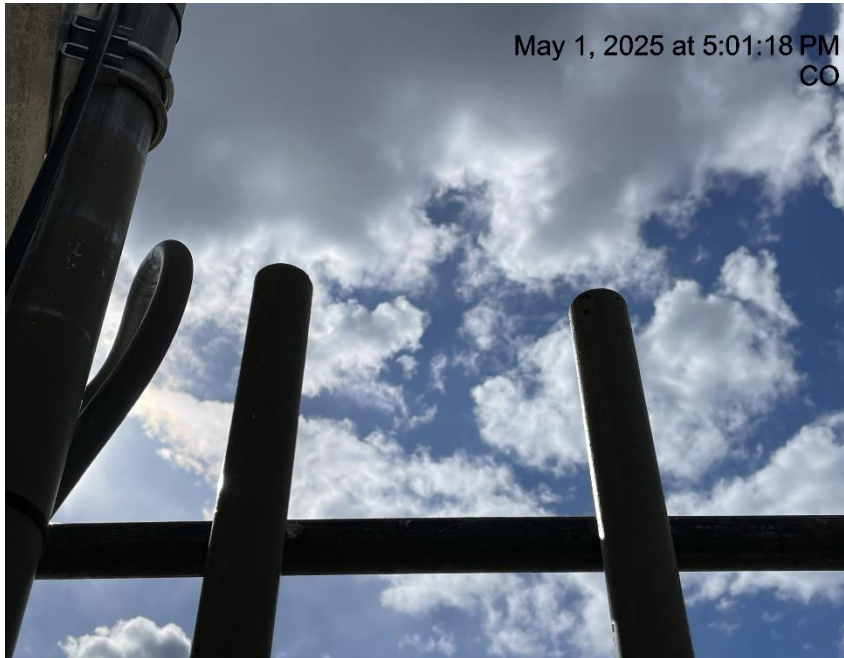
Photo # 8518 PRV & Rupture disc vent lines do not comply with CECMC pressure safety device rules

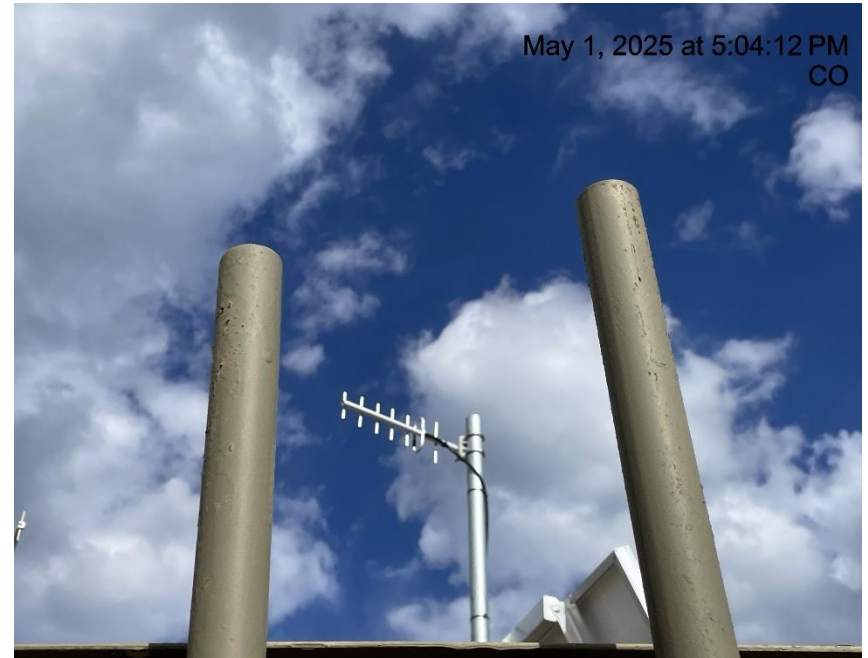
Photo # 8519 PRV & Rupture disc vent lines do not comply with CECMC pressure safety device rules

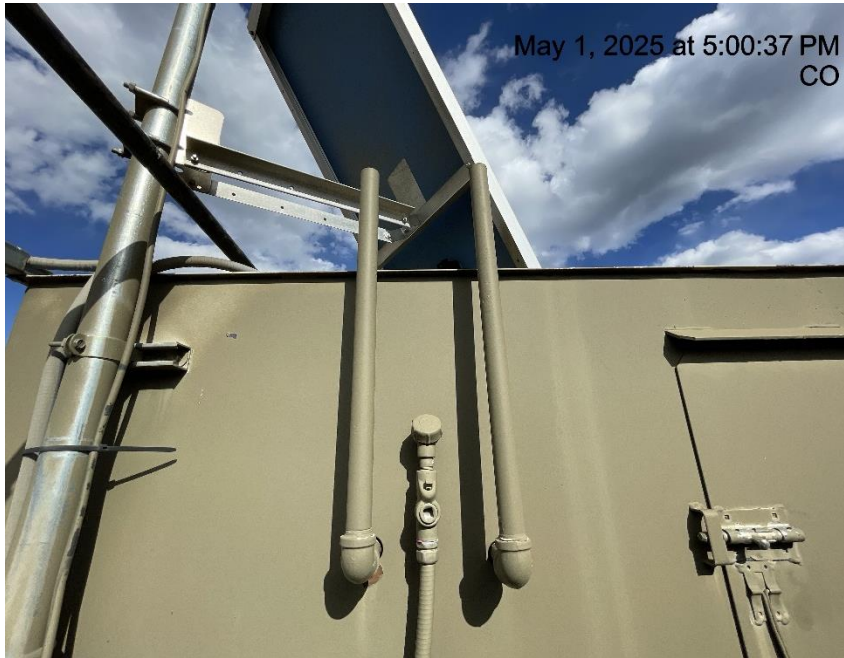
Photo # 8520 PRV & Rupture disc vent lines do not comply with CECMC pressure safety device rules

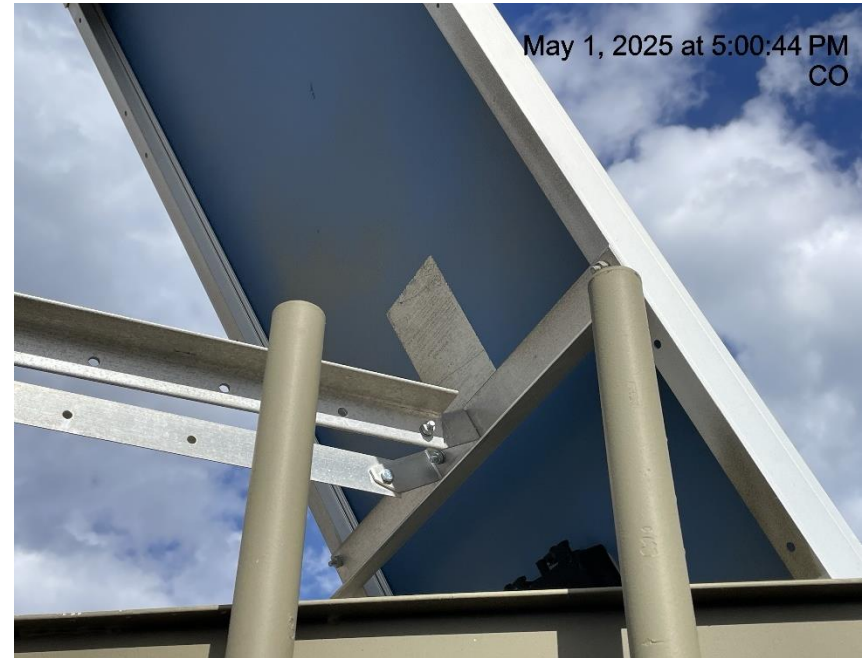
Photo # 8521 PRV & Rupture disc vent lines do not comply with CECMC pressure safety device rules

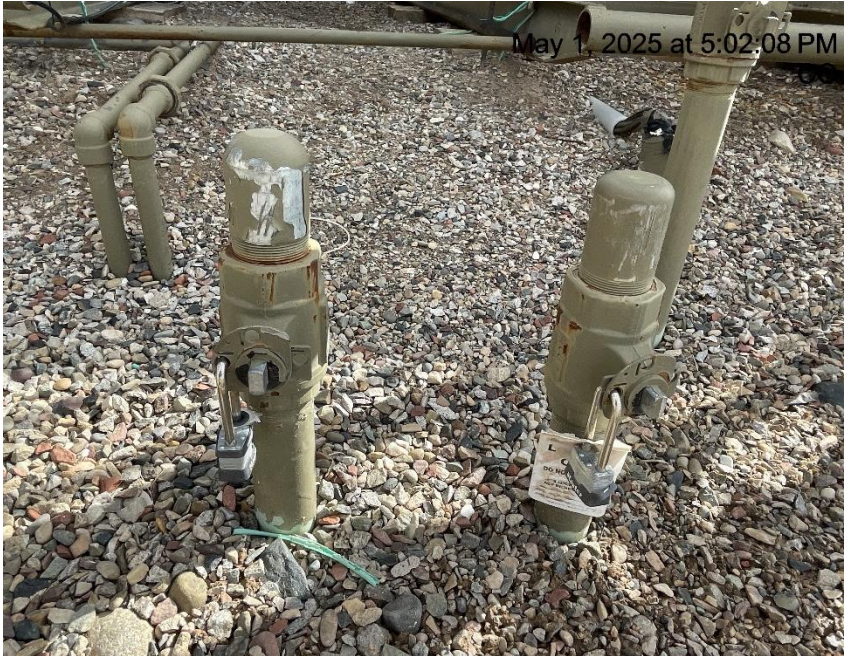
Photo # 8522 Unused flowlines at separators do not comply with general safety rules or lockout tagout rules (OOSLAT)

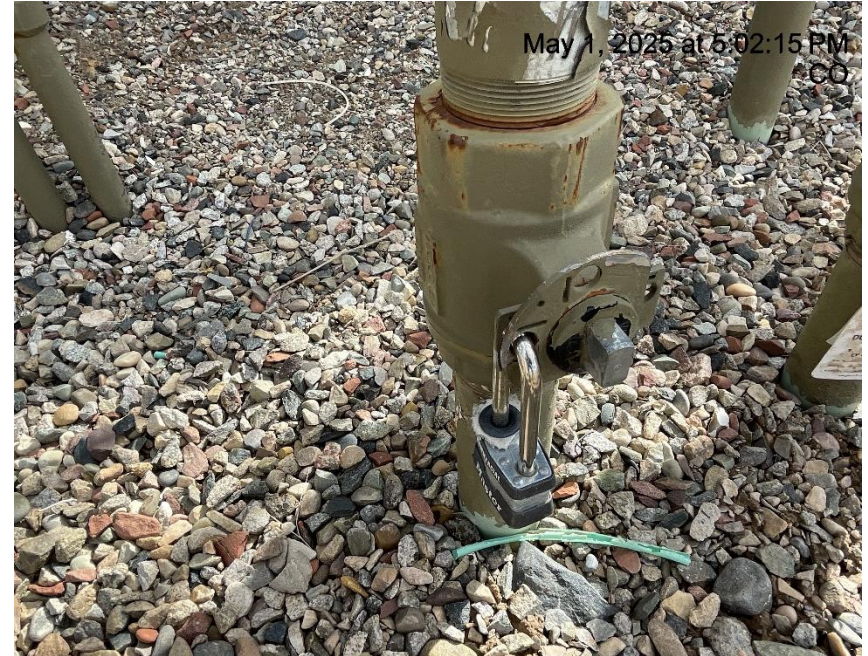
Photo # 8523 Unused flowline at separators does comply with general safety rules or lockout tagout rules (OOSLAT)

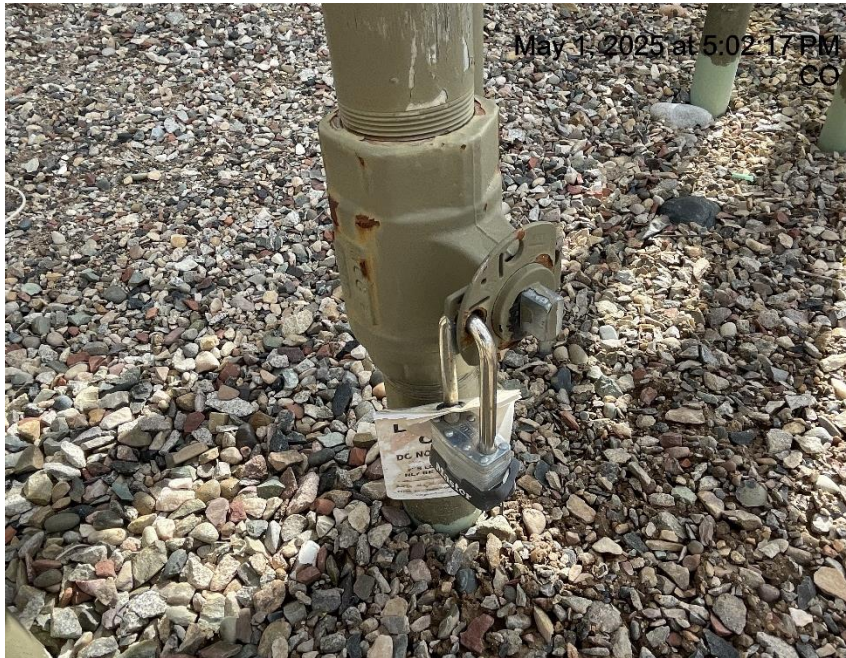
Photo # 8524 Unused flowline at separators does comply with general safety rules or lockout tagout rules (OOSLAT)

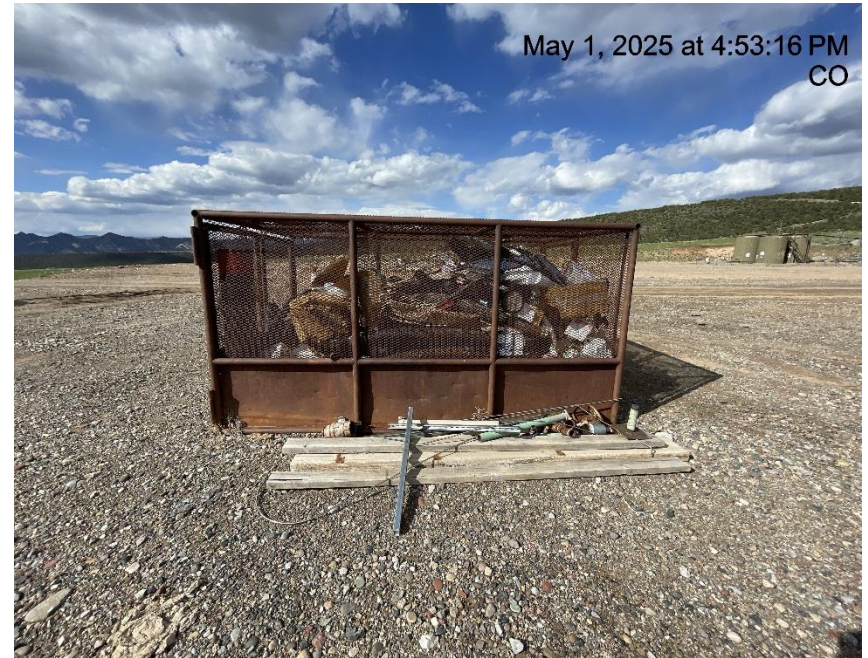
Photo # 8525 Debris laying on the ground near bear proof trash container
