## Inspection Photos

Location Name: MUSTANG RESOURCES LLC Mead 24-14MV Pad

Location ID: 335234

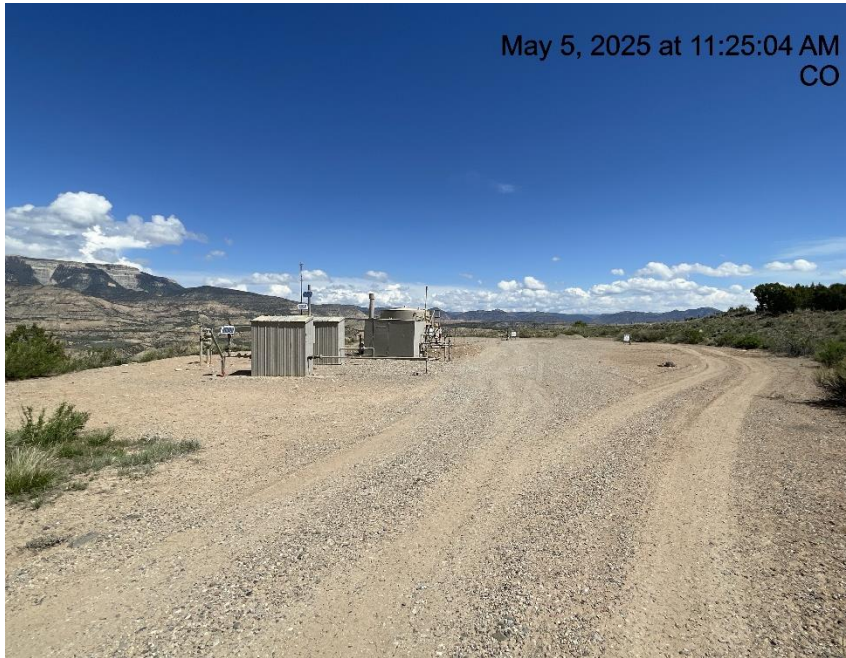
Photo # 8895 From entrance to location

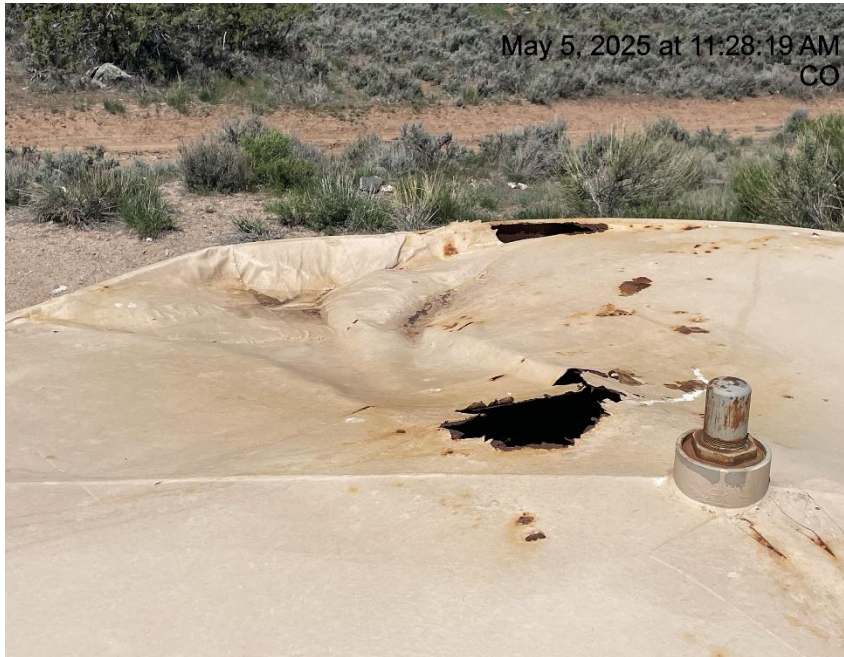
**Photo # 8903 Tank failure – Multiple holes in 210 bbl production tank/tank lacks integrity (Additionally the holes also constitute a wildlife hazard)**

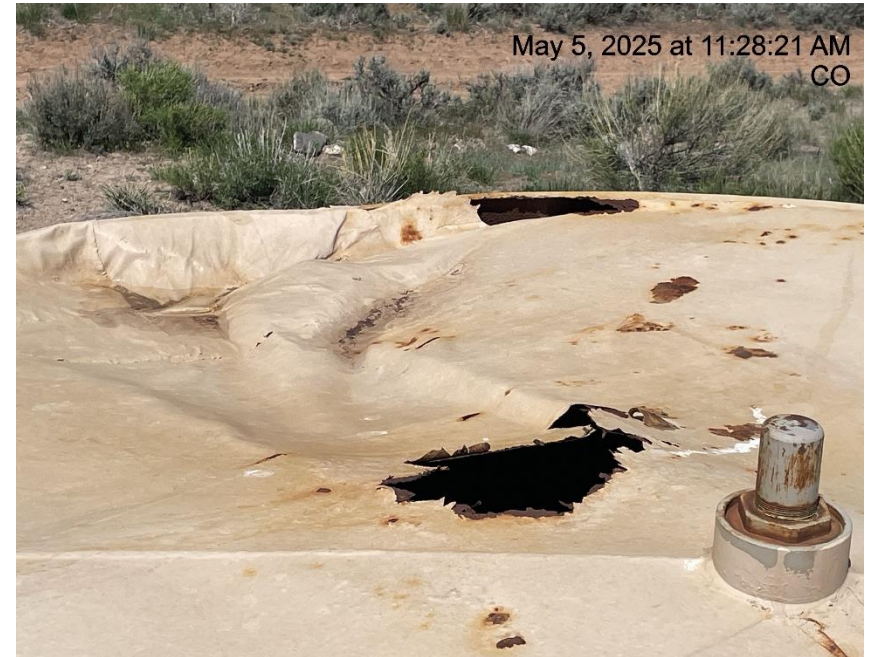
**Photo # 8904 Tank failure – Multiple holes in 210 bbl production tank/tank lacks integrity (Additionally the holes also constitute a wildlife hazard)**

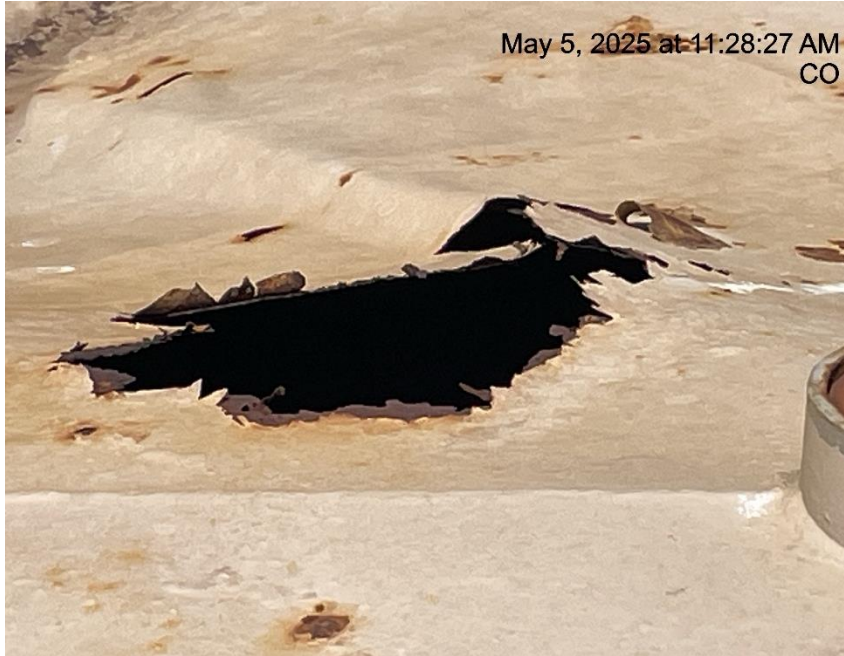
**Photo # 8905 Tank failure – Multiple holes in 210 bbl production tank/tank lacks integrity (Additionally the holes also constitute a wildlife hazard)**

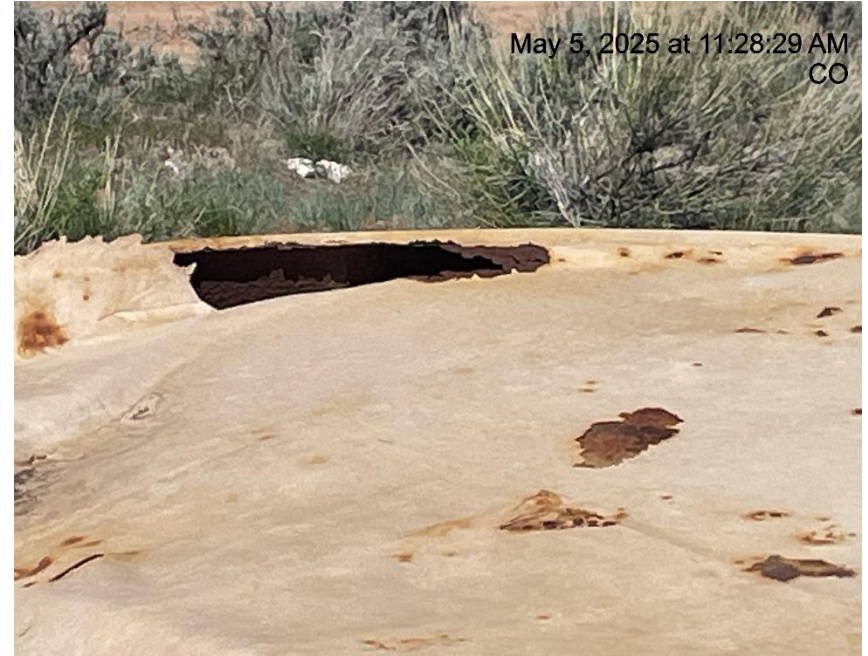
**Photo # 8906 Tank failure – Multiple holes in 210 bbl production tank/tank lacks integrity (Additionally the holes also constitute a wildlife hazard)**

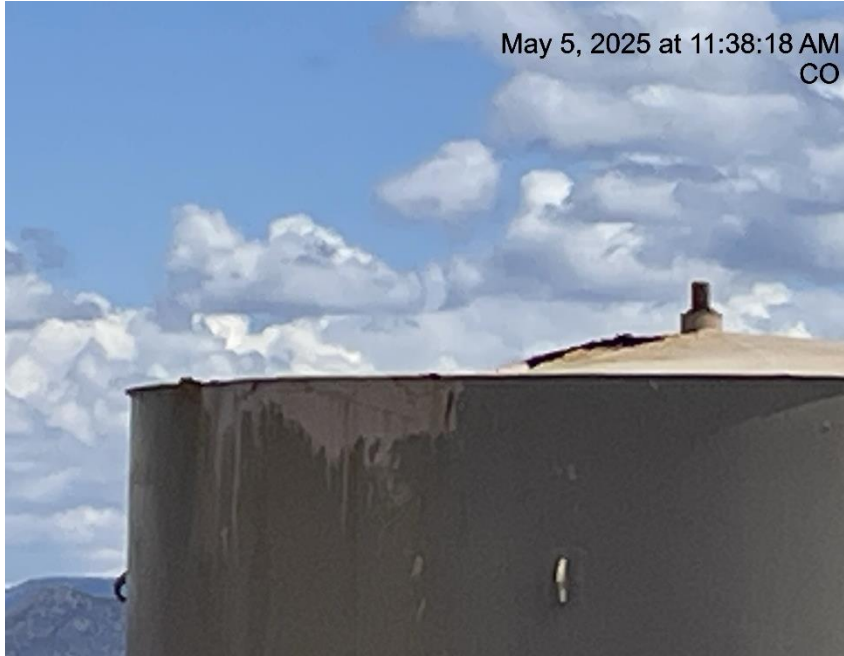
**Photo # 8907 Tank failure – Multiple holes in 210 bbl production tank/tank lacks integrity (Additionally the holes also constitute a wildlife hazard)**

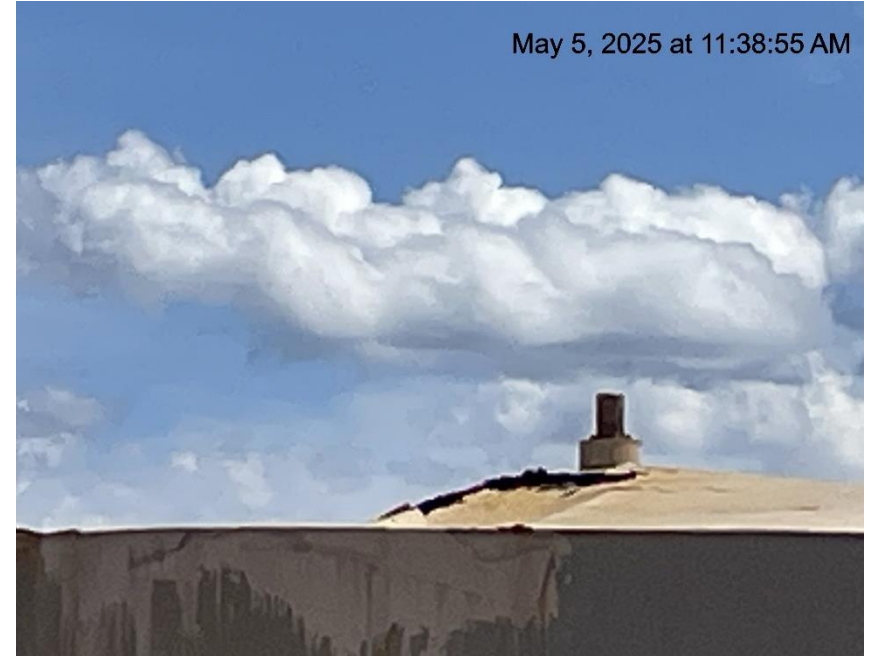
**Photo # 8908 Tank failure – Multiple holes in 210 bbl production tank/tank lacks integrity (Additionally the holes also constitute a wildlife hazard)**

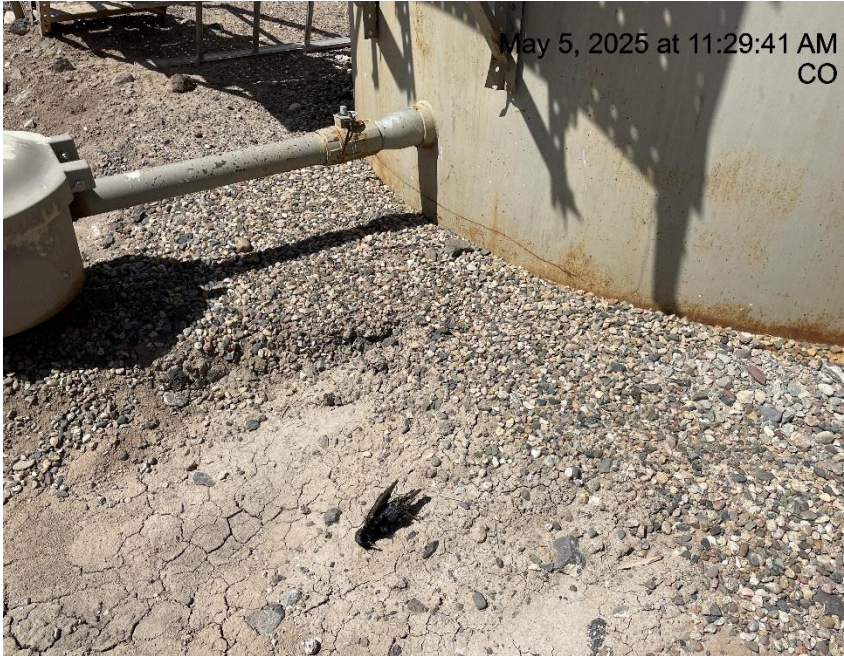
Photo # 8909 Dead bird in secondary containment

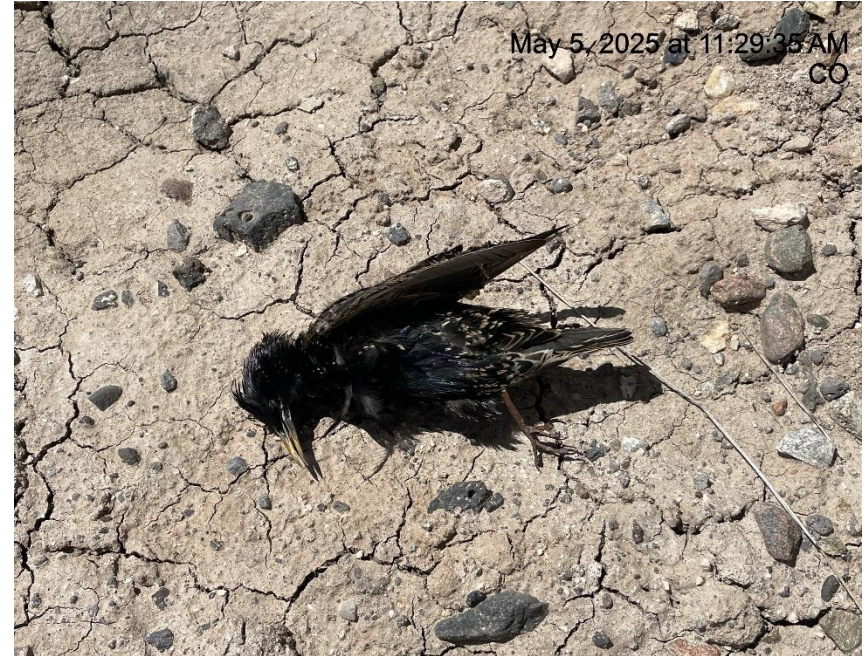
Photo # 8910 Dead bird in secondary containment

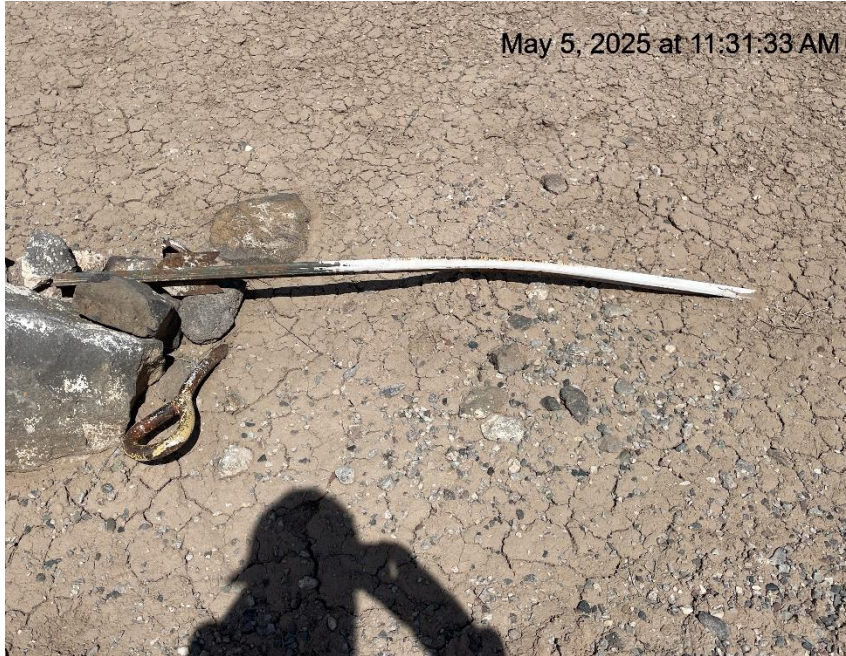
Photo # 8911 Improperly marked deadman

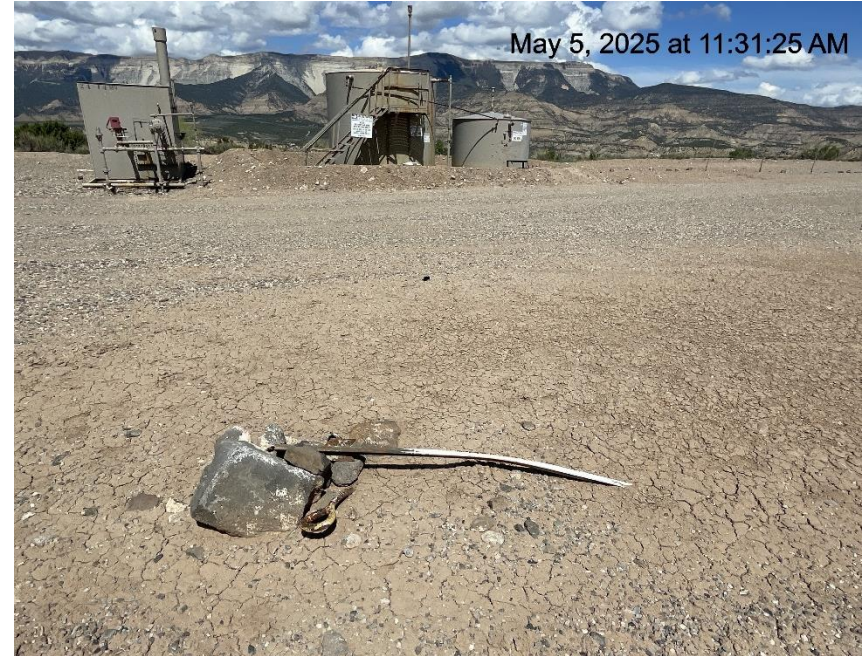
Photo # 8912 Same improperly marked deadman

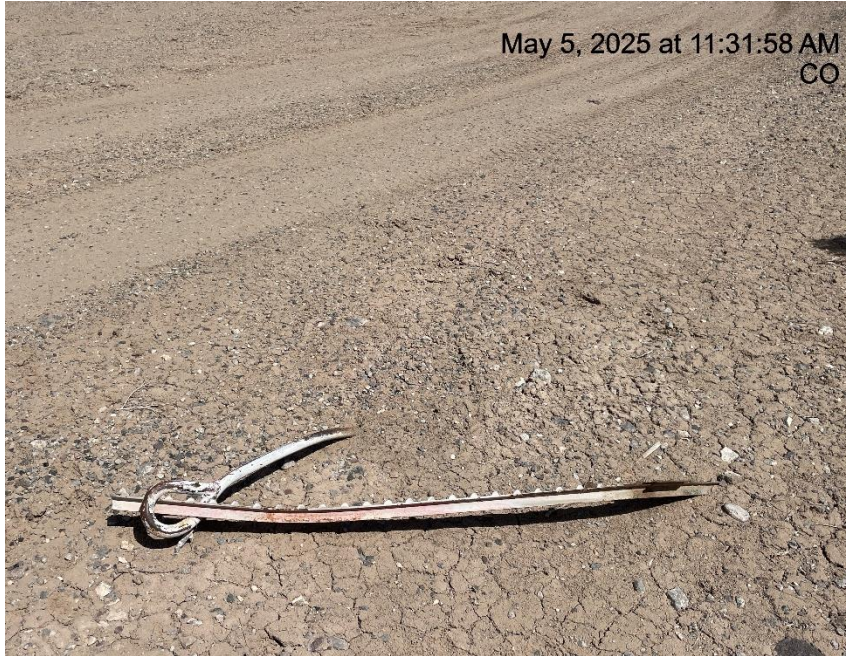
Photo # 8913 Improperly marked deadman

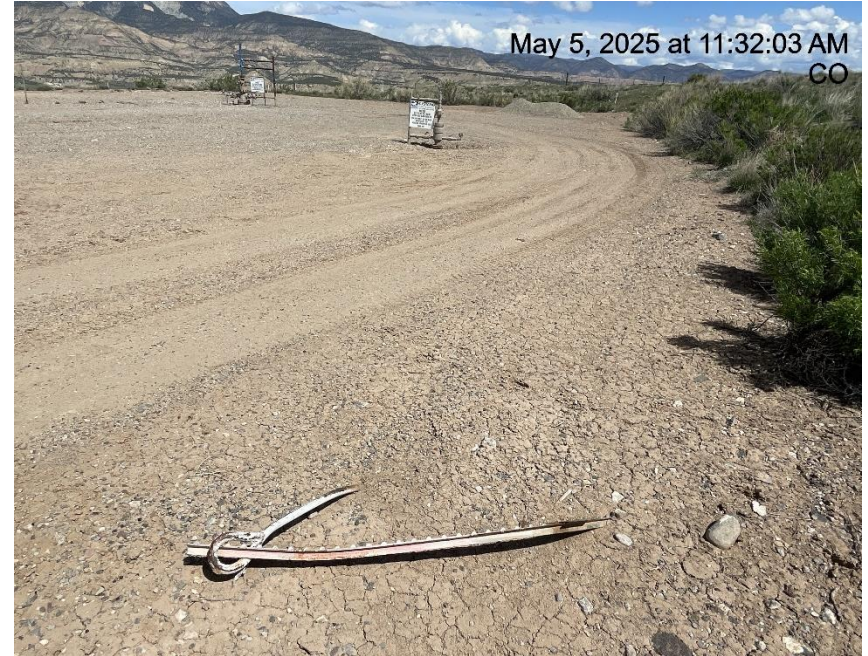
Photo # 8914 Same improperly marked deadman
