Inspection Photos

Operator: GUNNISON ENERGY LLC - 10515

Location ID: 324484

Inspection Doc: 718100503

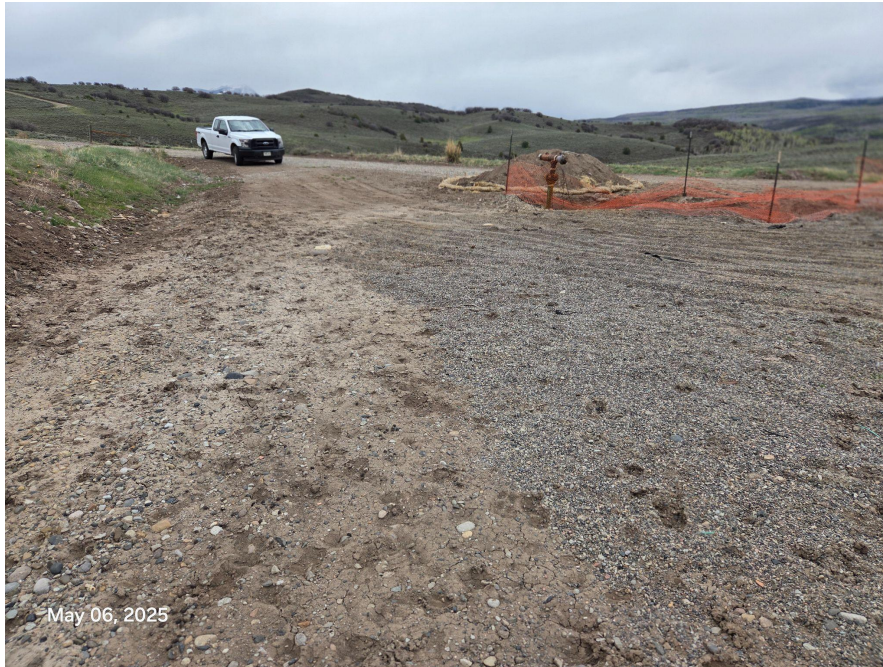
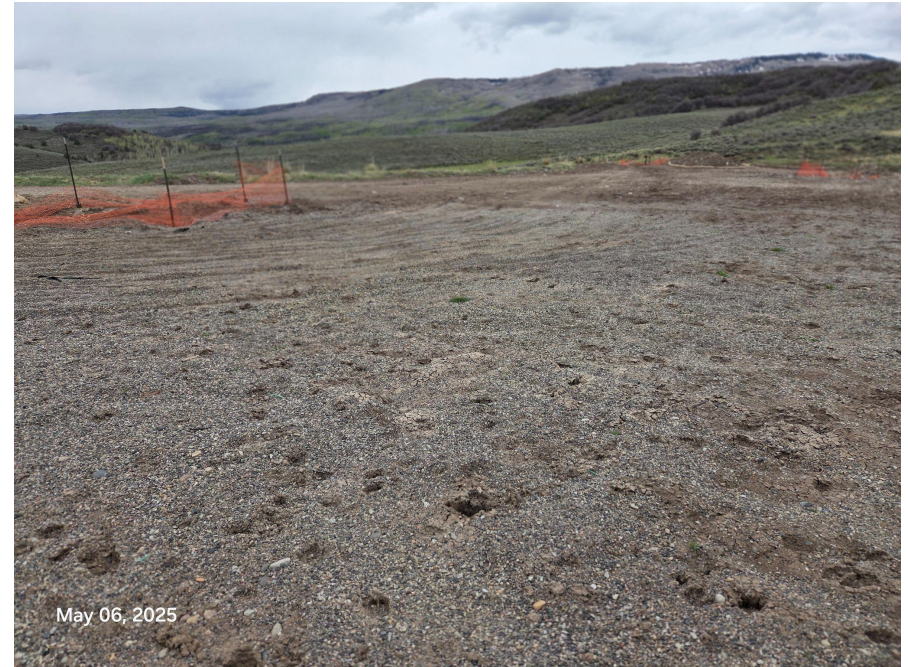
Photo 1: Photos 1-2 taken from the east end of the Location. Photos provide an overview of the Location from south, southwest, northwest to north. Well on Location has been P&Ad, the tank battery and other production facilitates have been removed from the Location.

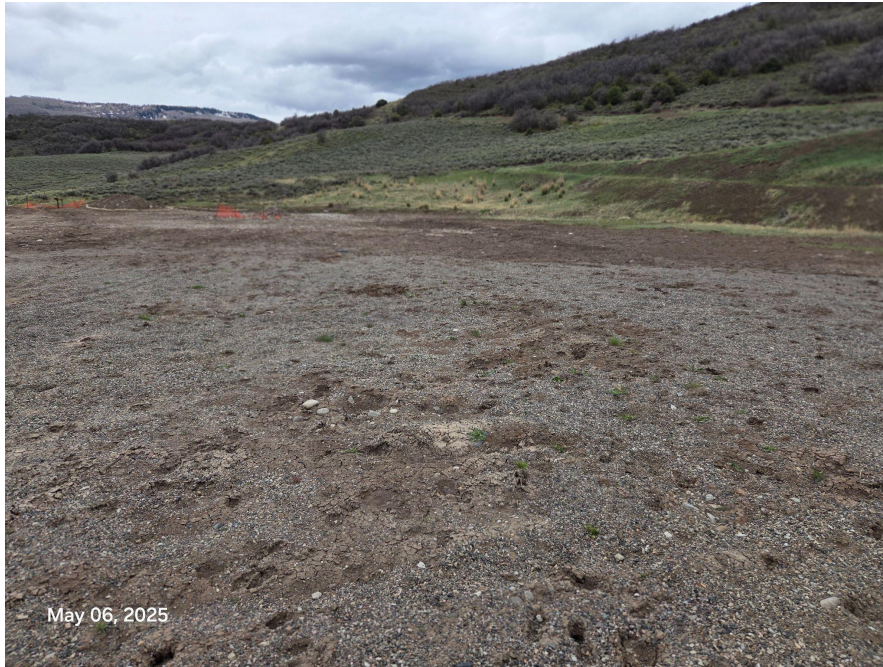
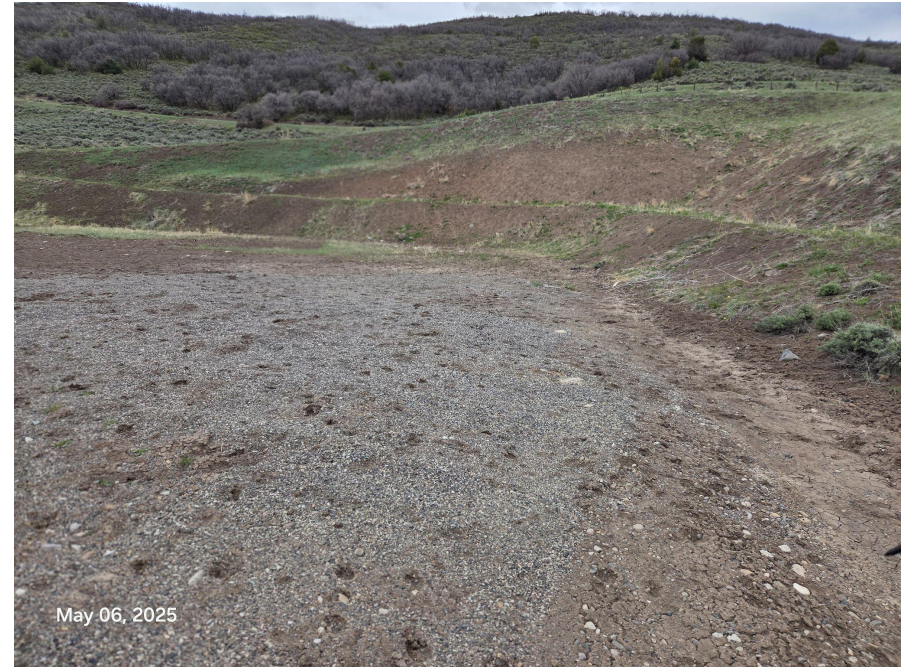
Photo 2: See comments under photo 2.

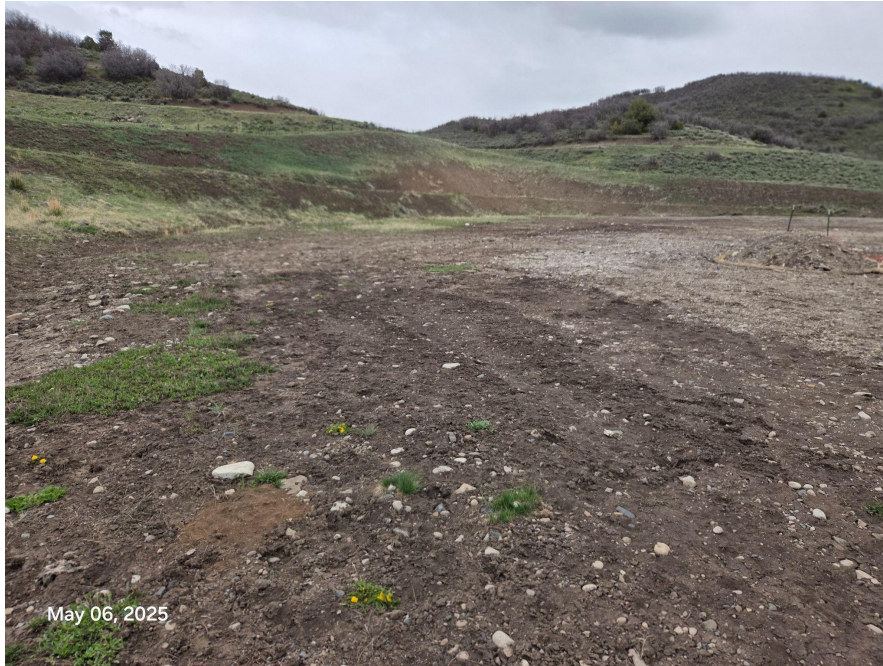
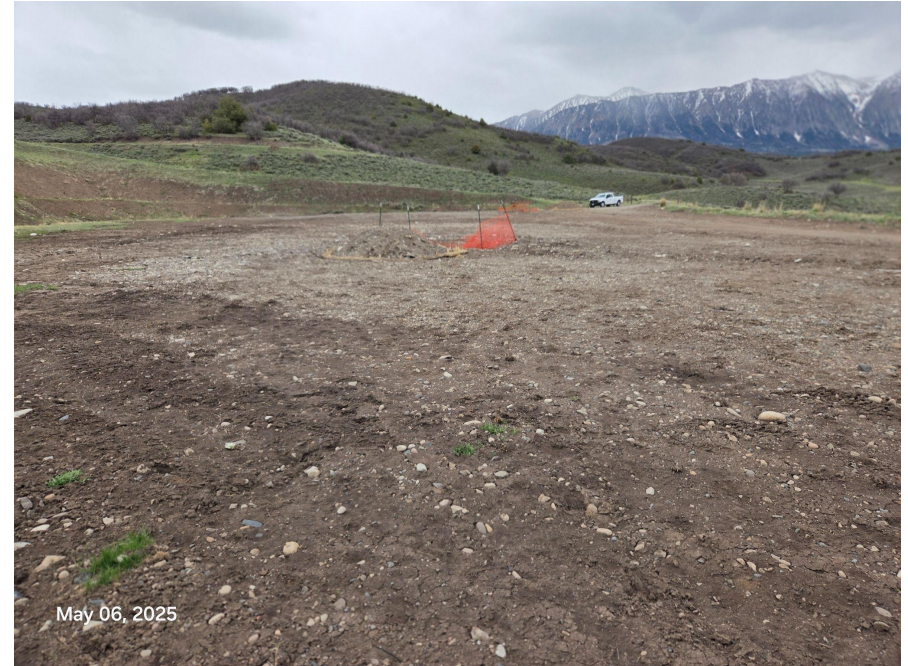
Photo 3: Photos 3-4 taken from the west end of the Location. Photos provide an overview of the Location north, northeast, southeast to south. Well on Location has been P&Ad, the tank battery and other production facilities have been removed from the Location.

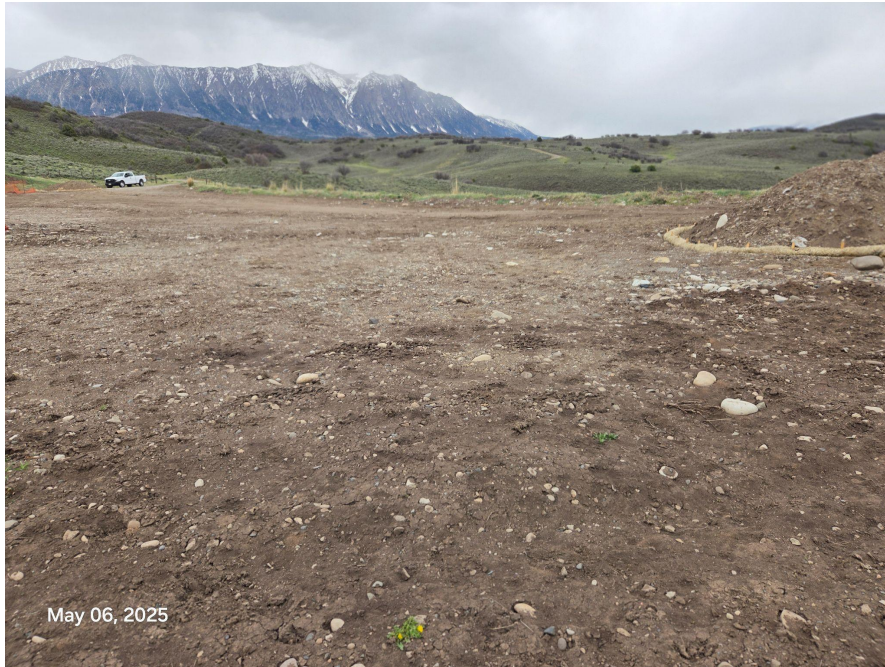
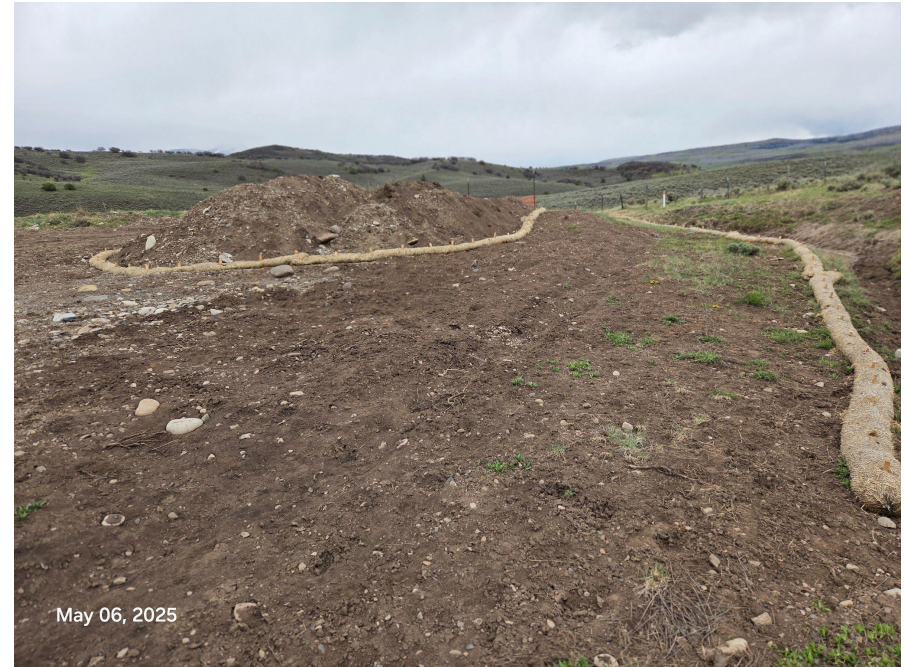
Photo 4: See comments under photo 3

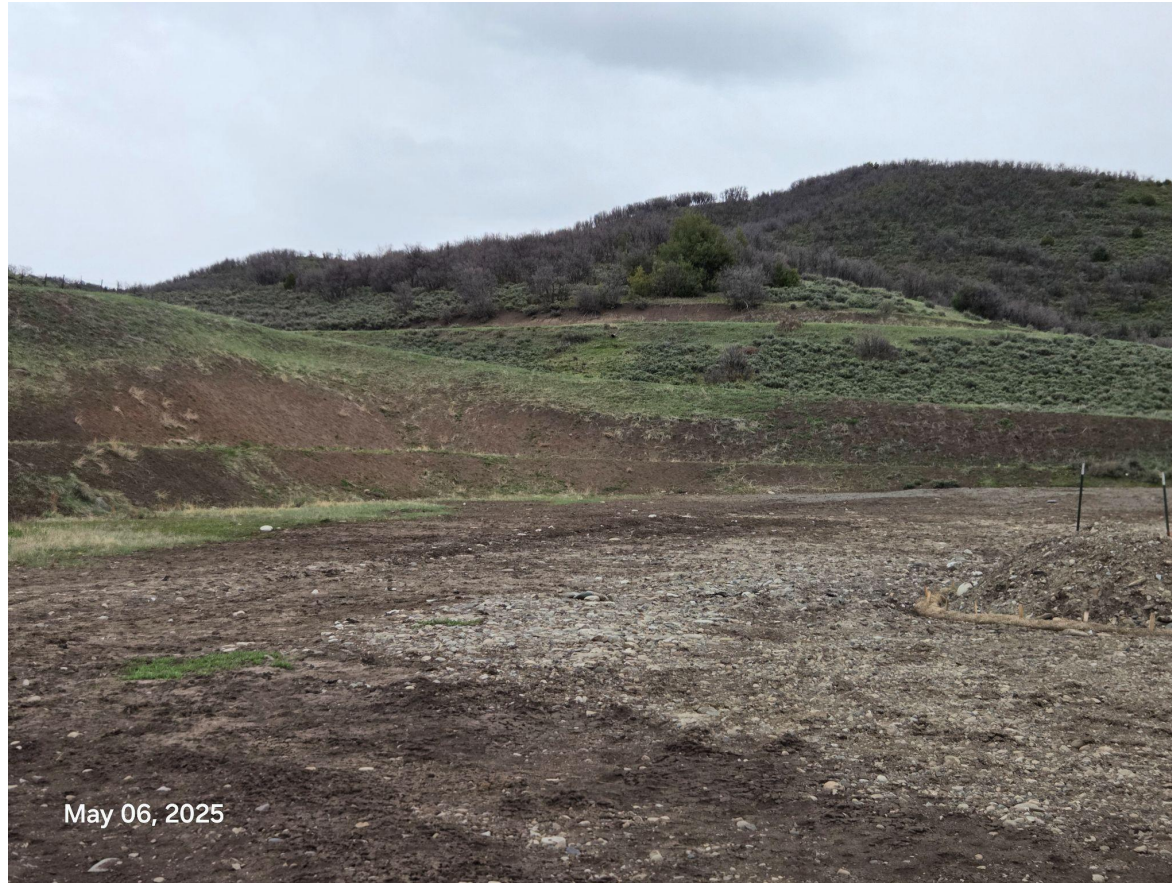
Photo 5: Photo taken from the north end of the Location, facing east. Photo example showing the cut slopes on the Location. Slopes are bare and at risk of erosion and degradation due to runoff. Stormwater and erosion control BMPs are missing or insufficient at the cut slopes.

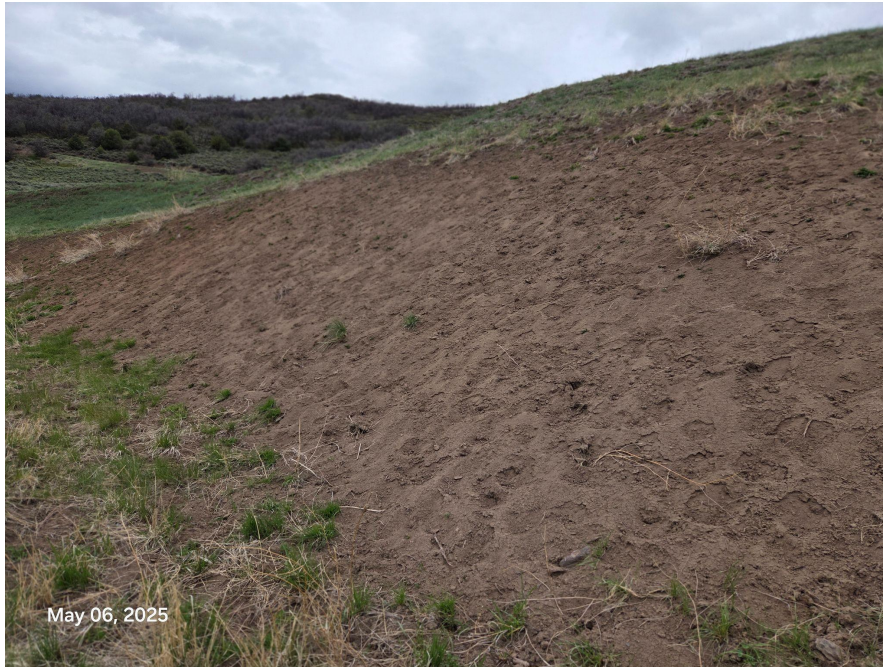
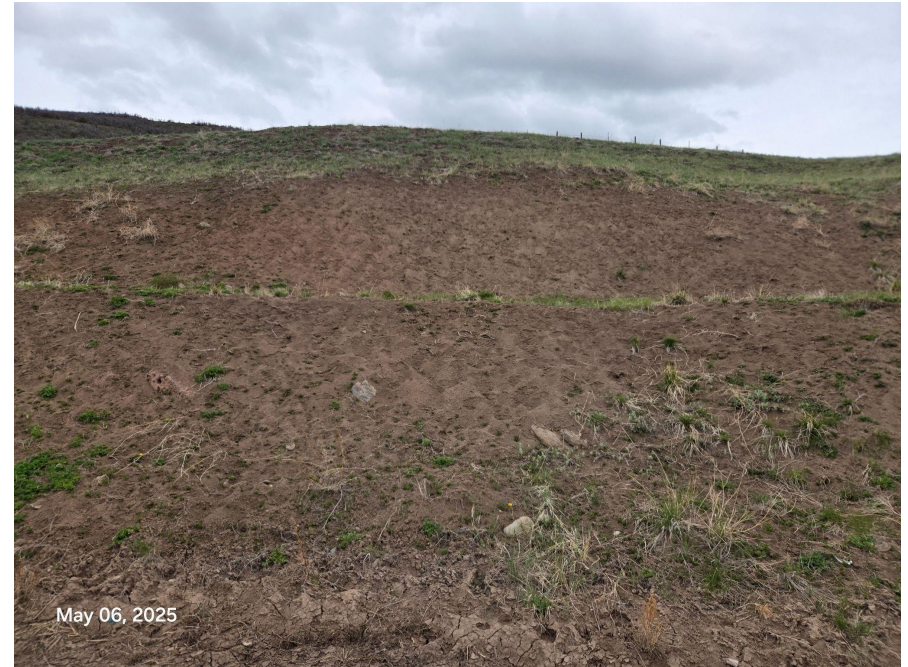
Photo 6: Photos 6-7 taken from the cut slopes on the north end of the Location. Photos examples showing the slopes are bare and at risk of erosion and degradation due to runoff. Stormwater and erosion control BMPs missing or insufficient at the cut slopes.

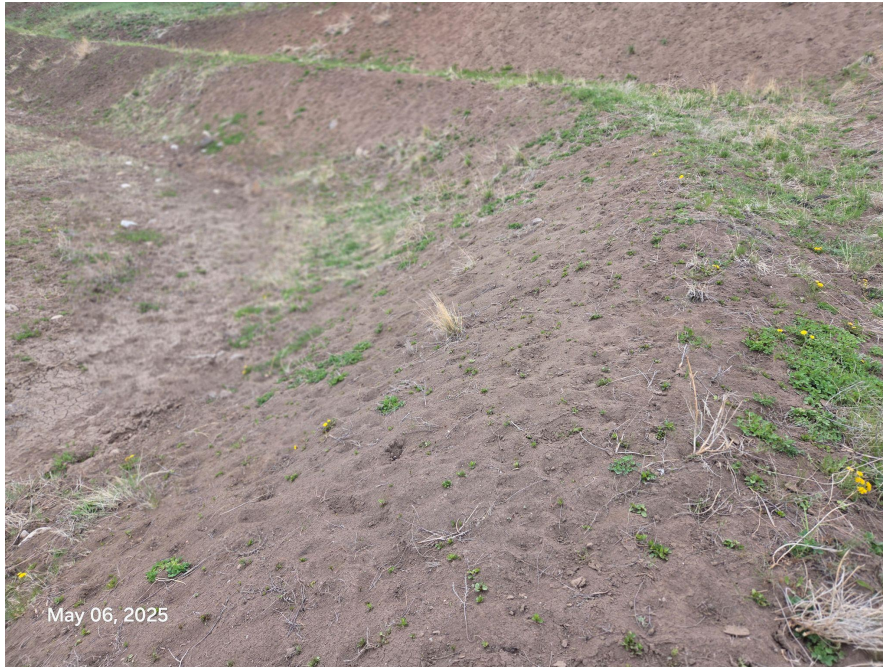
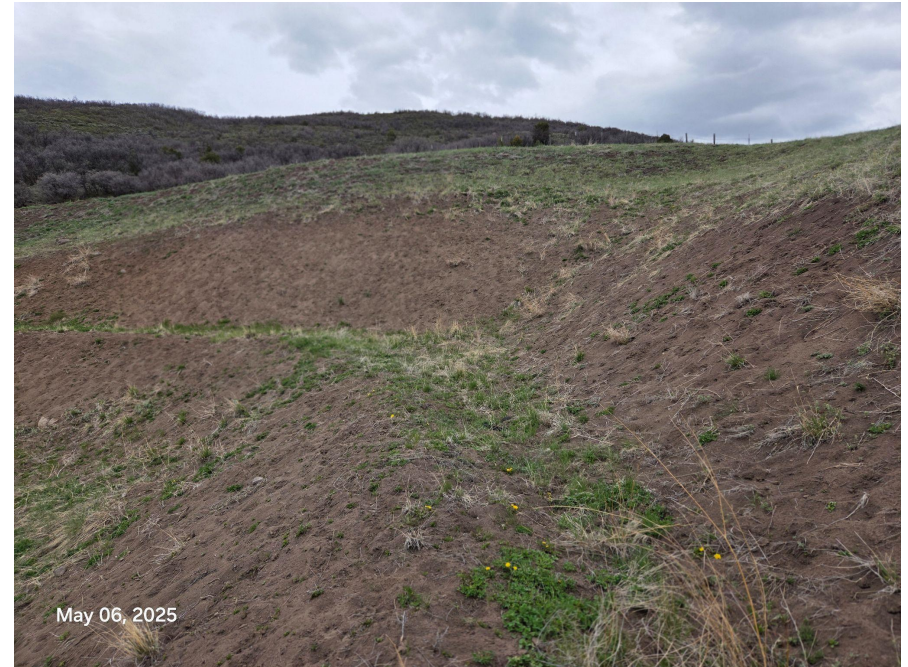
Photo 7: See comments under photo 6.

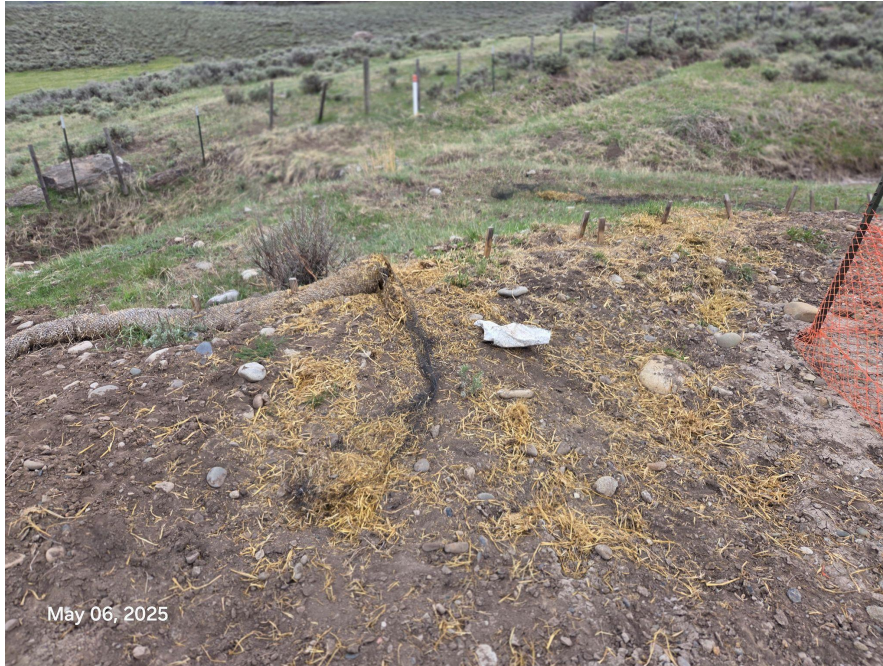
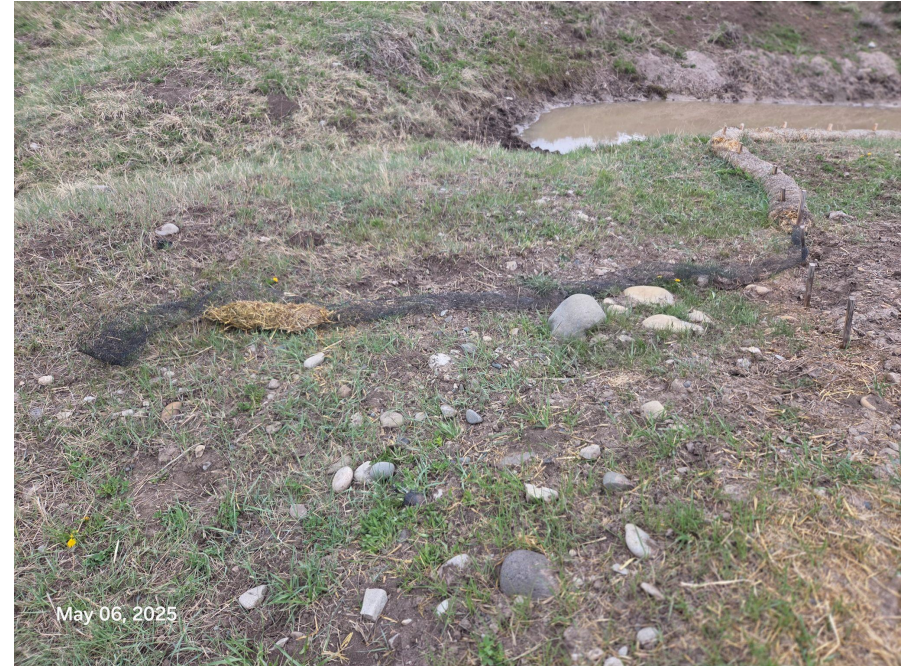
Photo 8: Photos taken from the south end of the Location. Photos example showing the erosion log (straw wattle) has not been maintained in proper functioning condition, is in disrepair and is now considered debris.

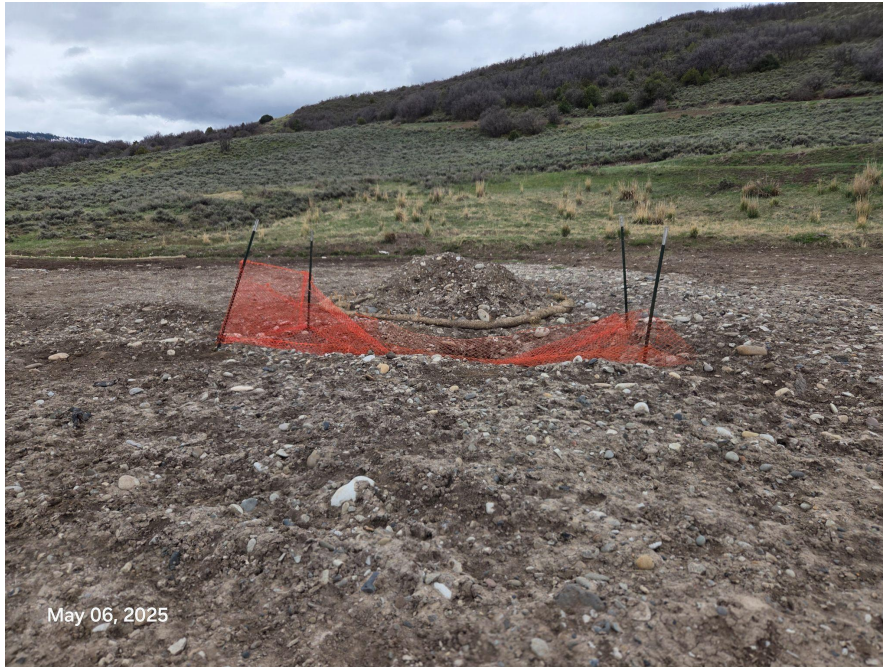
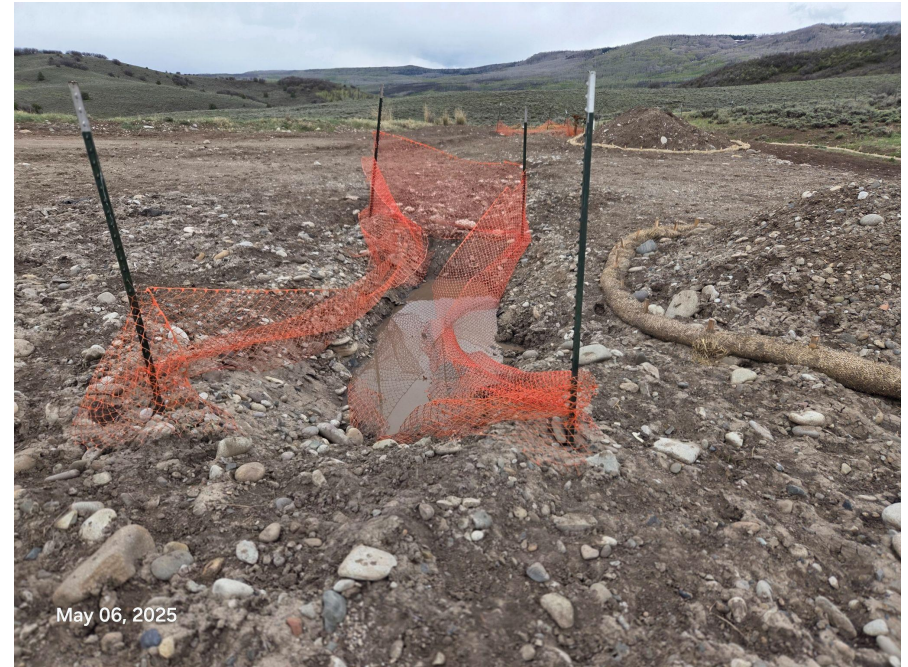
Photo 9: Photos 9-11 are examples showing fencing at excavations throughout the Location are in disrepair; fencing requires maintenance.

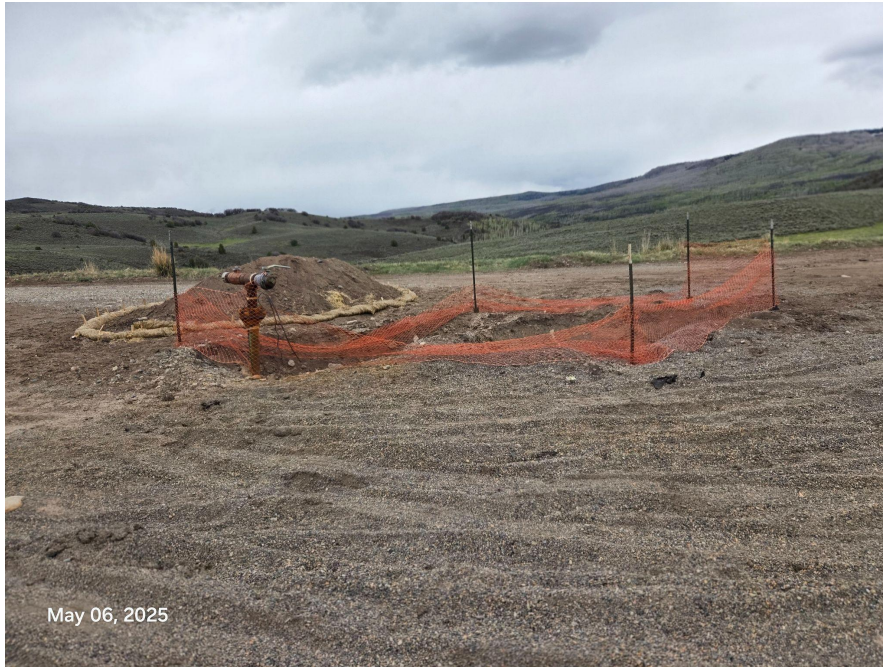
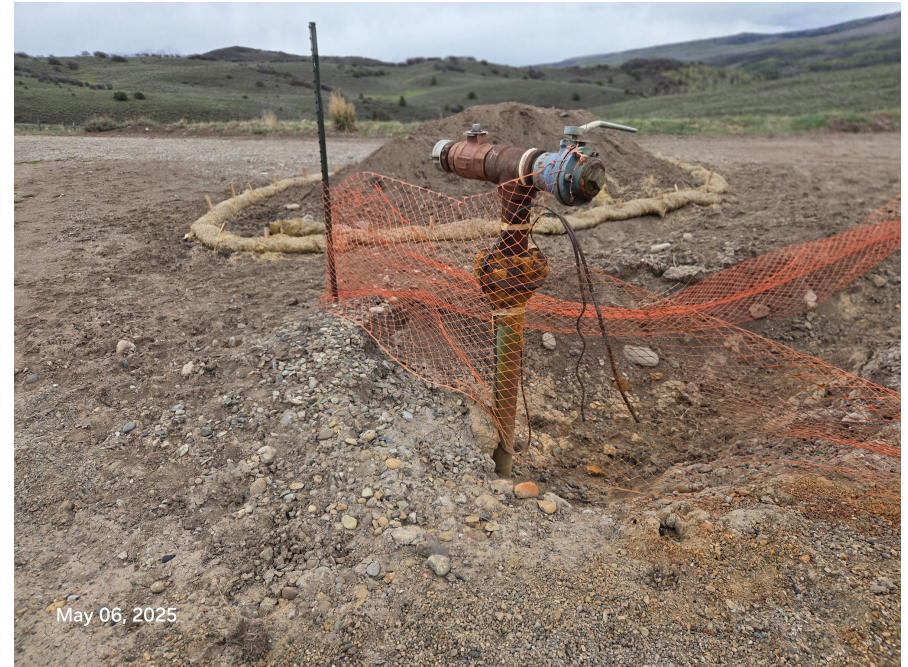
Photo 10: See comments under photo 9 regarding fencing. Photos 10-11 also show pipe riser / surface equipment remaining on the Location. All surface equipment was required to be removed within 3 months after plugging and abandonment of the well.

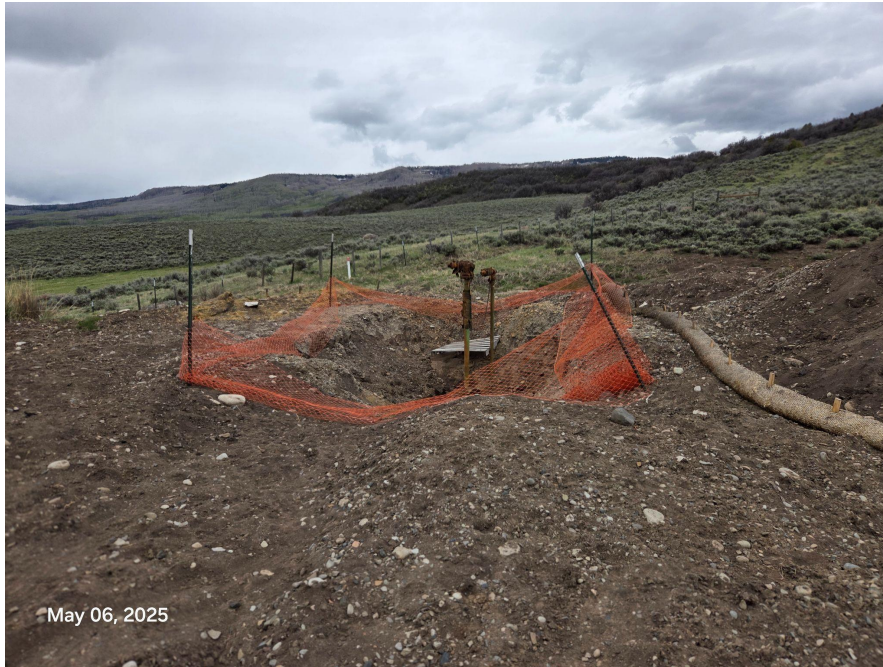
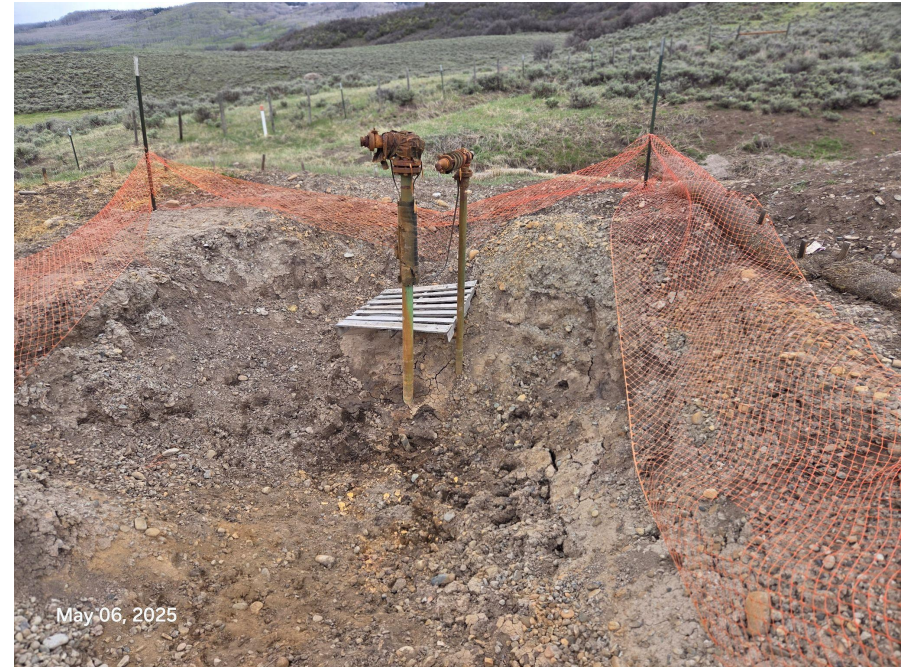
Photo 11: See comments under photo 10.

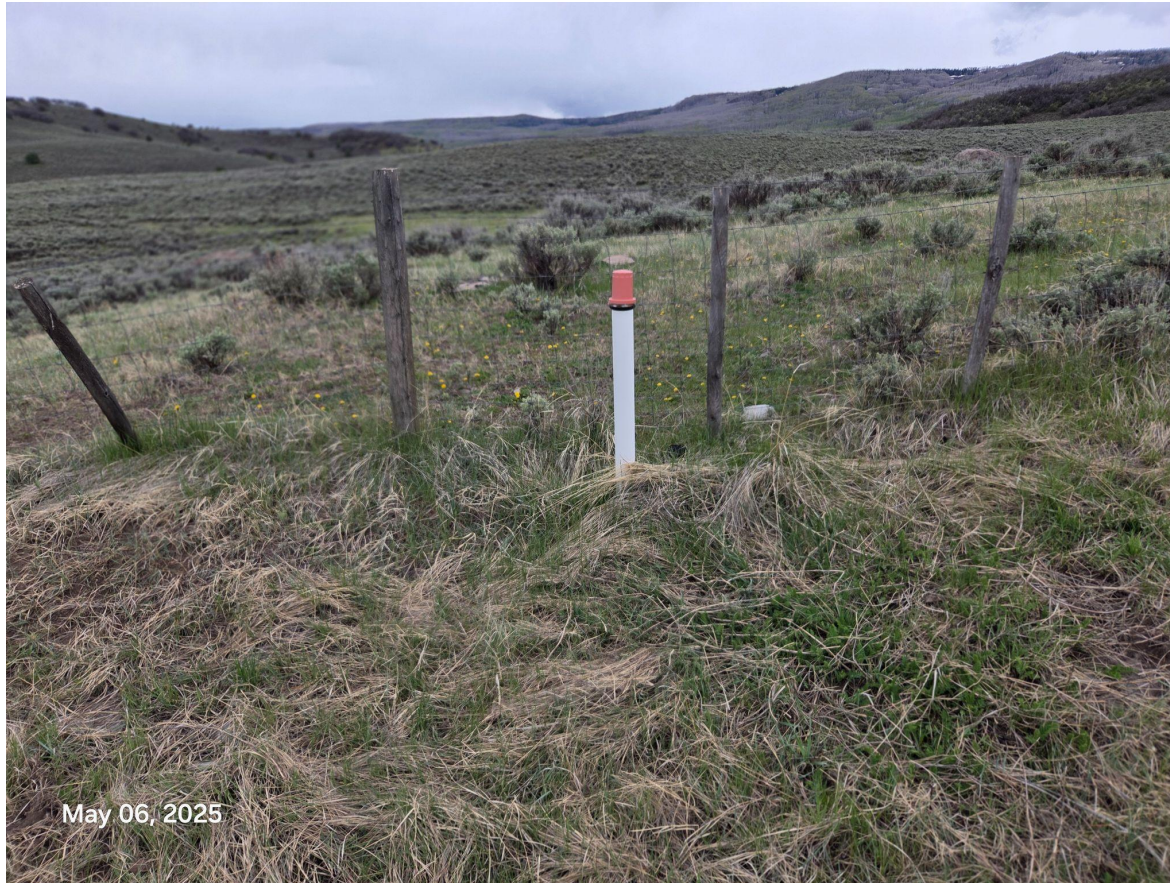
Photo 12: Photo taken from the south end of the Location, facing south. Photo shows what appears to be a monitoring well. See comments under photo 10 regarding removal of surface equipment.
