Final Reclamation Inspection

Operator: KERR MCGEE OIL & GAS ONSHORE LP - 47120

Location ID: 331225

Inspection Document #: 718800241

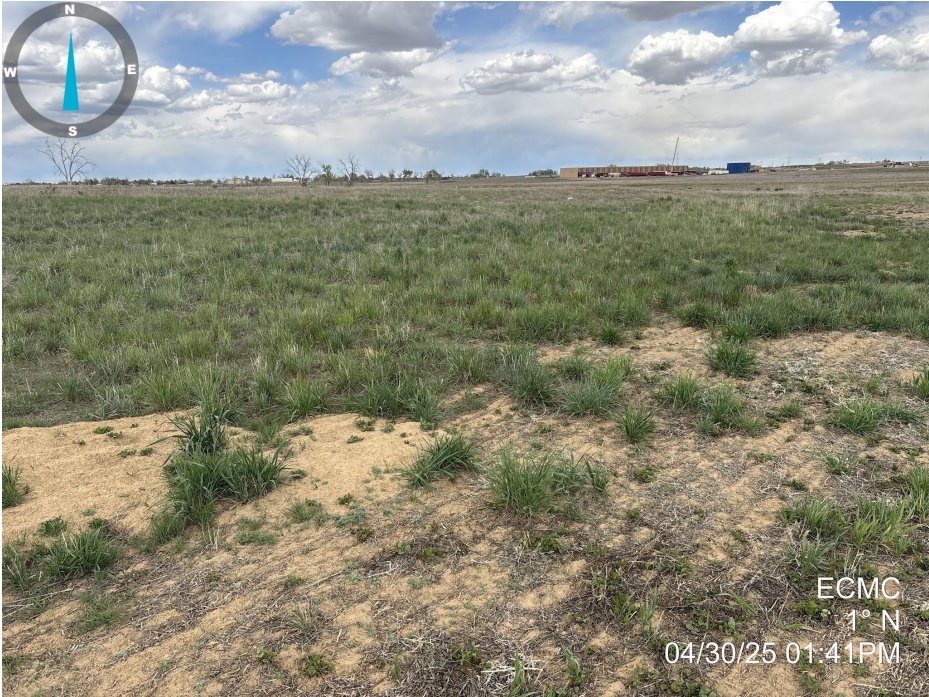
Photo 1. Photo taken from the well location, facing North. Photo illustrates that final reclamation activities have taken place, but vegetation establishment does not meet final reclamation standards.

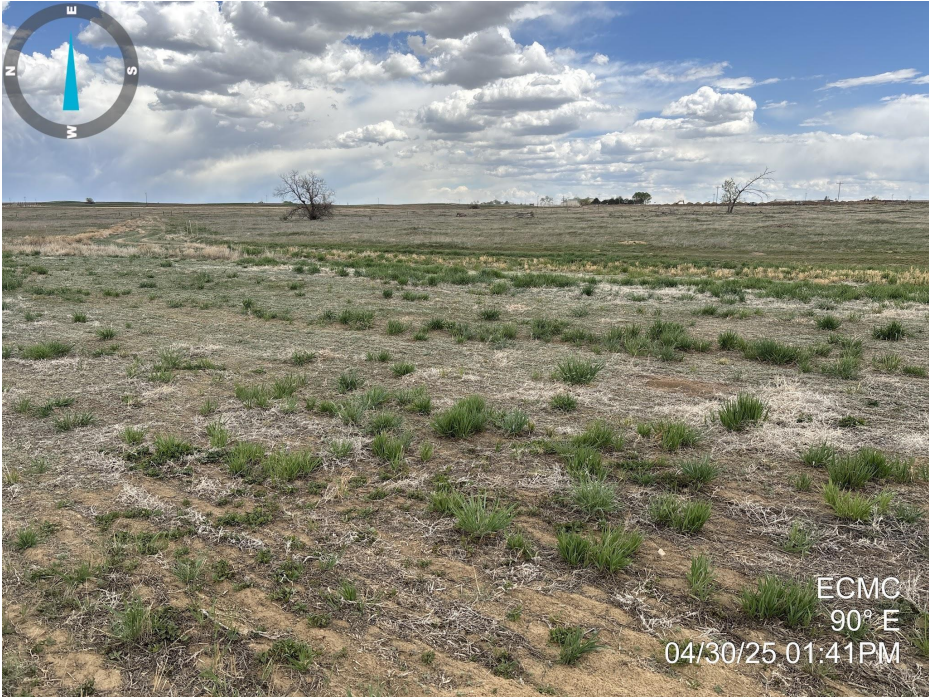
Photo 2. Photo taken from the well location, facing East. See comments under Photo 1.

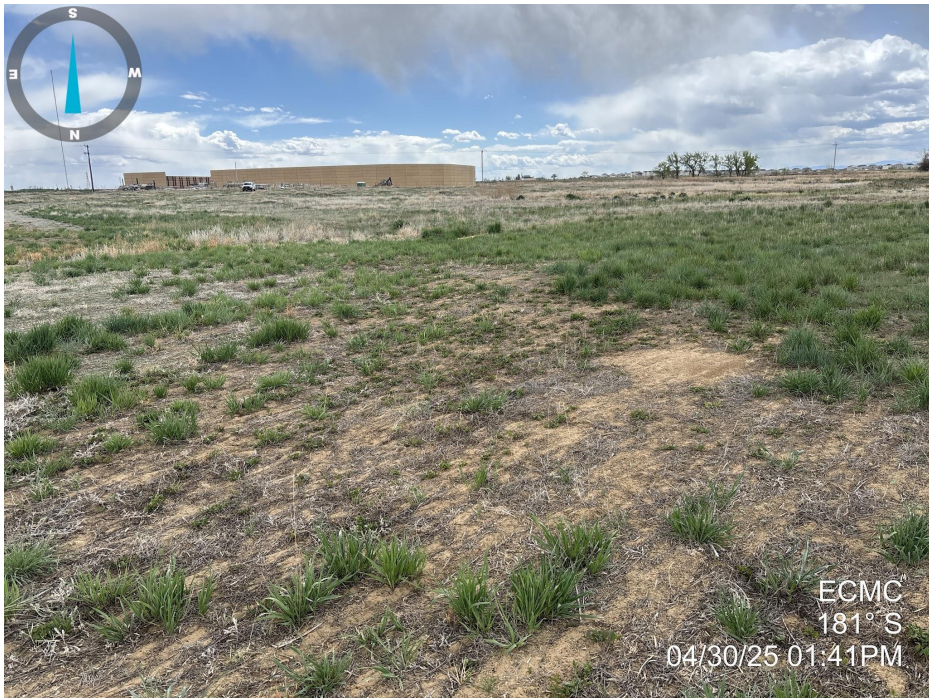
Photo 3. Photo taken from the well location, facing South. See comments under Photo 1.

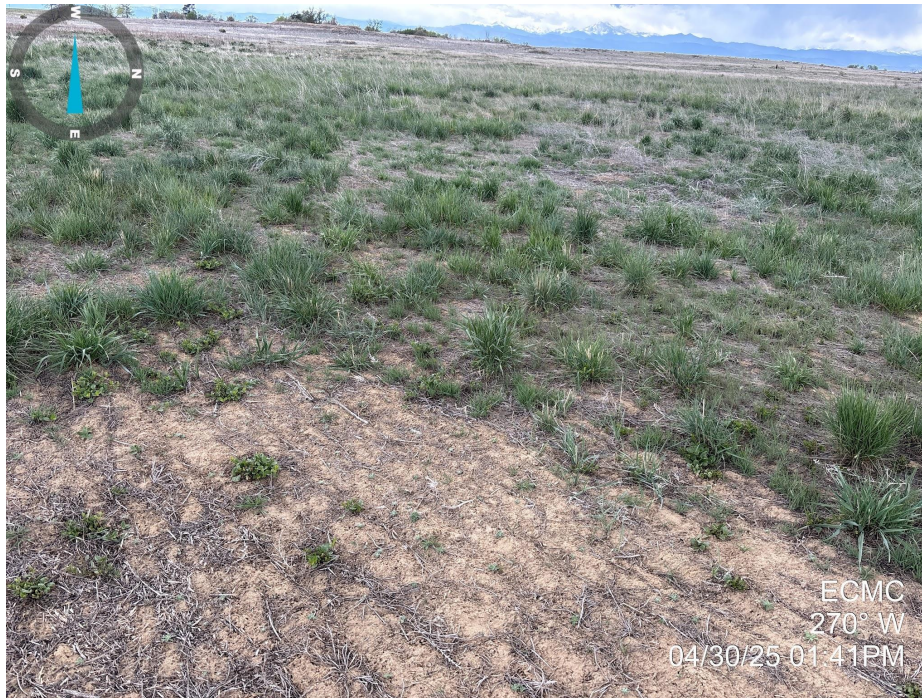
Photo 4. Photo taken from the well location, facing West. See comments under Photo 1.

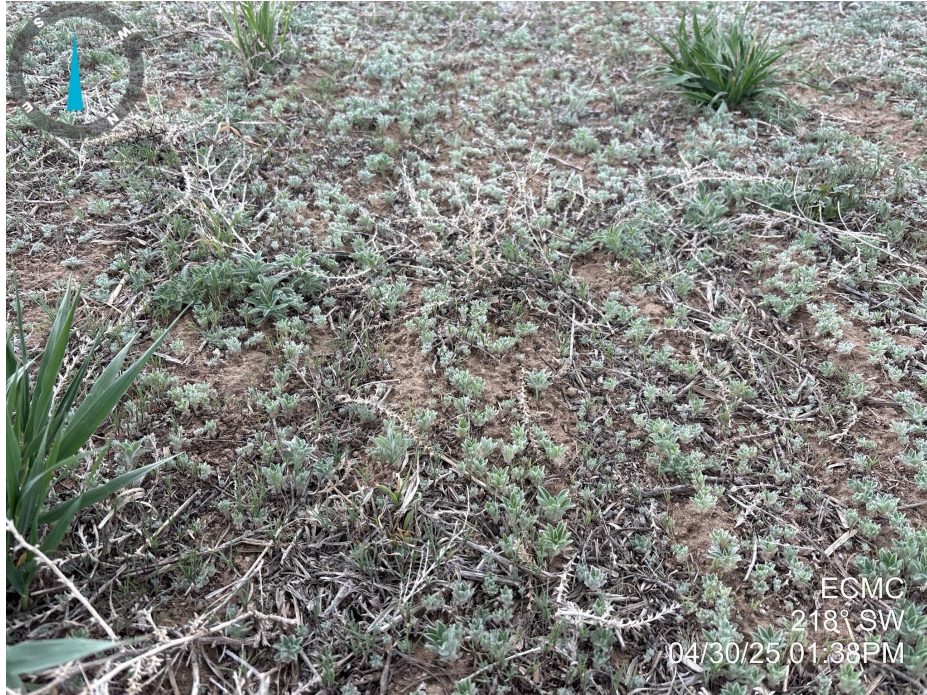
Photo 5. Photo taken of the well location. Photo illustrates weedy growth, dominated by kochia (*Bassia scoparia*) and russian thistle (*Salsola tragus*).

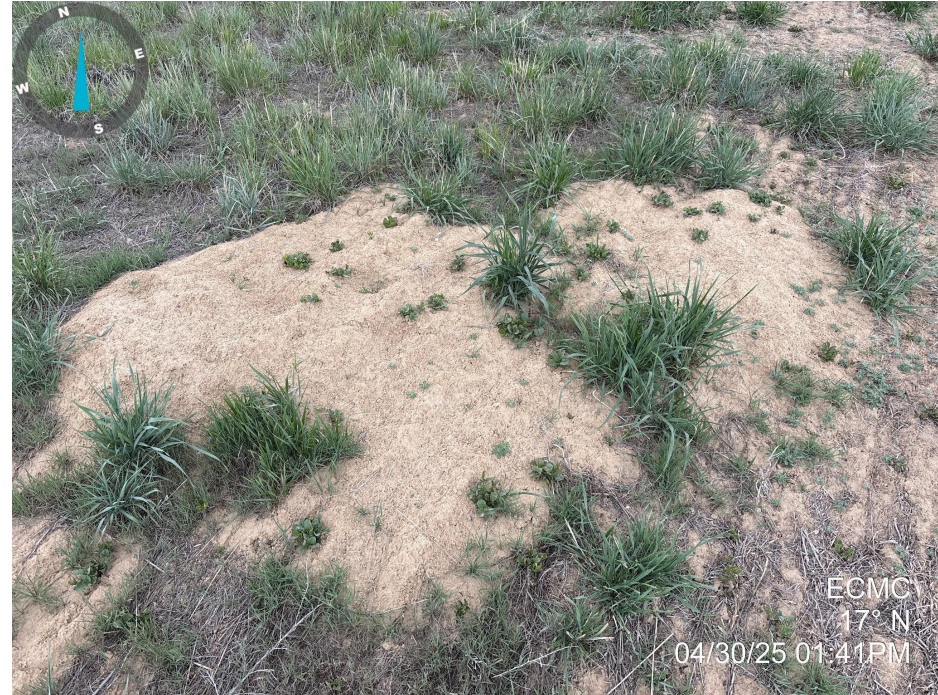
Photo 6. Photo taken of the well location. Photo illustrates some bare soil piles were observed at the location.

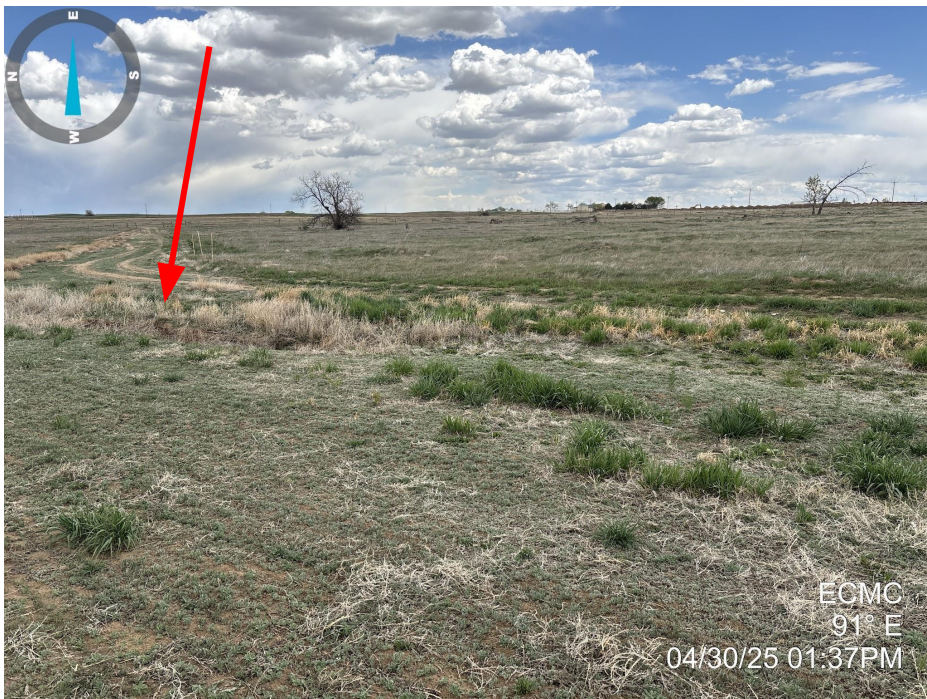
Photo 7. Photo taken of the access road from the well location. the access road remains in place for another location, Location ID# 319288. Erosion was observed north of the access road (delineated with red arrow).

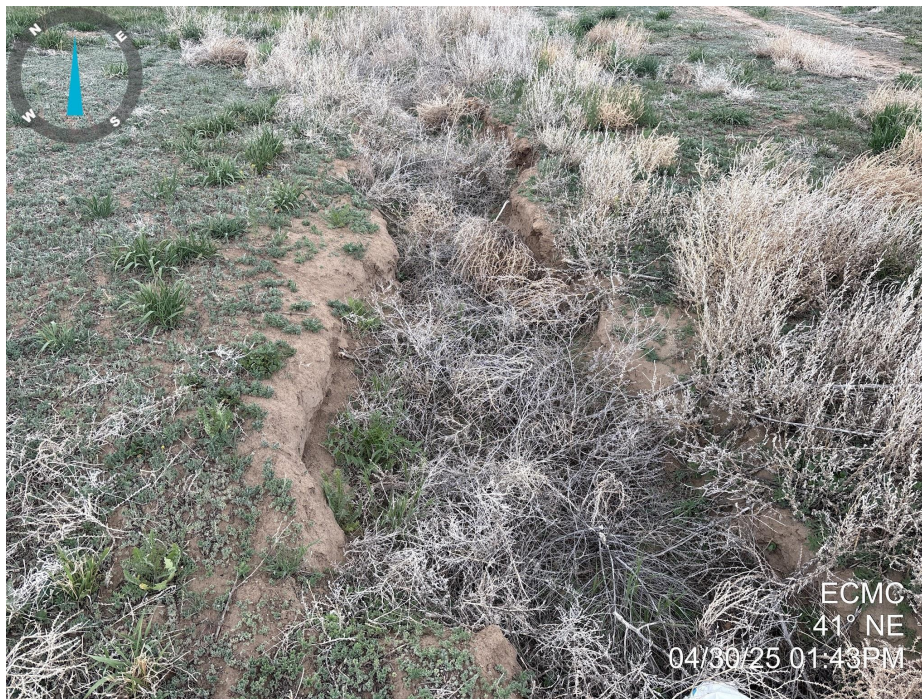
Photo 8. Photo taken of erosion north of the access road, directly east of the well site. A small gully, approximately one foot across and 8 feet in length has formed.

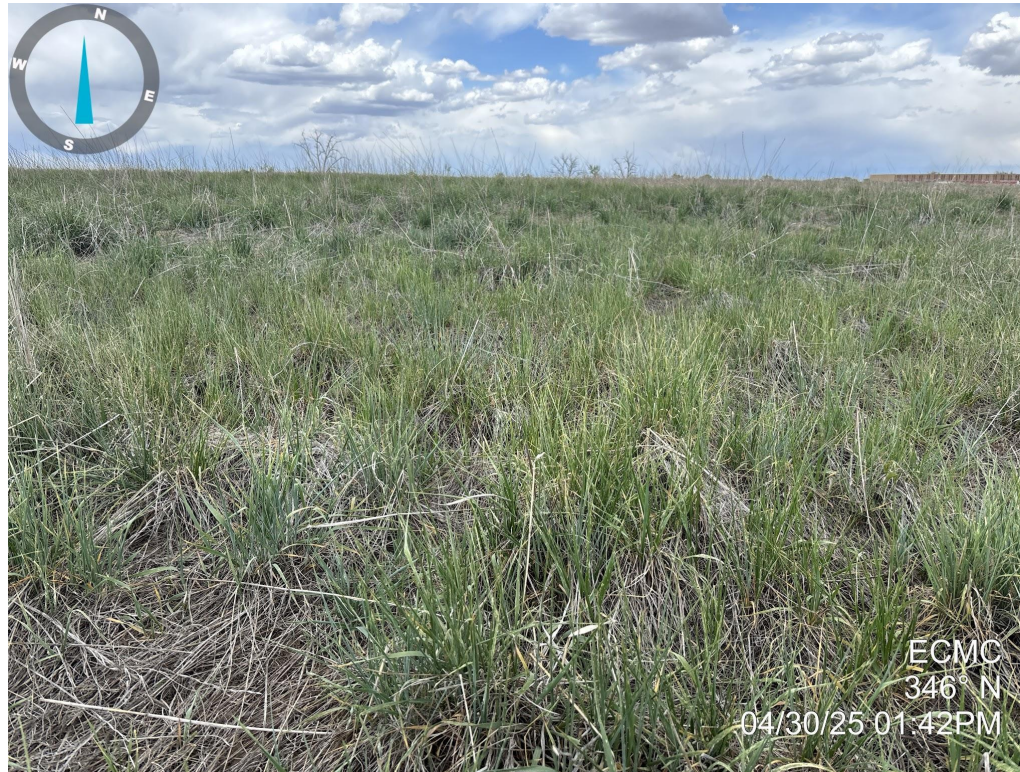
Photo 9. Photo taken of the reference area, north of the location, facing North. Photo illustrates perennial grass vegetation.
