Inspection Photos

Location Name: QB Energy BENZEL 36-2D (B36X) Pad

Location #: 335354

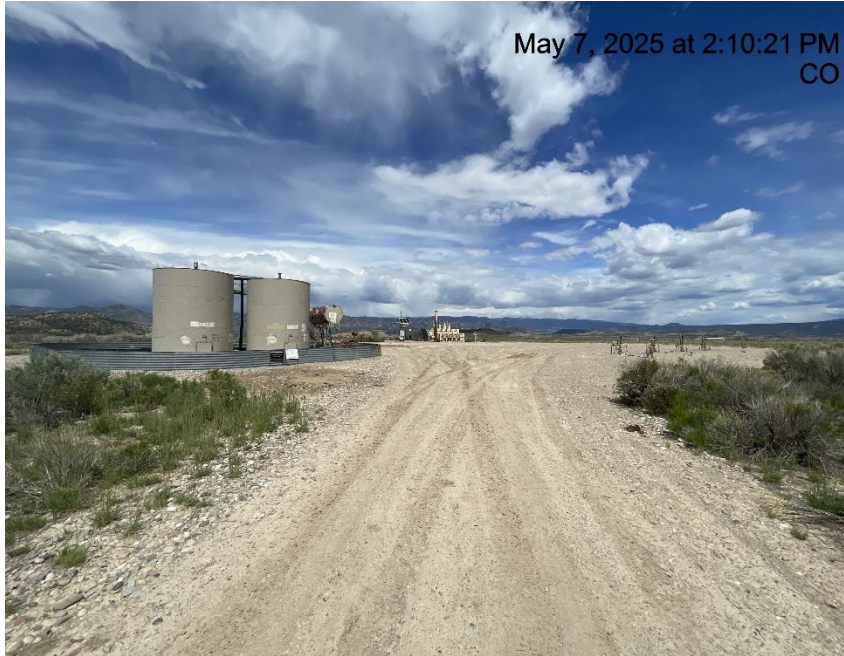
Photo # 9450 From Entrance to location

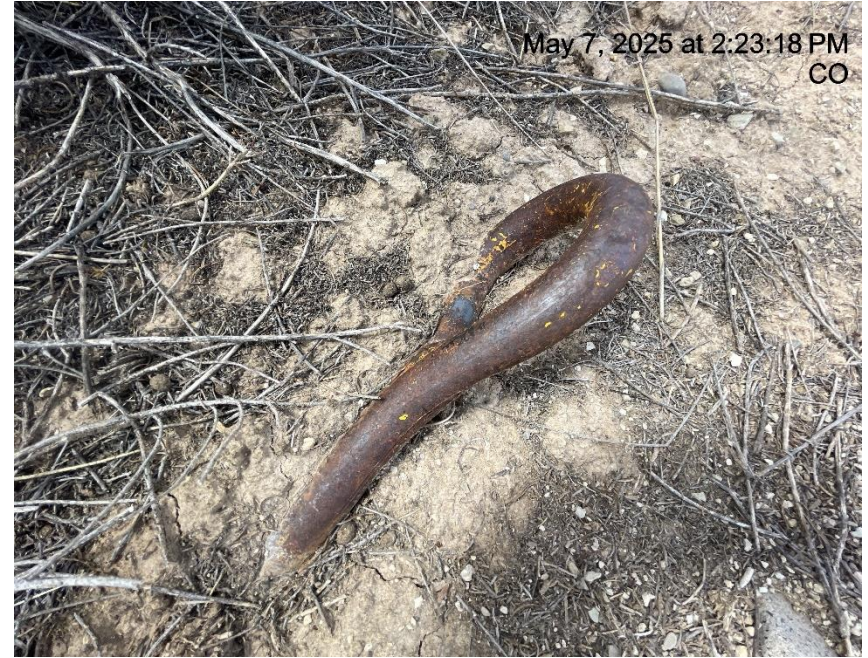
Photo # 9457 Unmarked deadman

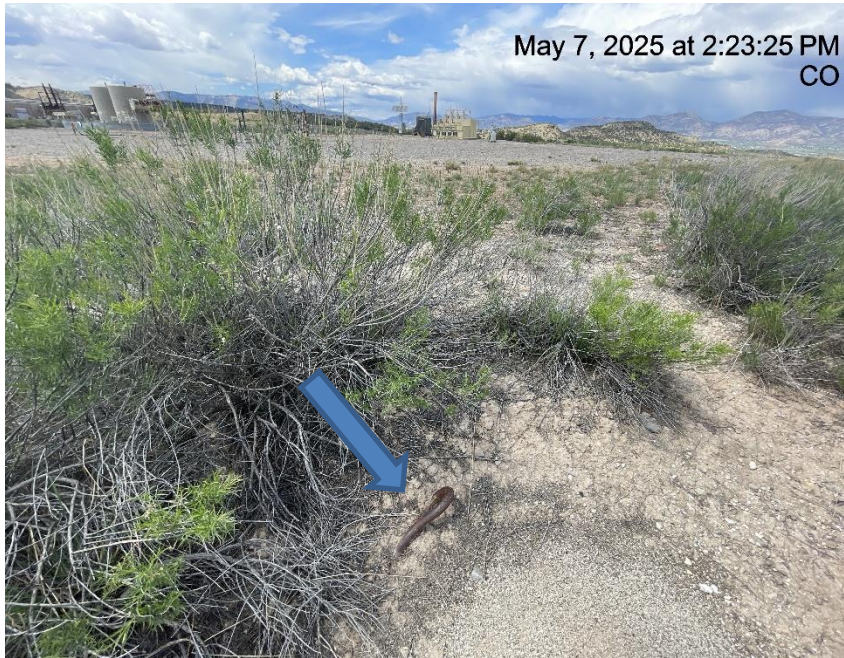
Photo # 9458 Same unmarked deadman

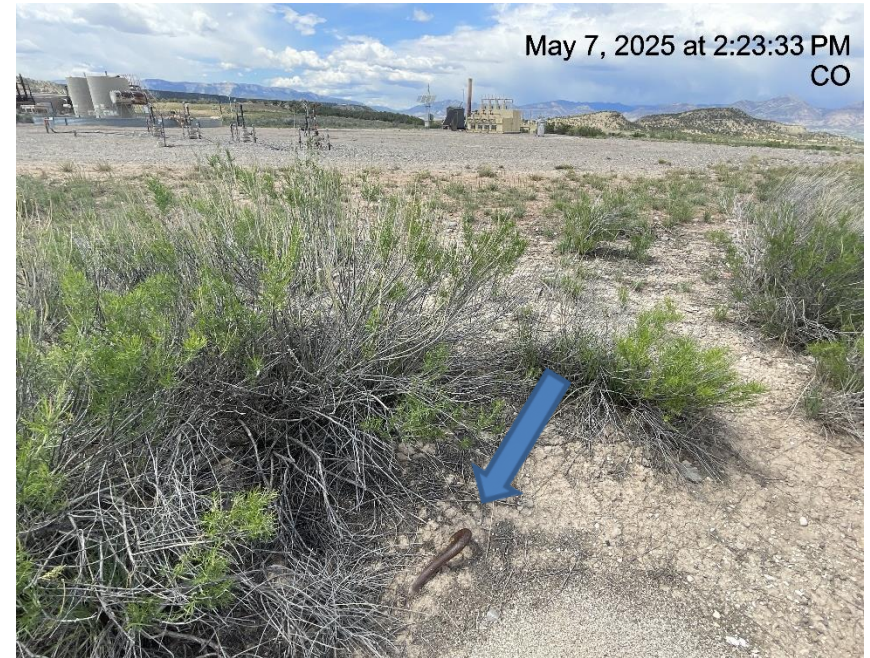
Photo # 9459 Same unmarked deadman from a different angle

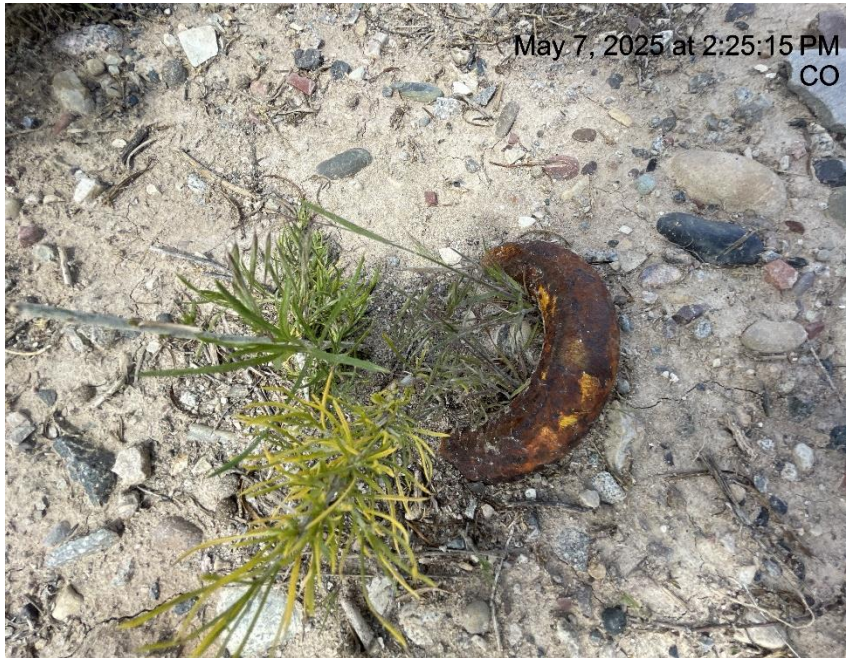
Photo # 9460 Unmarked deadman

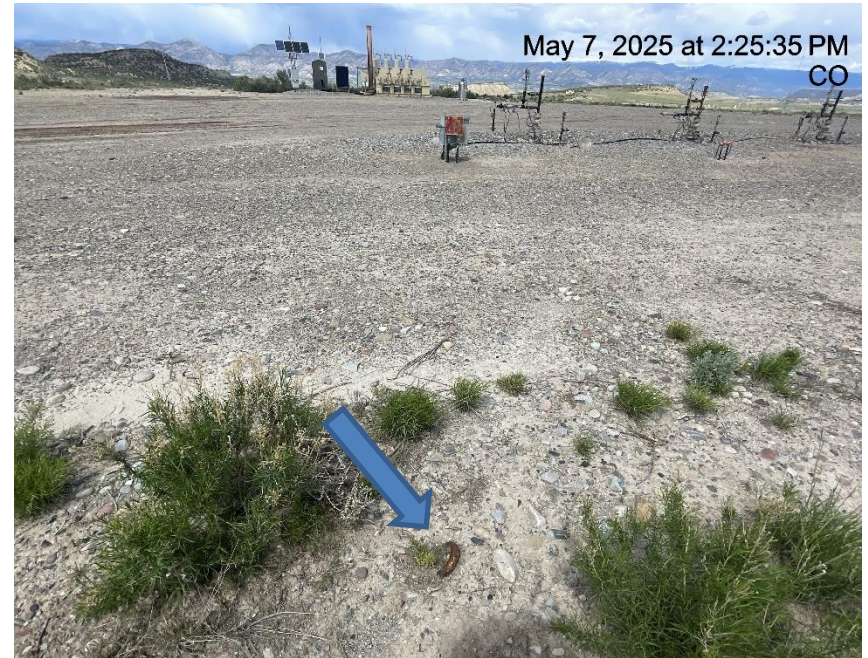
Photo # 9461 Same unmarked deadman

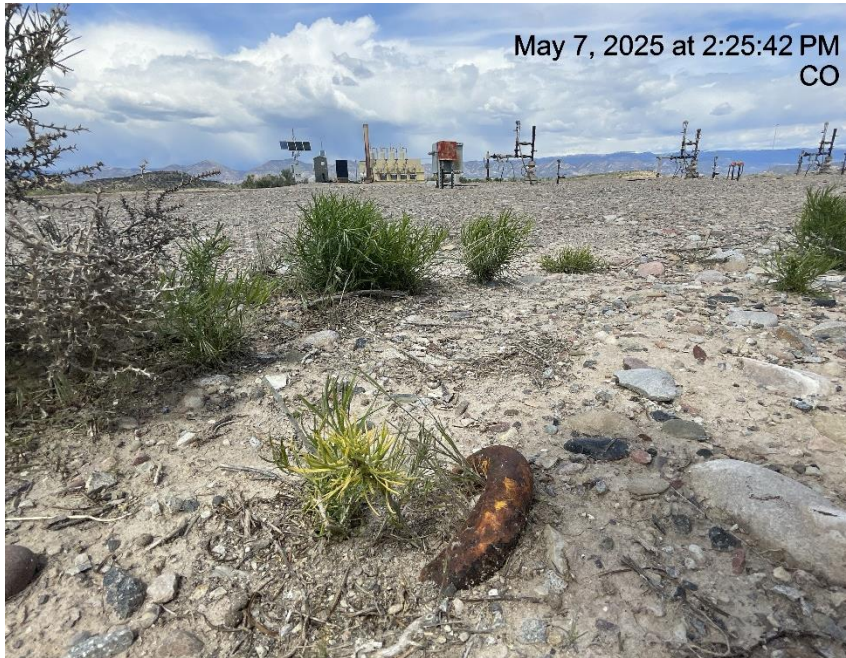
Photo # 9462 Same unmarked deadman from a different angle

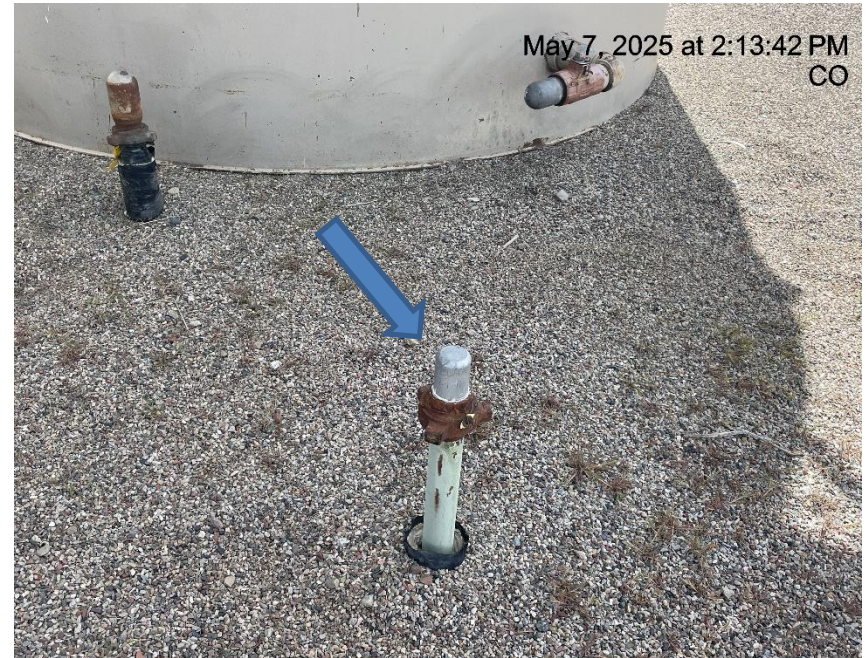
Photo # 9463 Unused flowline in secondary containment lacks lockout tagout (OOSLAT)

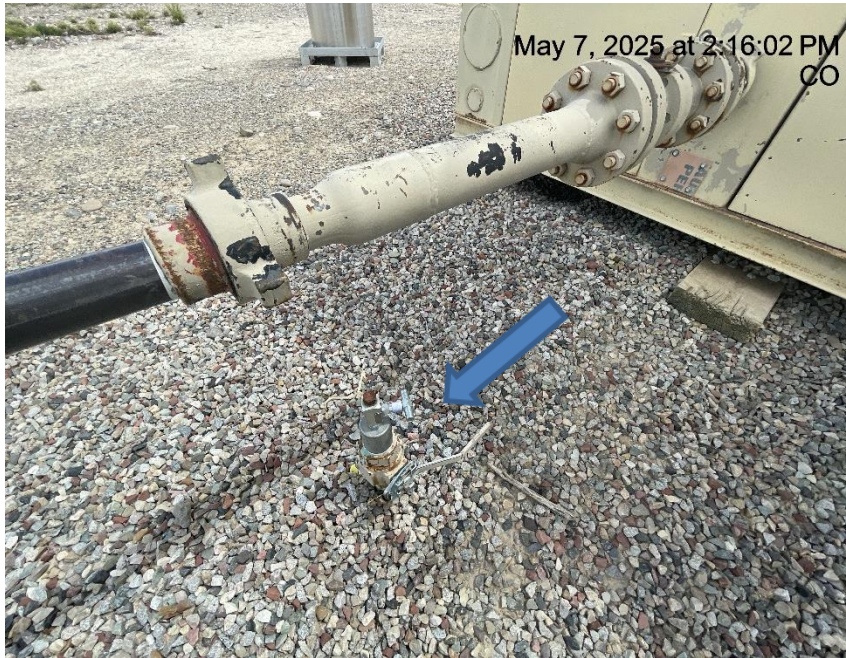
Photo # 9464 Unused flowline near separators lacks lockout tagout (OOSLAT)

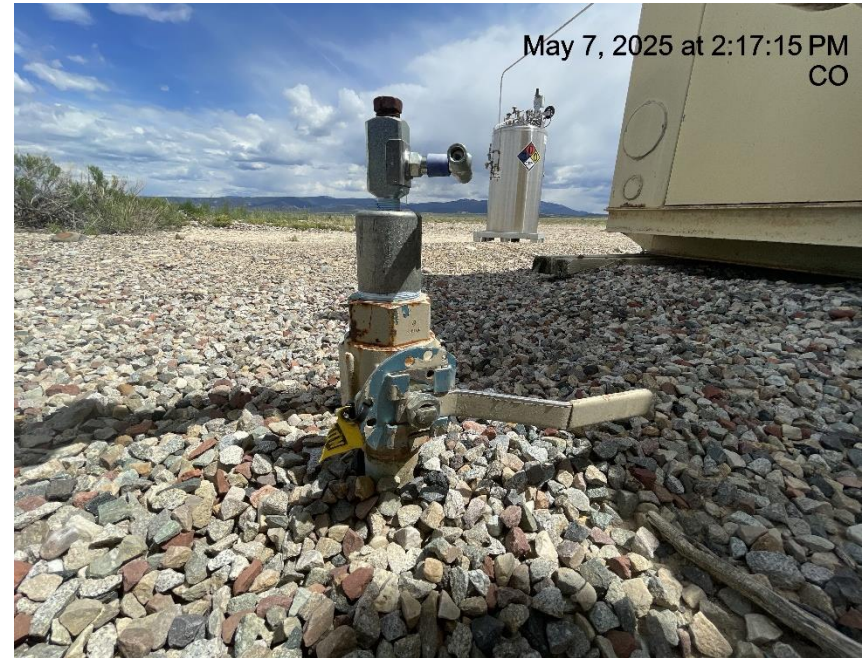
Photo # 9465 Unused flowline near separators lacks lockout tagout (OOSLAT)

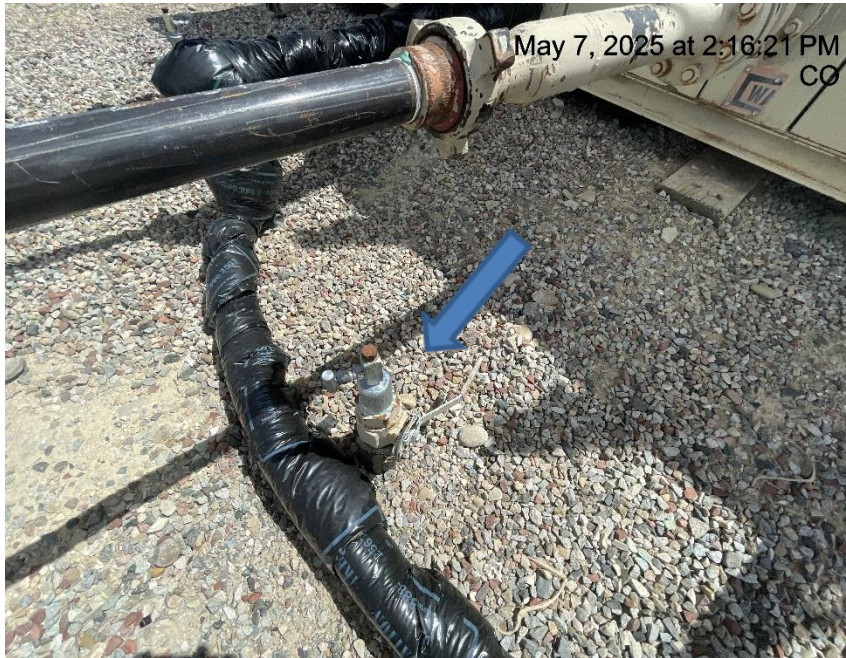
Photo # 9466 Unused flowline near separators lacks lockout tagout (OOSLAT)

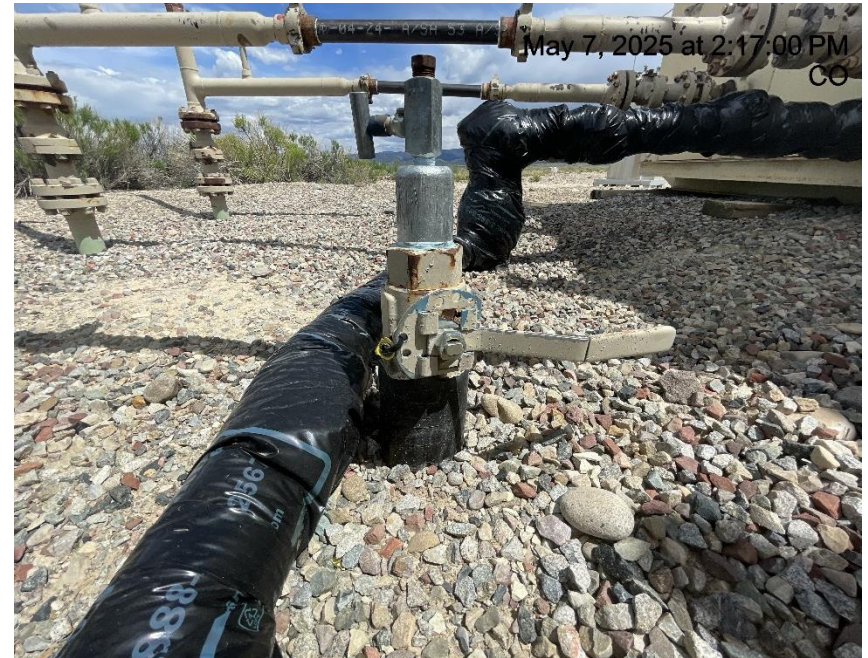
Photo # 9467 Unused flowline near separators lacks lockout tagout (OOSLAT)

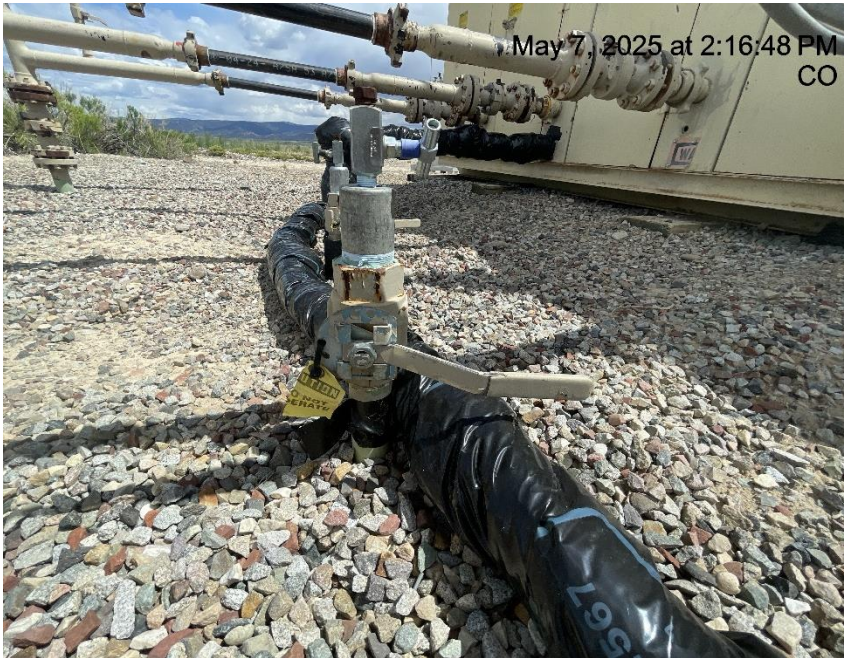
Photo # 9468 Unused flowline near separators does not comply with CECMC lockout tagout (OOSLAT) rules
