Inspection/Audit Photos

Location Name: QB ENERGY OPERATING LLC TWIN CREEK 12-6C1 (F12E) Pad

Location #: 421390

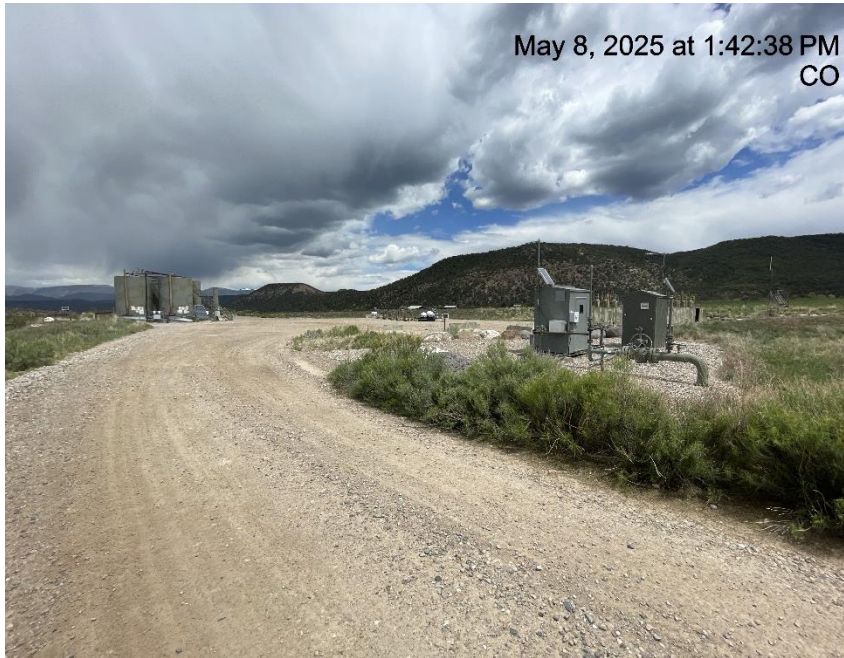
Photo # 25 From entrance to location

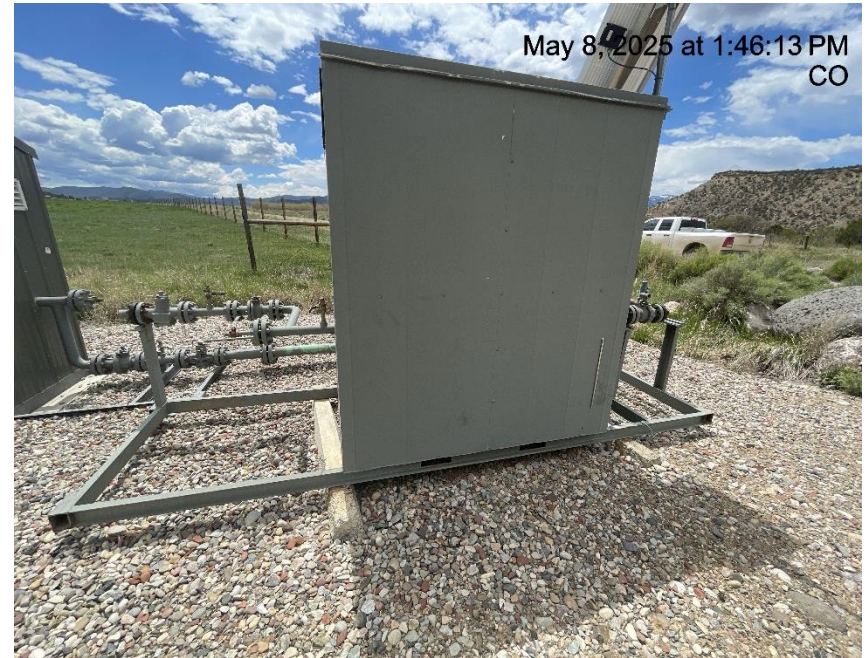
Photo # 38 Meter house is disconnected & not in use/unused equipment

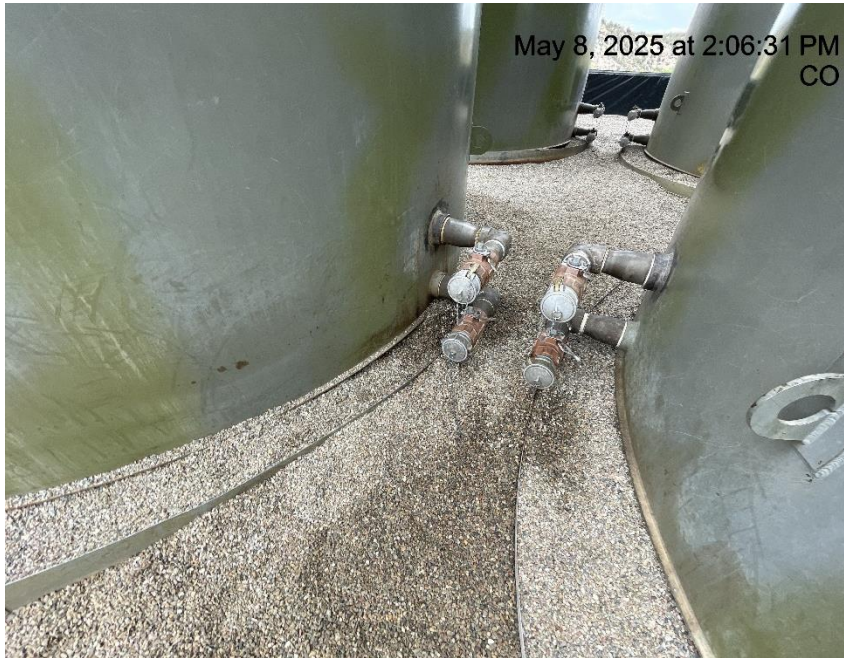
Photo # 39 Staining inside secondary containment

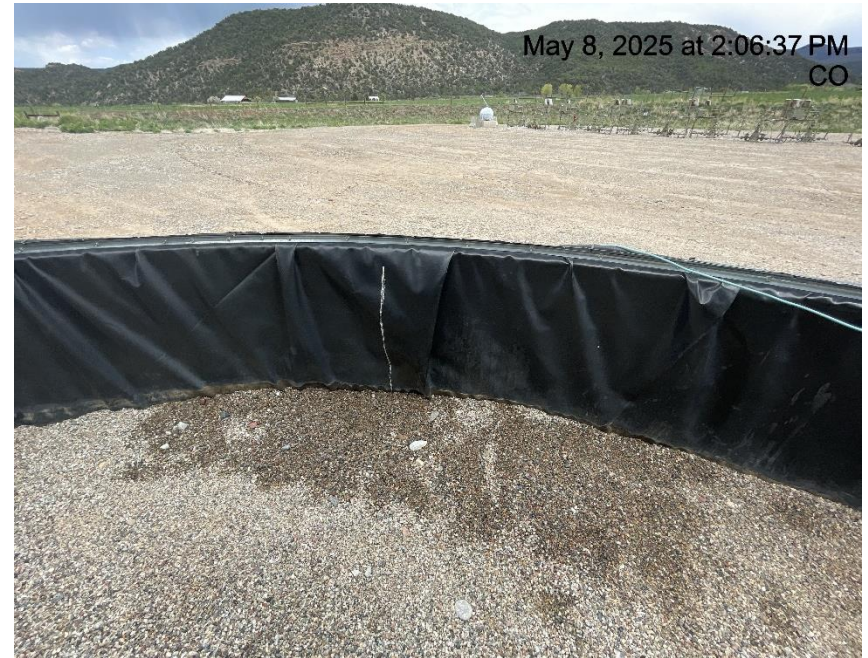
Photo # 40 Staining inside secondary containment

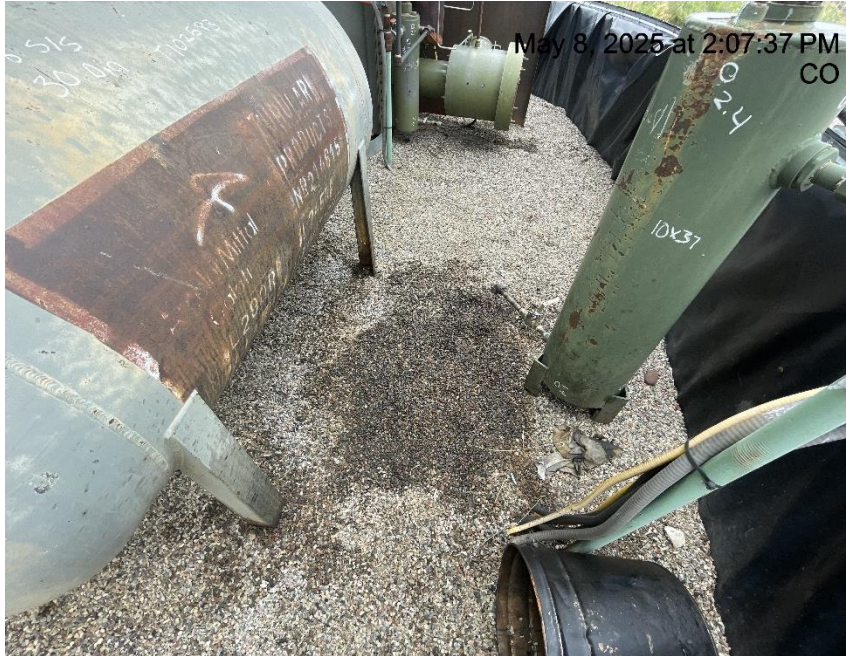
Photo # 41 Staining inside secondary containment

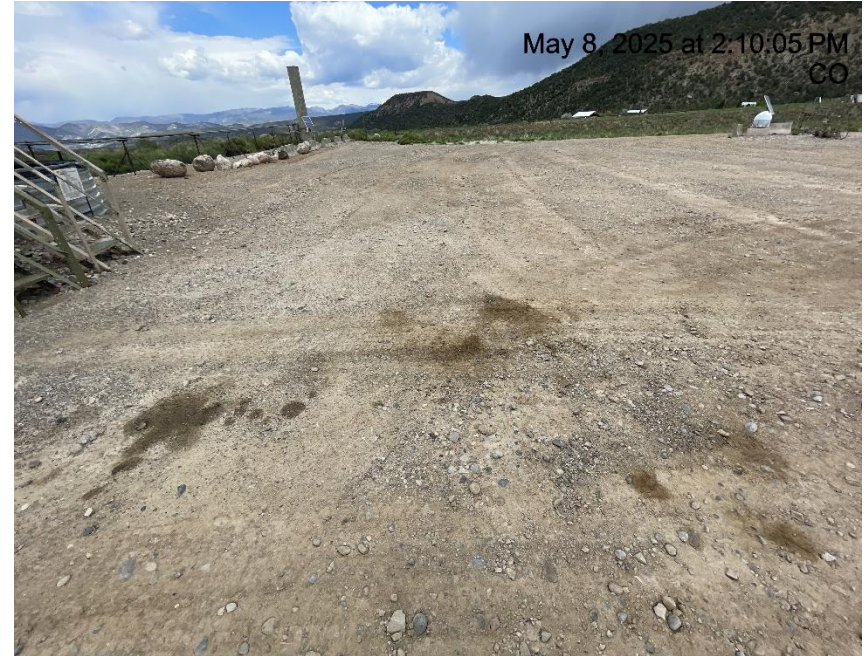
Photo # 42 Staining near tank battery

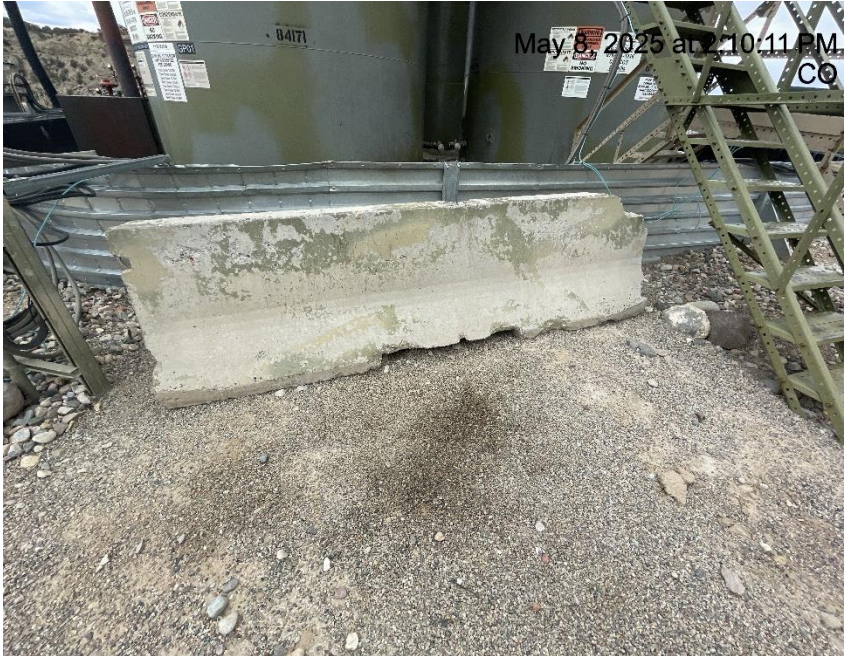
Photo # 43 Staining near tank battery
