Inspection/Audit Photos

Location Name: QB ENERGY OPERATING LLC BENZEL 25-10C (K25) Pad

Location #: 335344

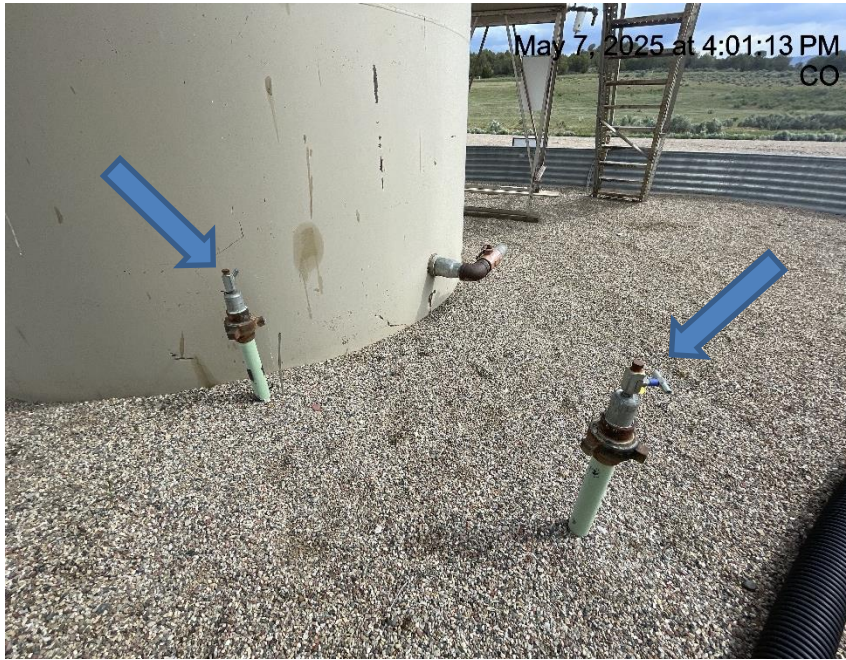
Photo # 9642 Unused flowlines lack lockout tagout (OOSLAT)

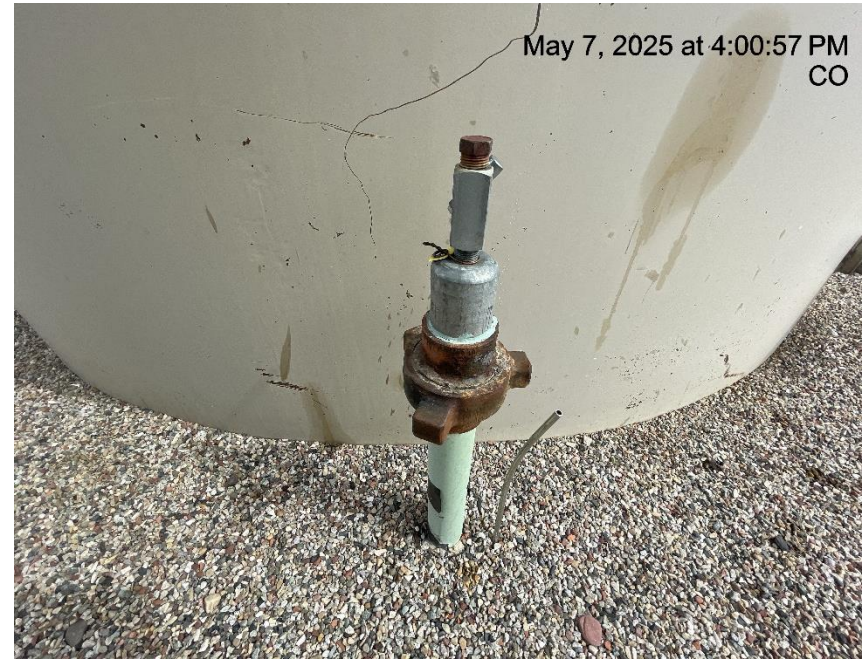
Photo # 9643 Unused flowline lacks lockout tagout (OOSLAT)

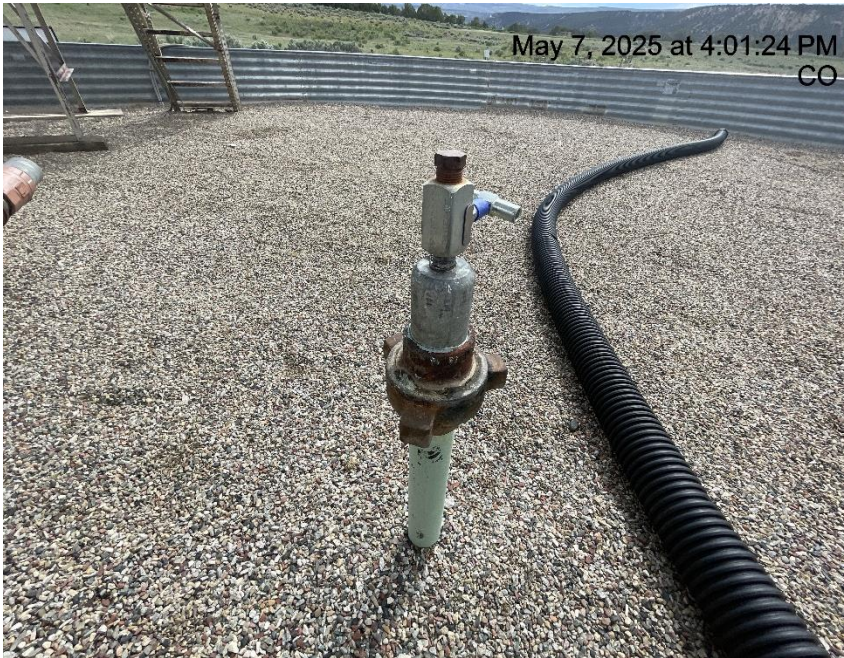
Photo # 9644 Unused flowline lacks lockout tagout (OOSLAT)

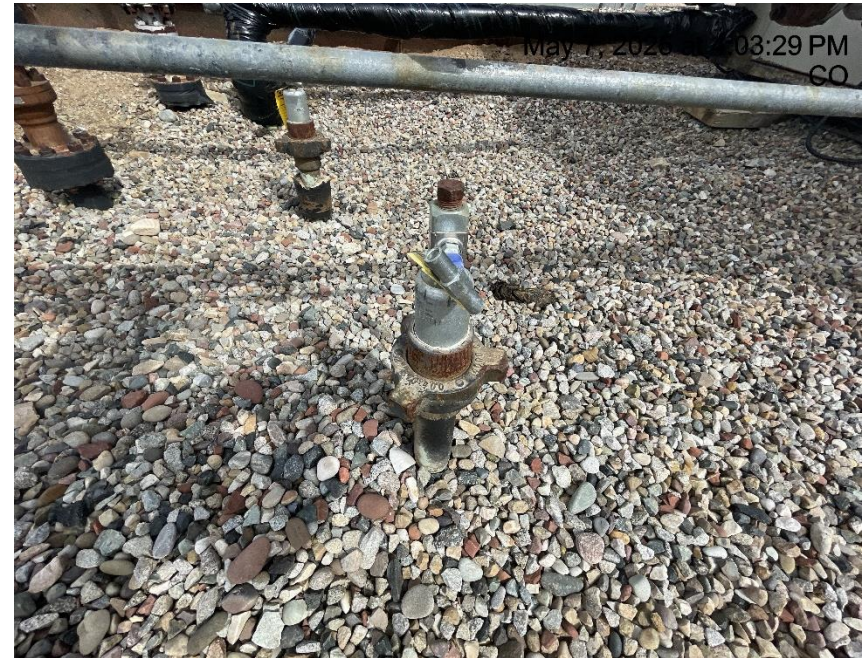
Photo # 9645 Unused flowline lacks lockout tagout (OOSLAT)
