Inspection Photos

Location Name: MUSTANG RESOURCES LLC MEAD 23-44-6S-94W Pad

Location ID: 323783

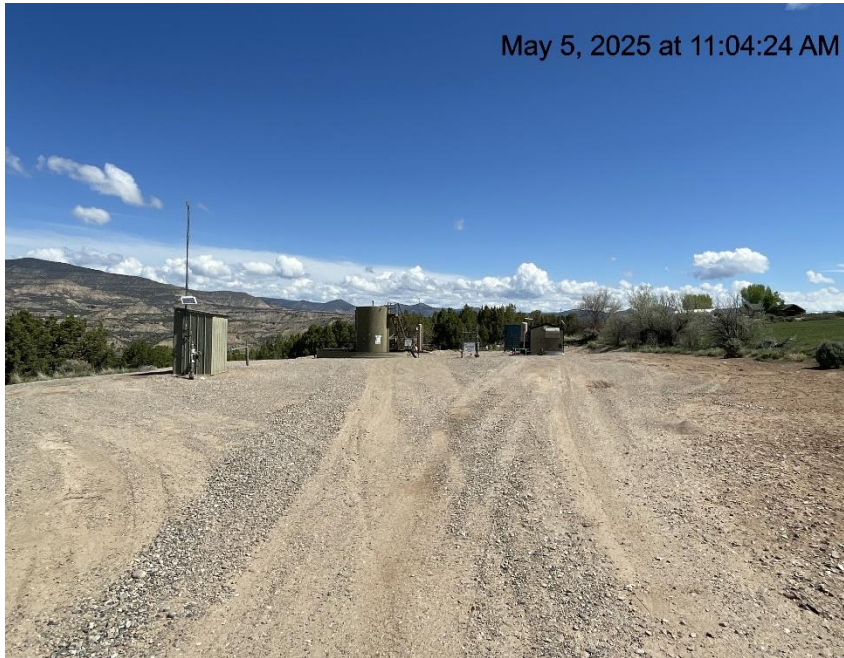
Photo # 8841 From entrance to location
