Inspection/Audit Photos

Location Name: TEP ROCKY MOUNTAIN LLC JOLLEY KP 22-16 Pad

Location ID: 335522

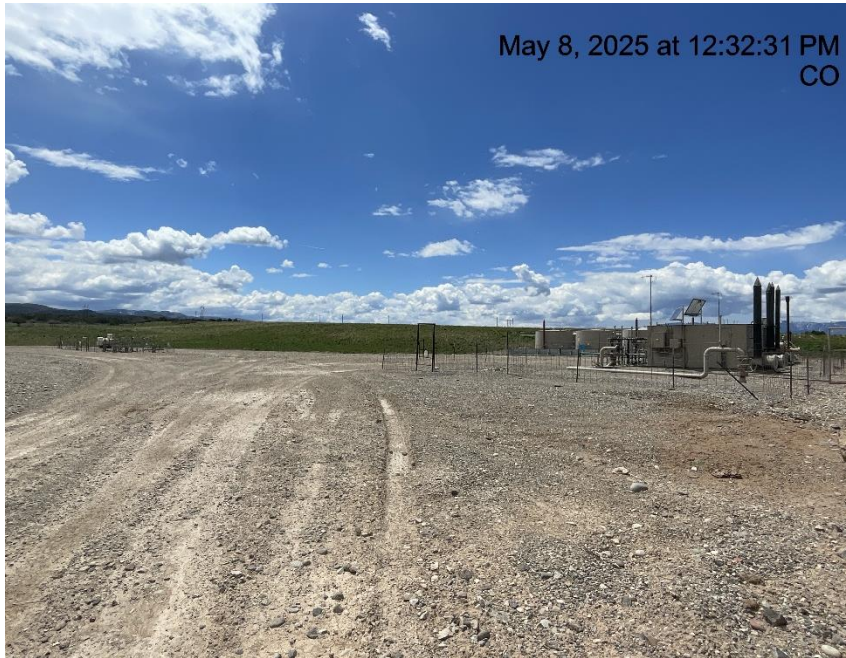
Photo # 9911 From entrance to location

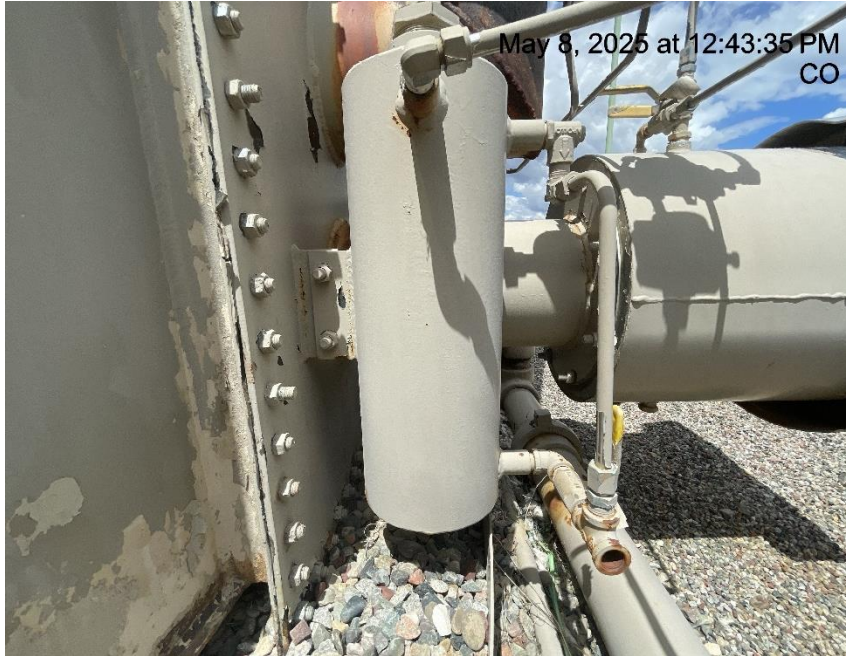
Photo # 9919 PRV vent line does not comply with CECMC pressure safety device rules or general safety rules

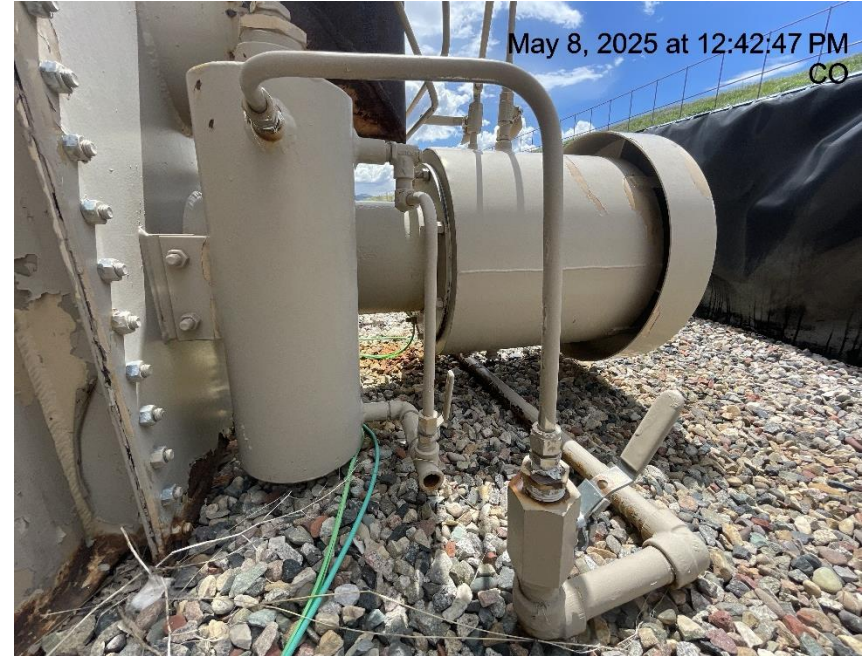
Photo # 9920 PRV vent line does not comply with CECMC pressure safety device rules or general safety rules
