## Inspection/Audit Photos

Location: LARAMIE ENERGY LLC My Way Ranch/7-8 Pad

Location ID: 334514

Date: 05/7/2025

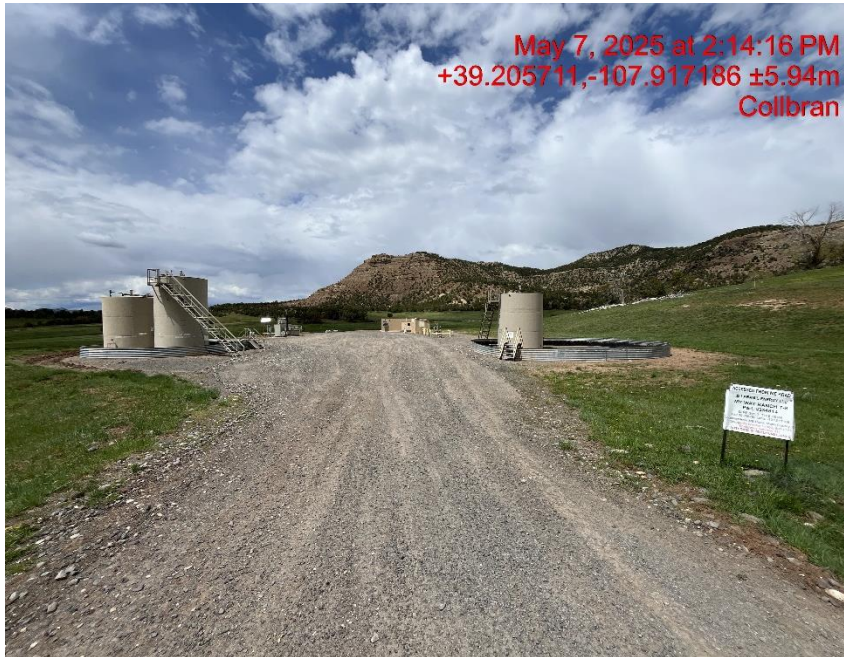
Photo # 7136 Entrance to location

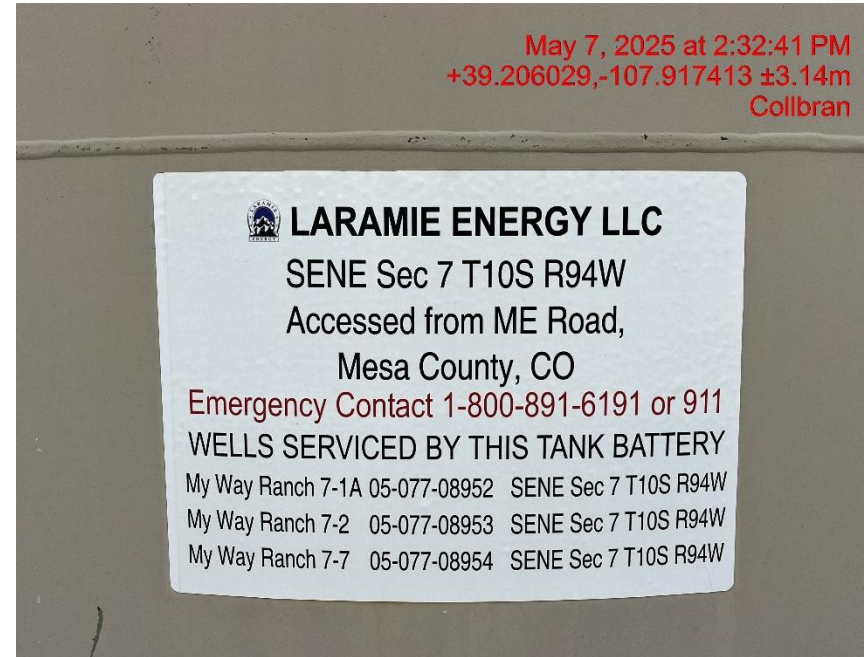
Photo # 7147 Location

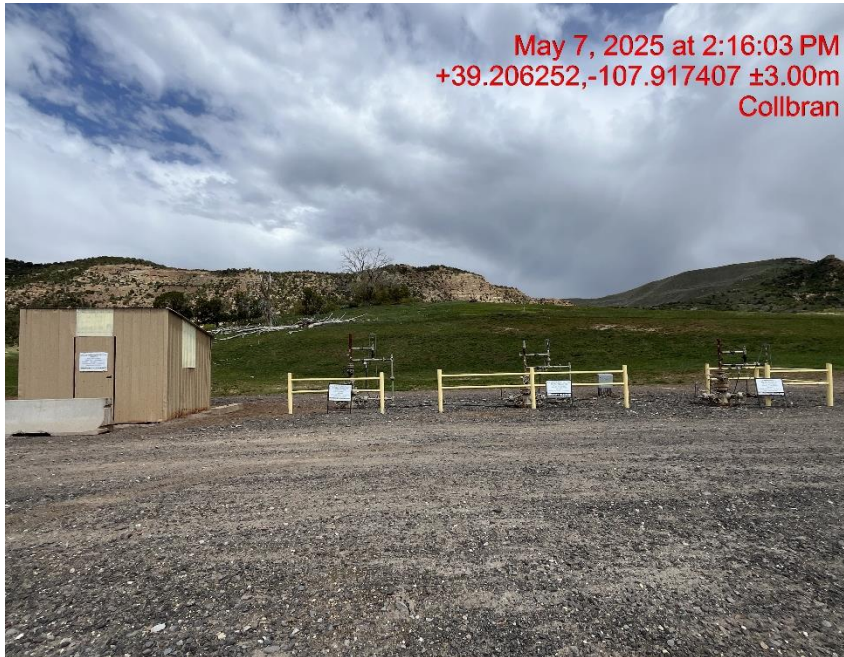
Photo # 7137 Location

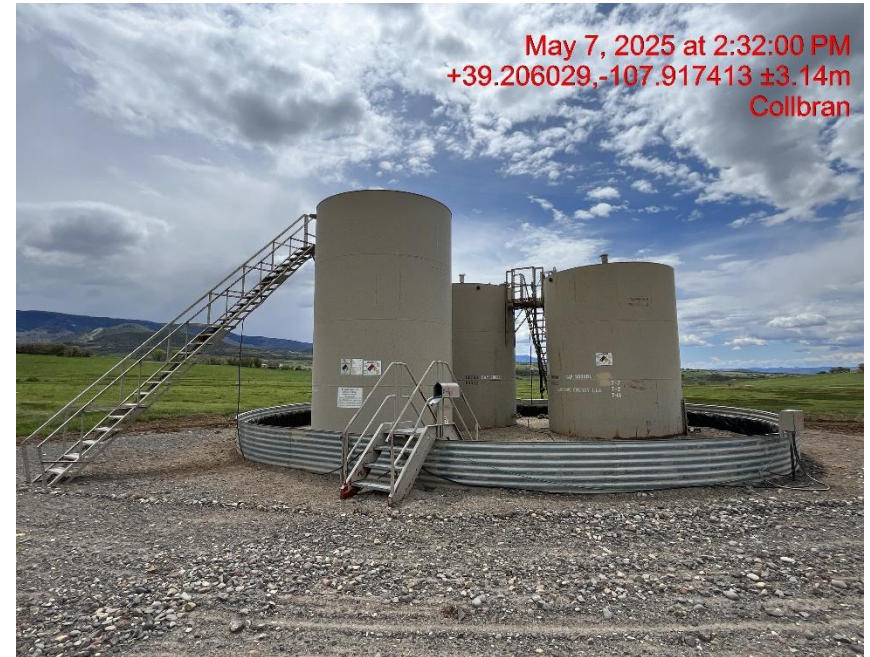
Photo # 7146 Location

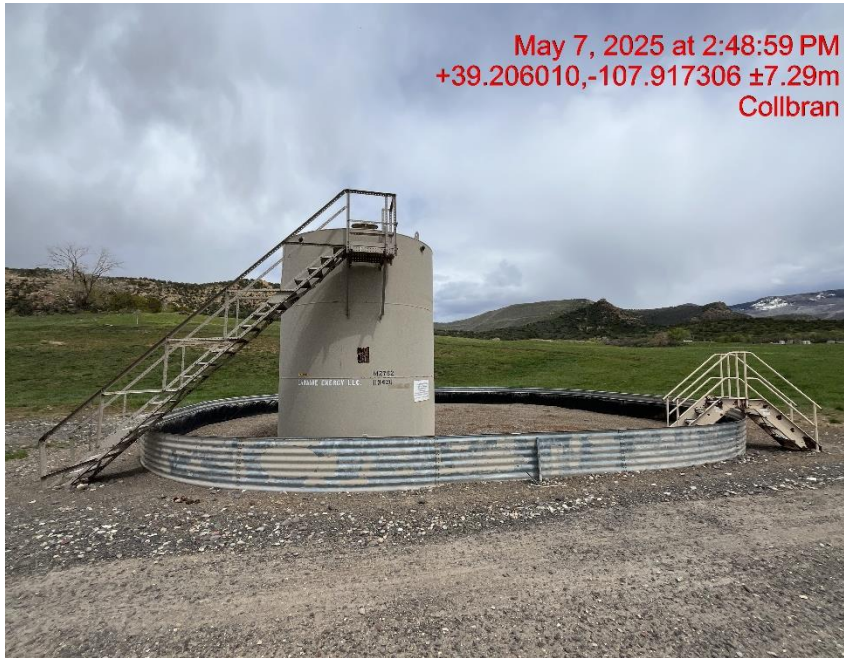
Photo # 7164 Location

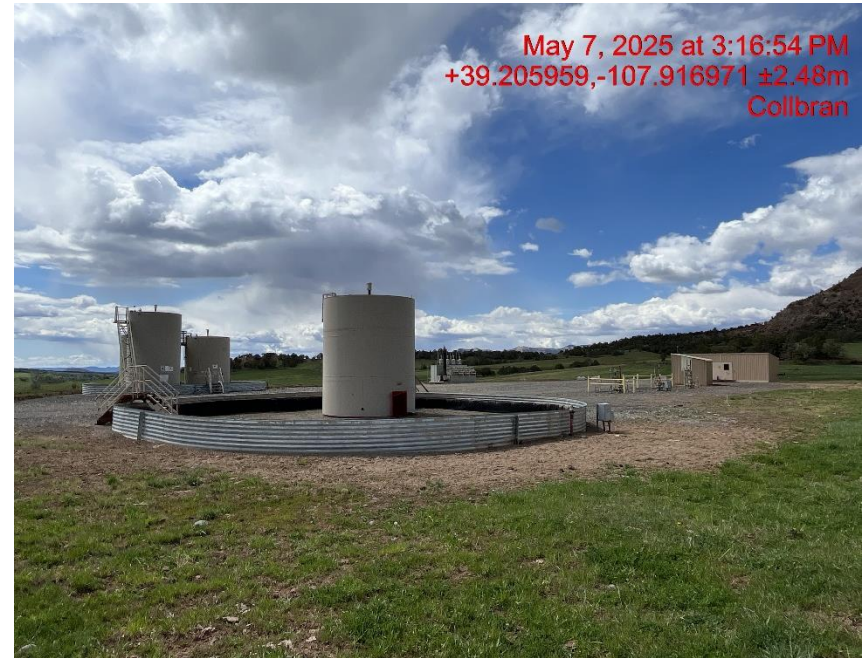
Photo # 7210 SE corner of location

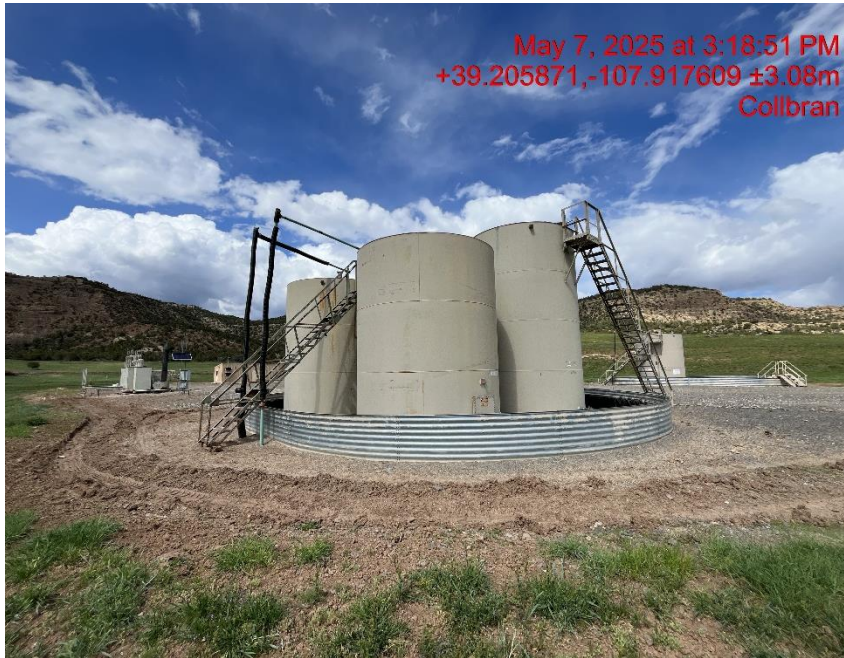
Photo # 7211 SW corner of location

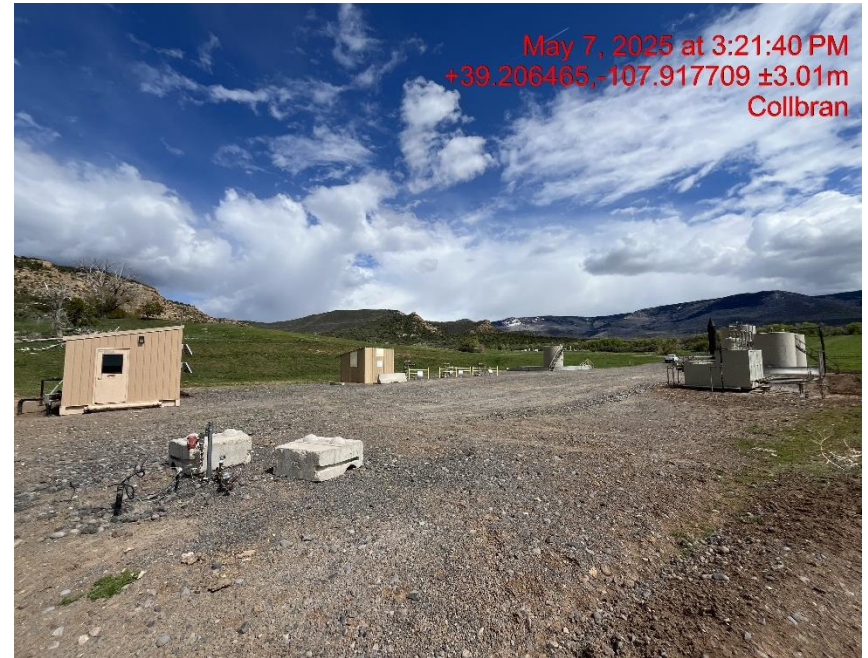
Photo # 7212 NW corner of location

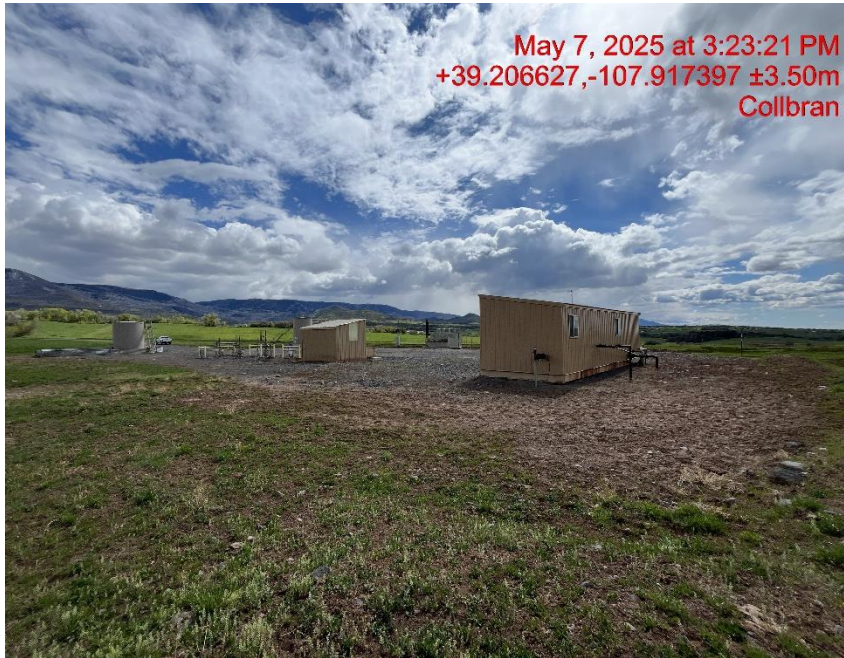
Photo # 7213 NE corner of location

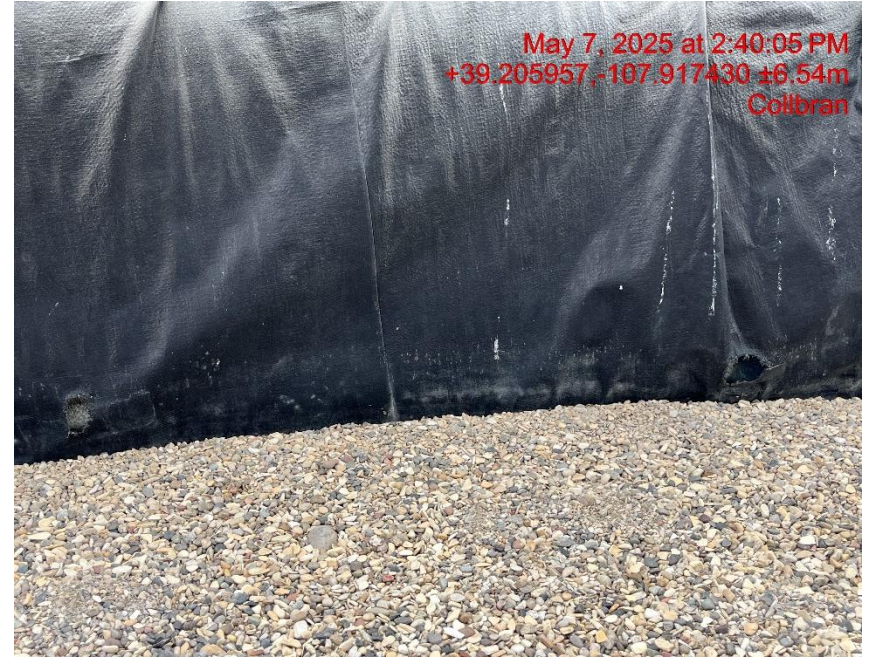
Photo # 7153 Multiple holes in both secondary containments on location liners/liners need maintenance

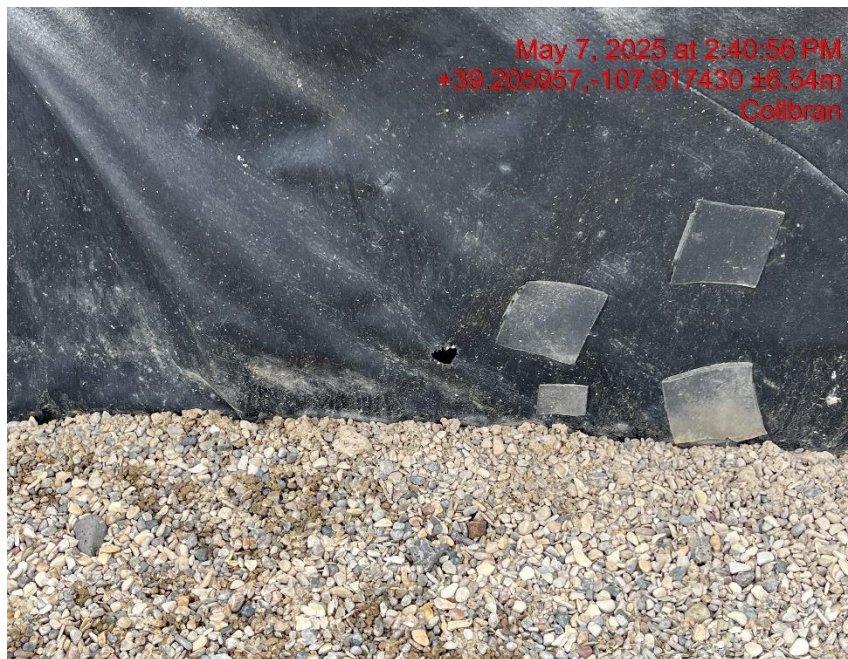
**Photo # 7154 Multiple holes in both secondary containments on location liners/liners need maintenance**

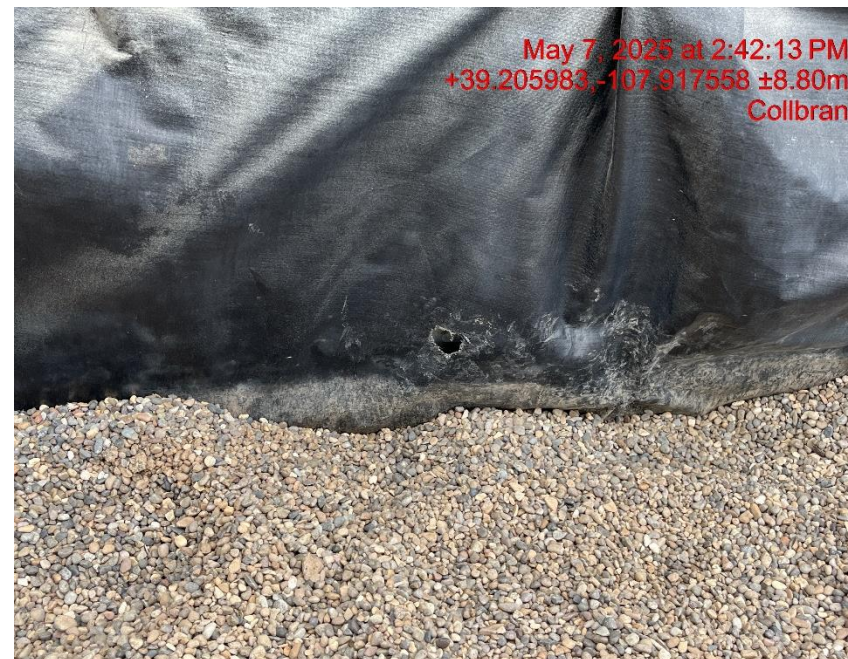
**Photo # 7156 Multiple holes in both secondary containments on location liners/liners need maintenance**

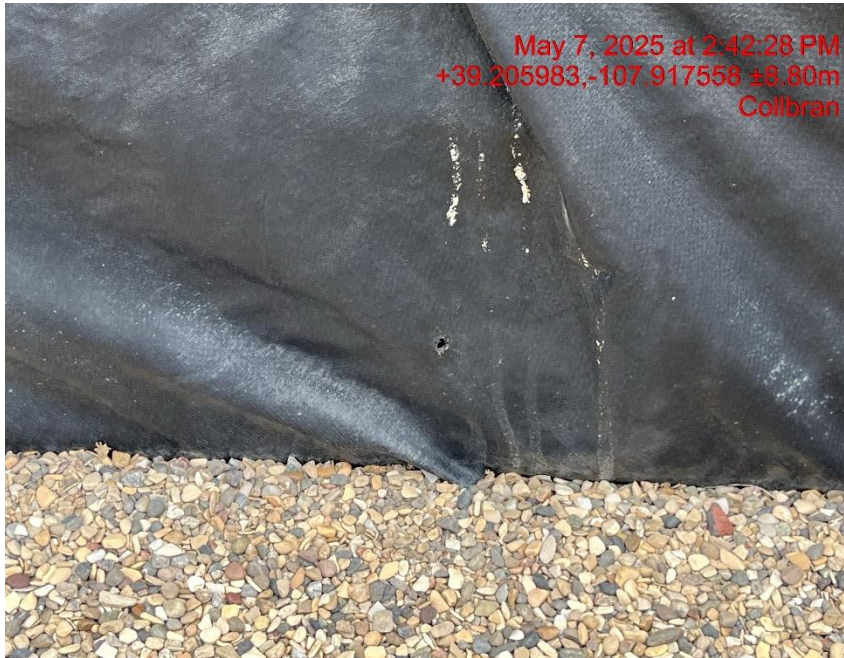
**Photo # 7157 Multiple holes in both secondary containments on location liners/liners need maintenance**

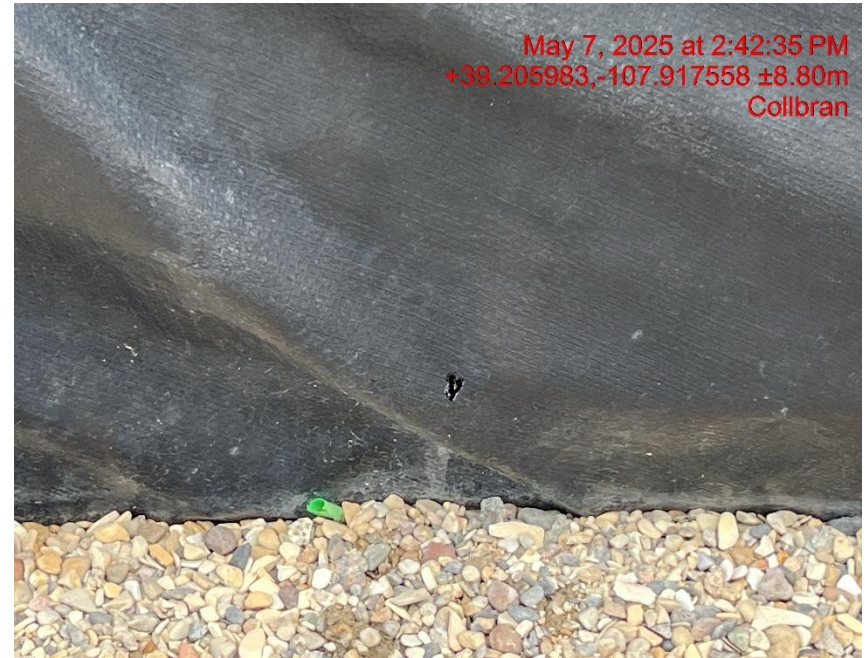
**Photo # 7158 Multiple holes in both secondary containments on location liners/liners need maintenance**

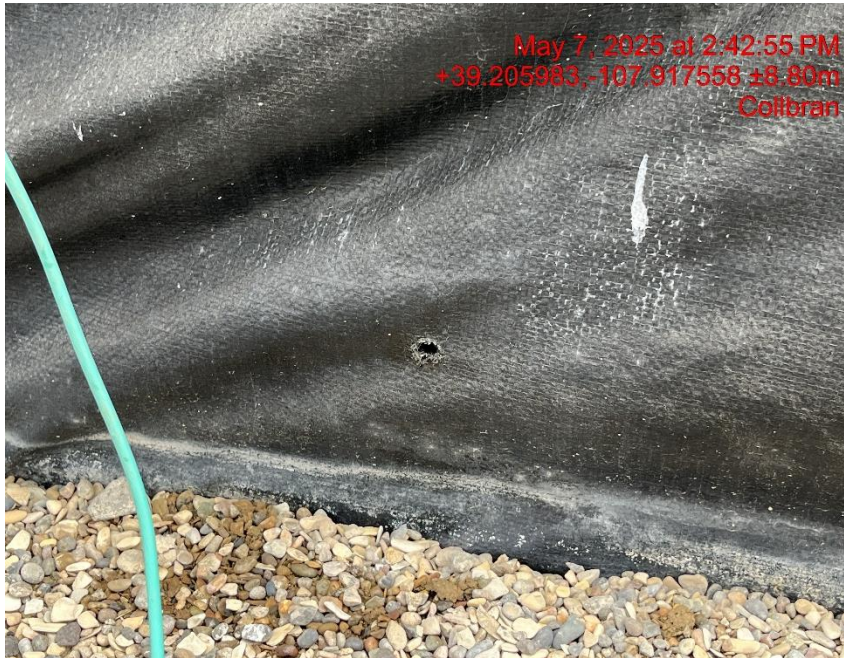
**Photo # 7159 Multiple holes in both secondary containments on location liners/liners need maintenance**

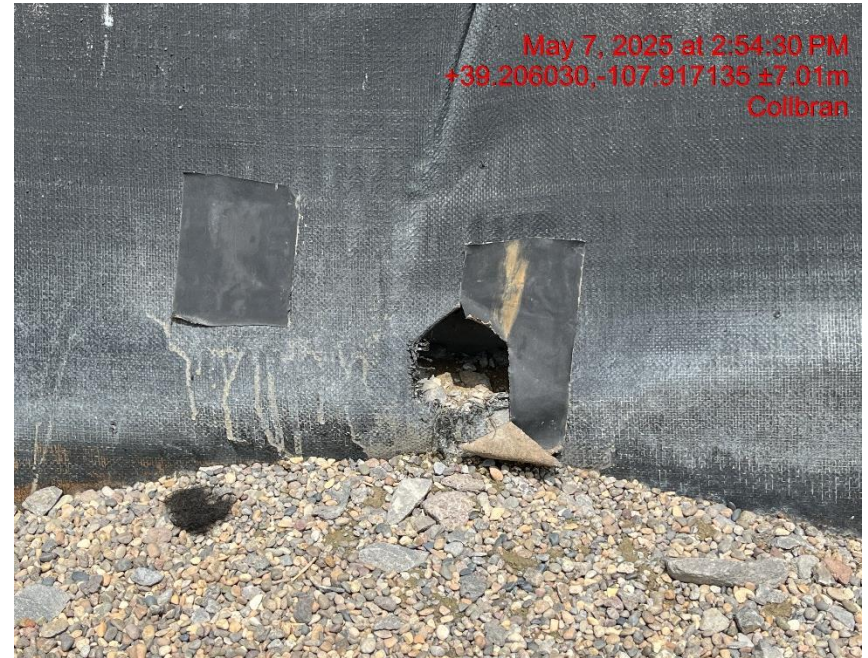
**Photo # 7174 Multiple holes in both secondary containments on location liners/liners need maintenance**

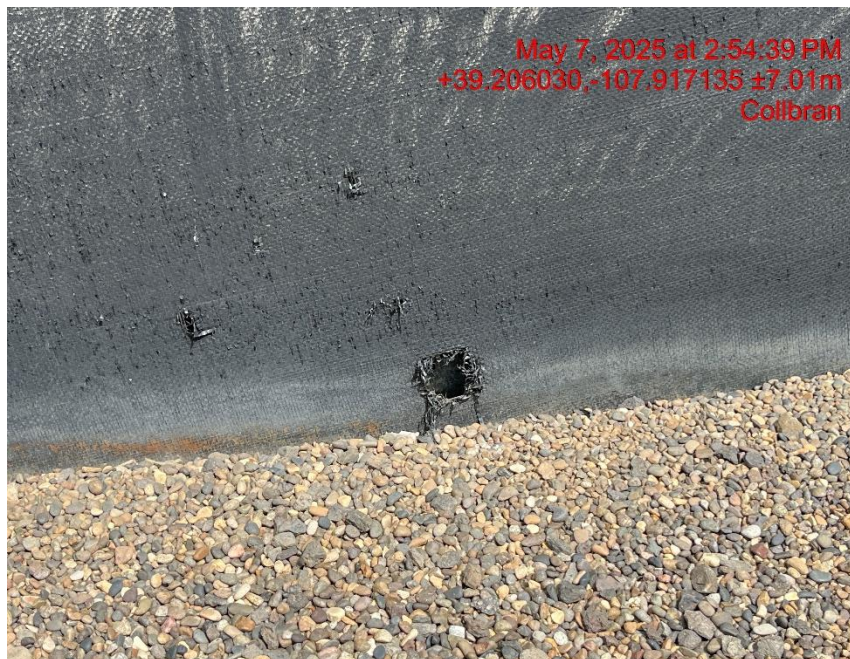
**Photo # 7175 Multiple holes in both secondary containments on location liners/liners need maintenance**

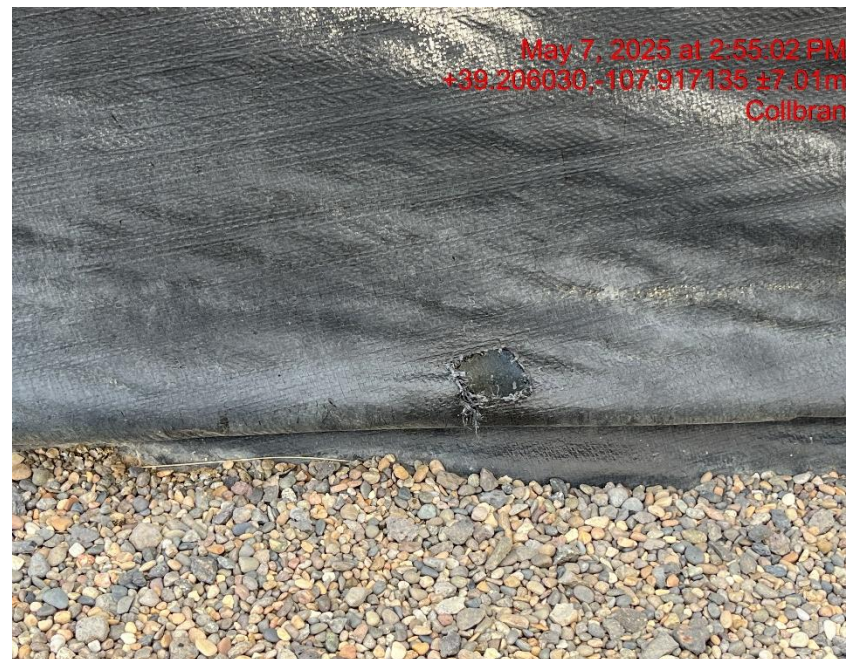
**Photo # 7176 Multiple holes in both secondary containments on location liners/liners need maintenance**

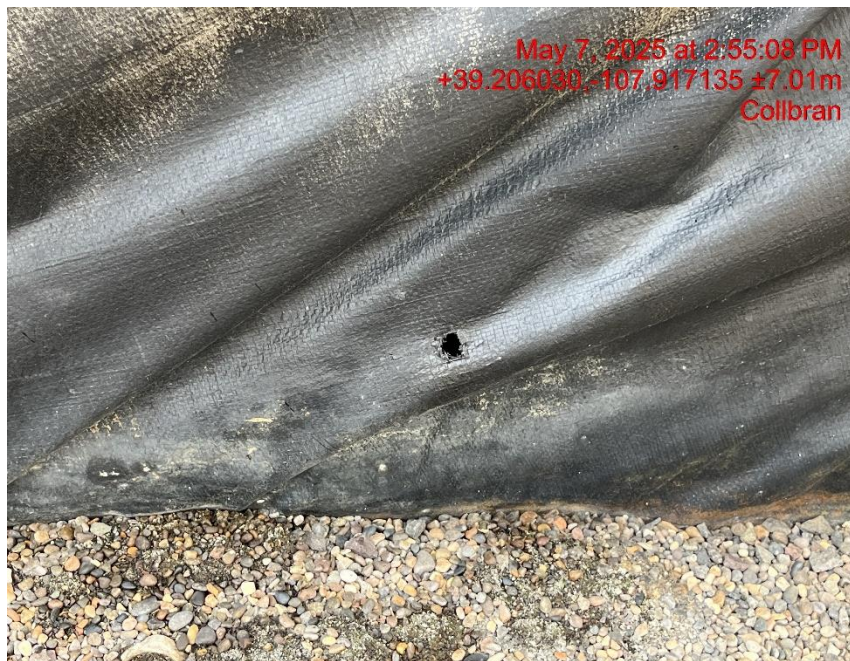
**Photo # 7177 Multiple holes in both secondary containments on location liners/liners need maintenance**

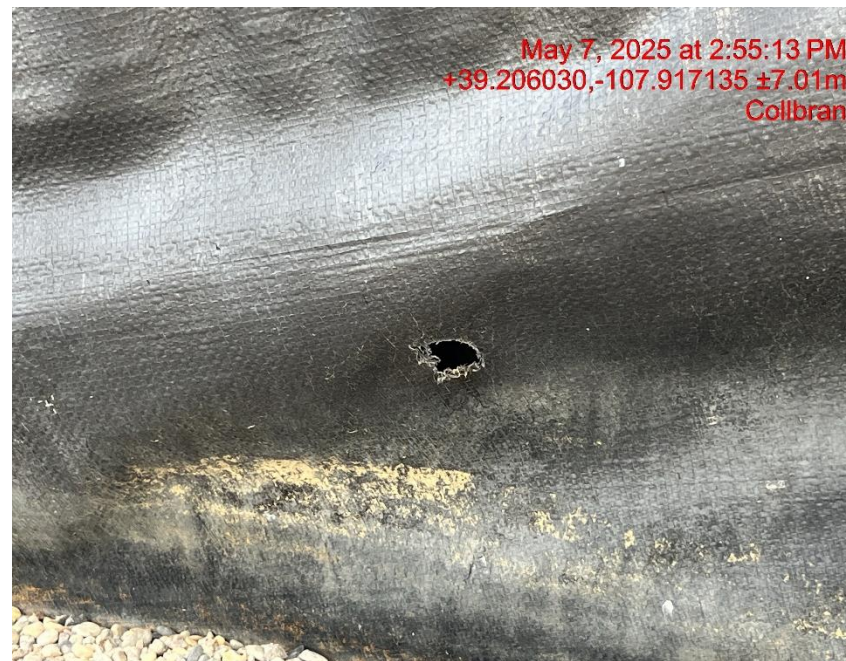
**Photo # 7178 Multiple holes in both secondary containments on location liners/liners need maintenance**

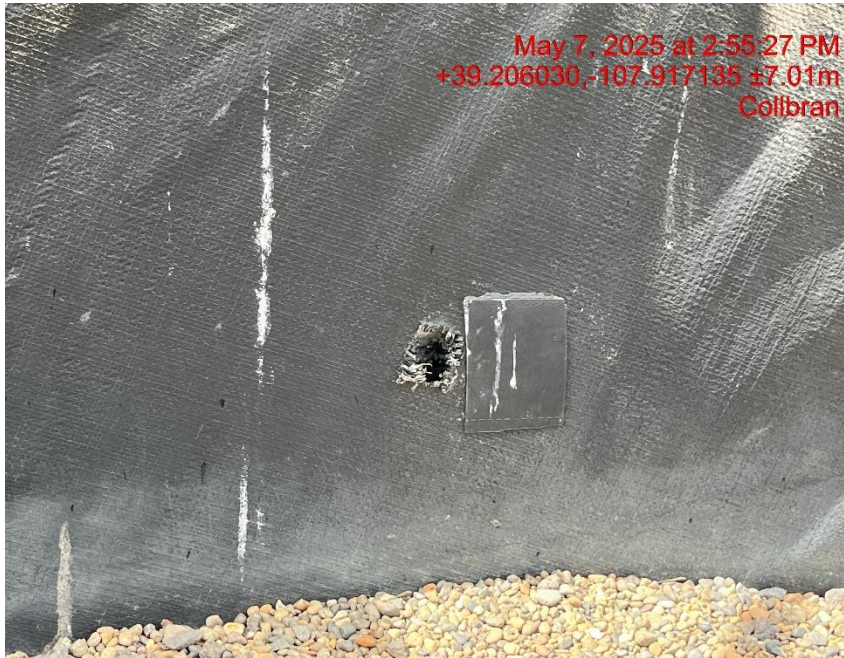
**Photo # 7179 Multiple holes in both secondary containments on location liners/liners need maintenance**

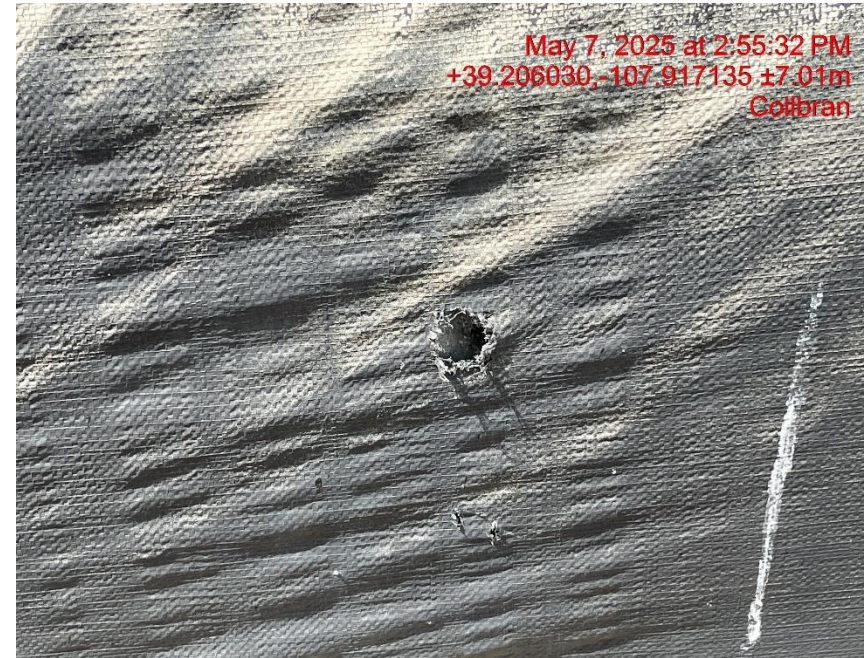
**Photo # 7180 Multiple holes in both secondary containments on location liners/liners need maintenance**

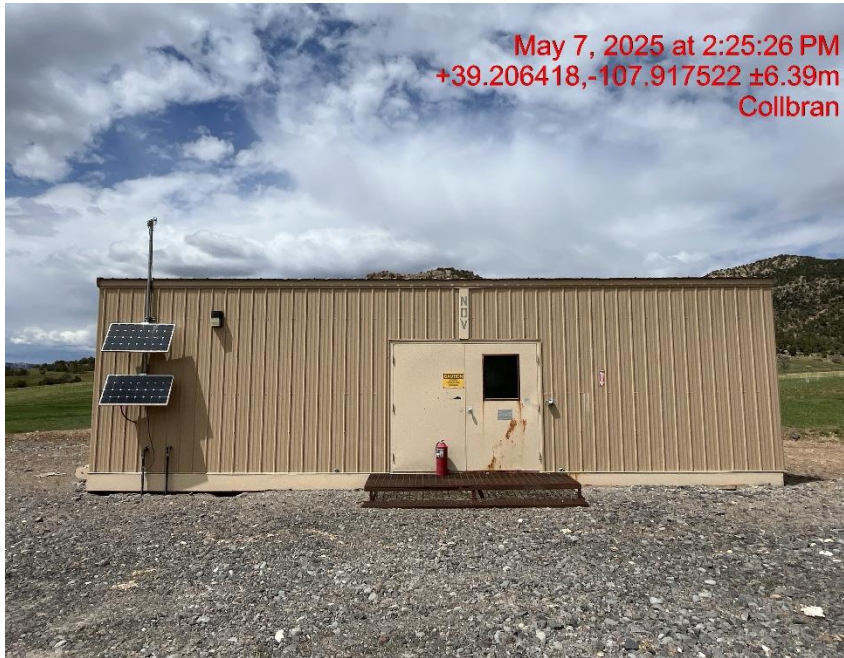
Photo # 7143 Unused equipment

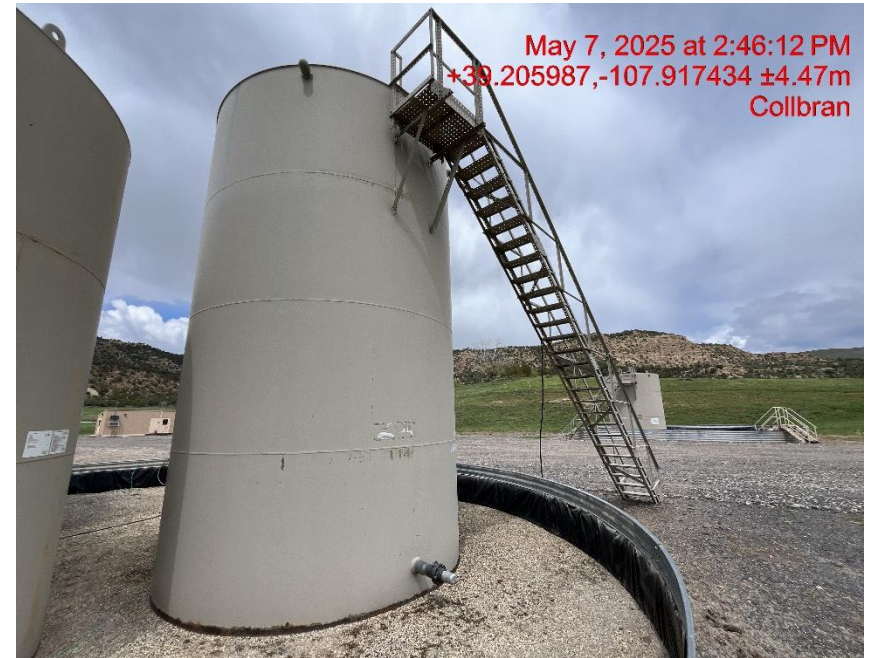
Photo # 7160 Unused equipment

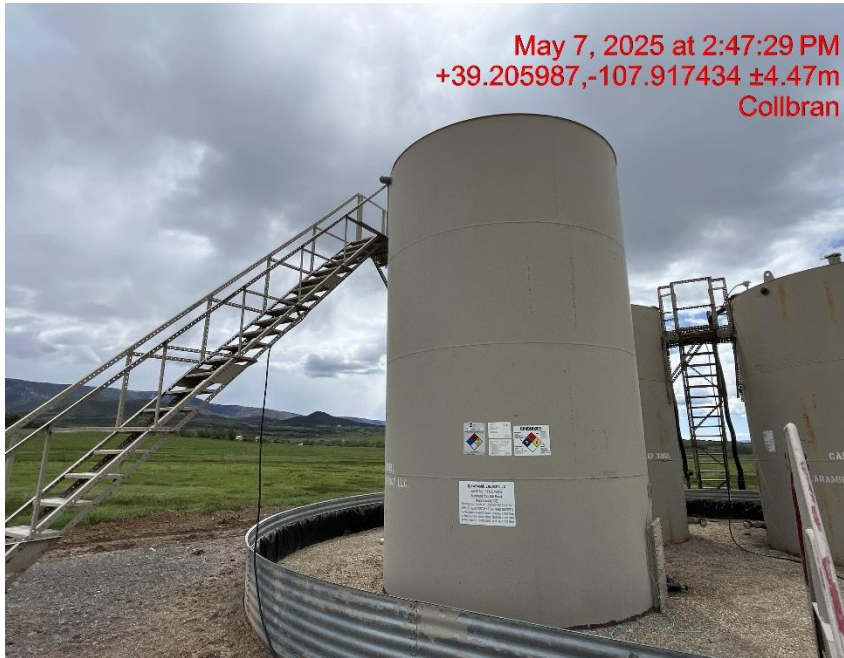
Photo # 7162 Unused equipment

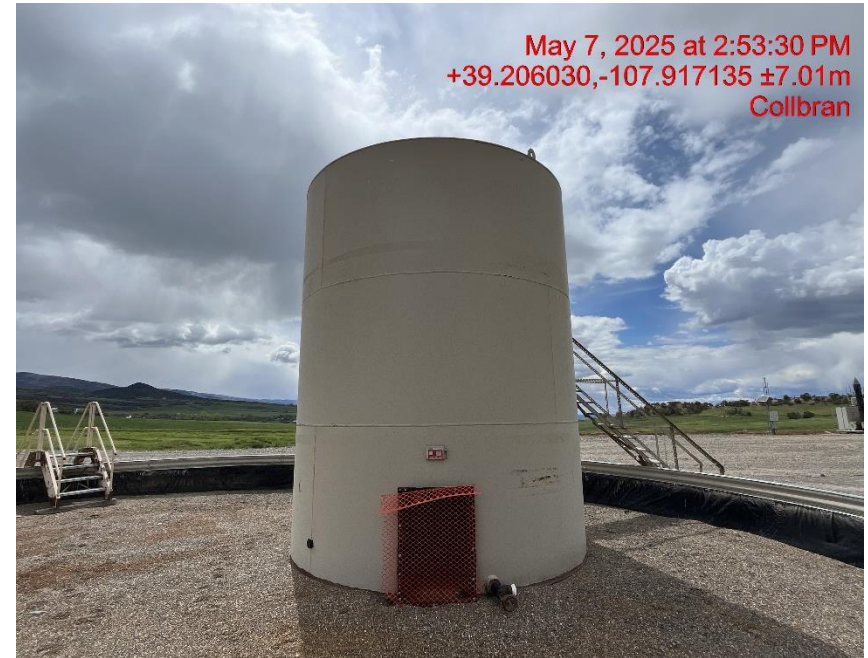
Photo # 7173 Unused equipment

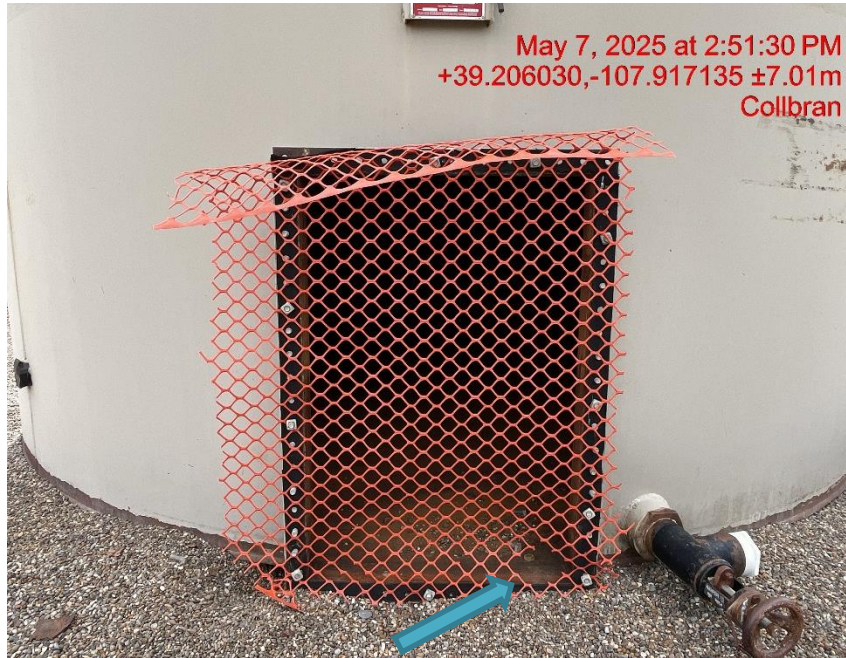
Photo # 7170 Wildlife hazard

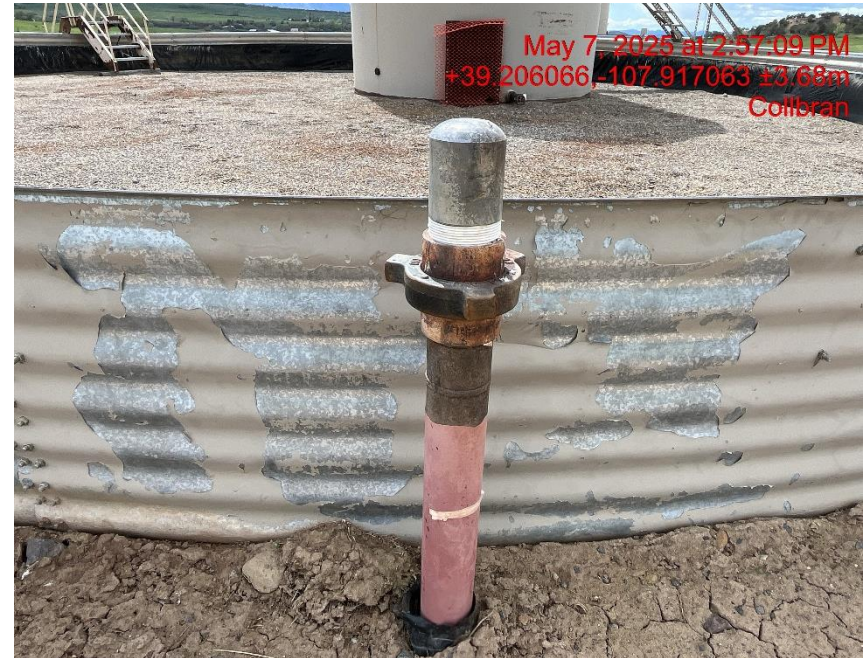
Photo # 7183 Unused flowline at tank battery lacks lockout tagout (OOSLAT)

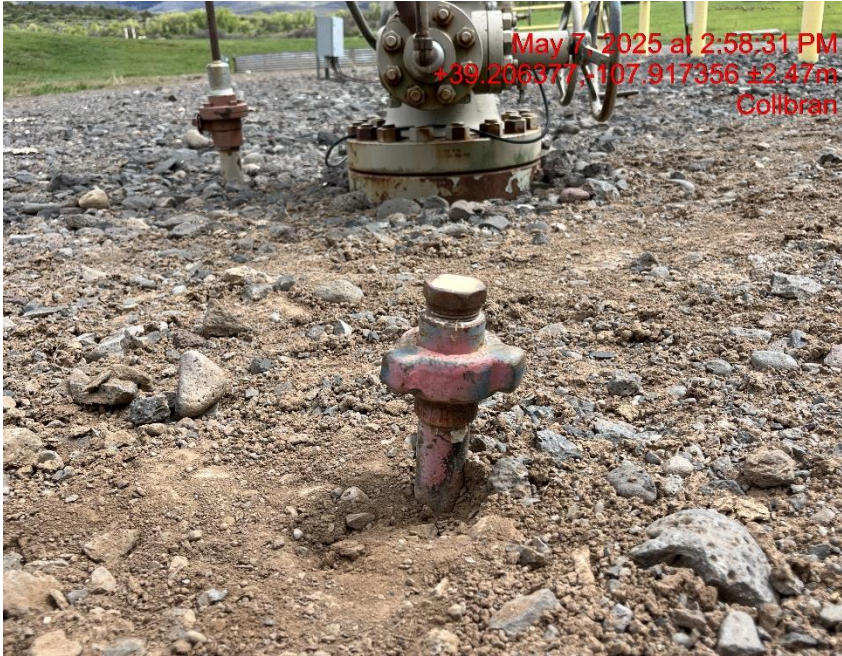
**Photo # 7184 Unused flowline near MWR 7-1A wellhead  
lacks lockout tagout (OOSLAT)**

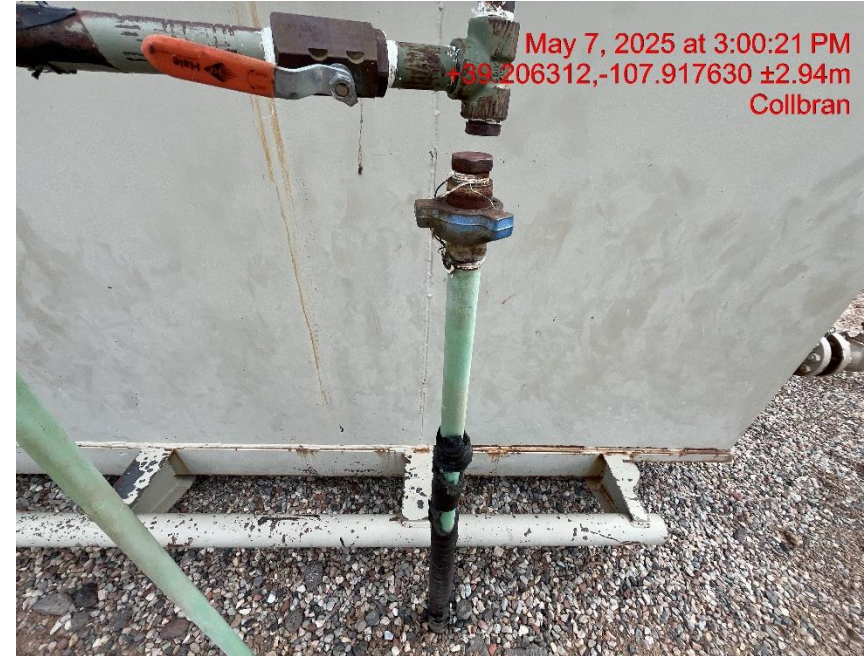
**Photo # 7188 Unused flowline at separators lack lockout  
tagout (OOSLAT)**

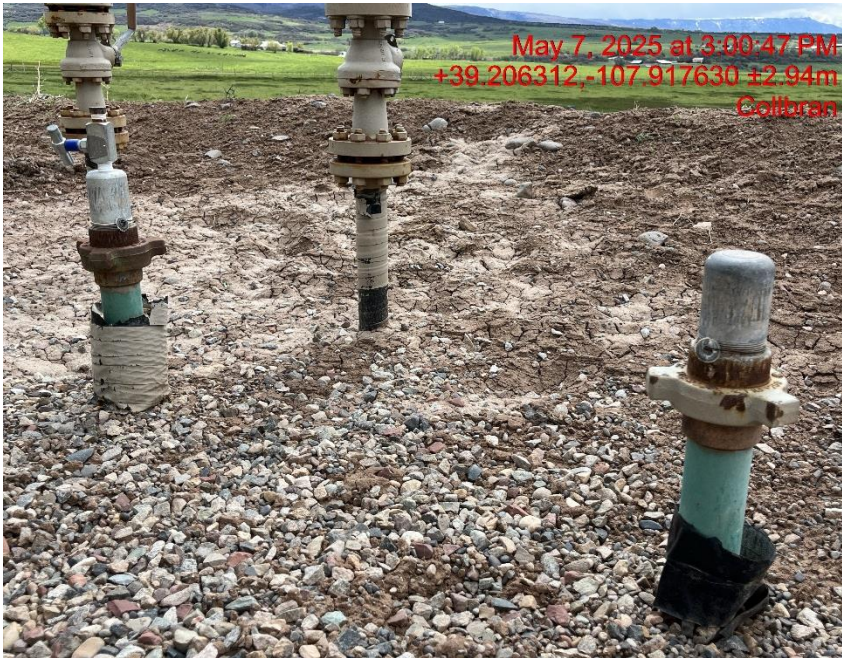
**Photo # 7189 Unused flowlines at separators lack lockout tagout (OOSLAT)**

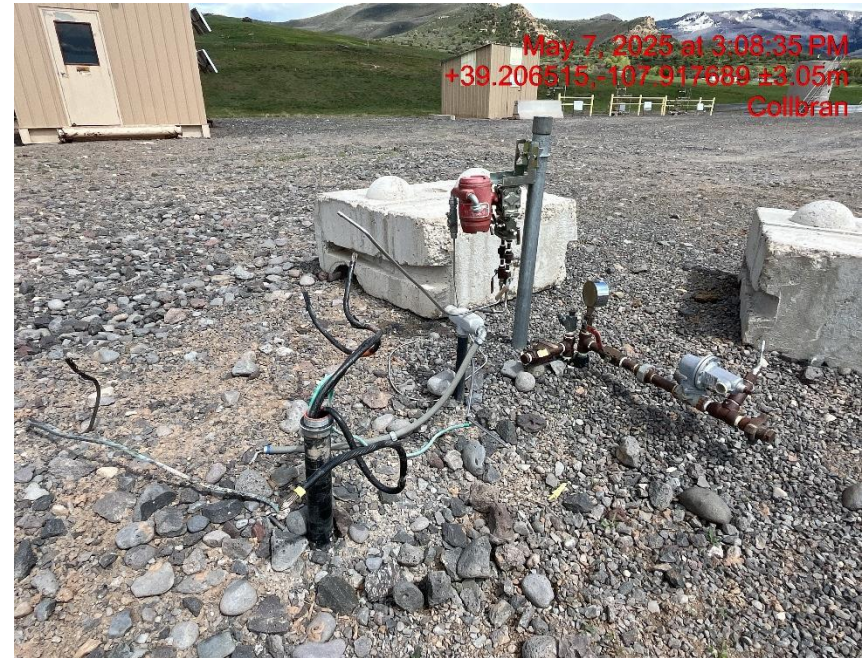
**Photo # 7197 Unused flowlines near pump house lack lockout tagout (OOSLAT)**

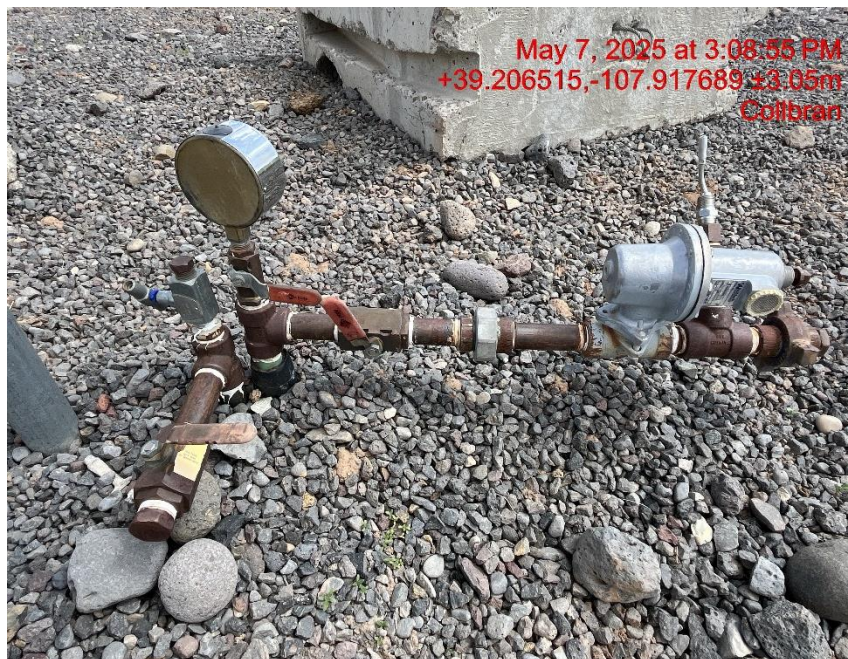
**Photo # 7199 Unused flowlines near pump house lack lockout tagout (OOSLAT)**

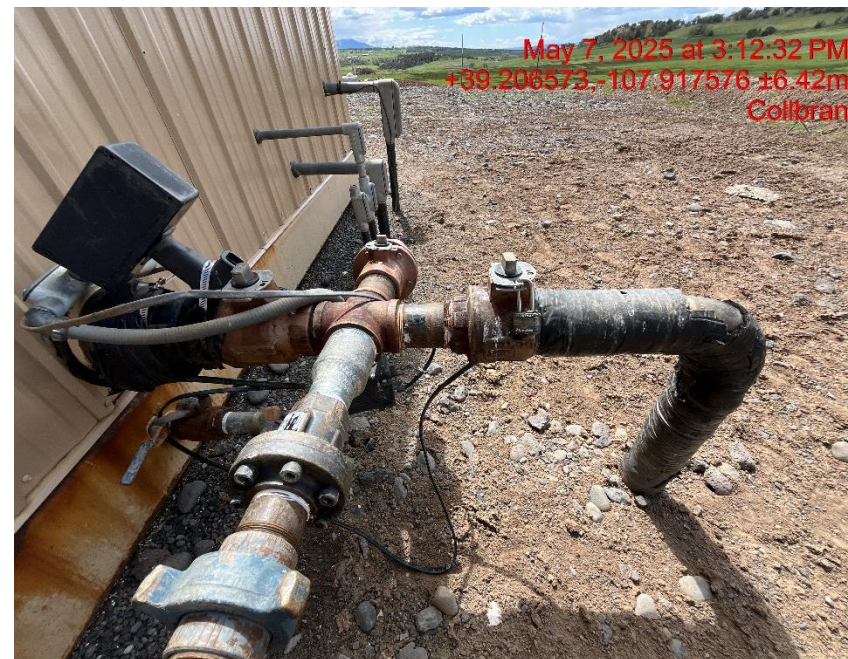
**Photo # 7204 Unused flowlines at pump house lack lockout tagout (OOSLAT)**

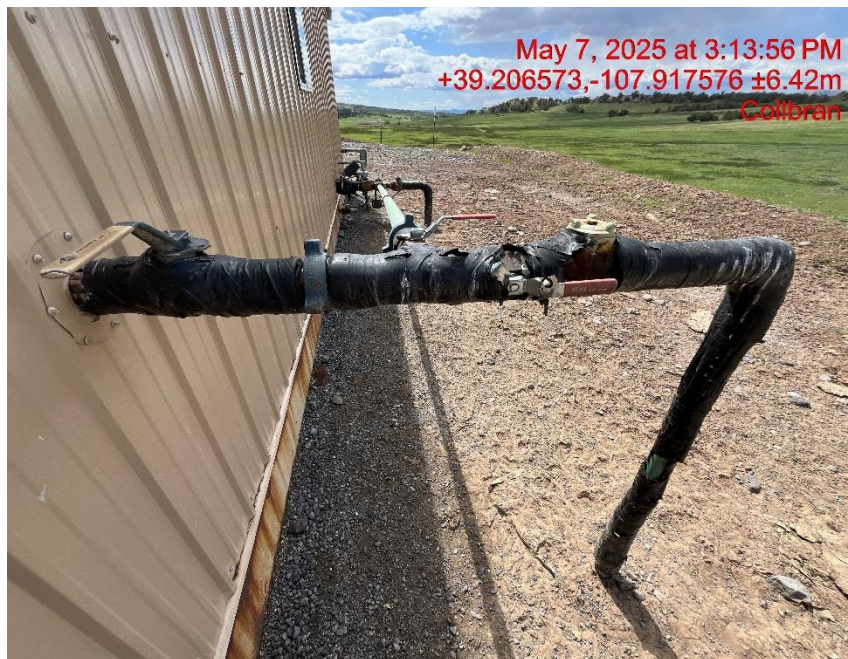
Photo # 7208 Unused flowlines at pump house lack lockout tagout (OOSLAT)

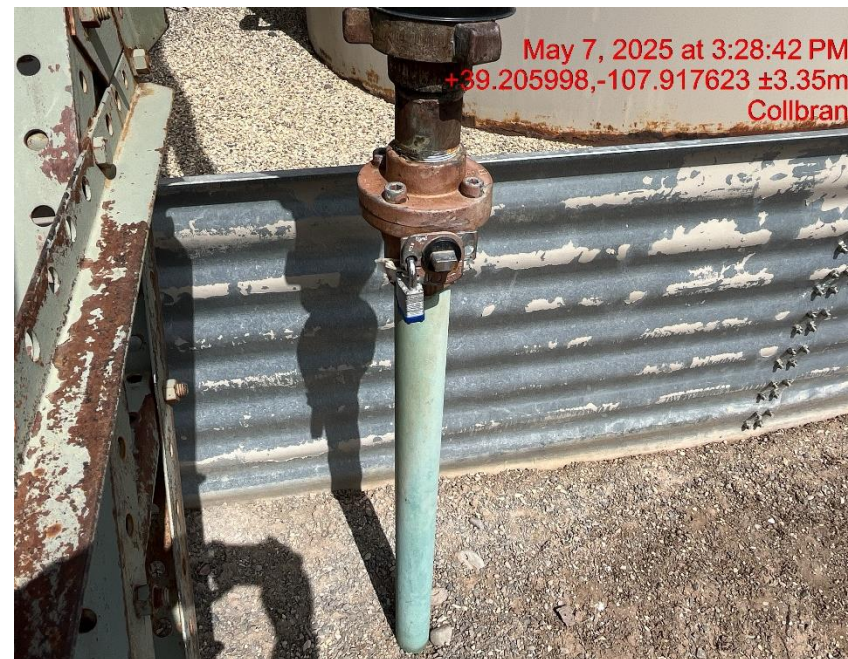
Photo # 7223 Unused flowline at tank battery lacks lockout tagout (OOSLAT)

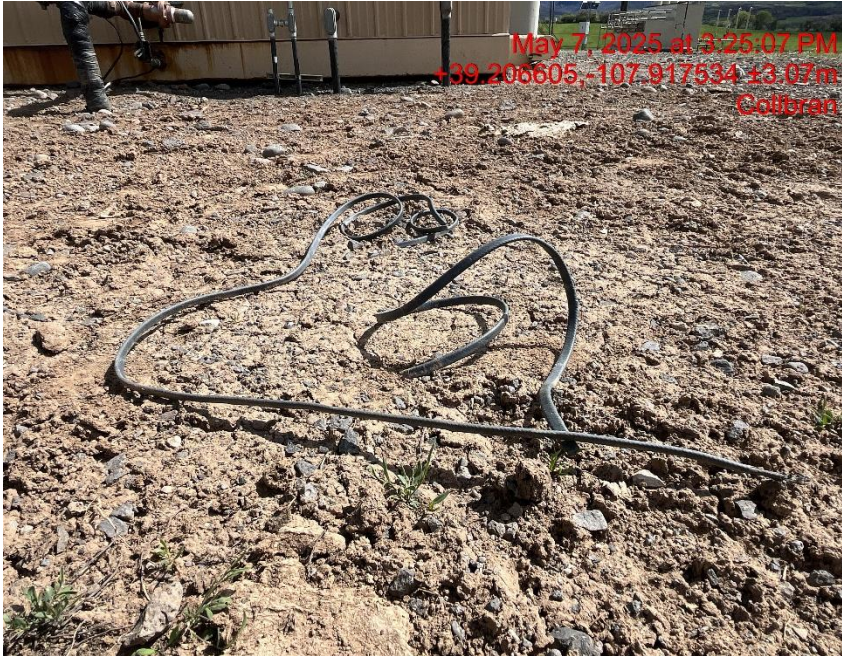
Photo # 7215 Debris on location

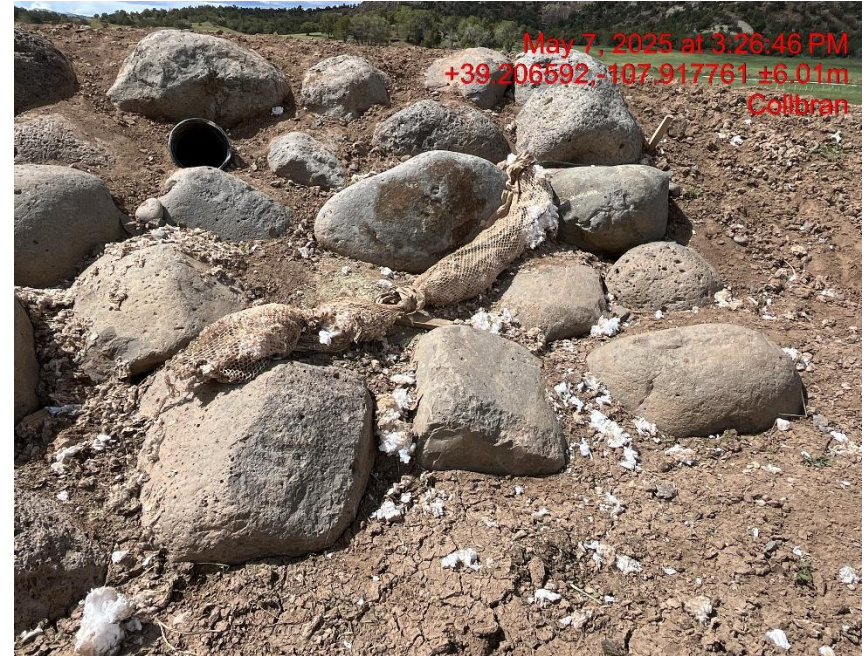
Photo # 7218 Debris on location
