Miller 2 & 7-7 Facility
Ⓢ 06-May-25 10:16:05 AM
ECMC Environmental Inspection

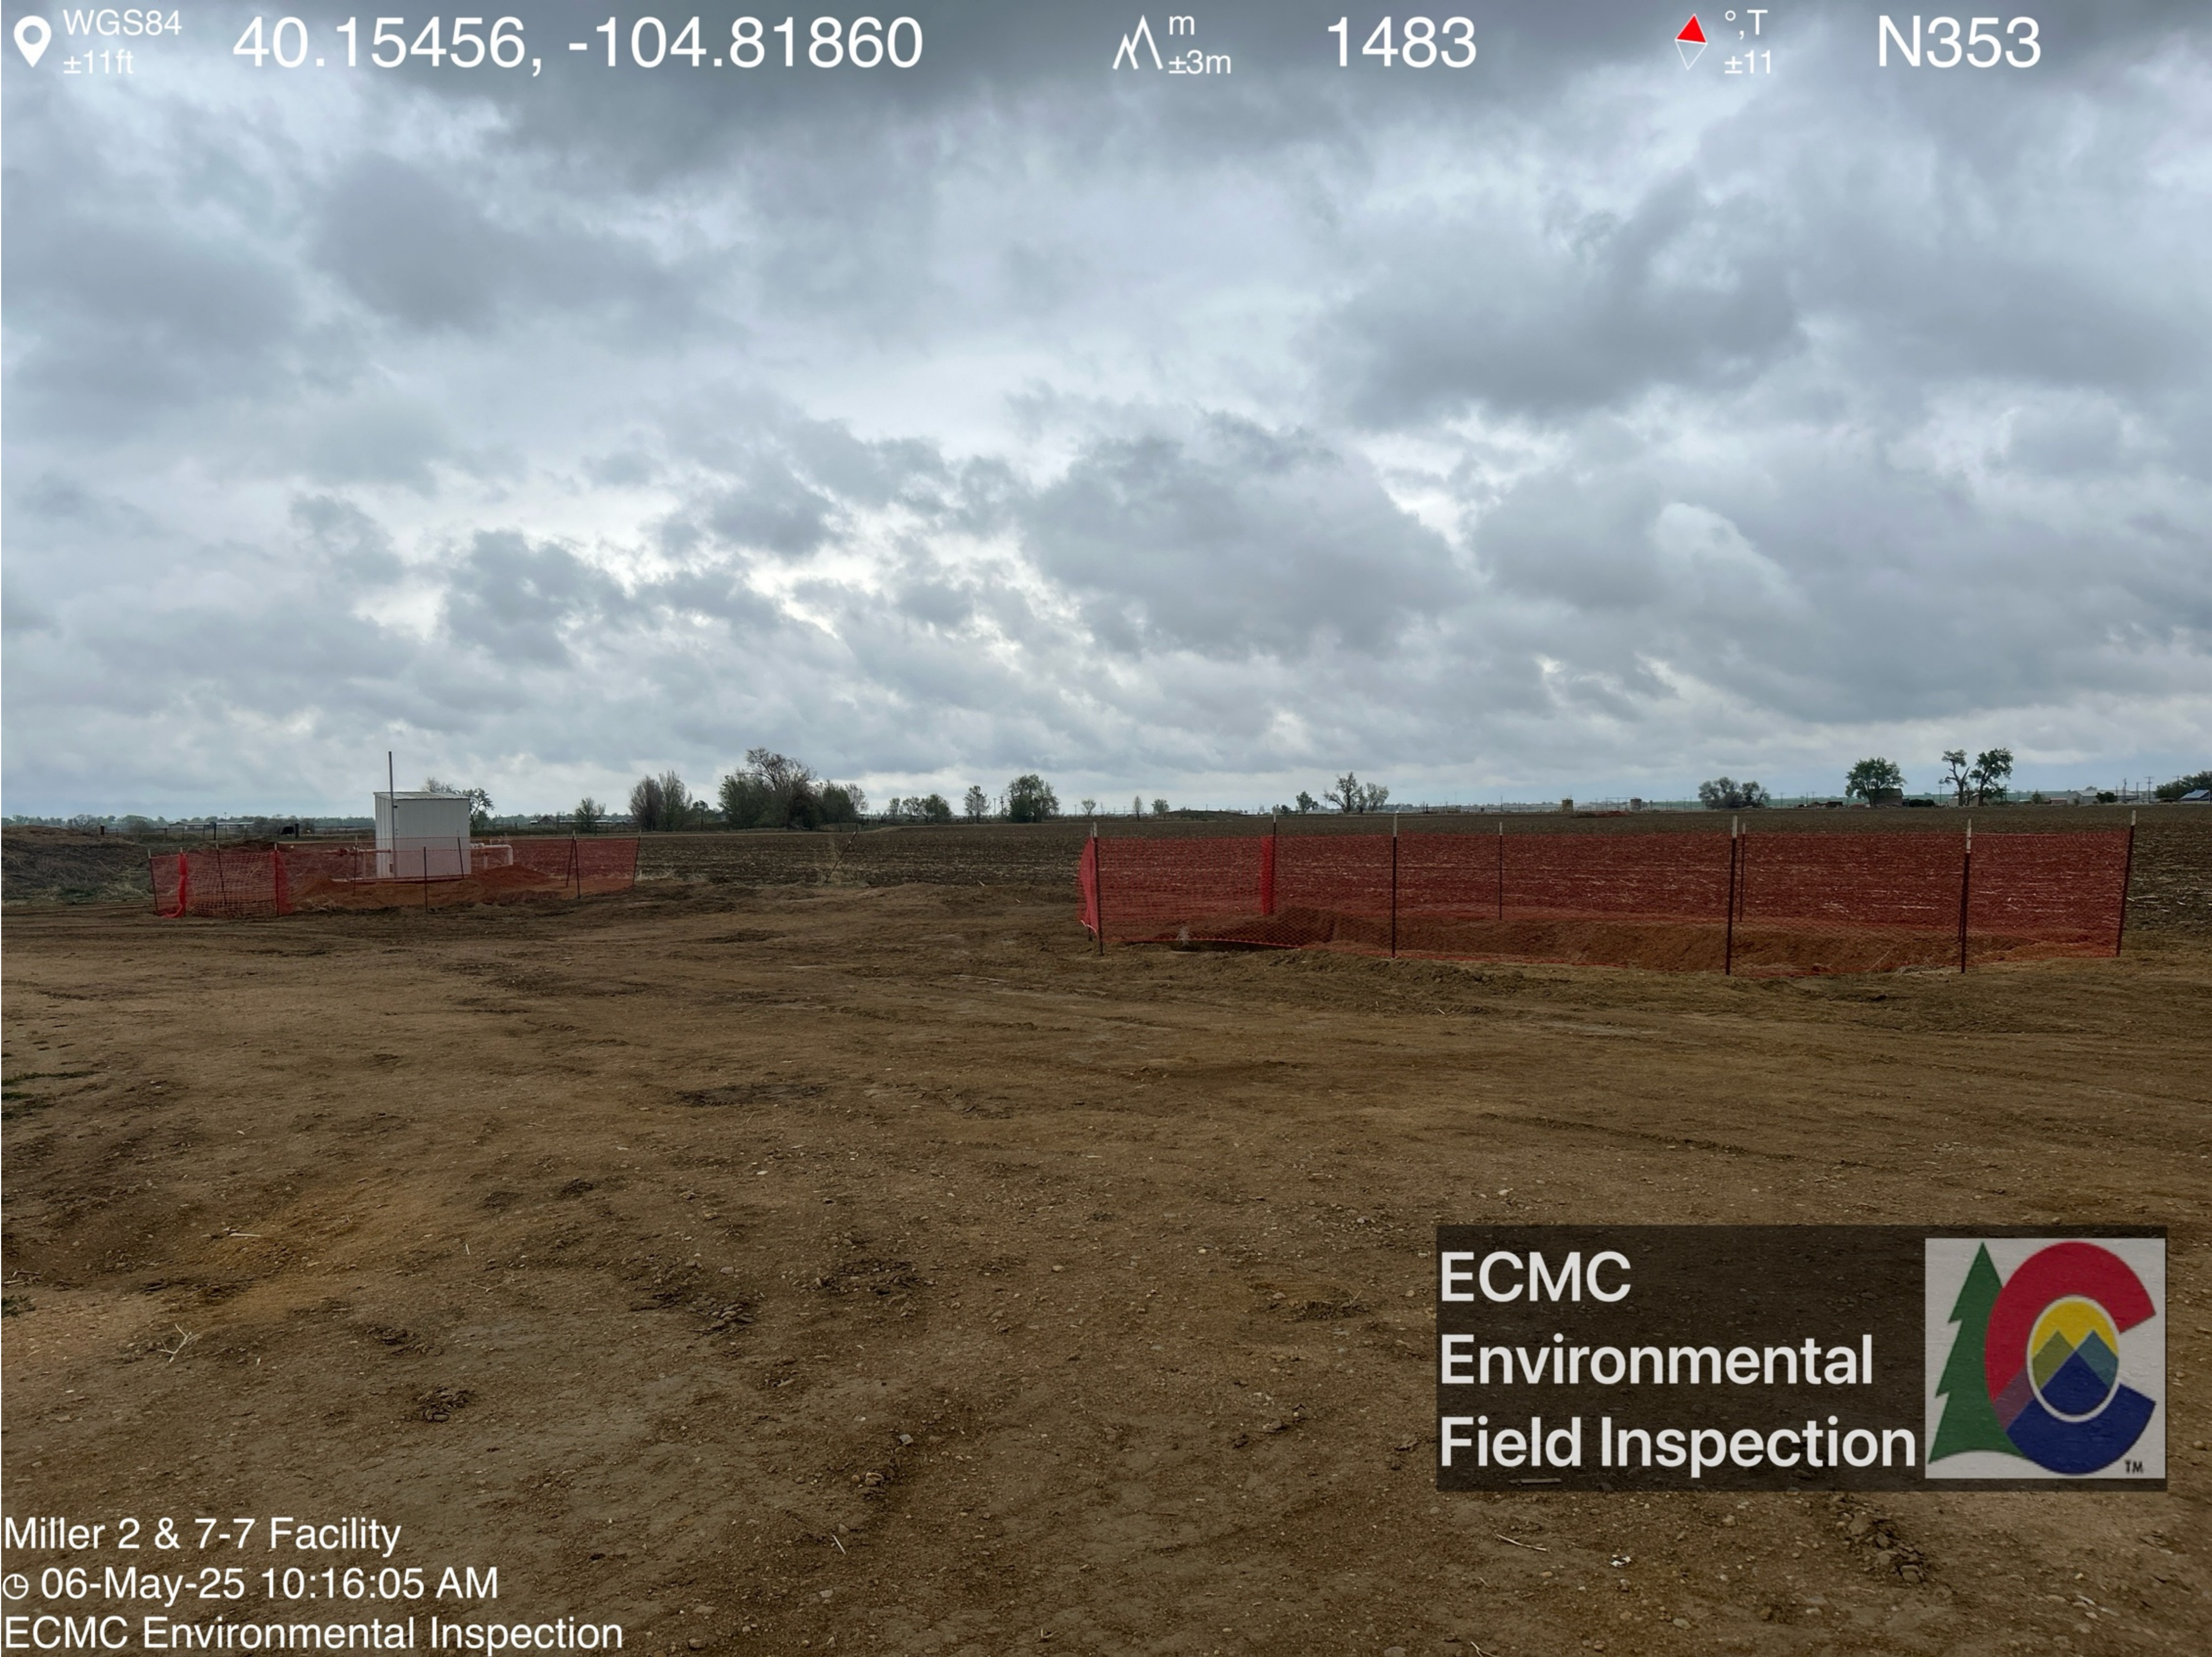
Former tank battery location. Orange construction fencing surrounds two open excavations at the former separator and produced water vault.

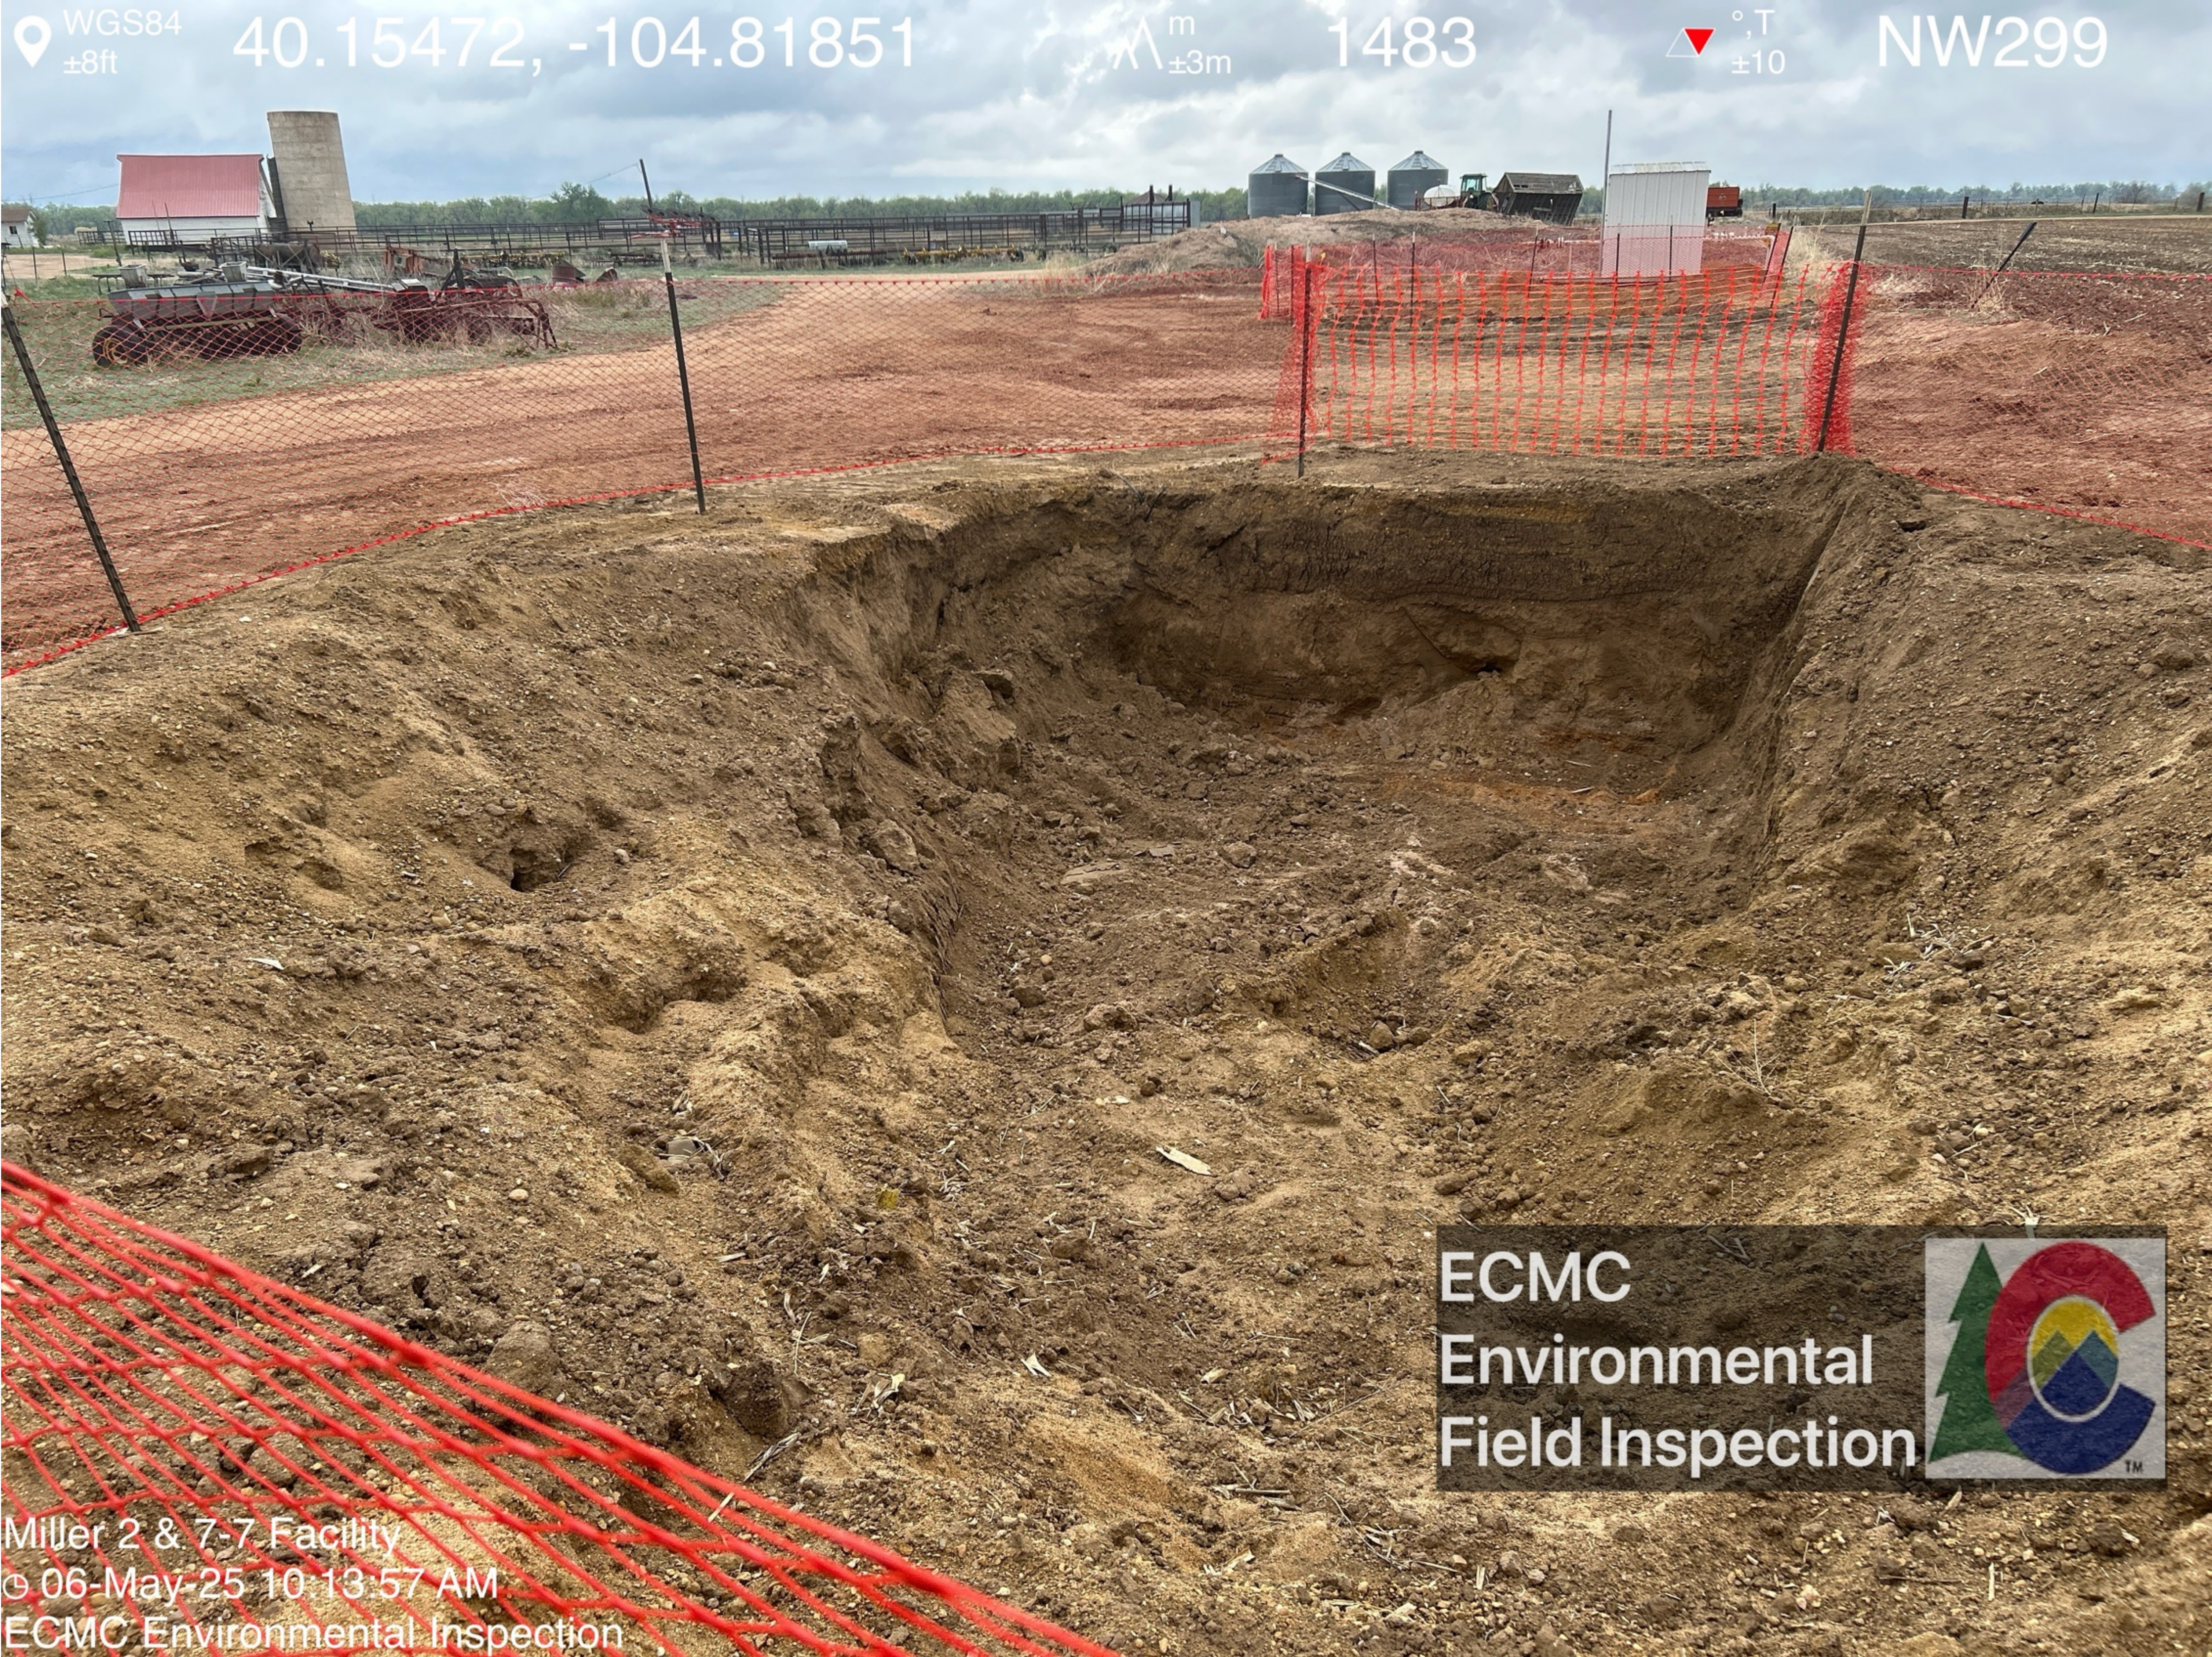
Approximate location of Spill ID 489966 (former produced water vault).

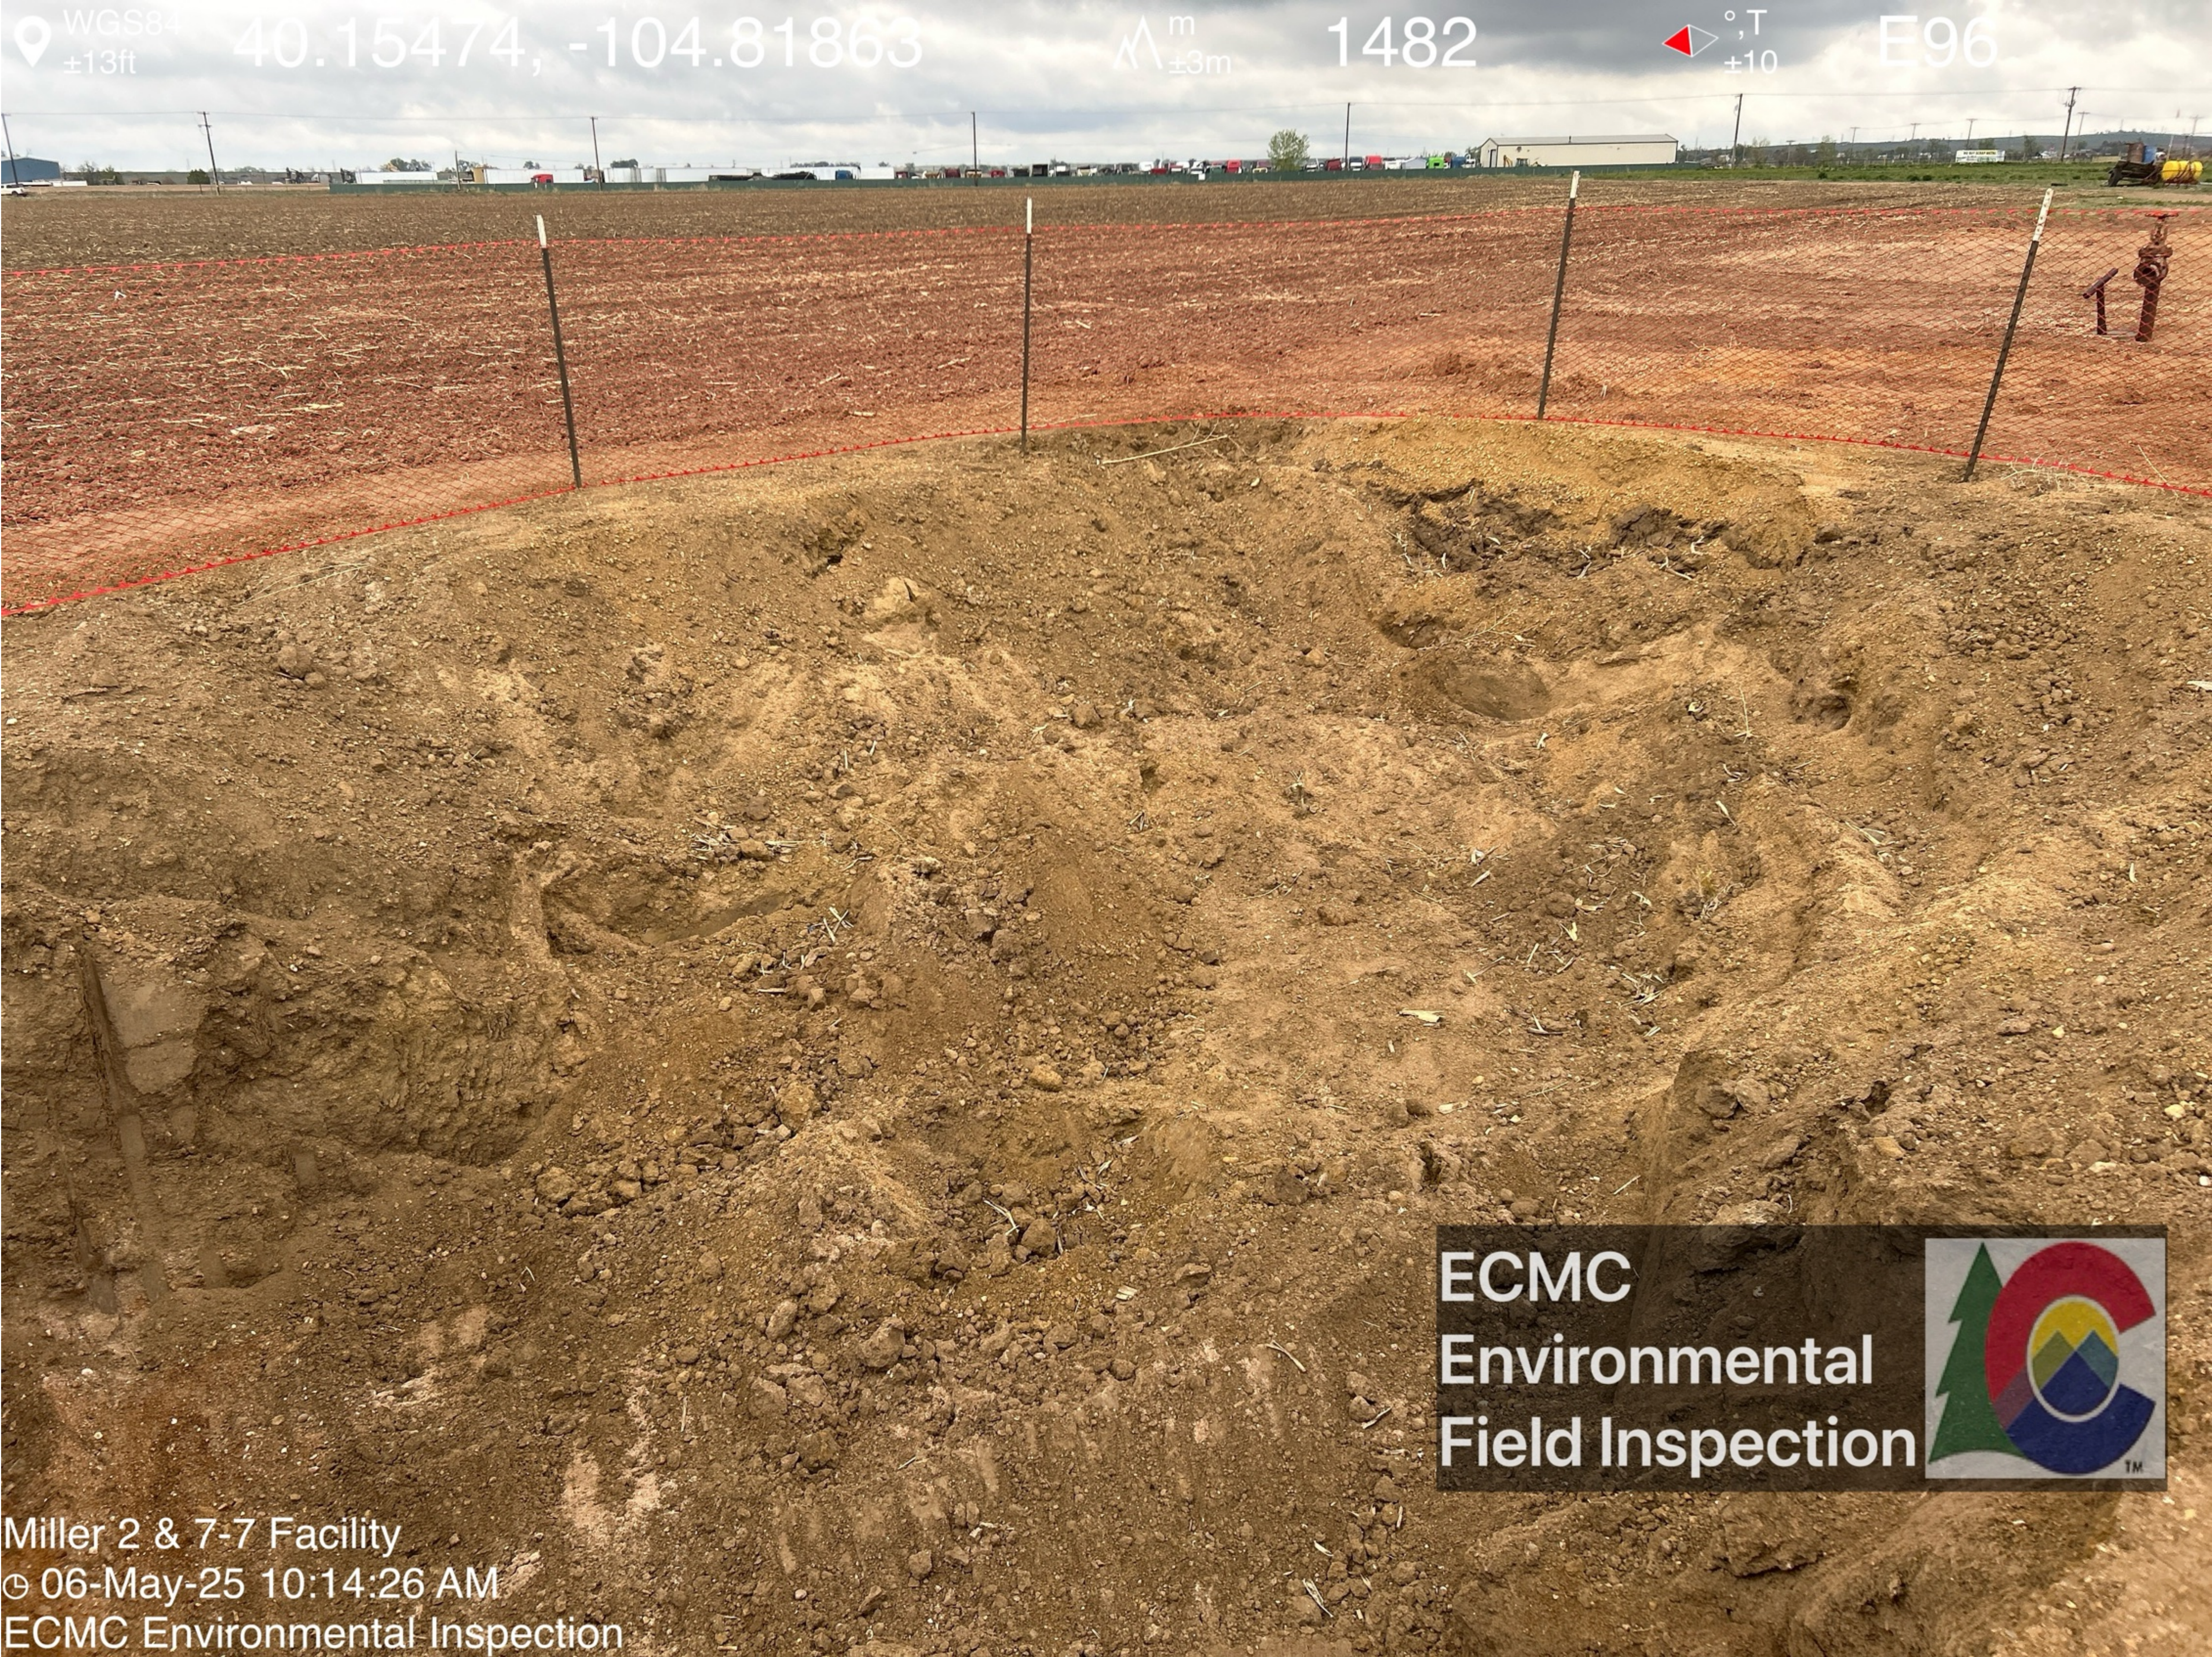
Approximate location of Spill ID 489966 (former produced water vault).

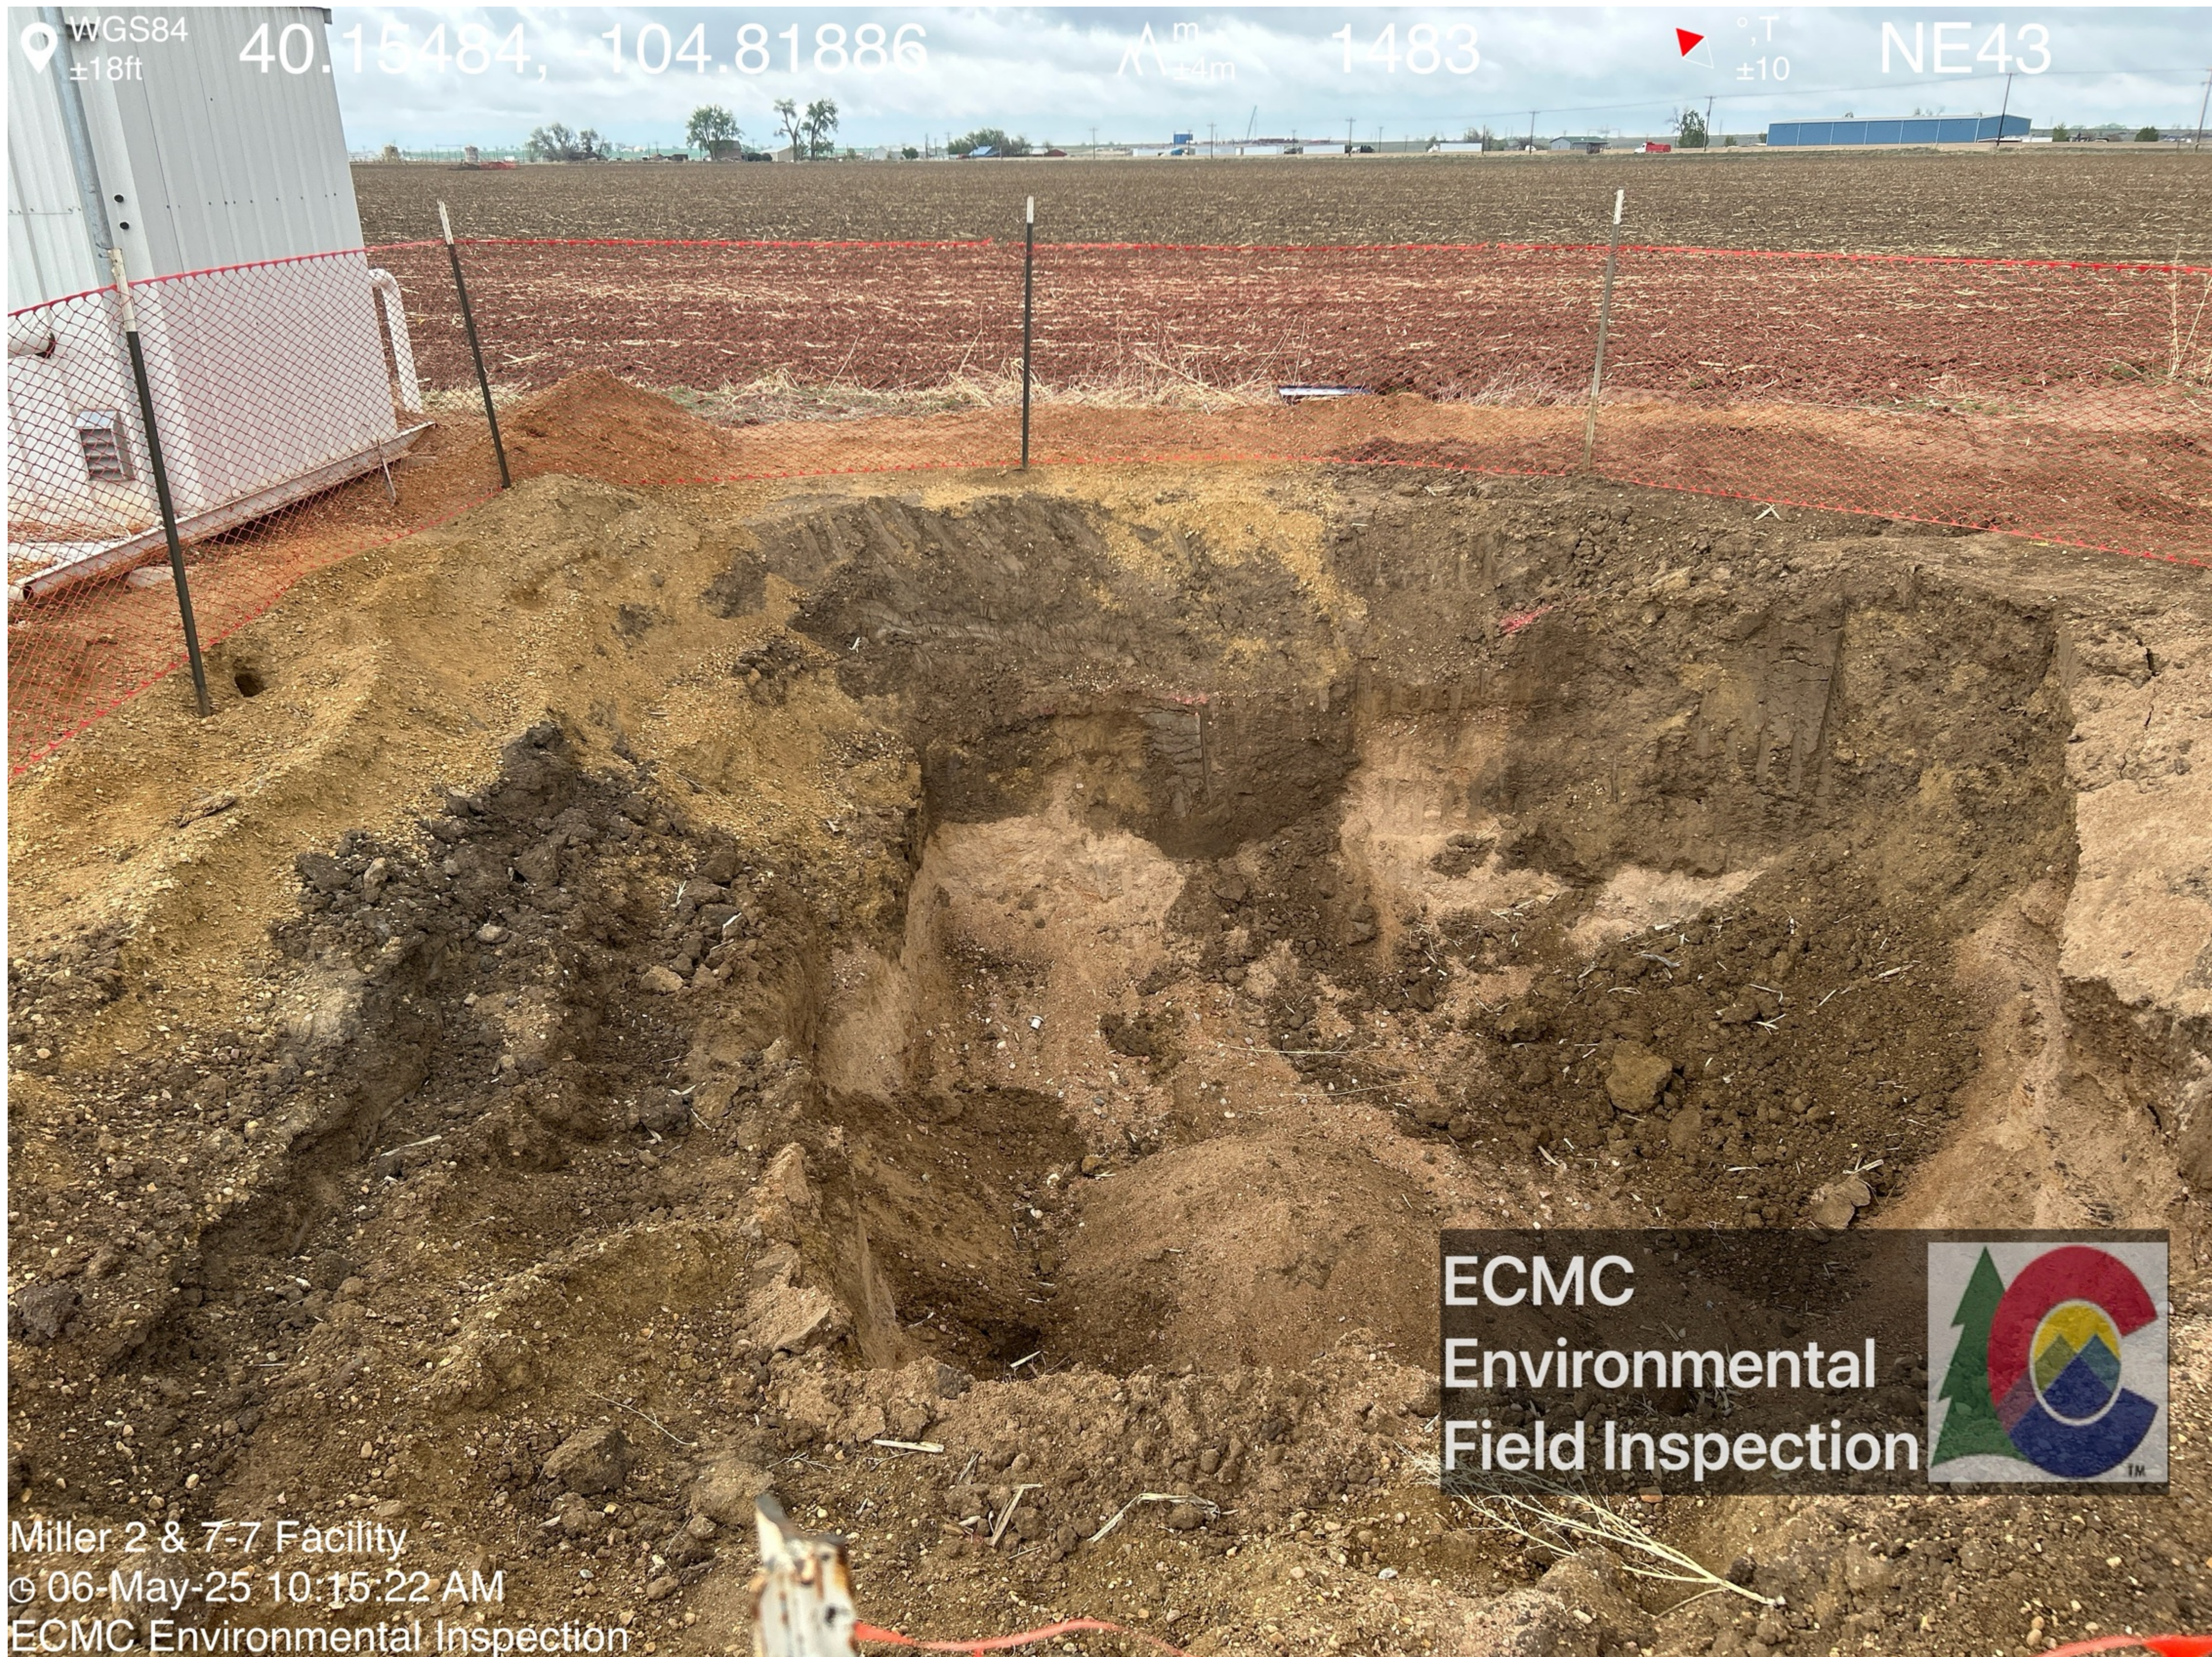
Approximate location of Spill ID 489977 (former separator location). Gray staining observed on excavation sidewalls.
