Miller-62N67W 17SWSW
© 06-May-25 09:49:39 AM
ECMC Environmental Inspection

ECMC
Environmental
Field Inspection

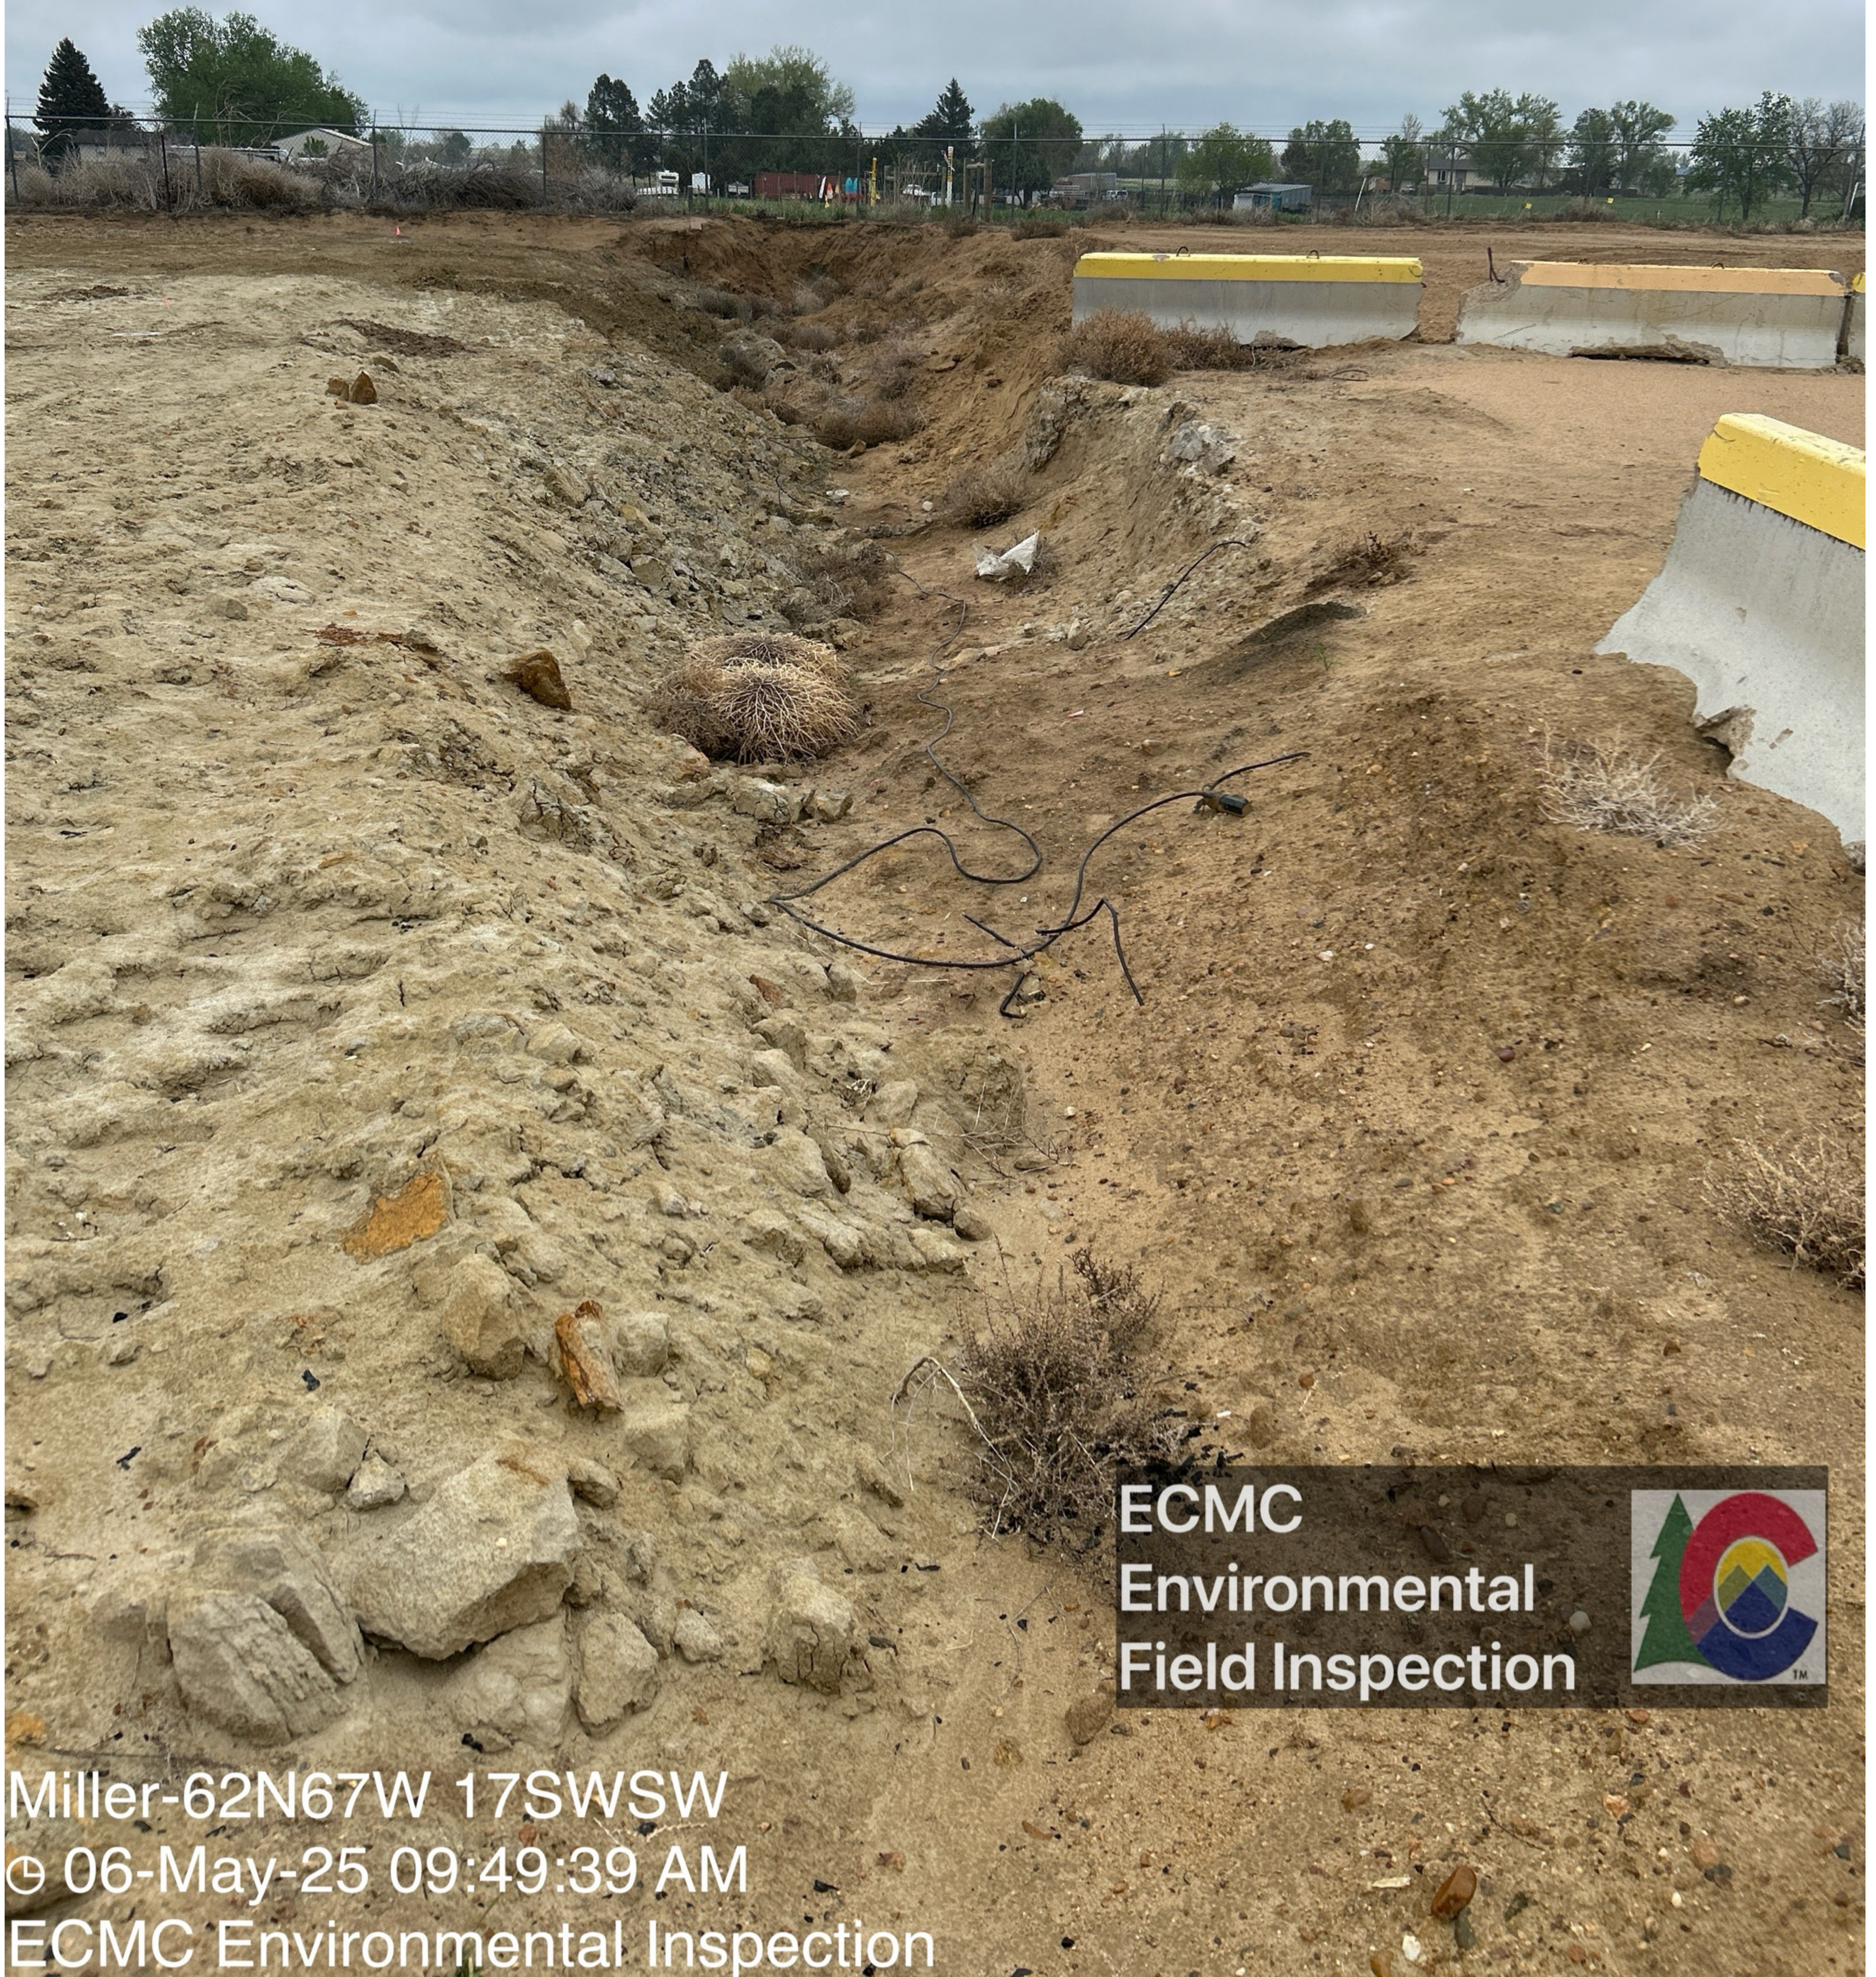
An open excavation was observed on location. Debris has collected within the excavation. Concrete barriers were observed near the excavation, but did not surround the perimeter. No excavation fencing has been installed.

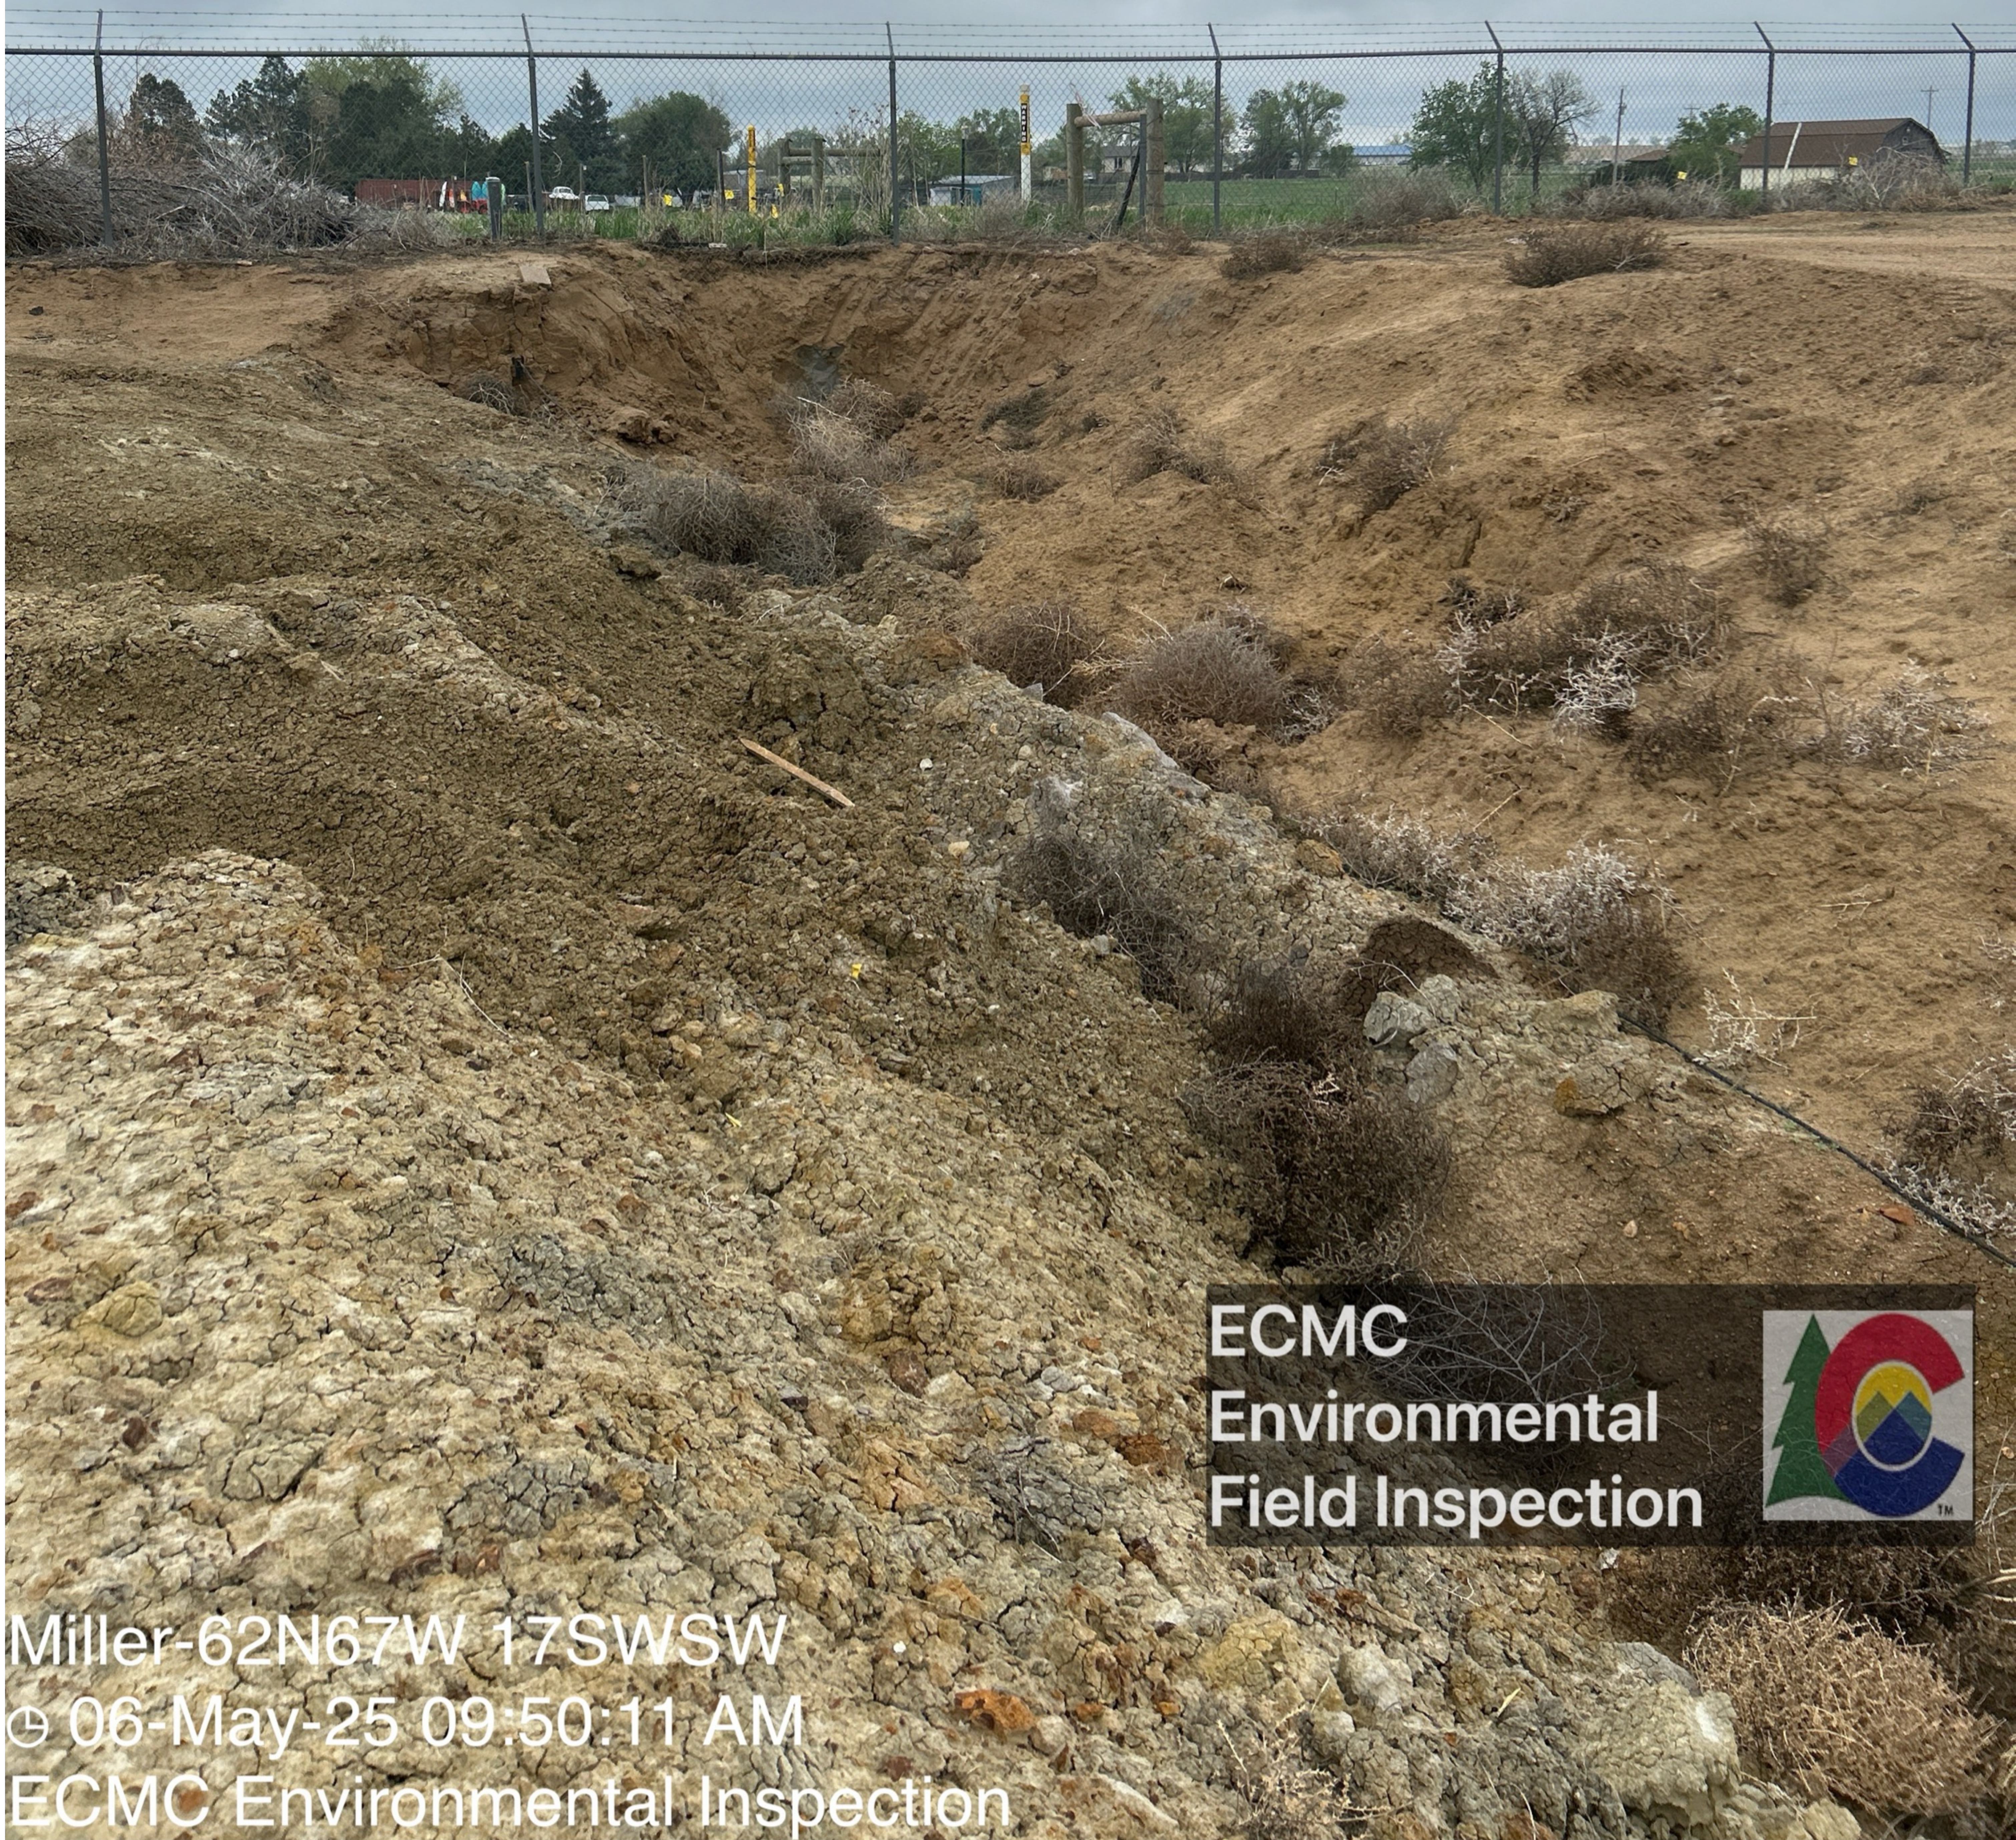
A monitoring well completed as a flush mount was observed adjacent to the excavation.

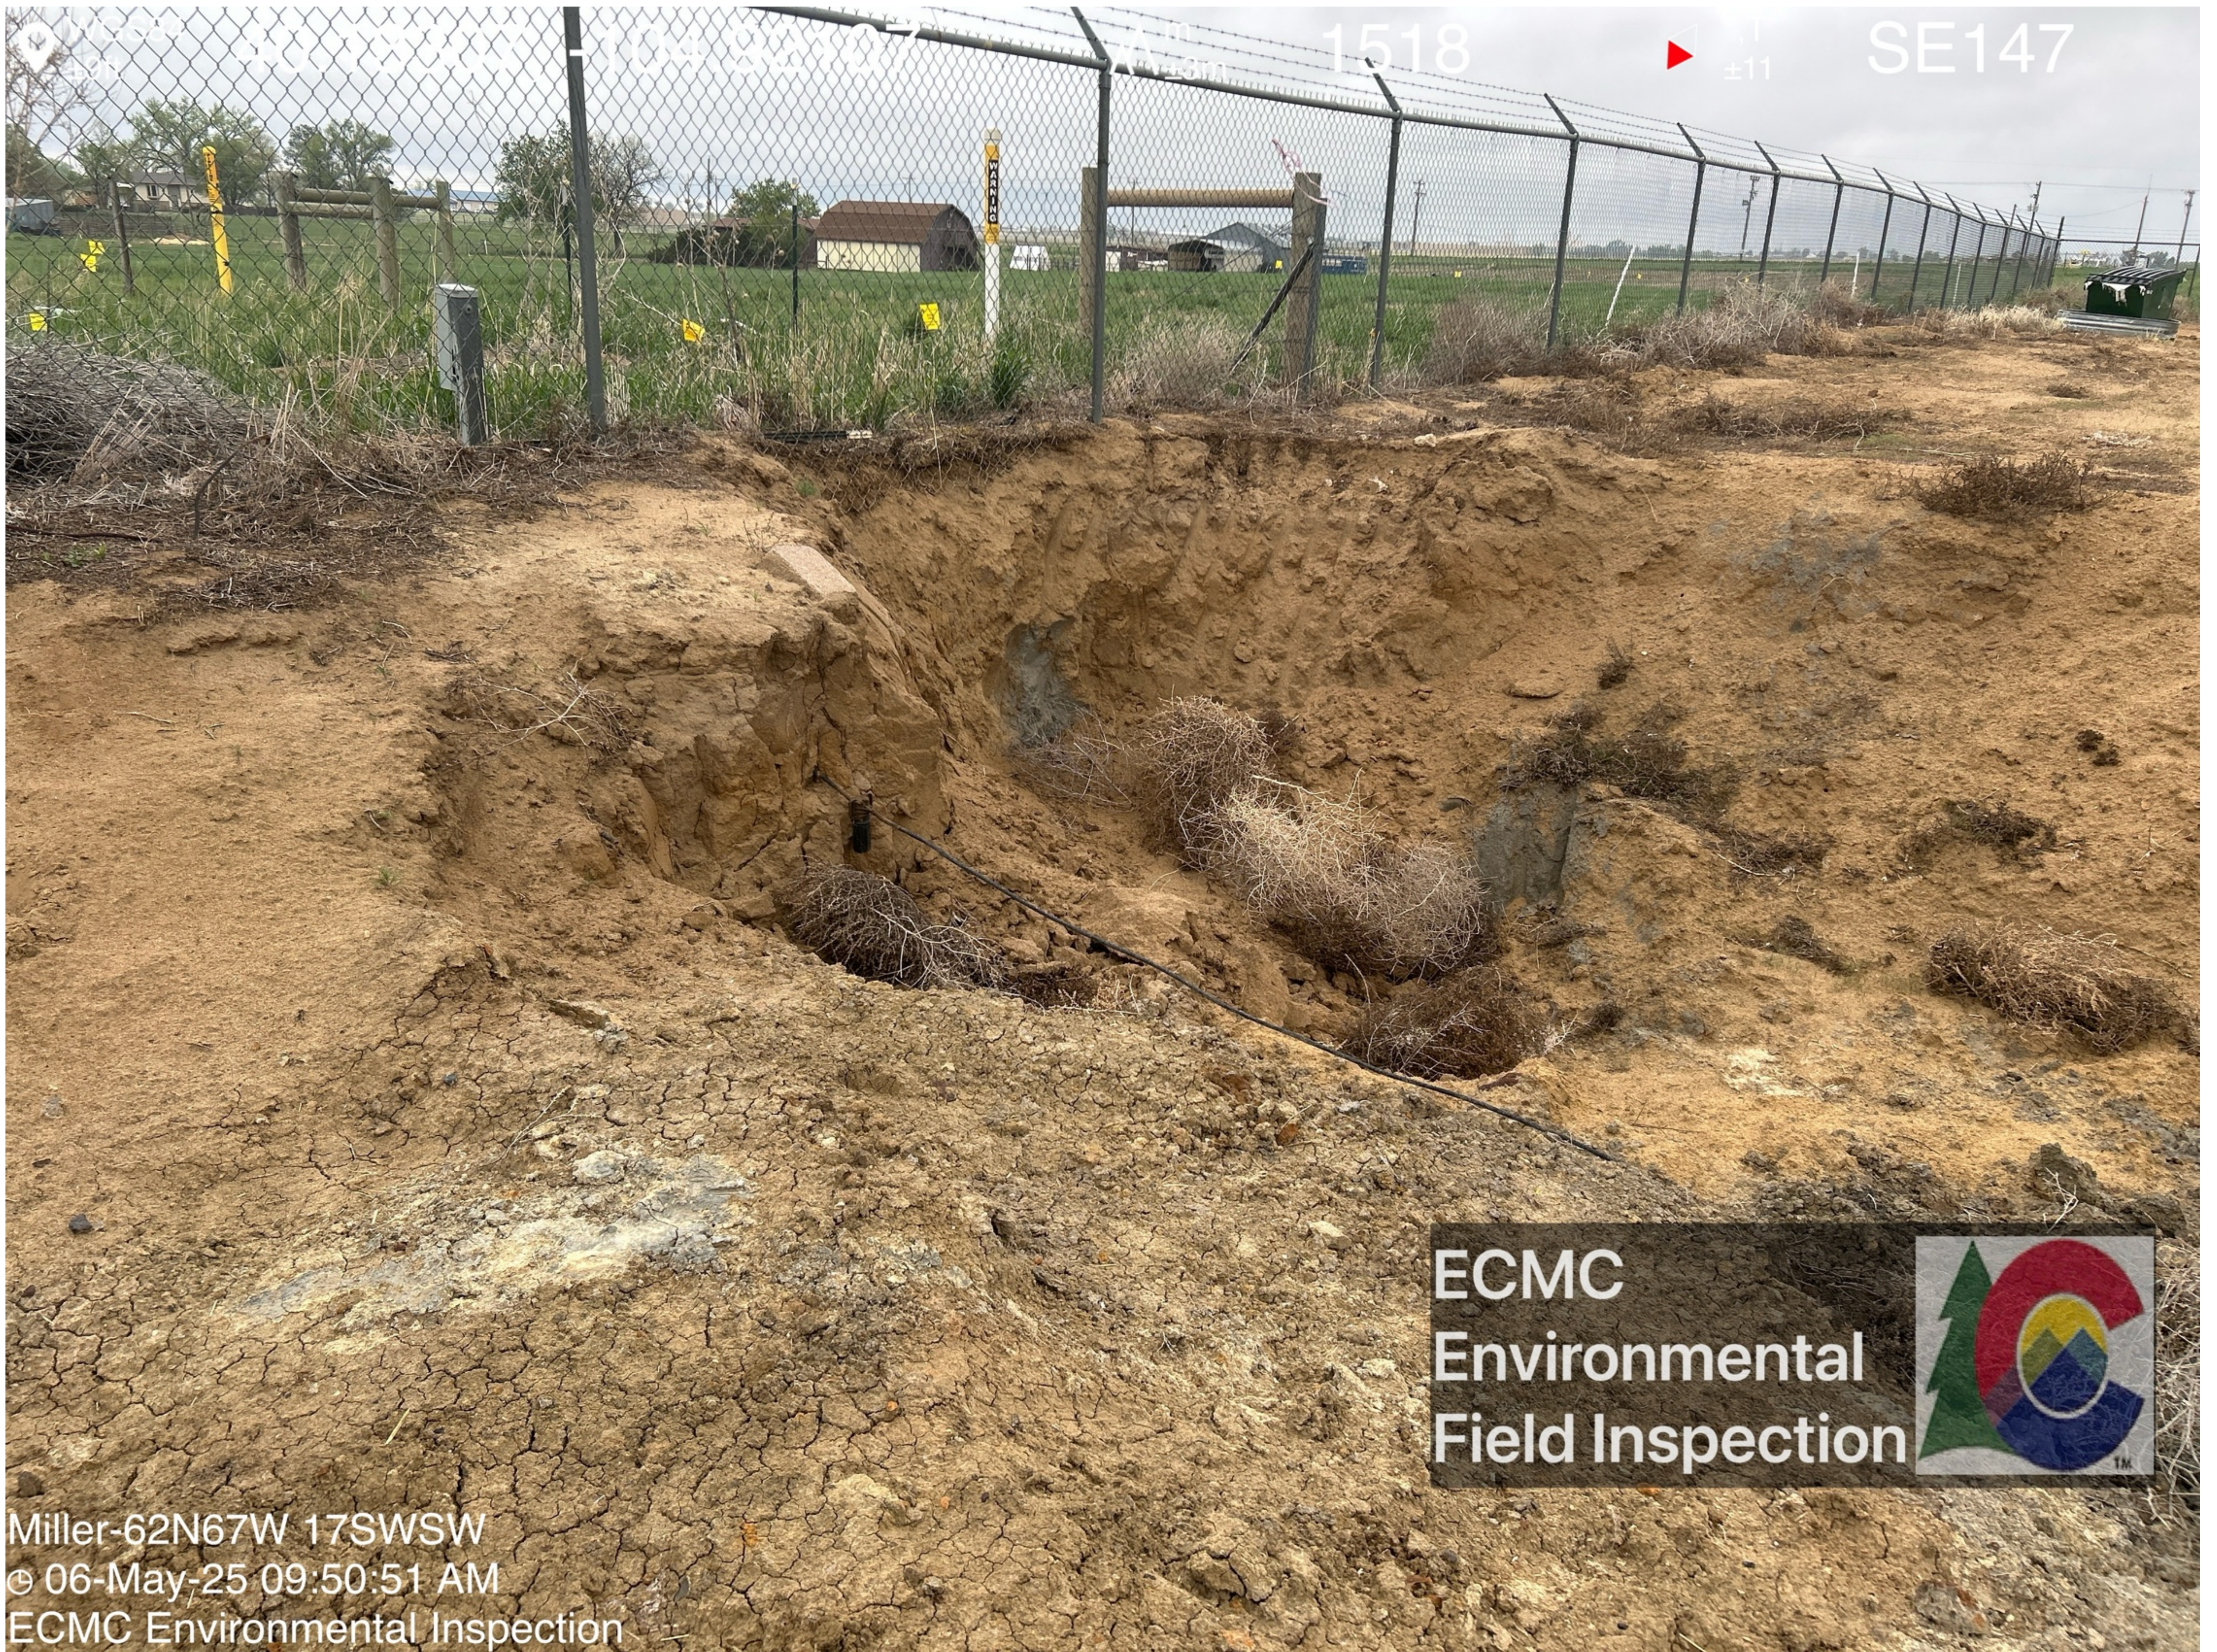
Gray staining is visible on the sidewalls of the excavation. A black wire extends along the excavation.

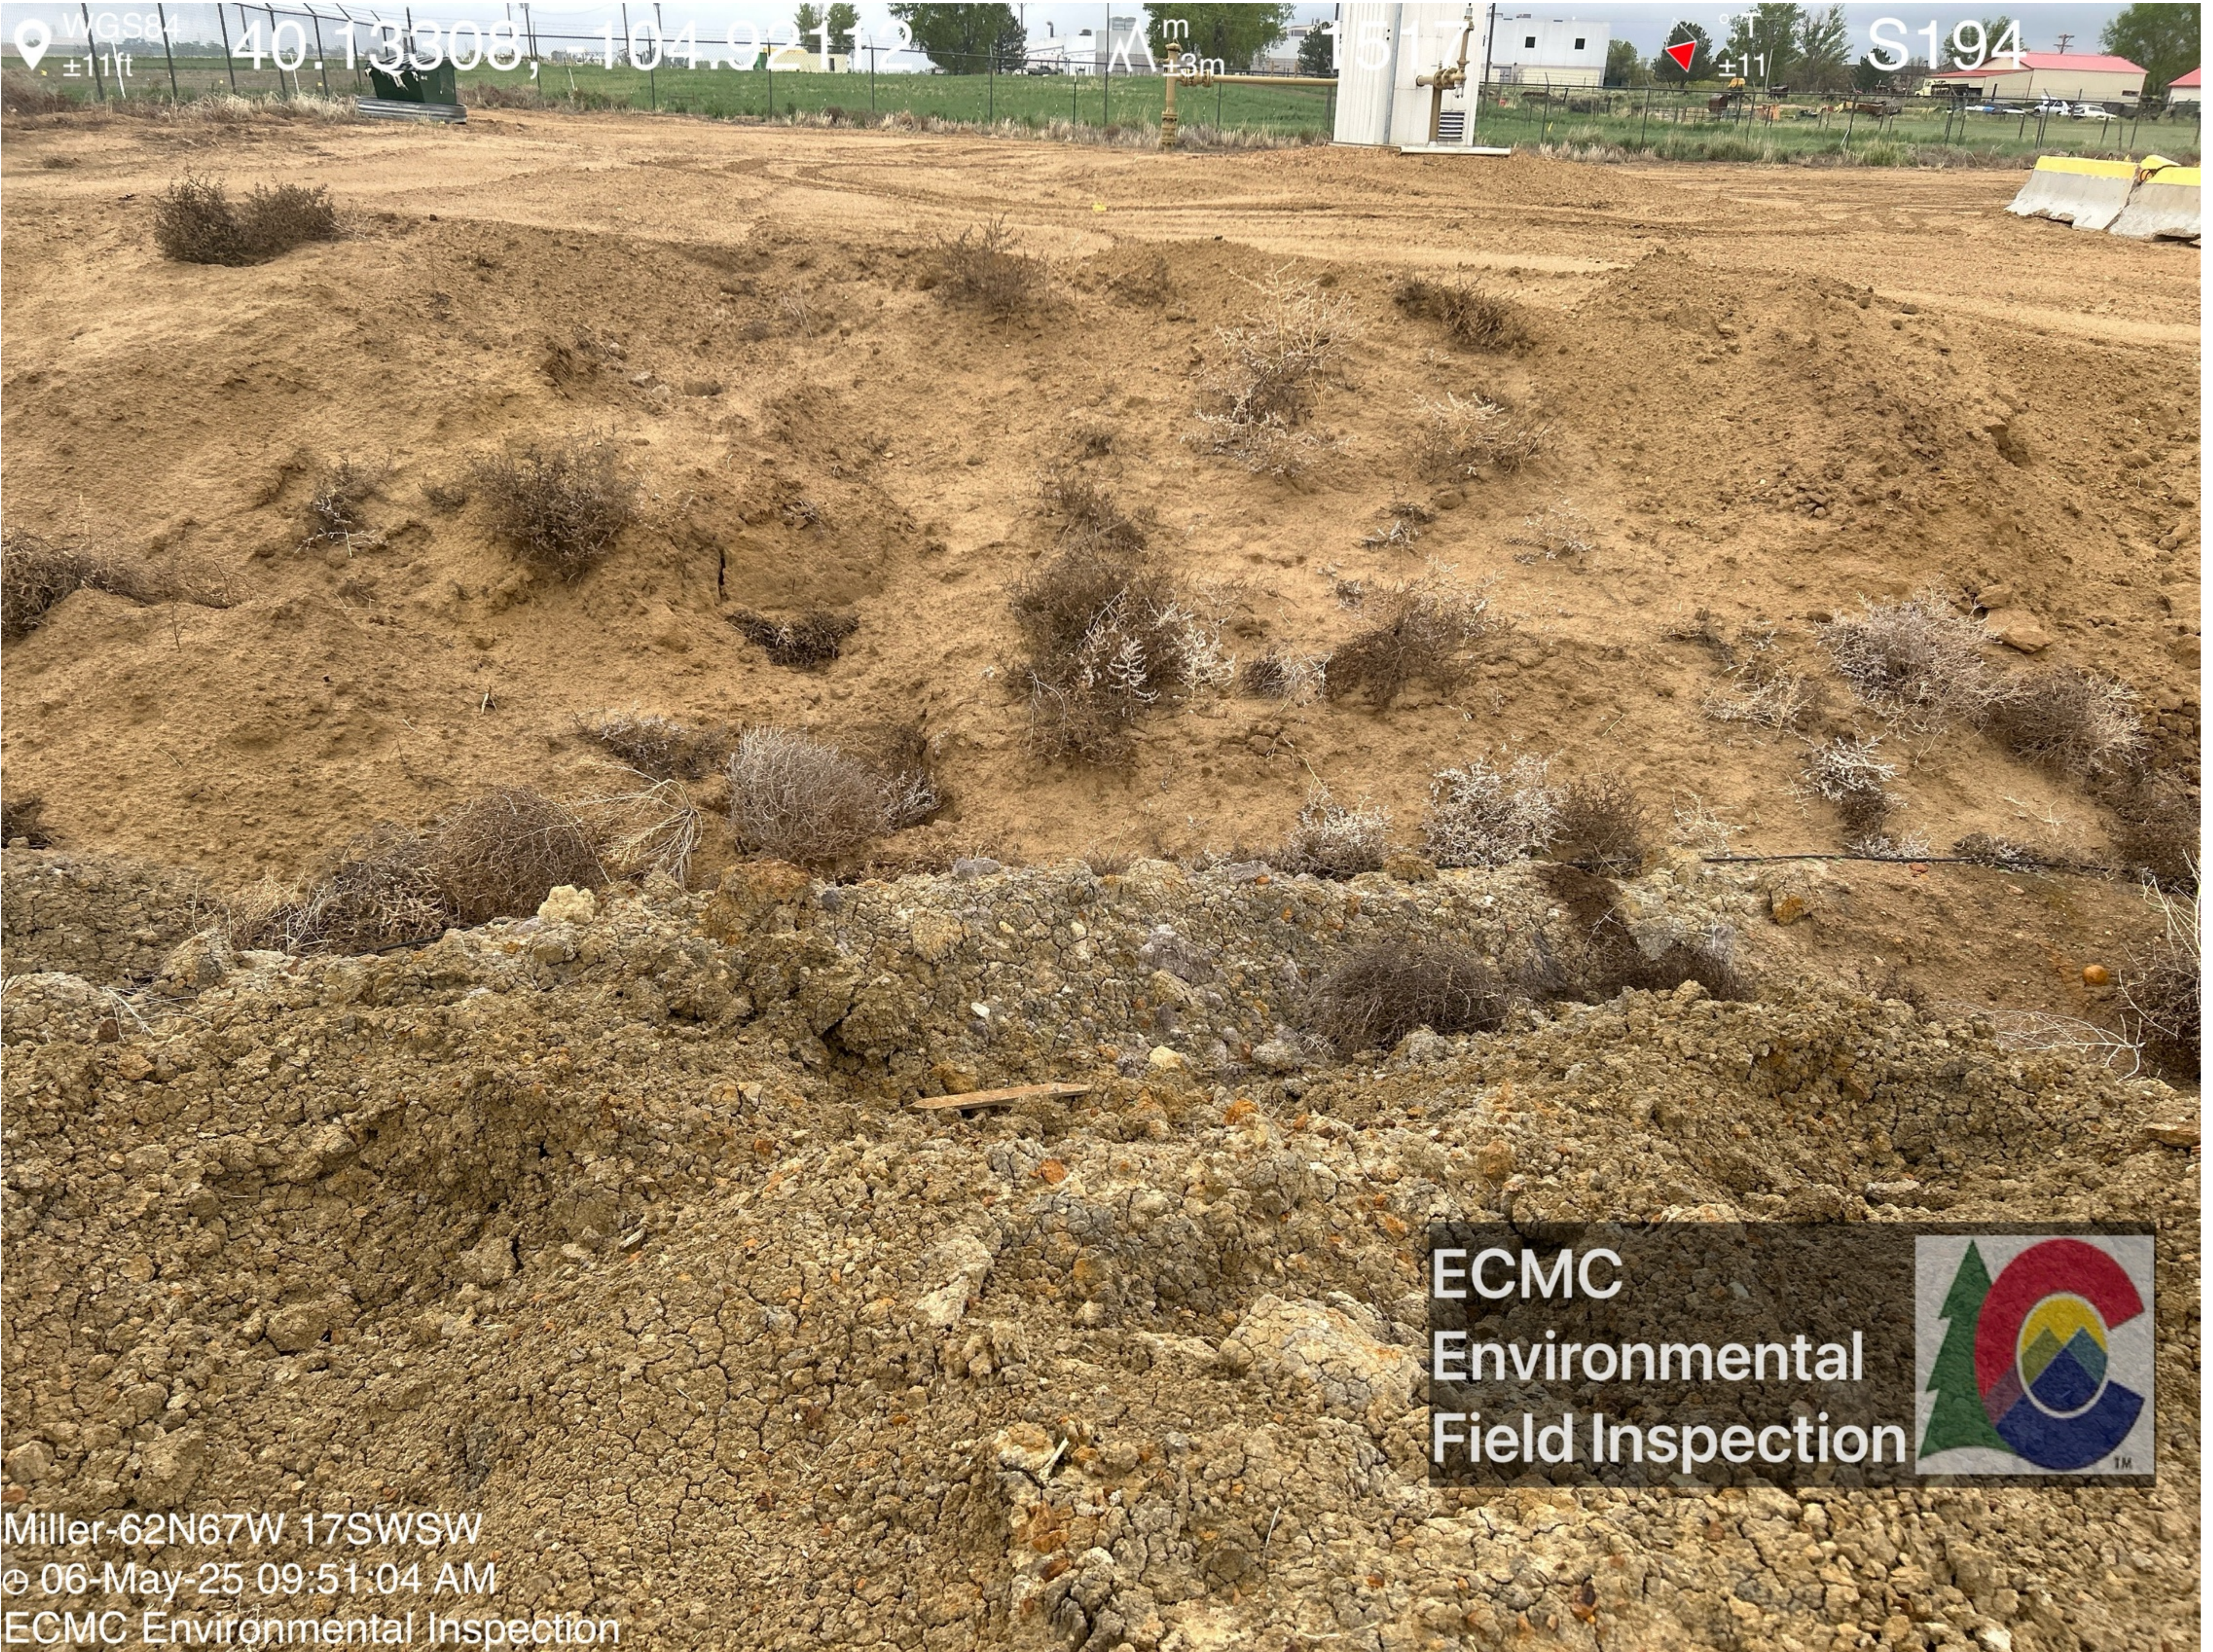
The former tank battery location is visible in the background.

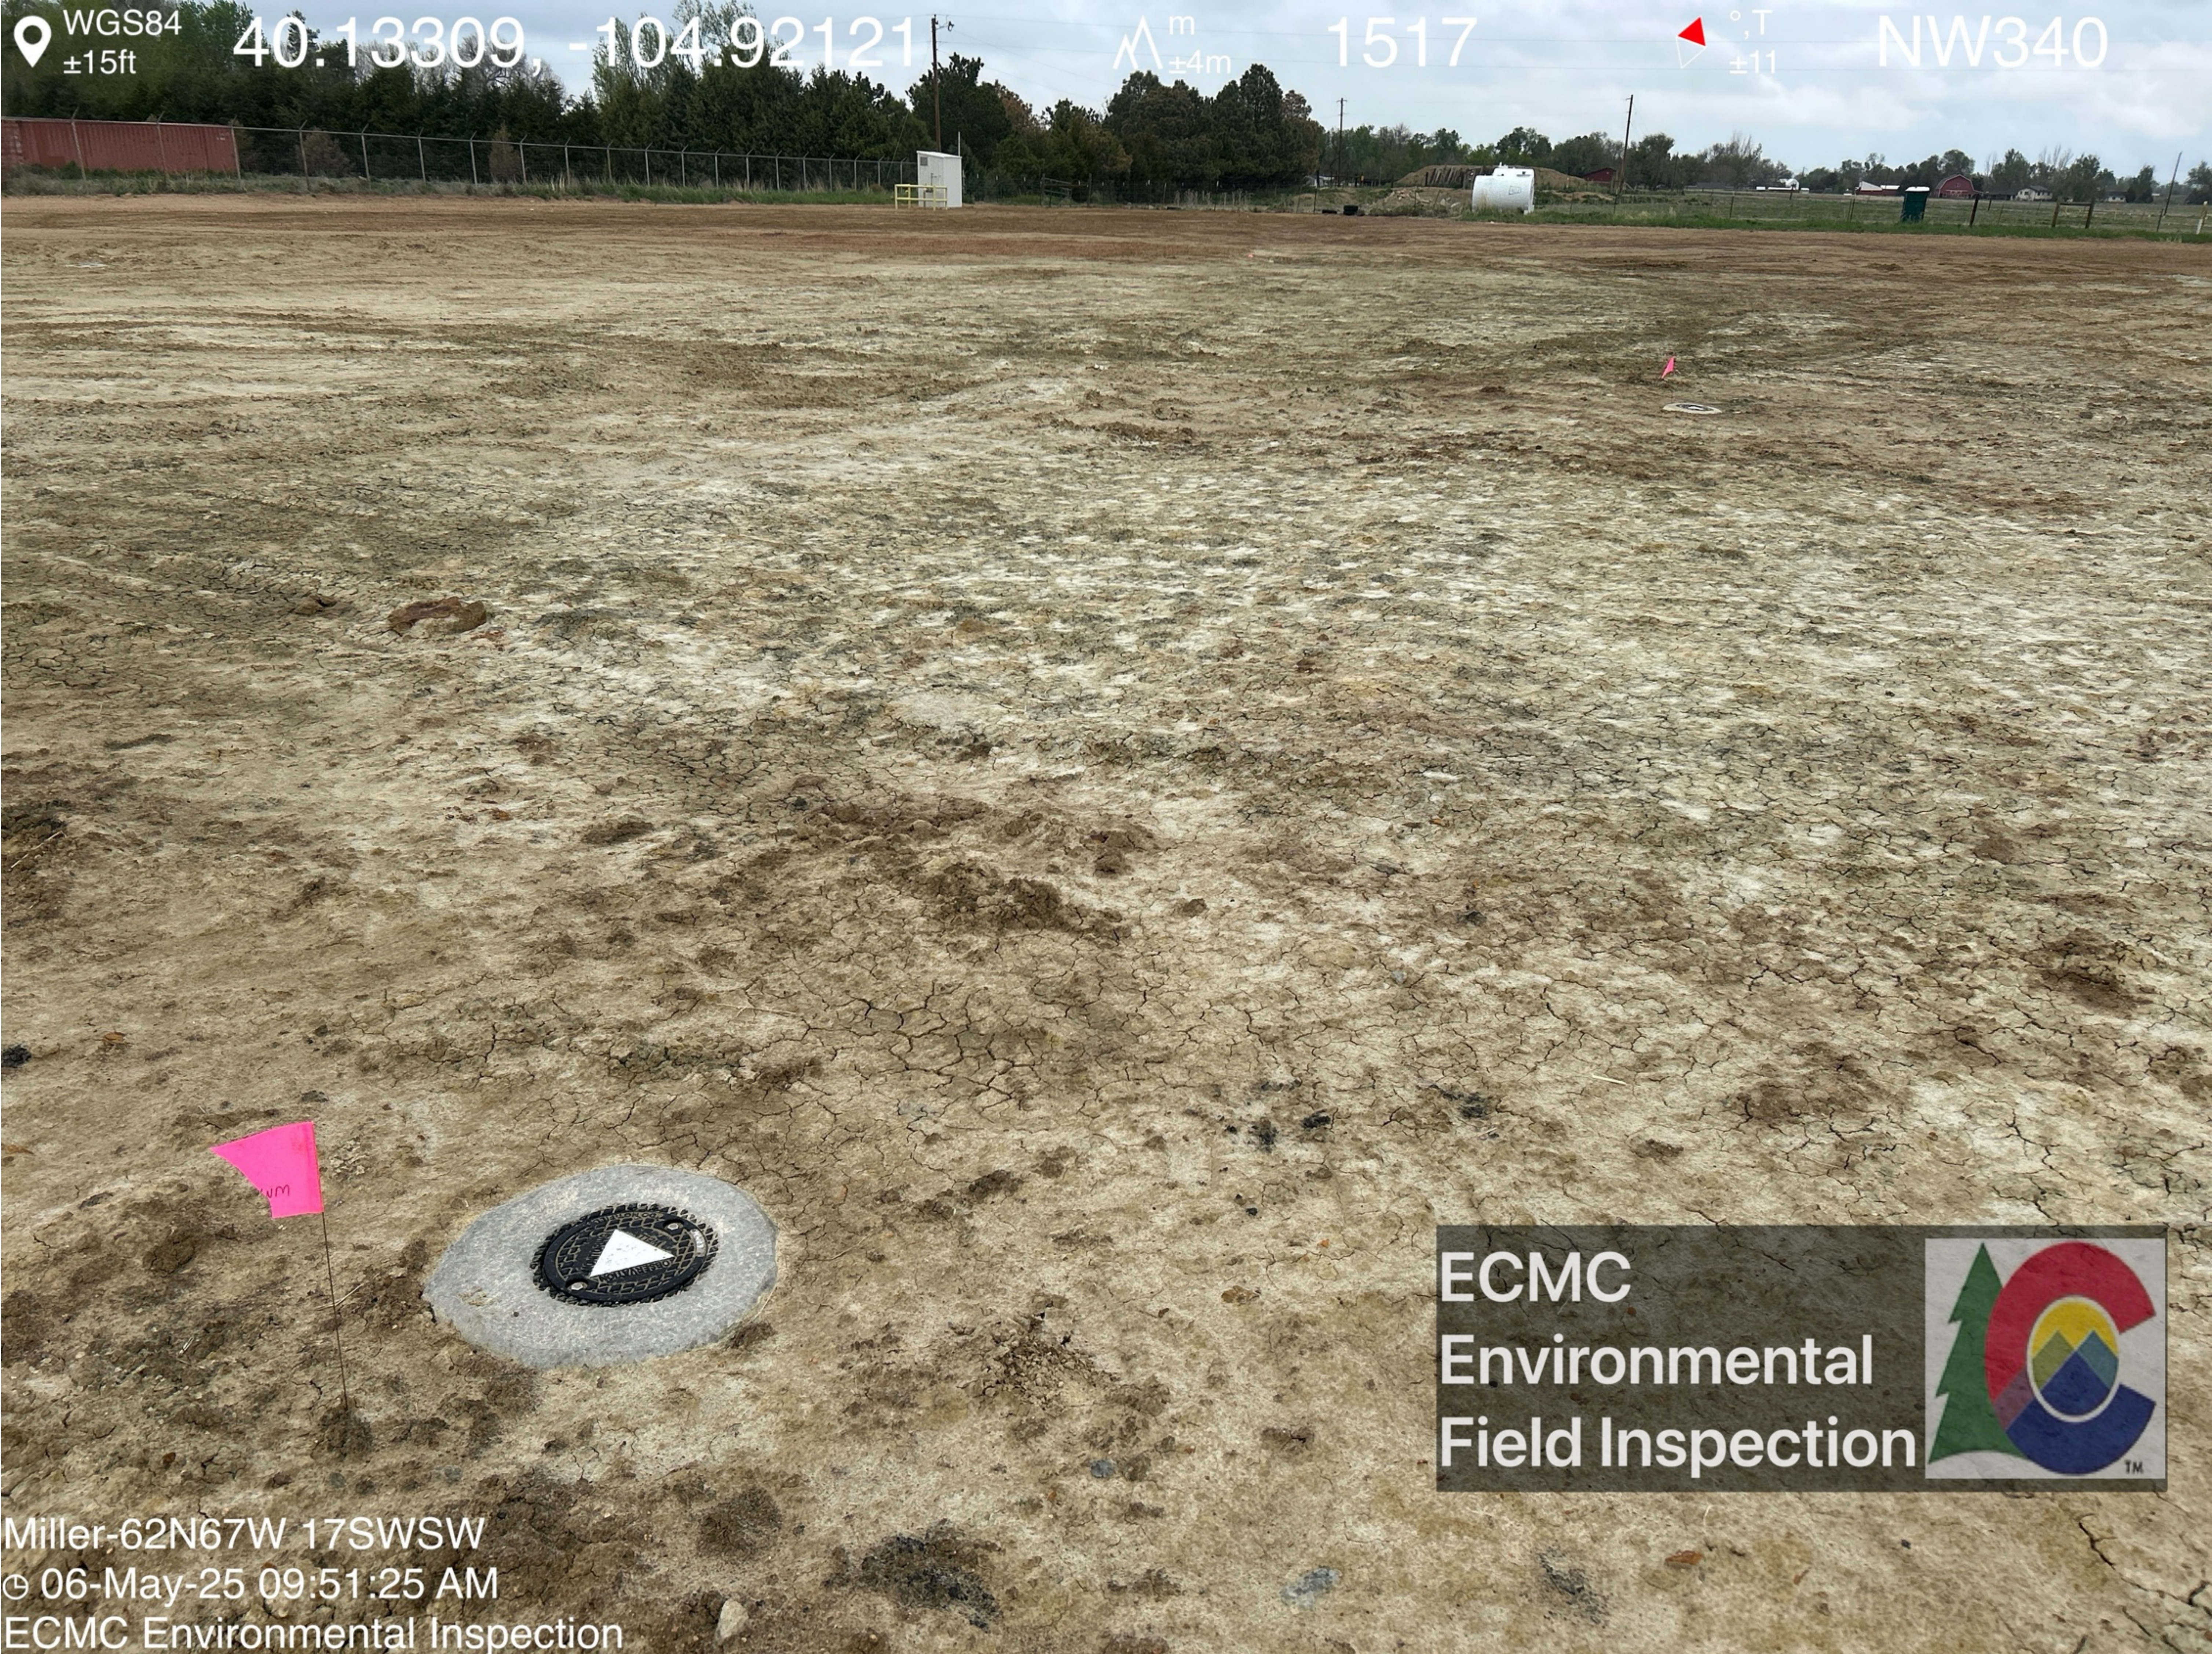
Multiple monitoring wells completed as flush mounts were observed on the location.
