Inspection/Audit Photos

Location: QB ENERGY OPERATING LLC M17OU PAD

Location ID: 311752

Date: 05/8/2025

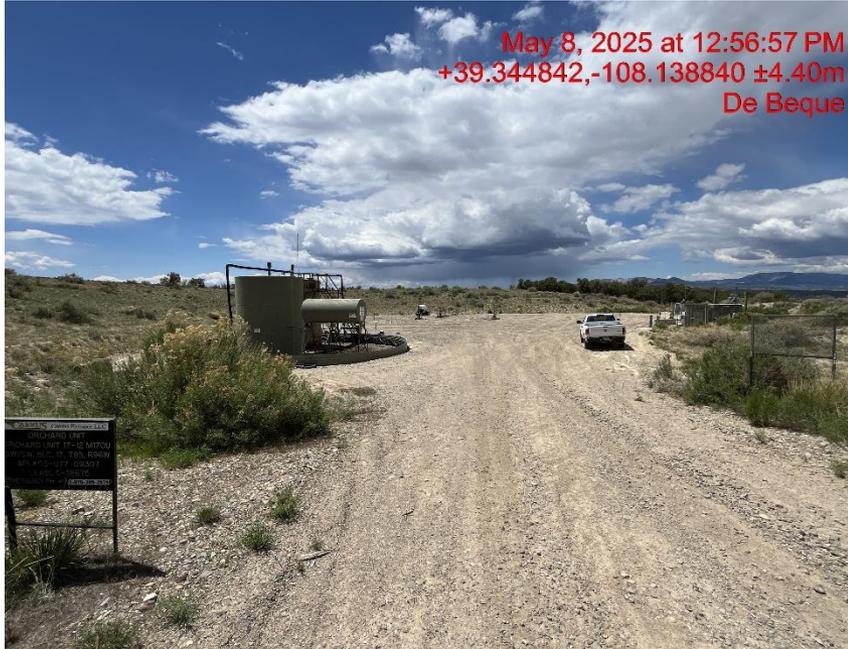
Photo # 7272 Entrance to location

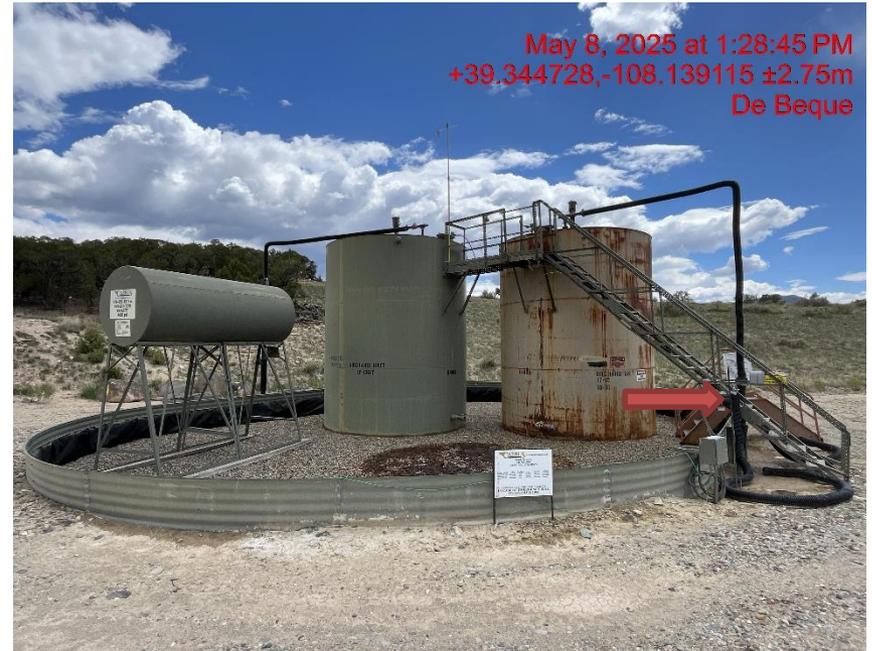
Photo # 7305 Location - 1 unused flowline at tank battery lacks lockout tagout (OOSLAT)

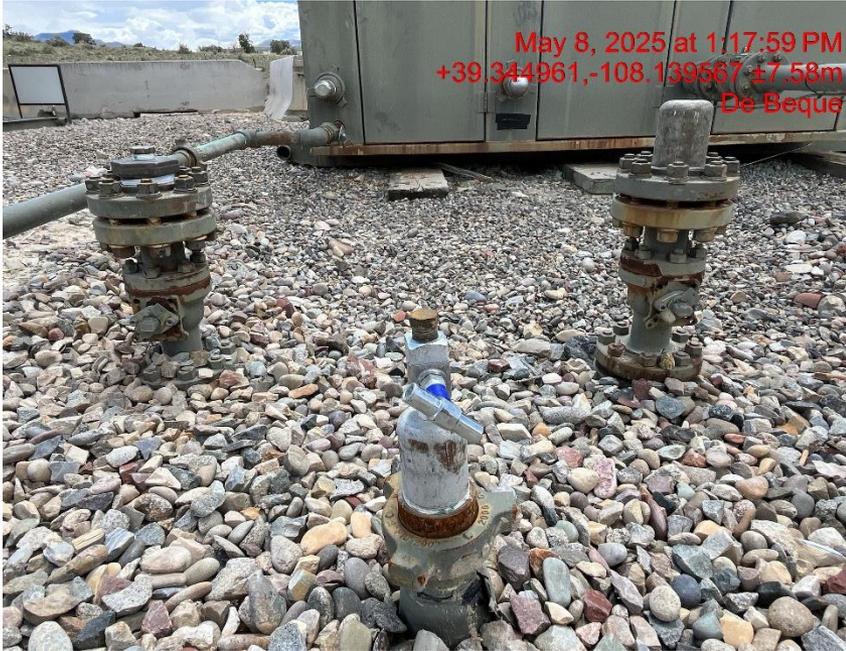
Photo # 7293 Multiple unused flowlines at separators lack lockout tagout (OOSLAT)

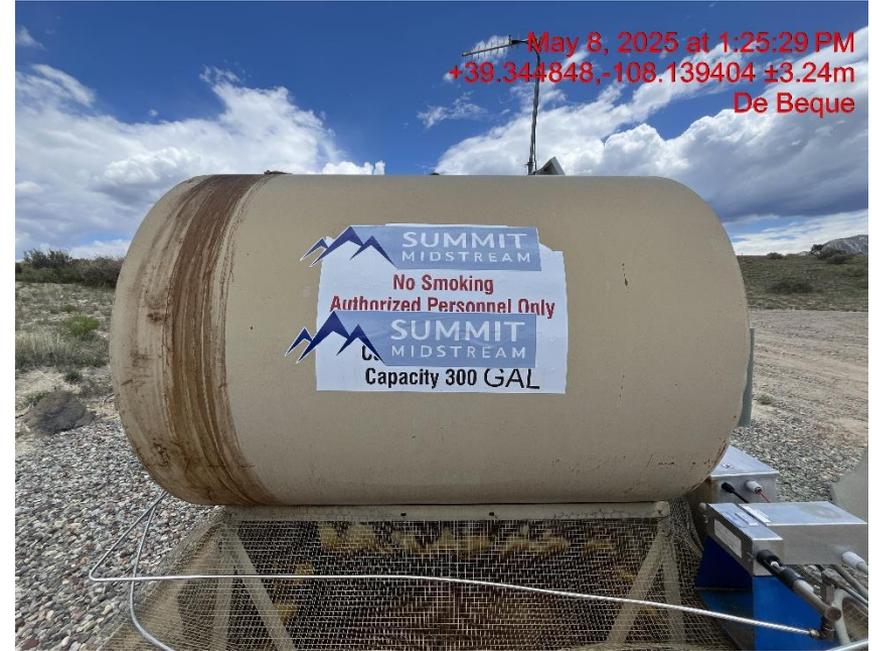
Photo # 7301 Methanol tank lacks required information. Additionally capacity is incorrect.

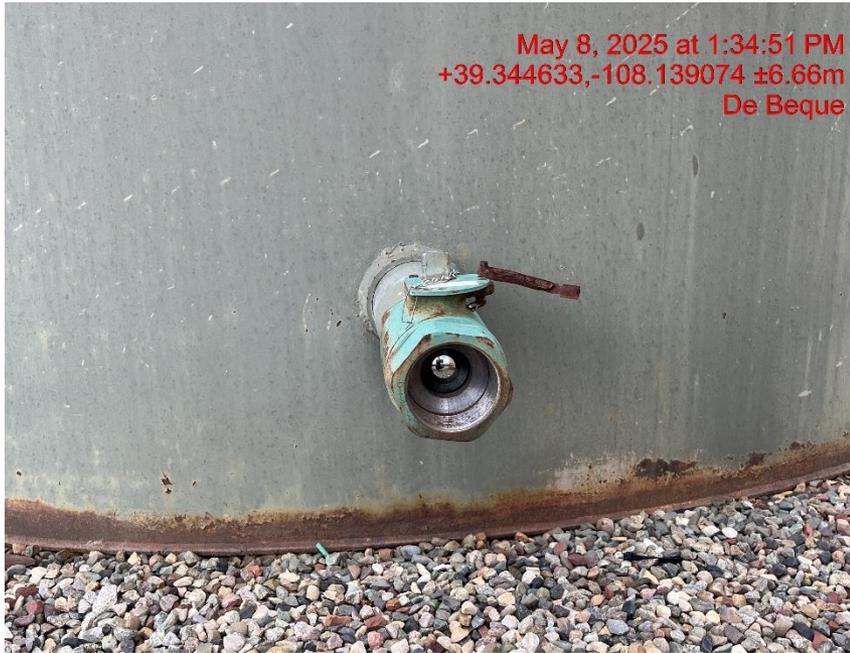
Photo # 7315 Open ended load line

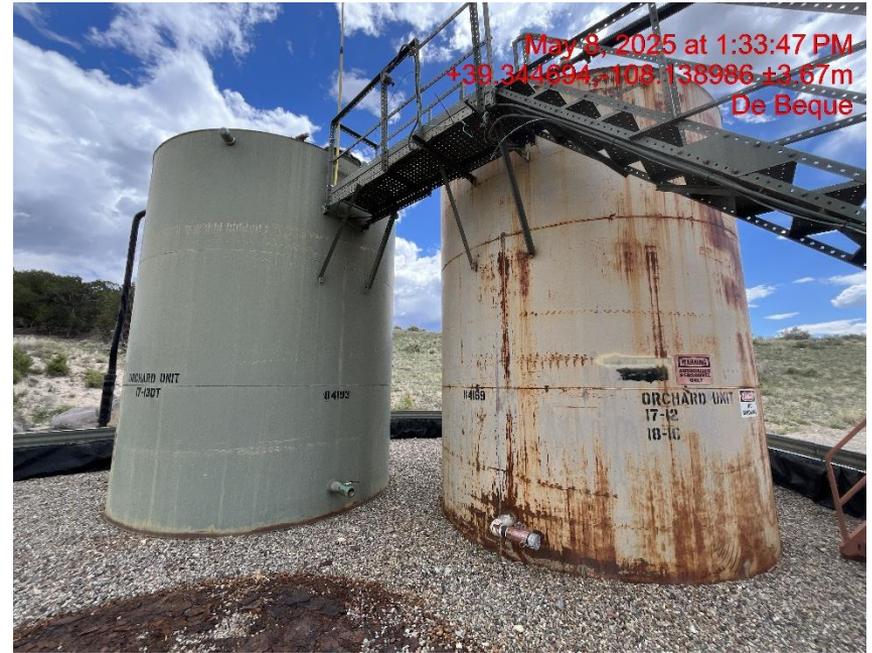
Photo # 7314 One condensate tank is rusting in some areas, paint is inadequate.
