Inspection Photos

Operator: Maralex Resources - 53255

Location ID: 333984

Location Name: Artfgance 33-7-14 2A, 3C

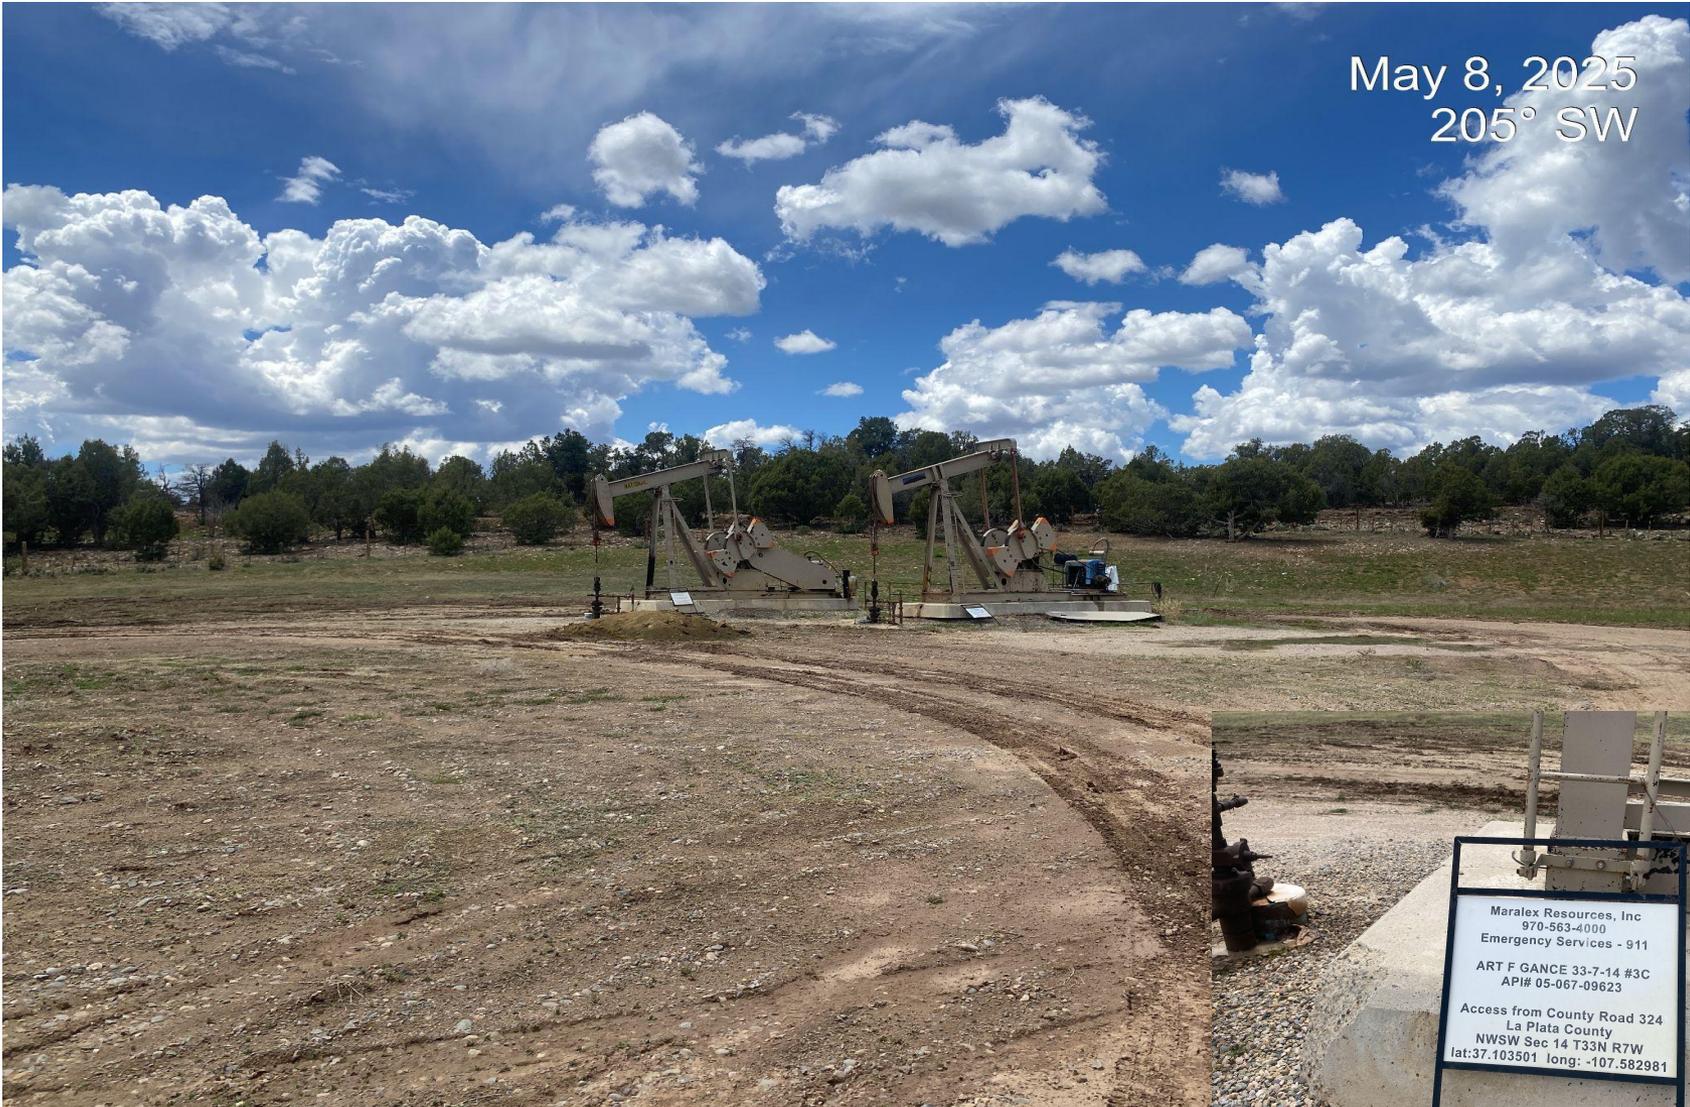
Photo 1. View of the well pad taken from the access point facing center.

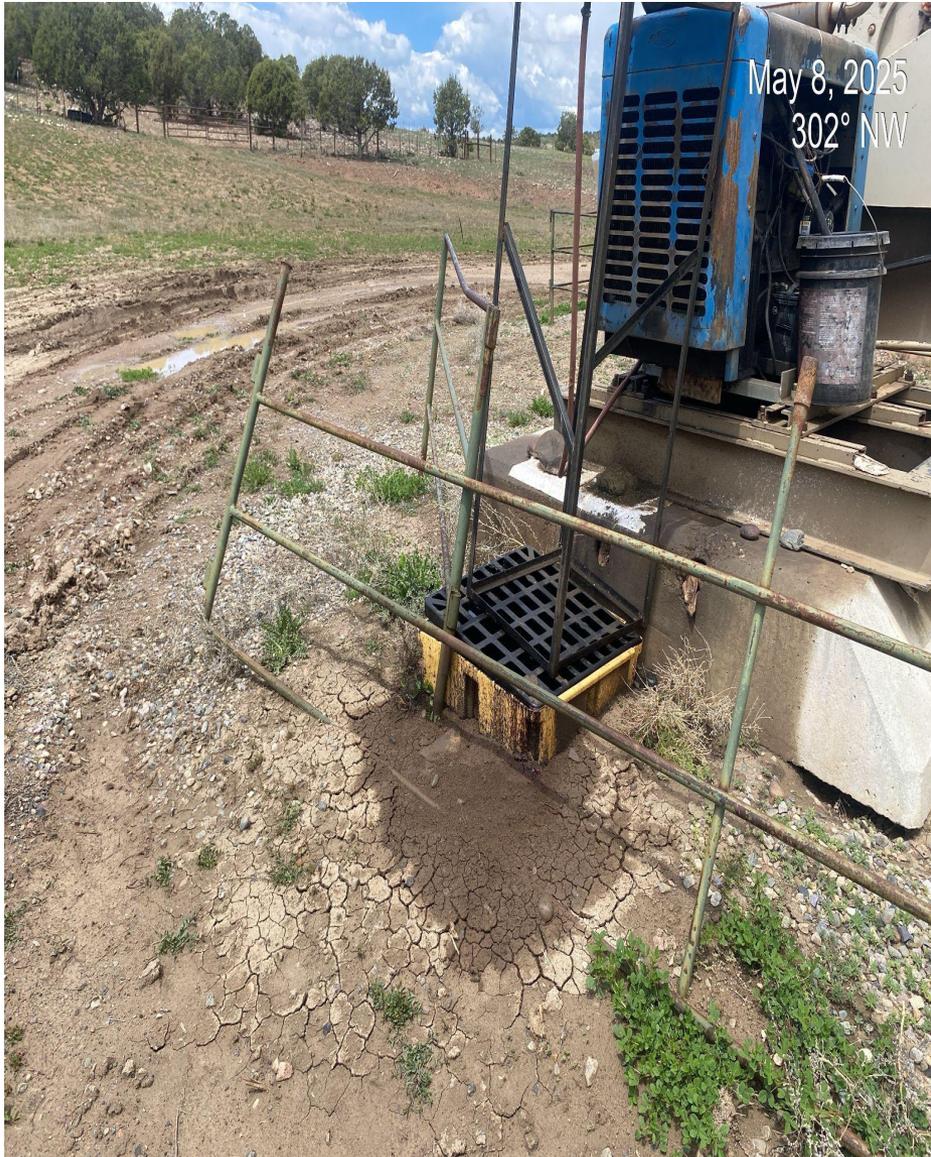
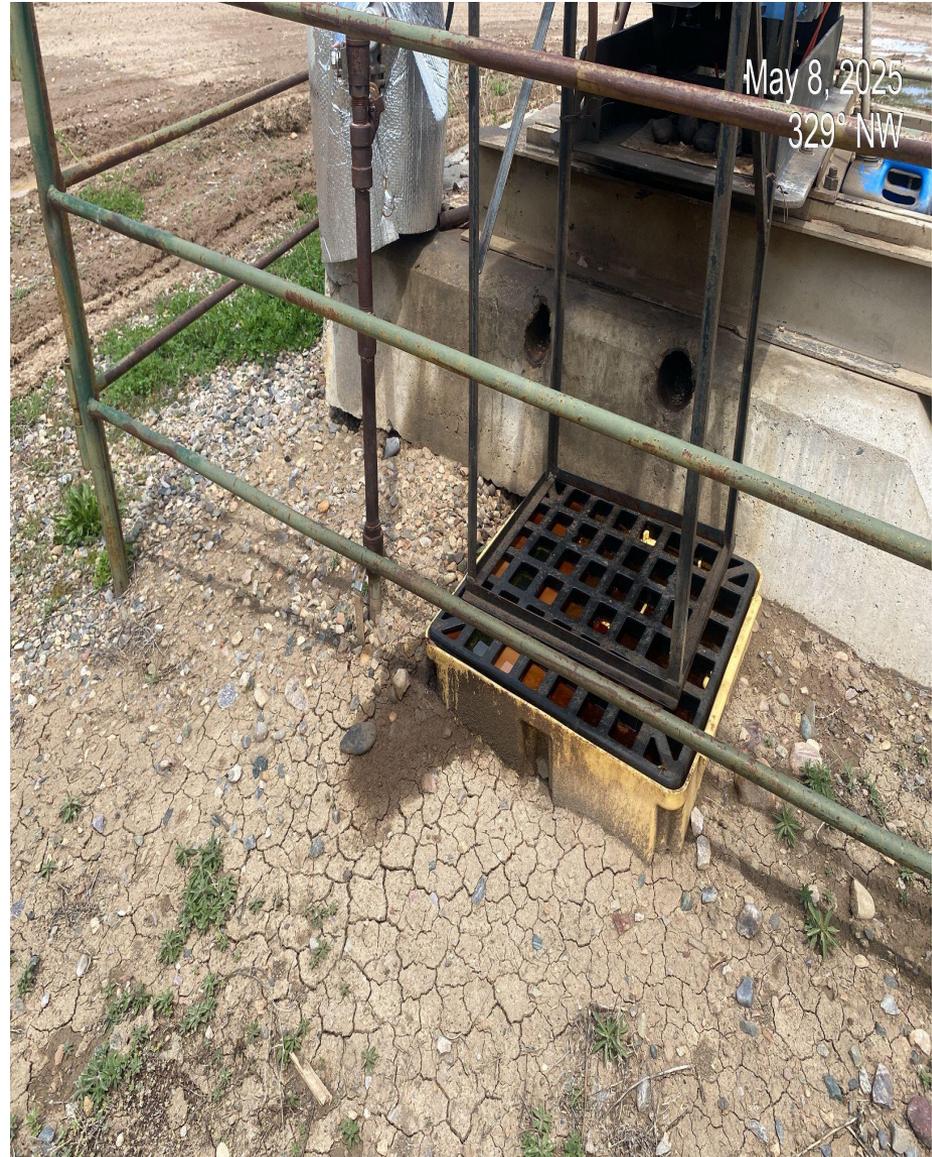
Photo 3. Stained soils at lube tank secondary contaminants.

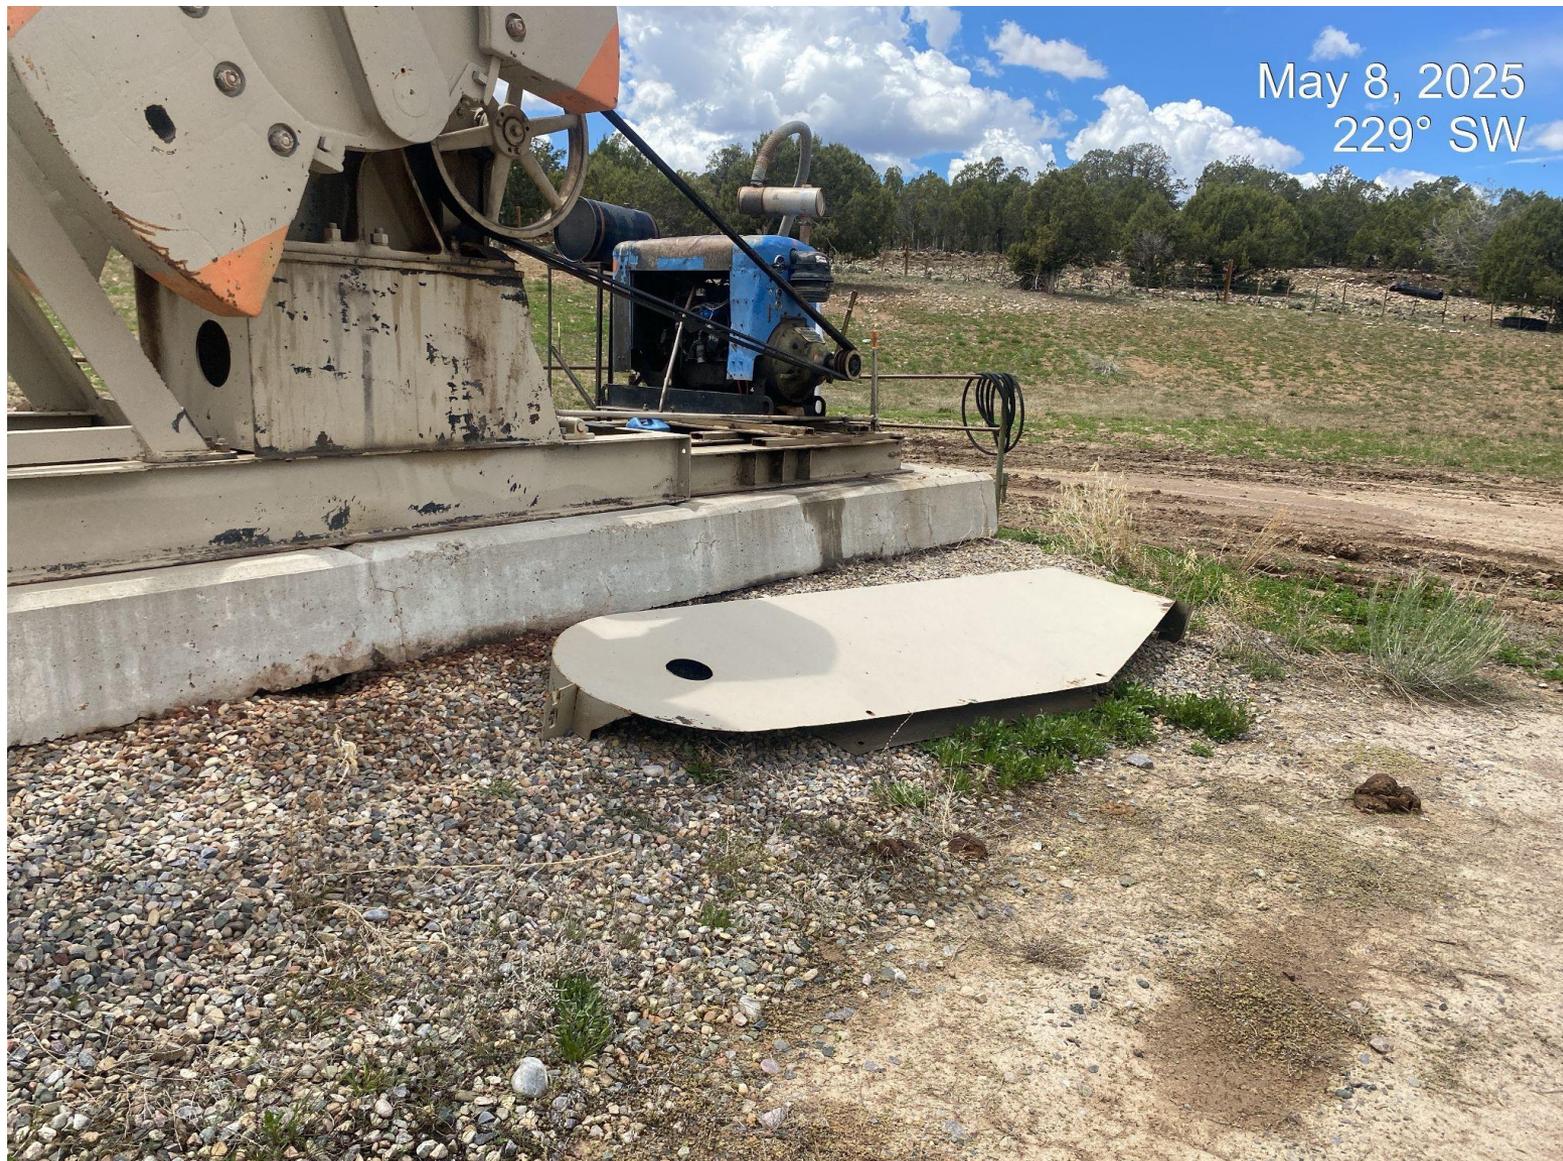
Photo 4. Unused pumpjack panel stored on location.

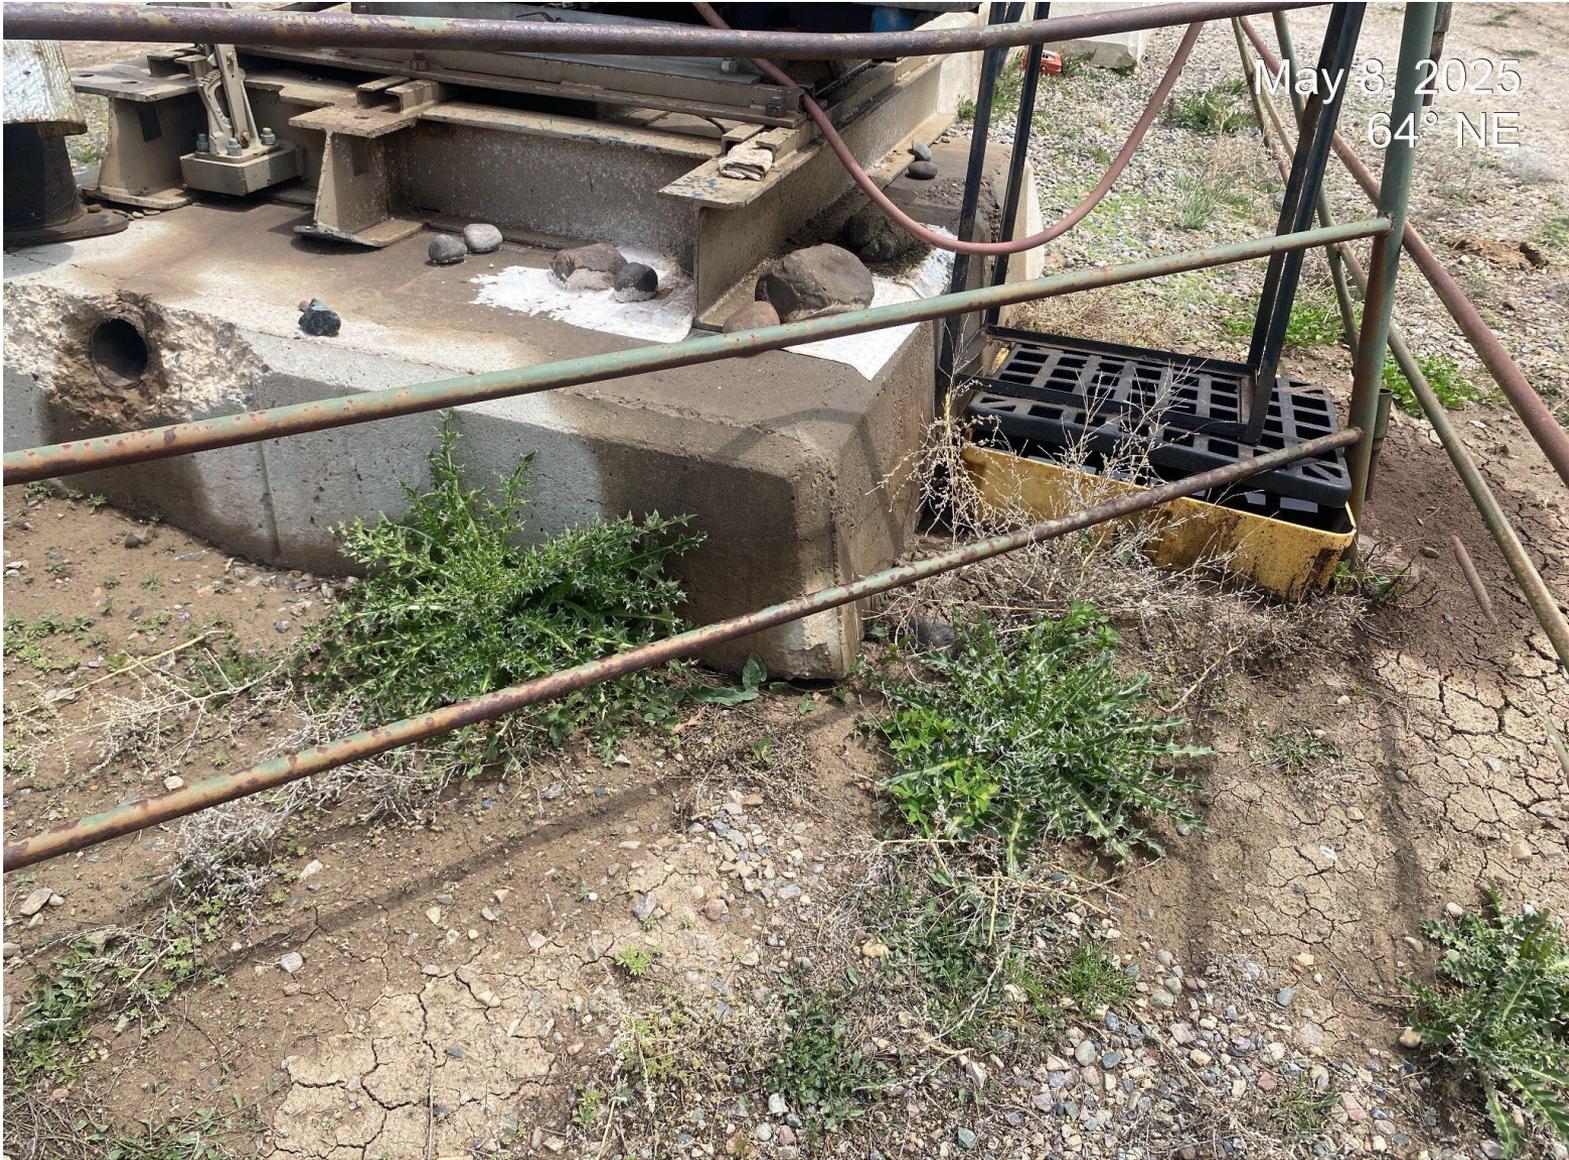
Photo 5. Patch of Musk Thistle observed at pumpjack.

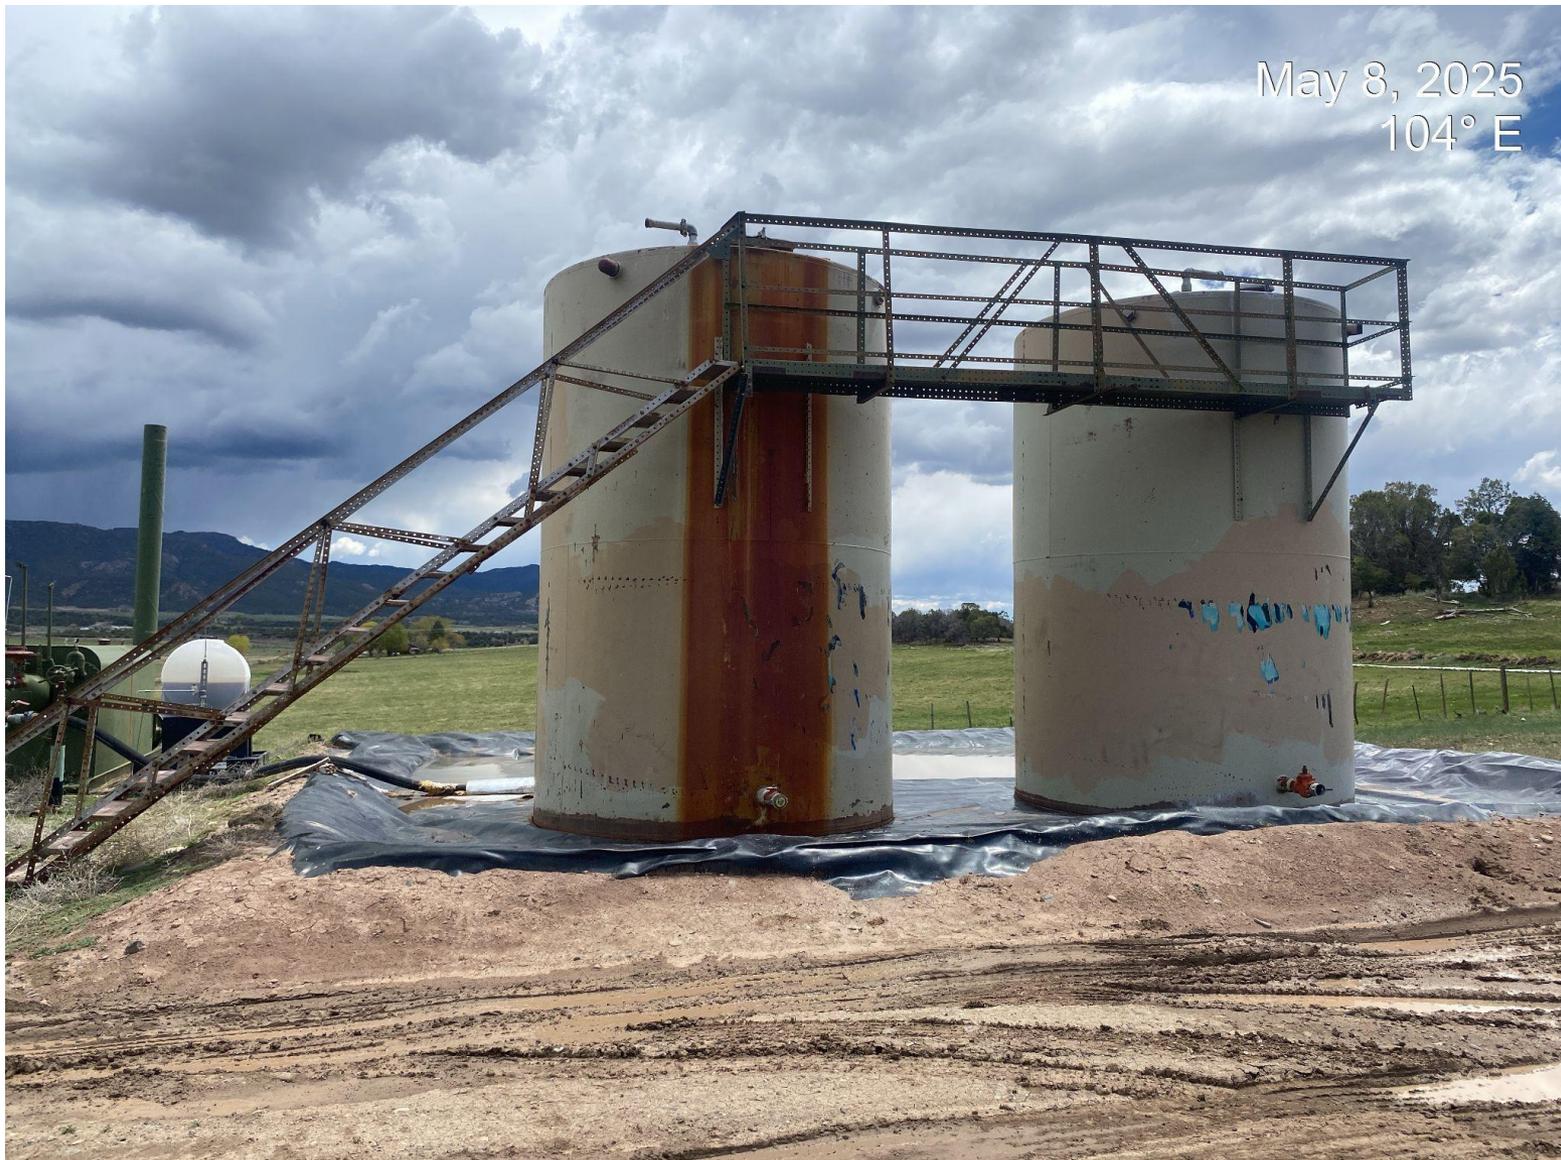
Photo 6. Tanks on location are missing labels.
