Inspection Photos  
Location Name: Franson 34-28 4N47W  
API Number: 125-09698

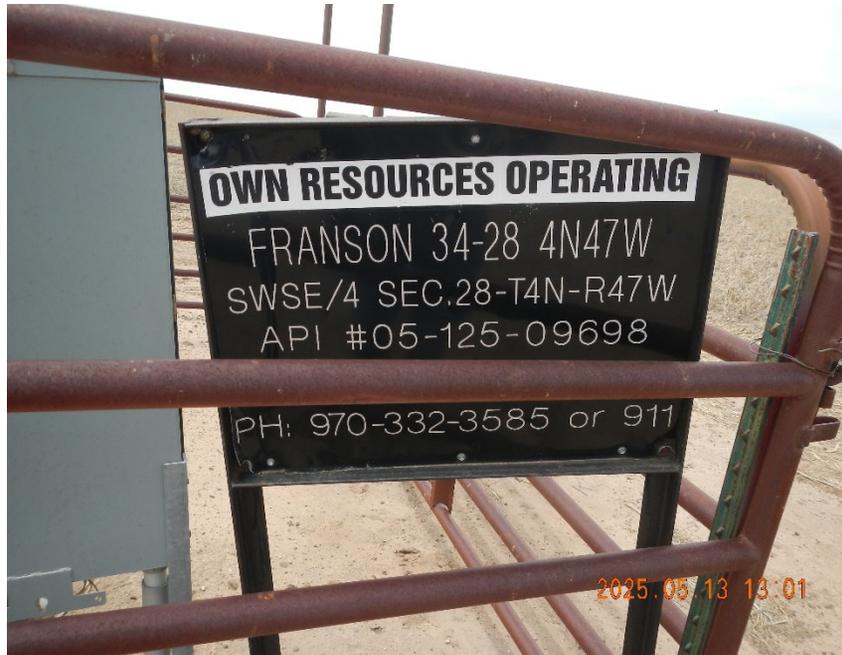
1. Lease sign at well location.

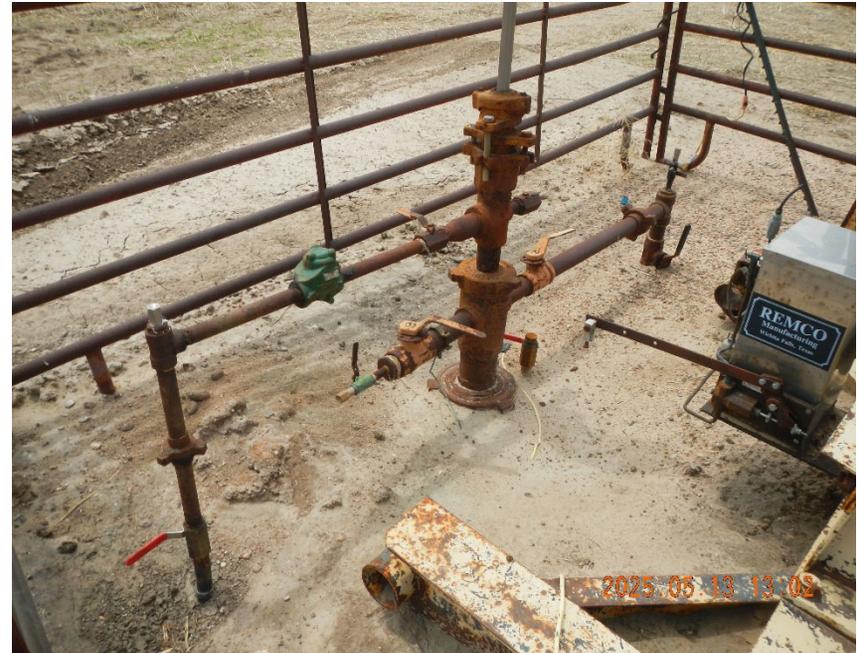
2. View of wellhead.

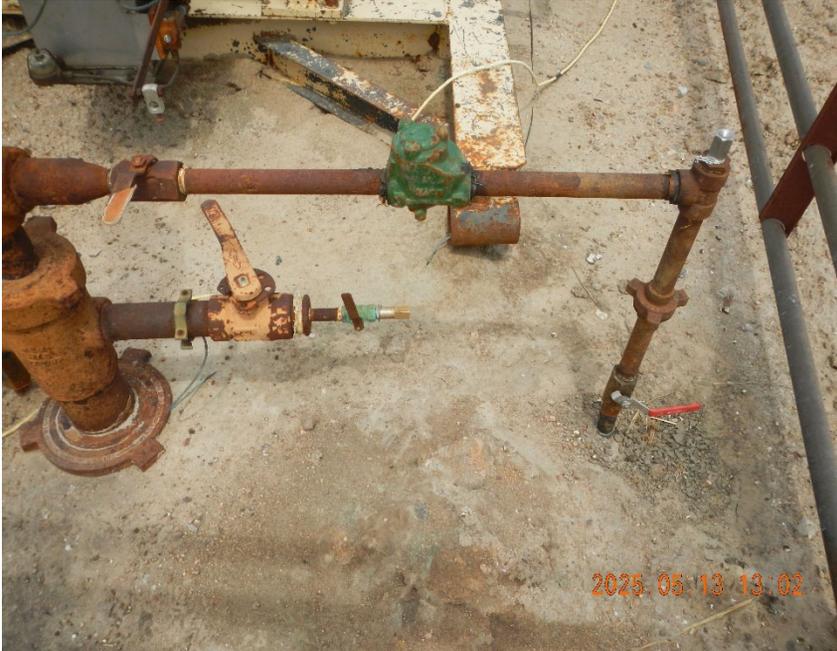
**3. View where previous FIR had noted release from check valve. CA completed with no fluid release at check valve.**

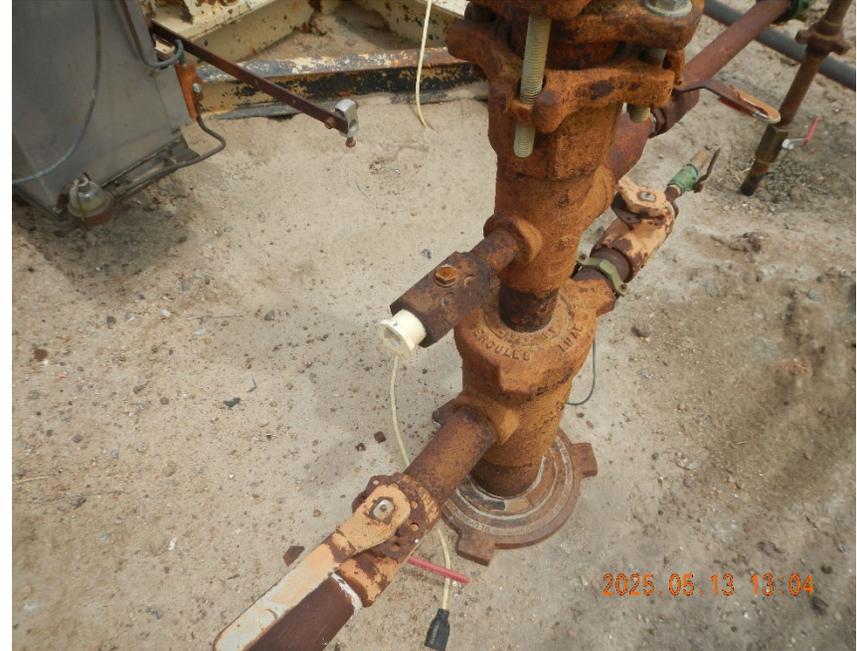
**4. Open ended line noted in previous FIR. CA completed and plug installed on tubing line.**
