**Inspection Photos**  
**Location Name: Carl Miller Flowline**  
**Spill ID: 490177**

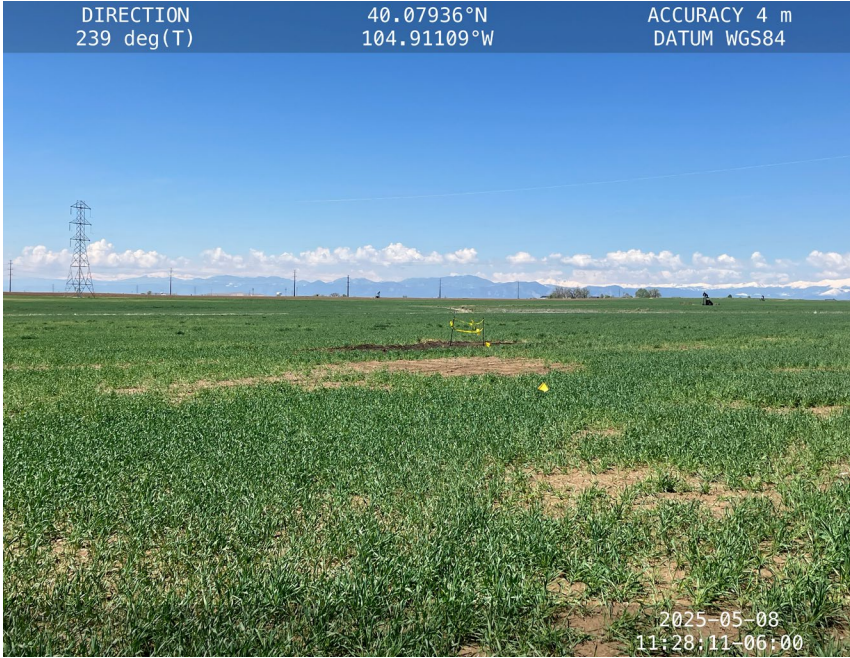
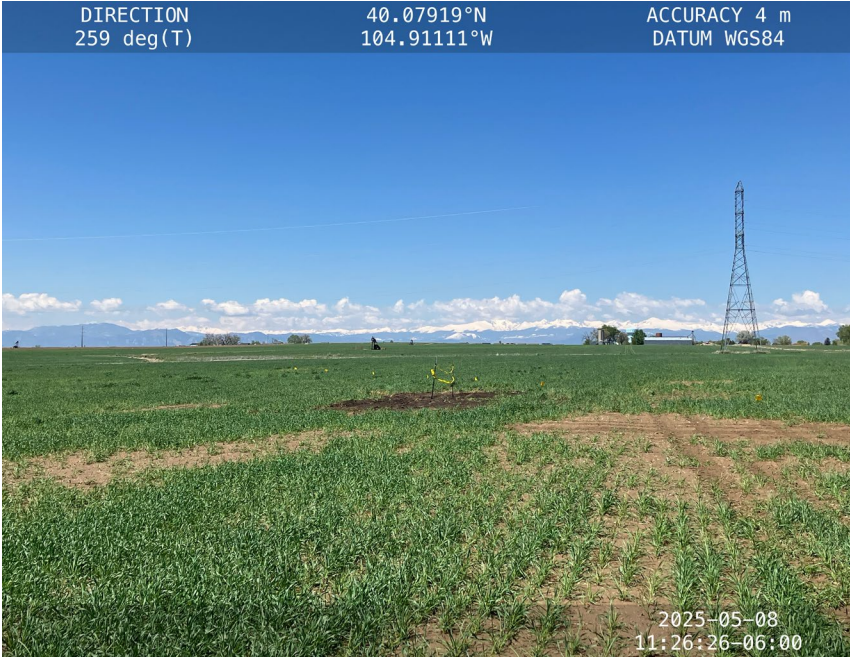
**Spill from a distance**

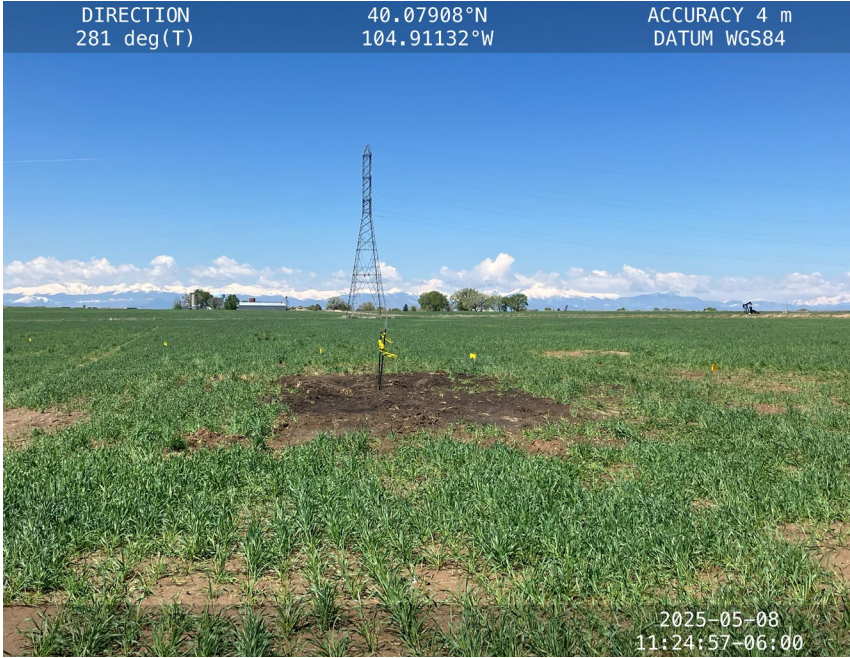
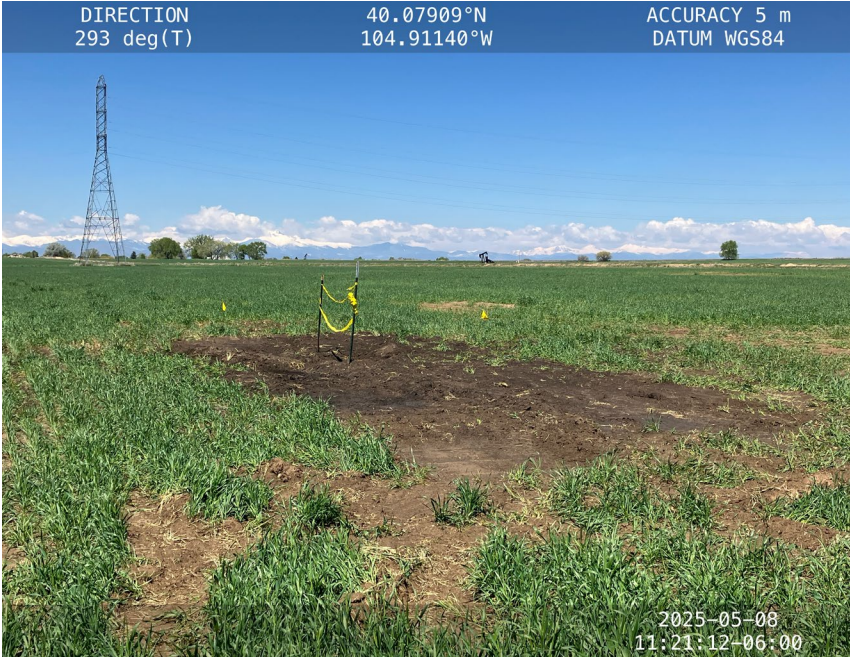
**Spill up close**

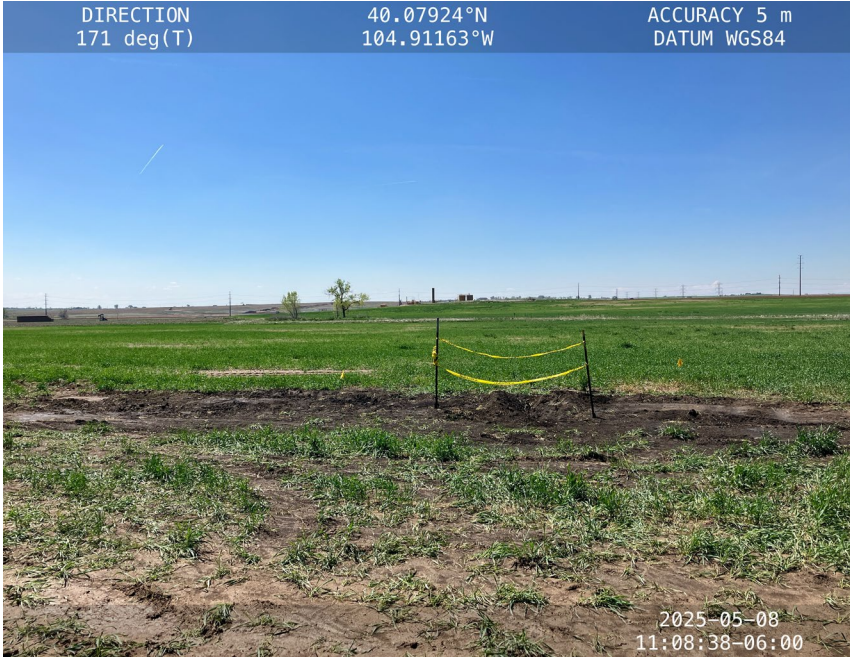
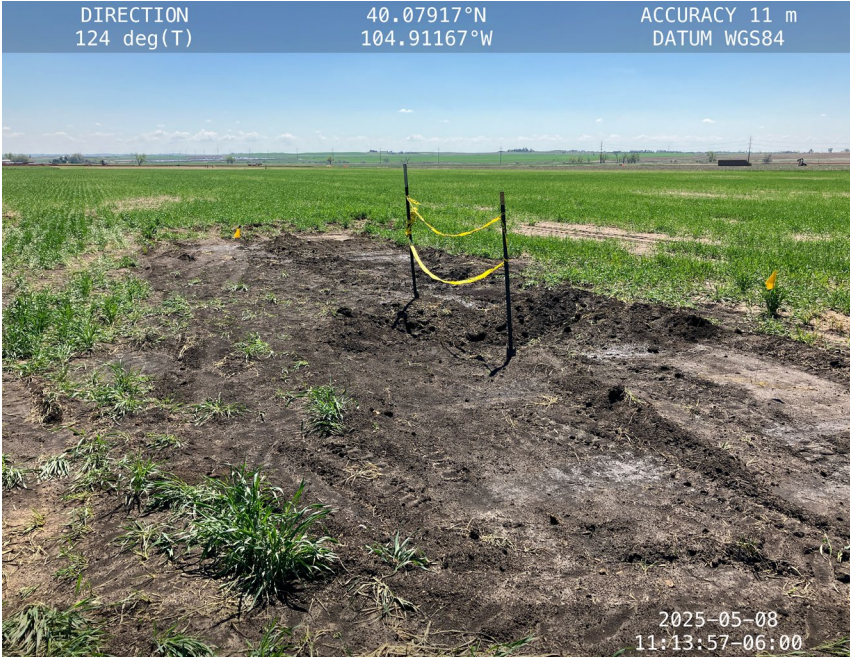
**Spill with visible dark staining and hydrocarbon odor**

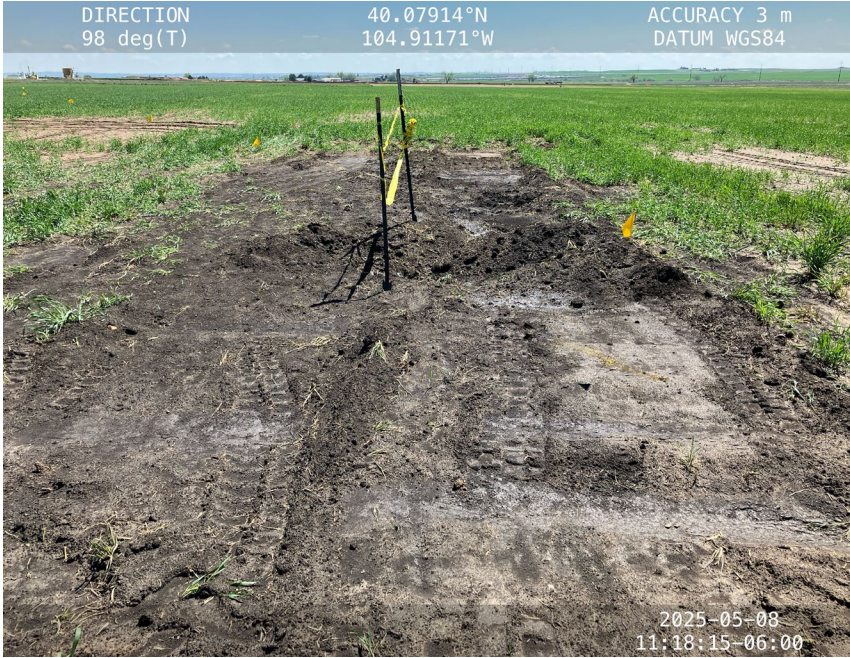
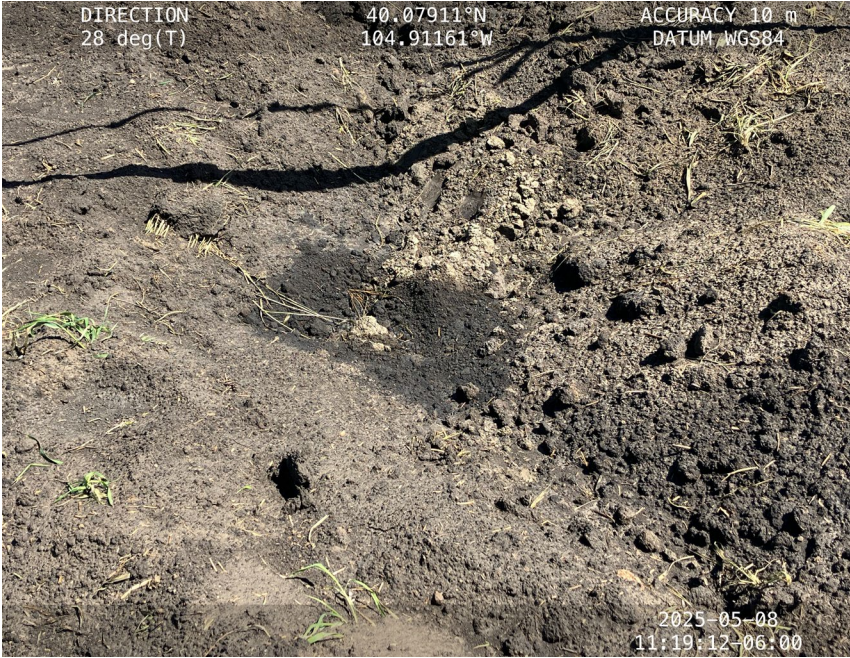
Spill with visible dark staining and hydrocarbon odor

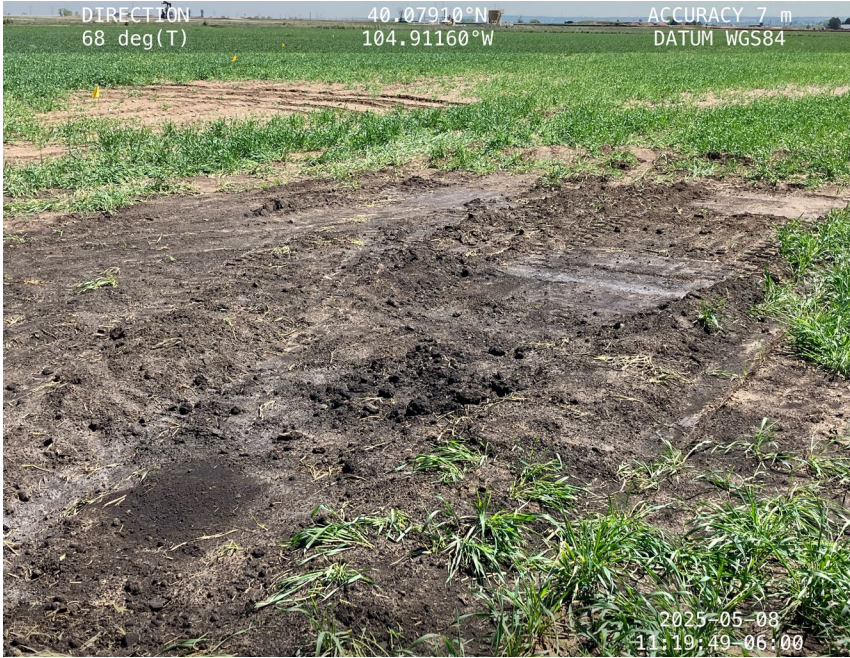
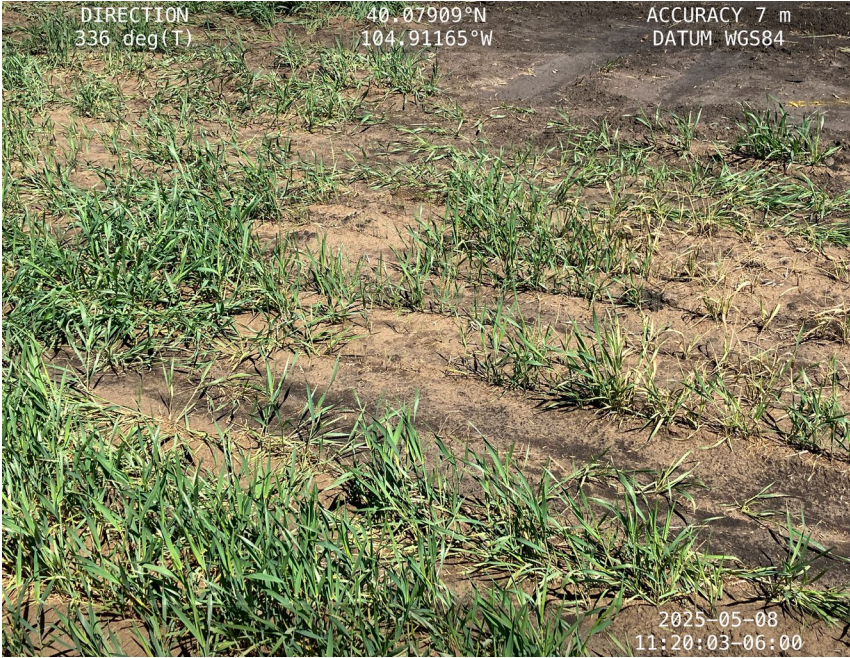
Spill with visible dark staining and hydrocarbon odor

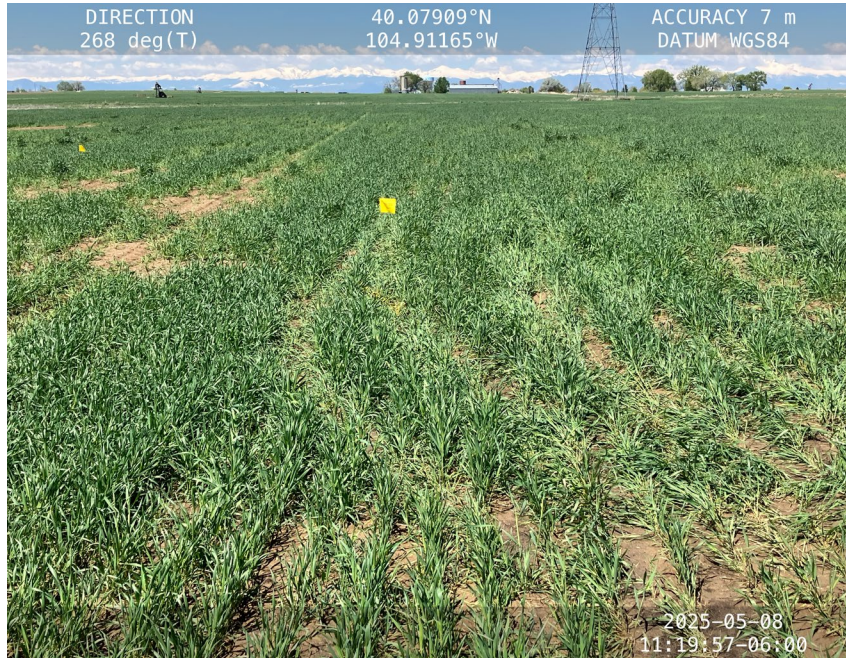
**Tire tracks and flags**
