**Inspection Photos**  
**Location Name: Lanson Farms 15 Flowline**  
**Spill ID: 487675**

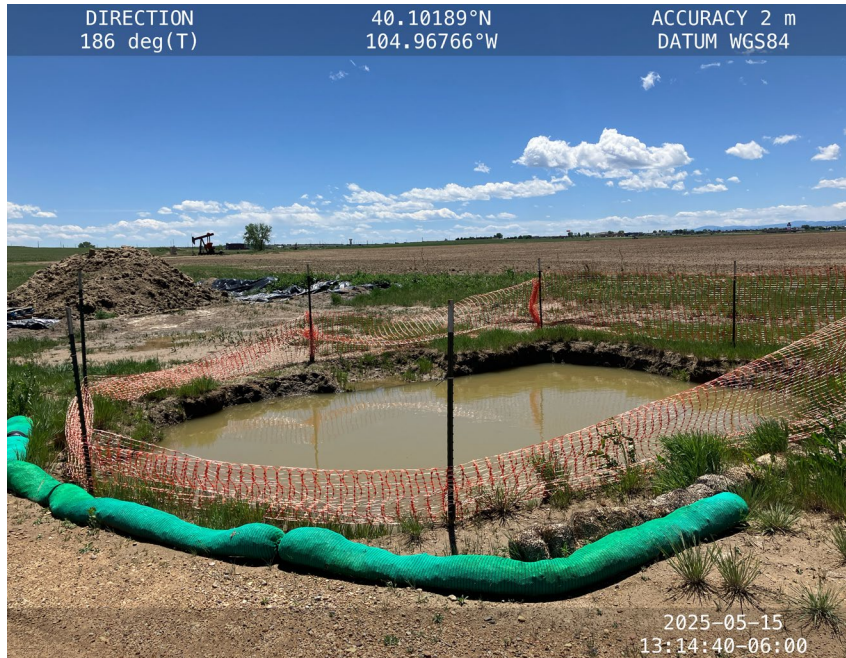
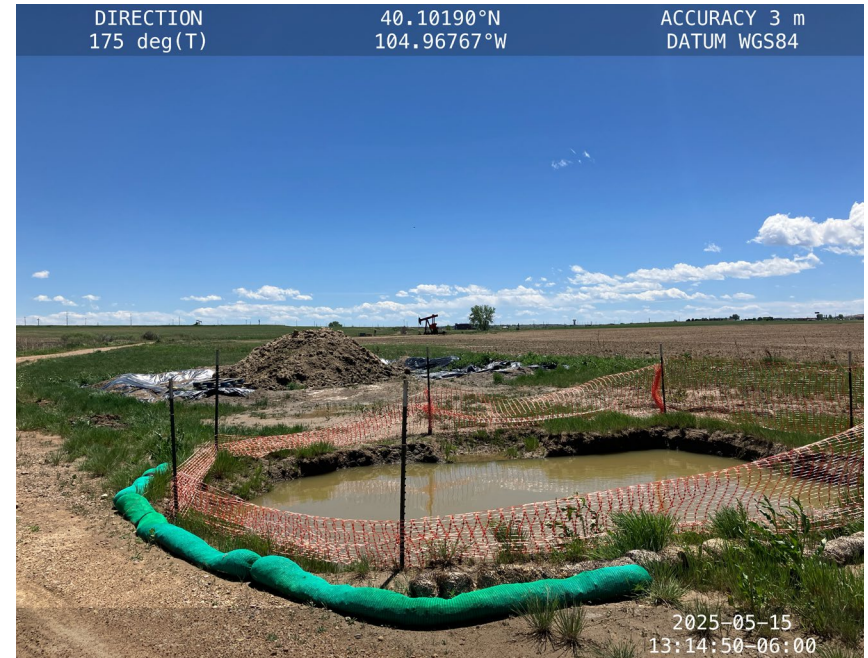
**Fencing around the excavation has fallen**

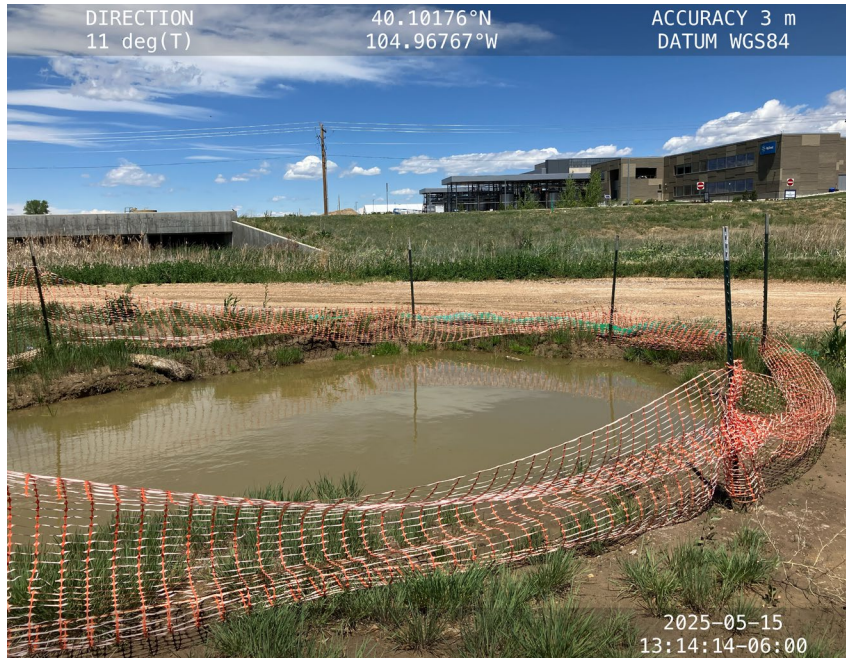
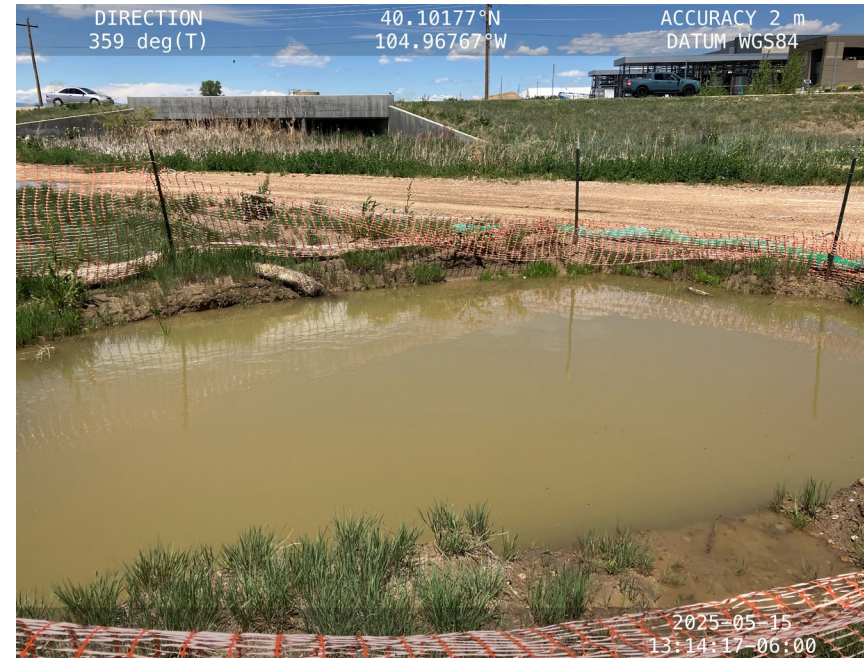
**Fencing around the excavation has fallen**

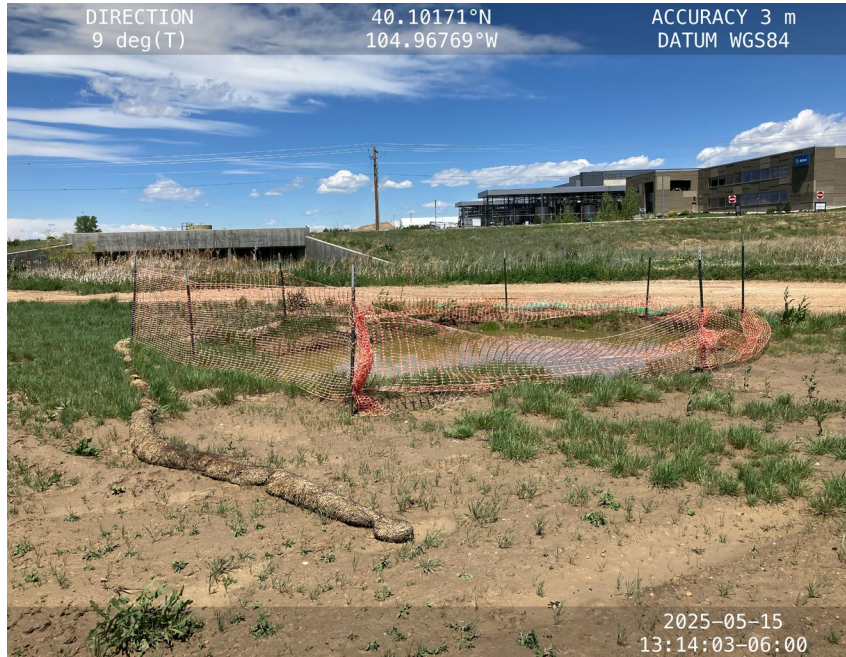
**Fencing around the excavation has fallen**

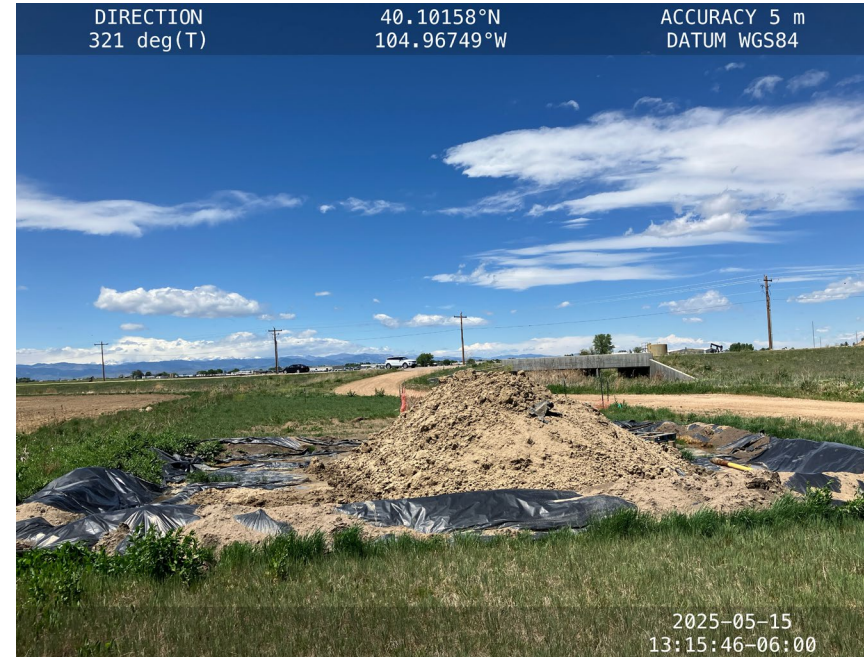
**Stockpile**

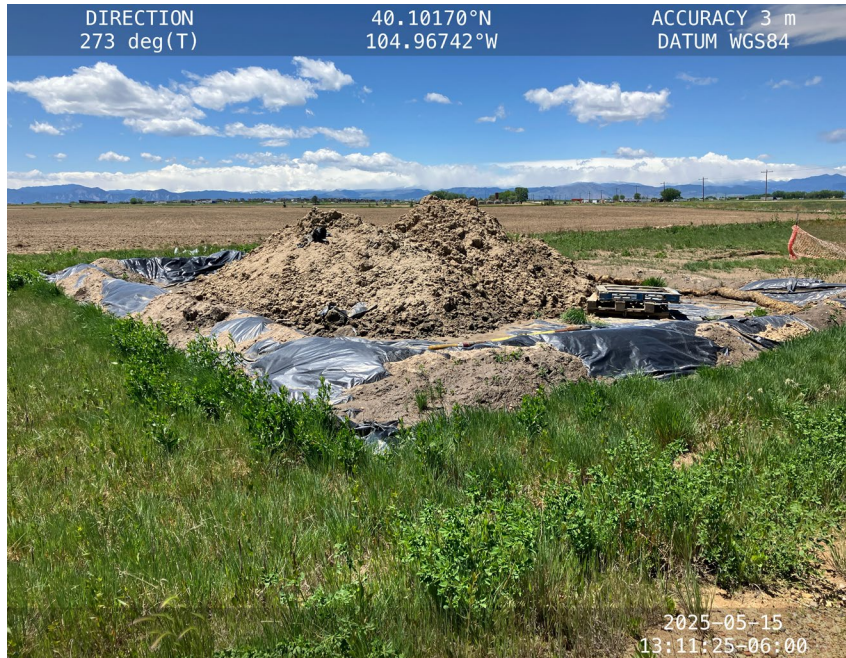
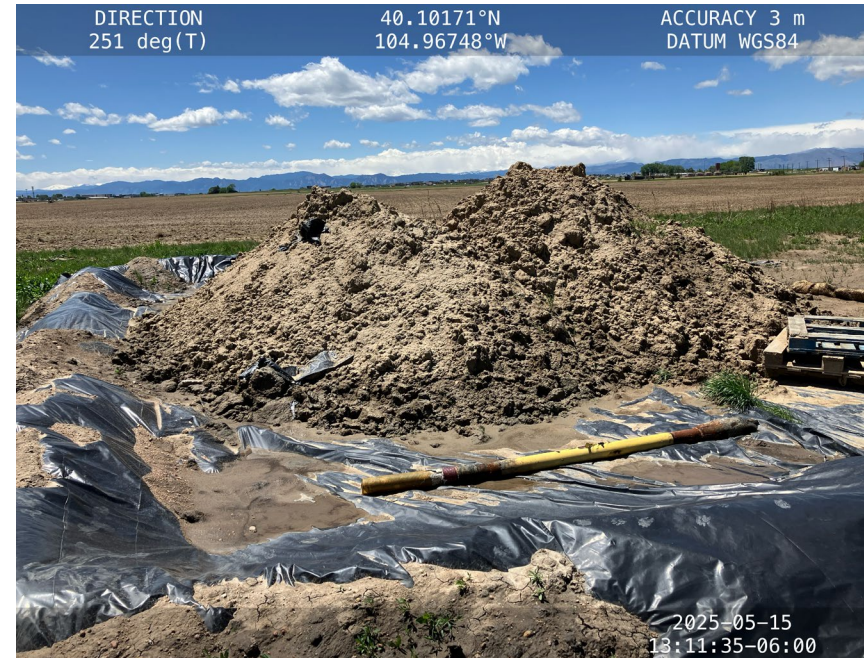
**Stockpile**

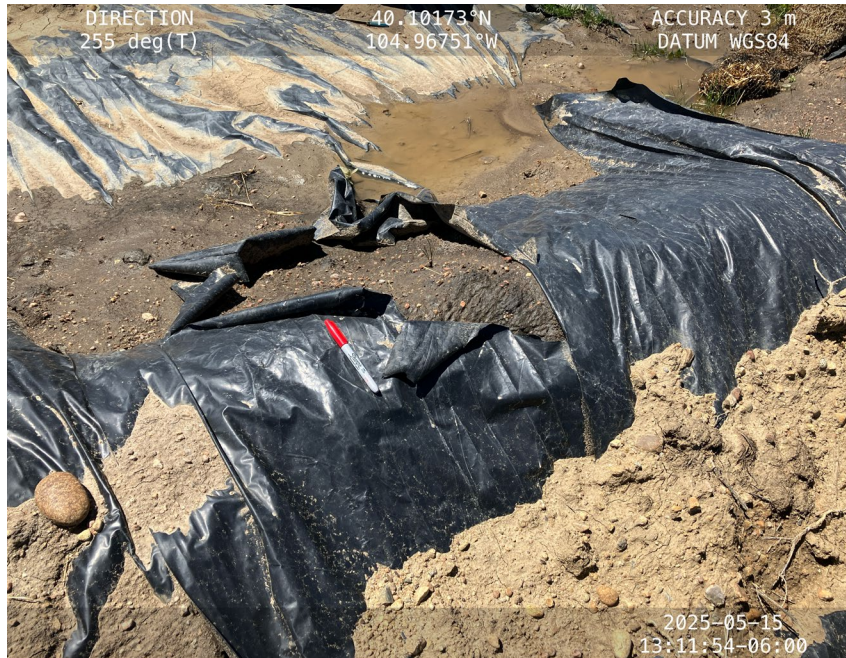
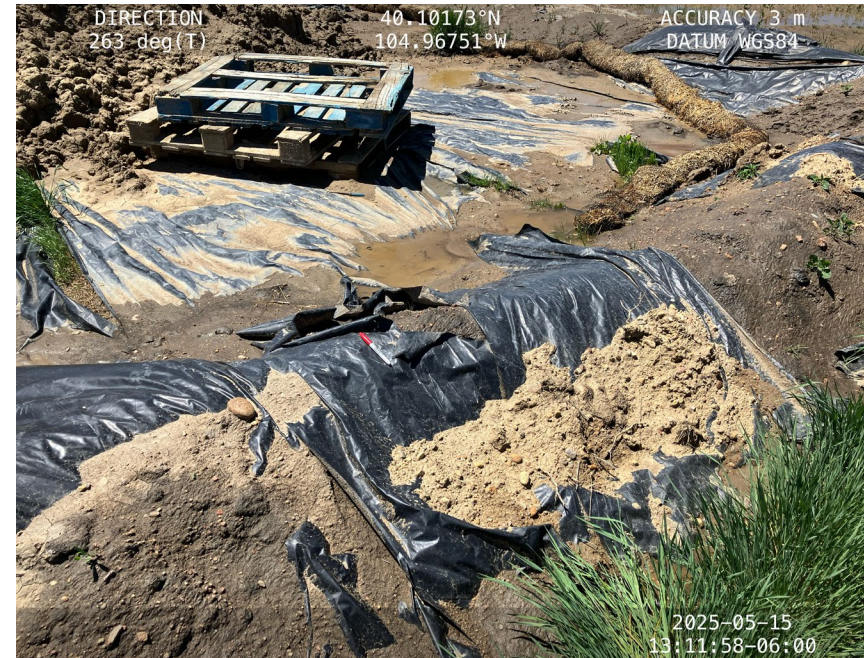
**Rips and tears in the liner under the stockpile**

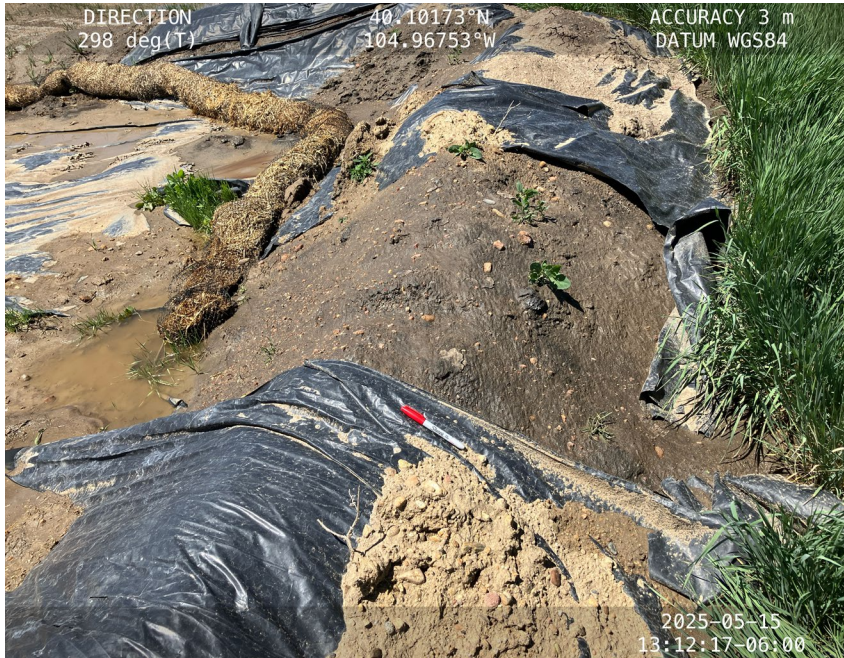
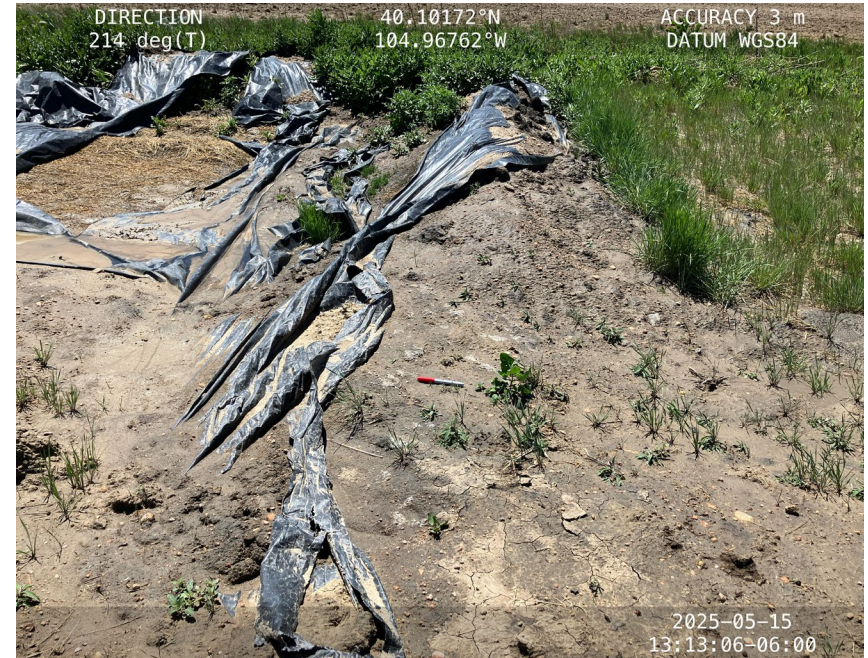
**Rips and tears in the liner under the stockpile**

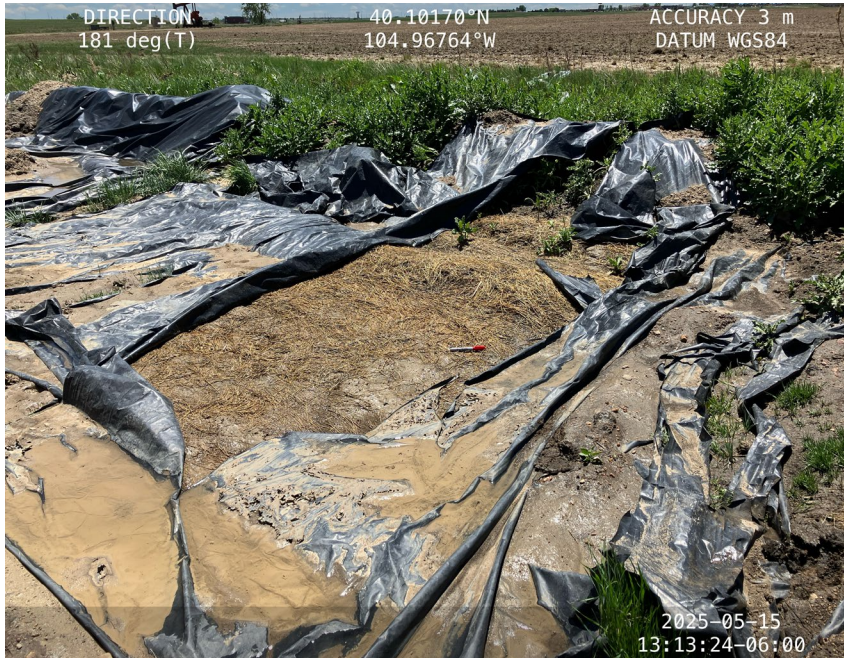
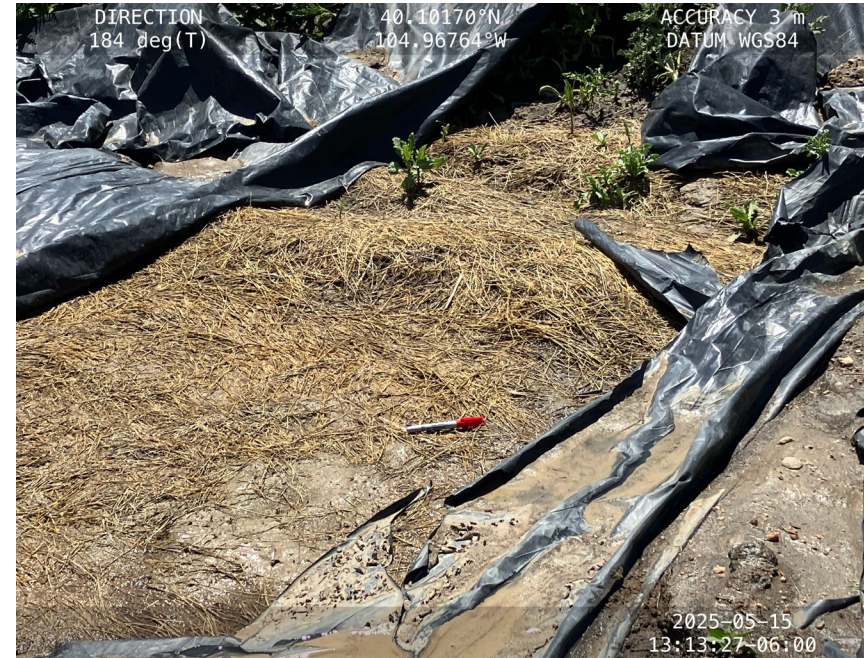
**Rips and tears in the liner under the stockpile**

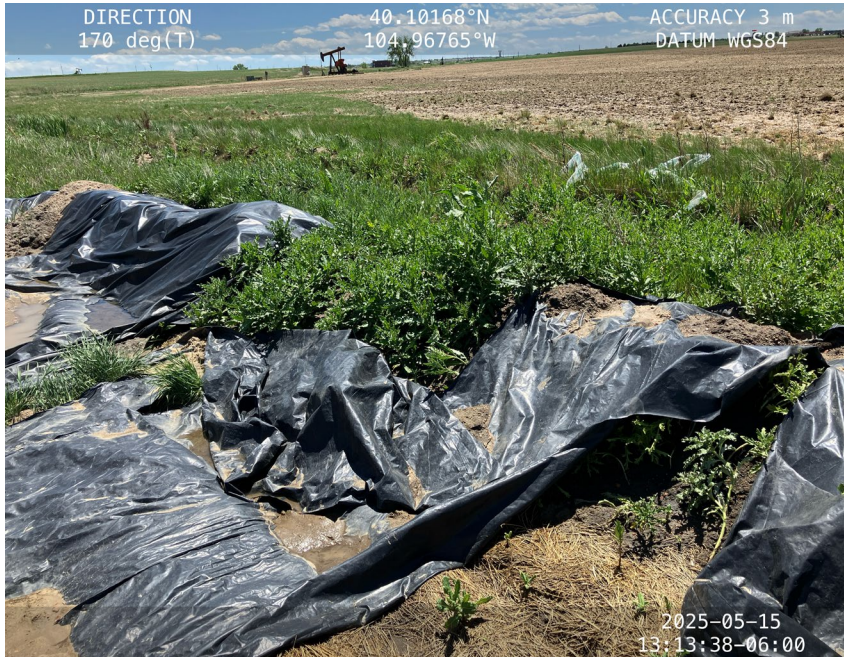
**Rips and tears in the liner under the stockpile**

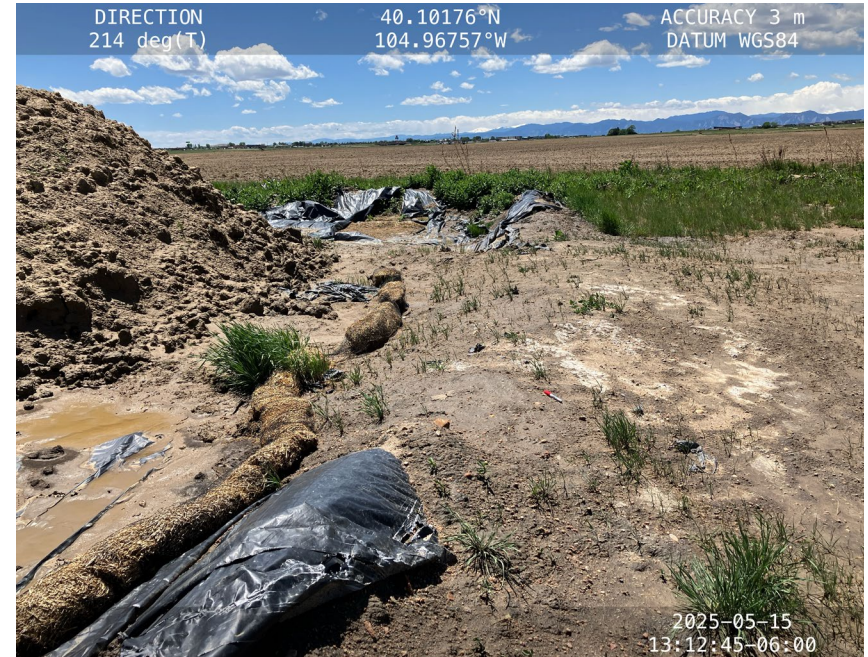
**Contaminated soil has overflowed off the line and onto the ground surface**

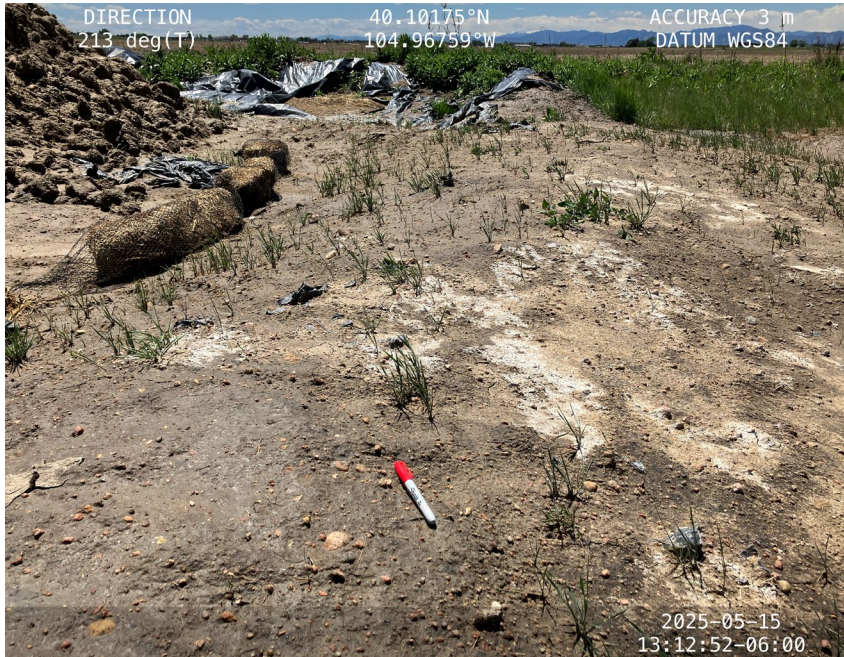
**Contaminated soil has overflowed off the line and onto the ground surface**
