TEP  
Daley 1  
Location ID: 323891

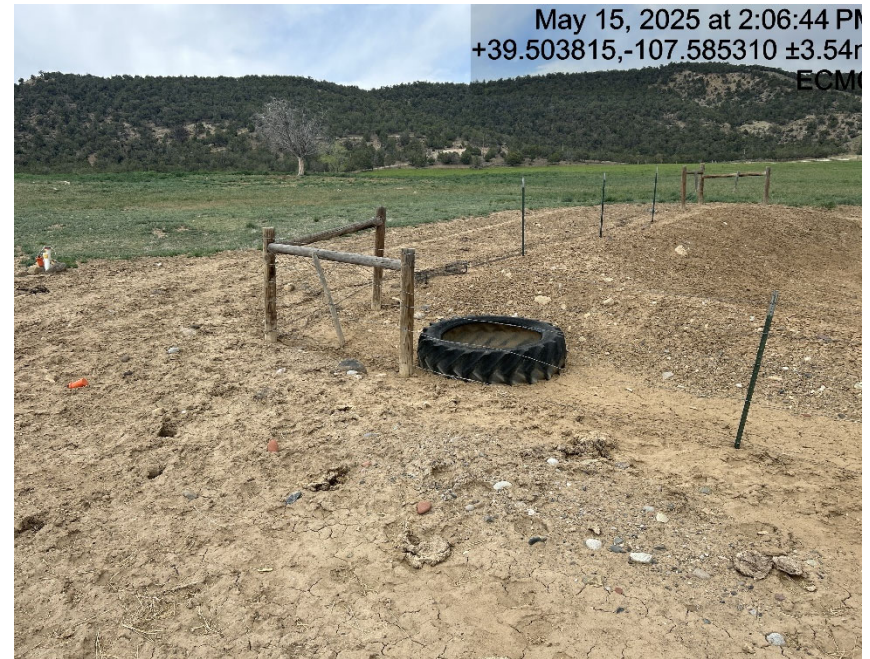
Debris inside tank battery fence

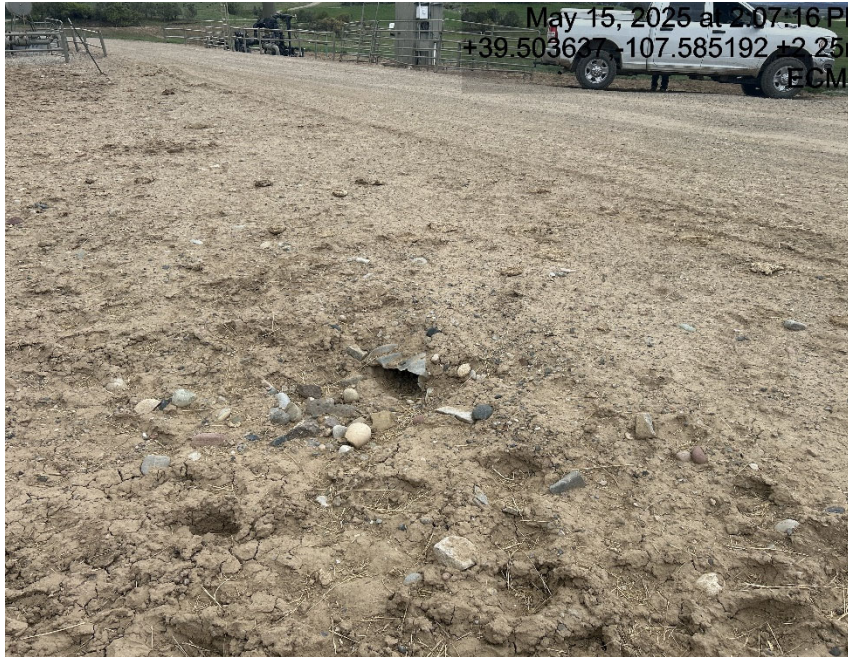
**Recent inspection photo of culvert lacks maintained**

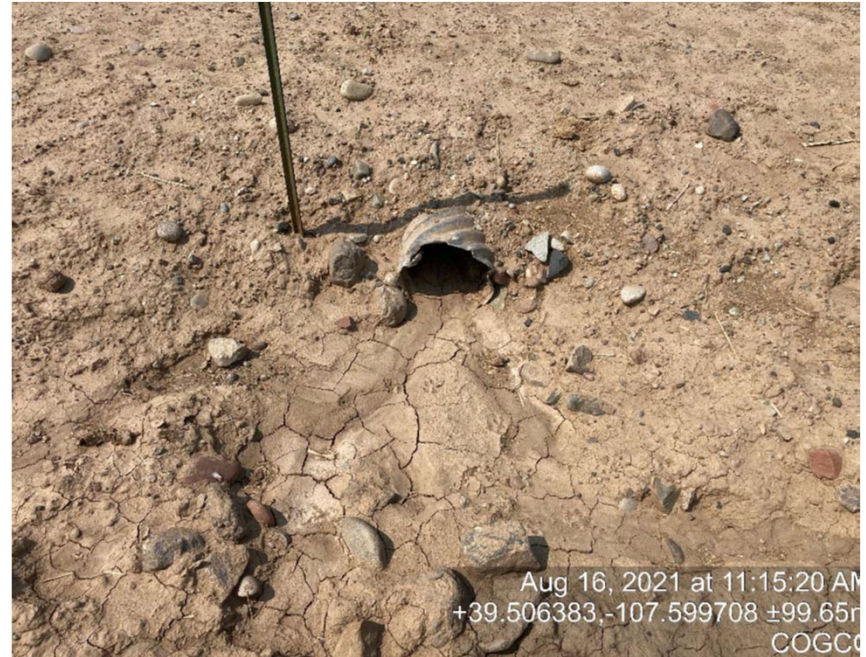
**Previous inspection photo of culvert**

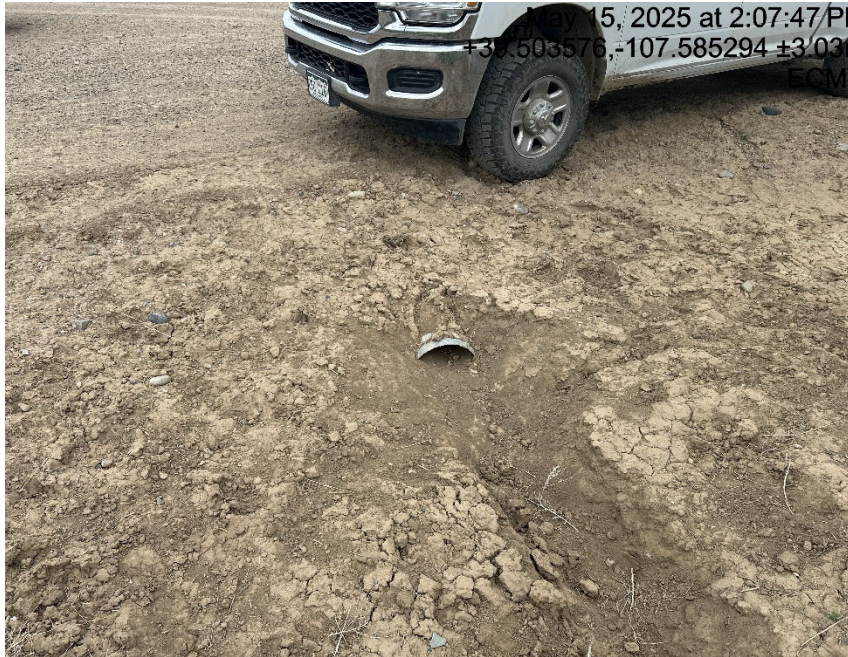
**Recent inspection photo of culvert lacks maintained**

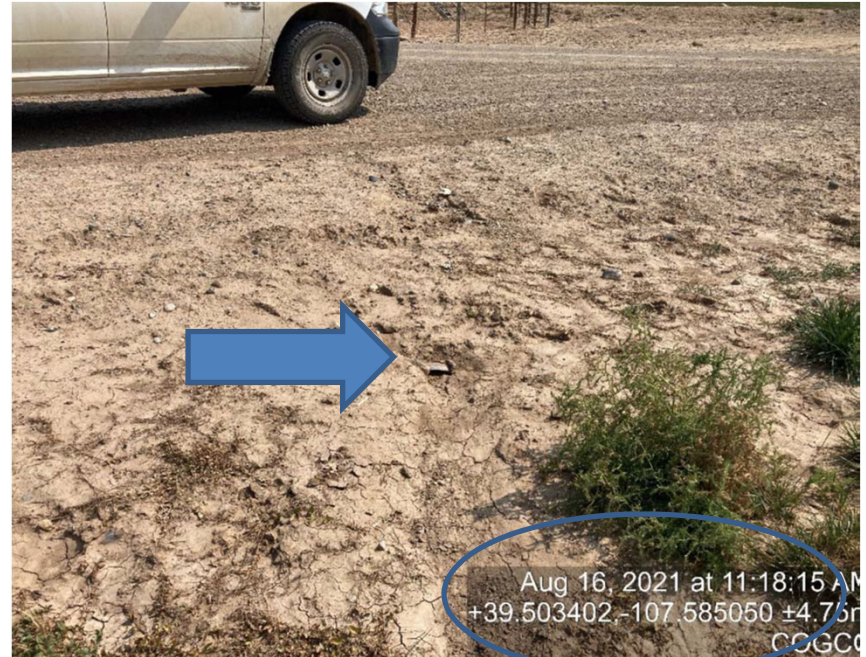
**Previous inspection photo of culvert**

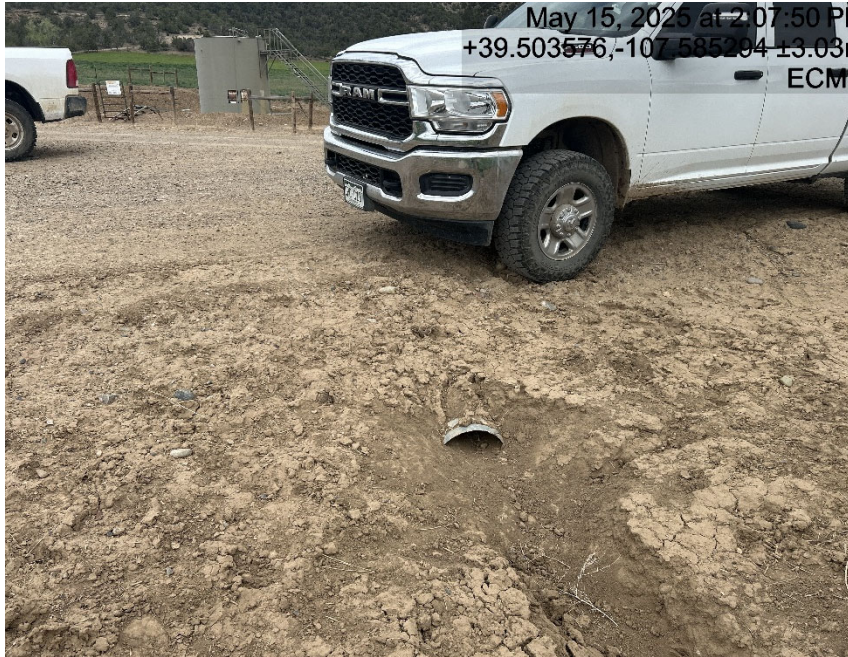
Recent inspection photo of culvert lacks maintained

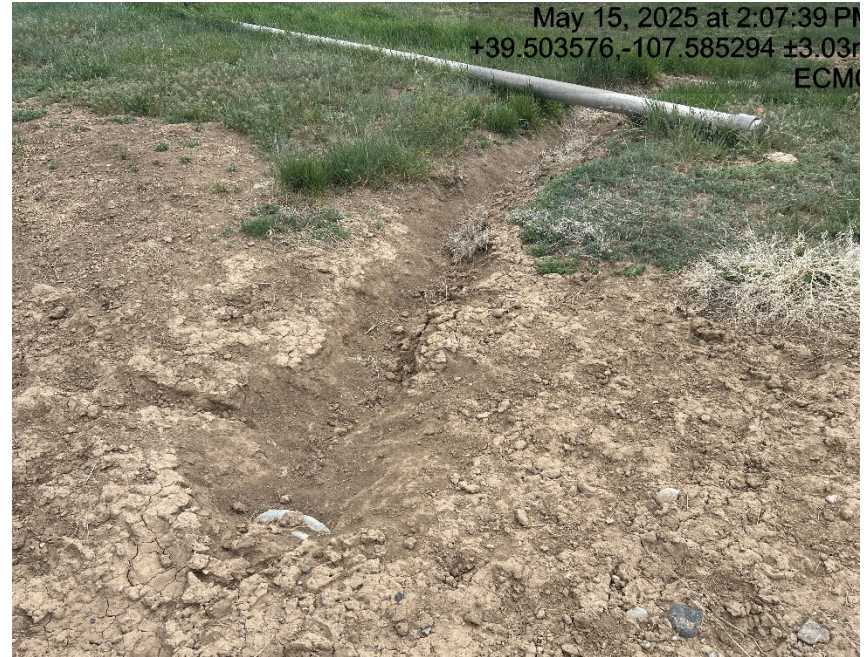
Recent inspection photo of culvert lacks maintained
