Inspection/Audit Photos

Location Name: QB ENERGY OPERATING LLC BENZEL 1-16C (P1W) Pad

Location #: 334612

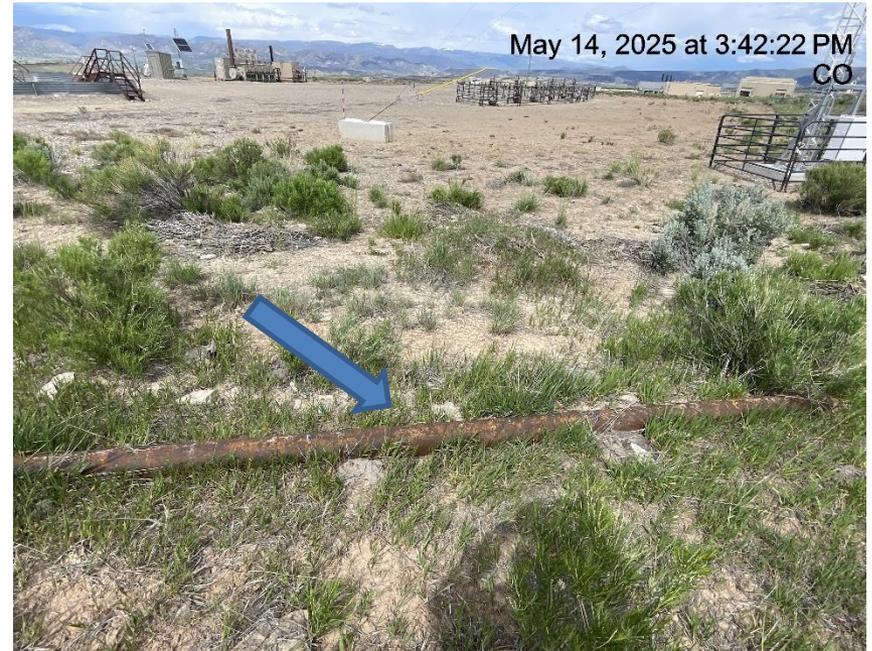
Photo # 1676 Debris

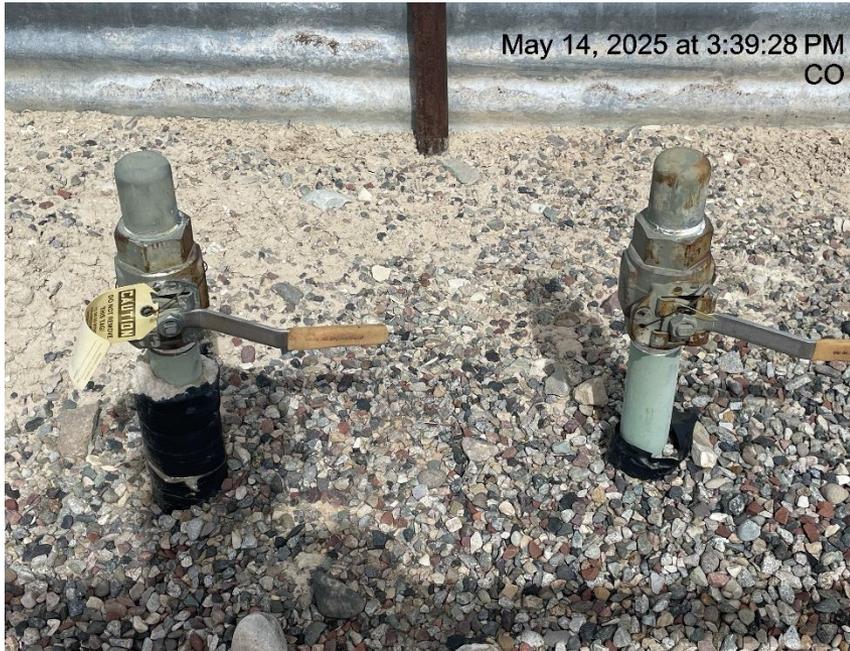
Photo # 1677 Unused flowlines do not comply with CECMC rules

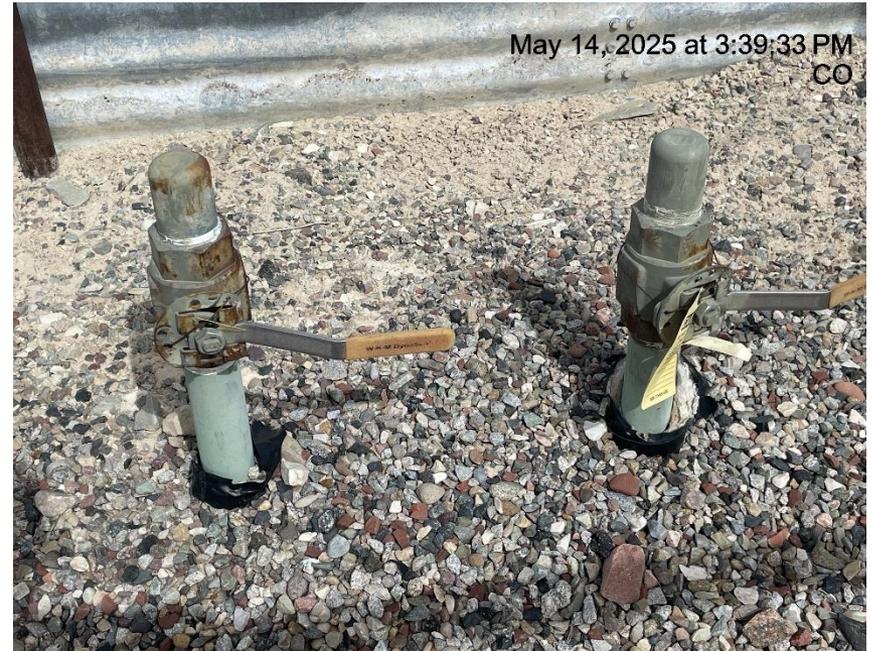
Photo # 1678 Unused flowlines do not comply with CECMC rules

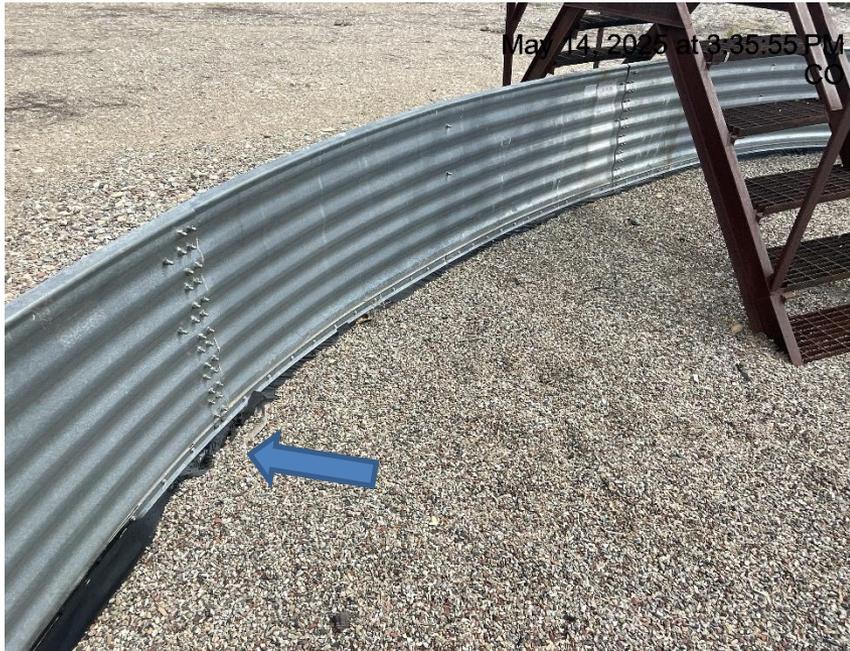
Photo # 1679 Holes in secondary containment liner/liner needs maintenance

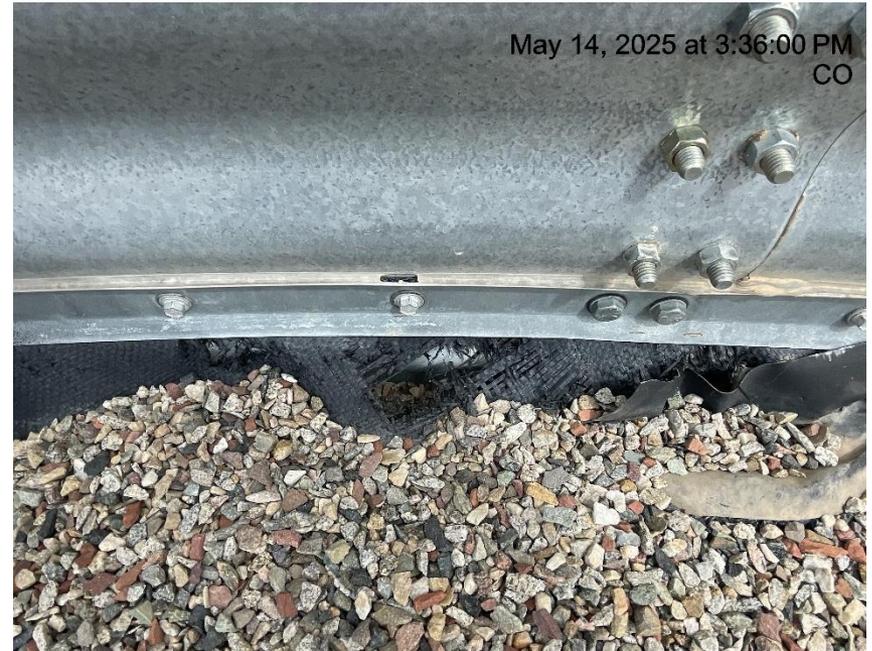
Photo # 1680 Holes in secondary containment liner/liner needs maintenance

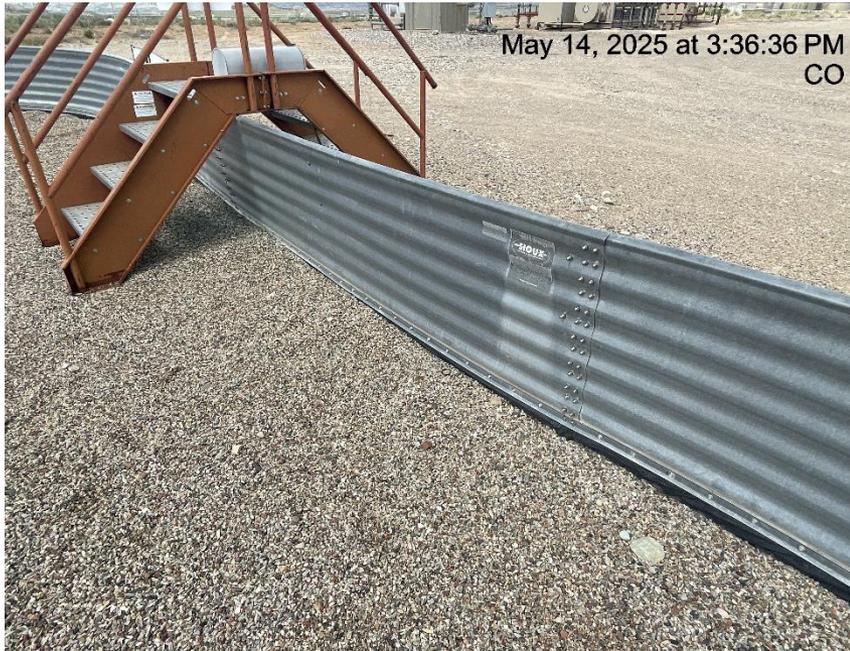
Photo # 1681 Hole in secondary containment liner/liner needs maintenance

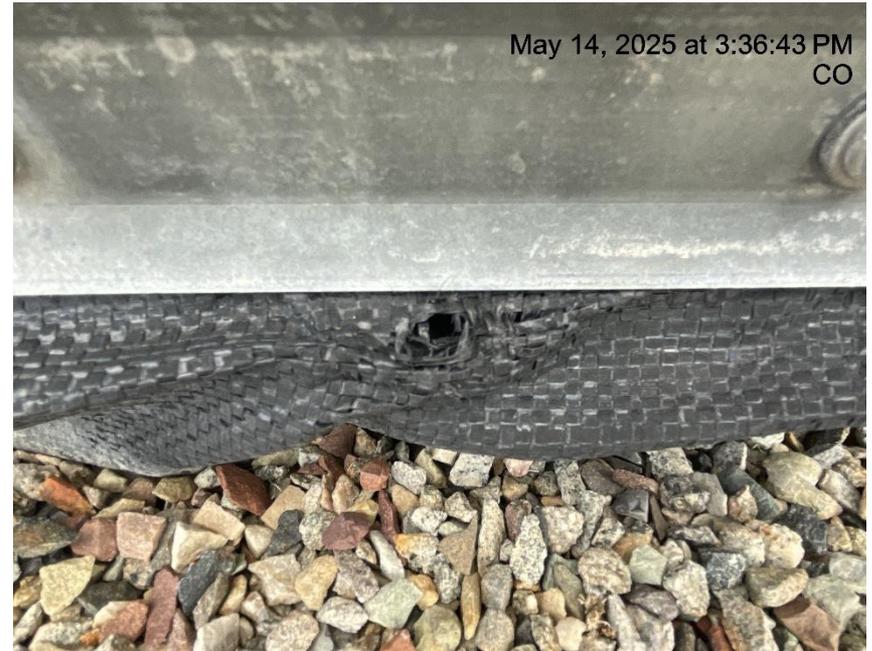
Photo # 1682 Hole in secondary containment liner/liner needs maintenance

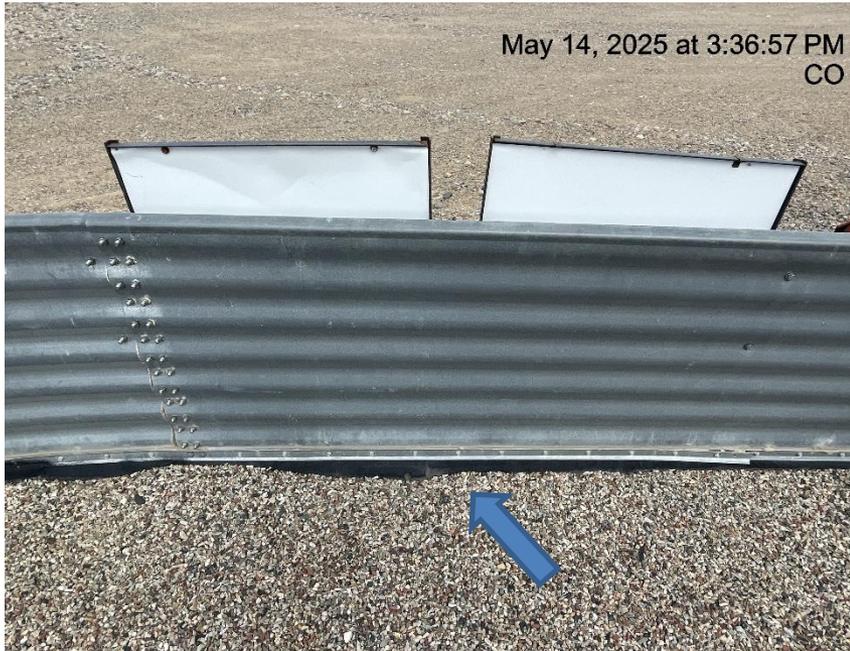
Photo # 1683 Hole in secondary containment liner/liner needs maintenance

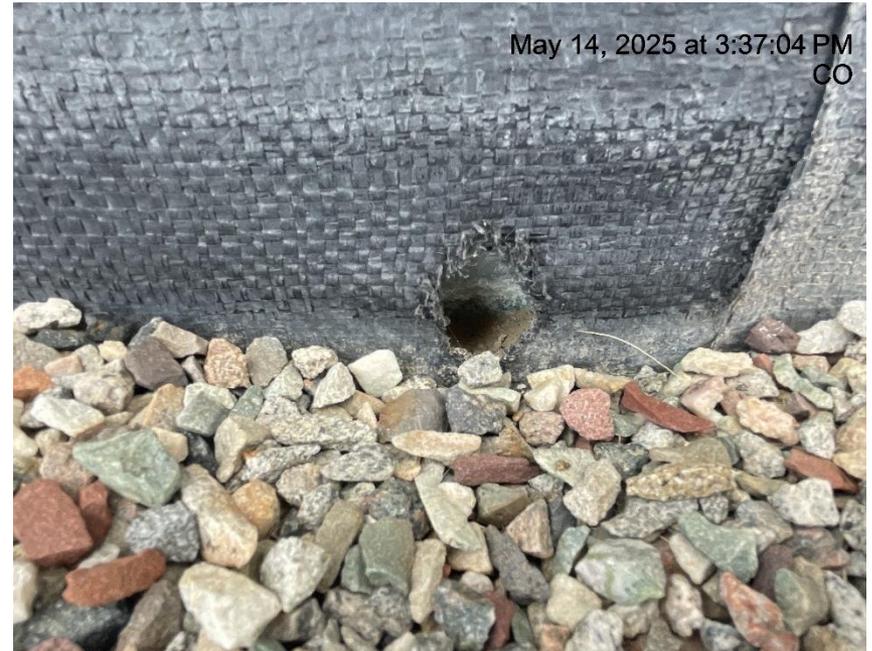
Photo # 1684 Hole in secondary containment liner/liner needs maintenance

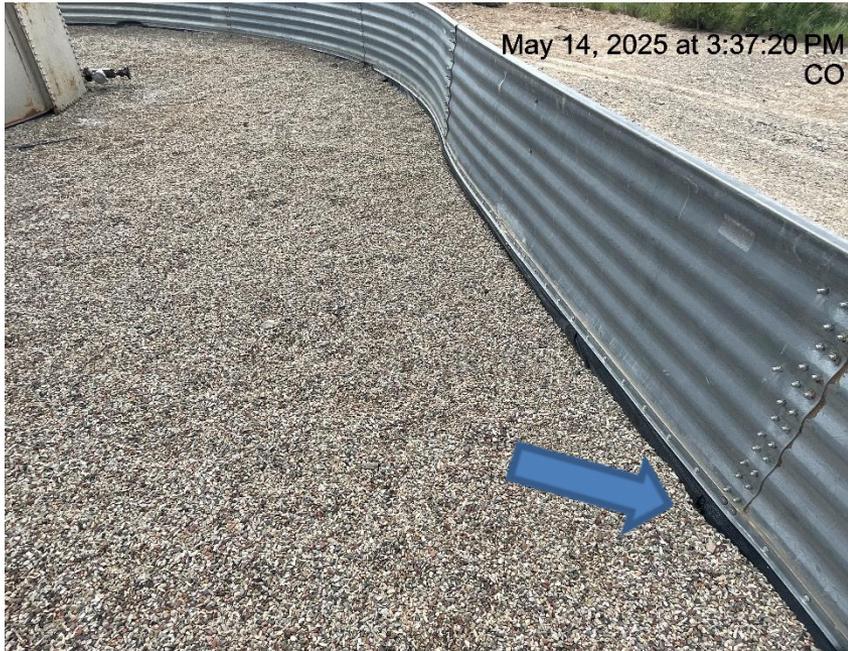
Photo # 1685 Hole in secondary containment liner/liner needs maintenance

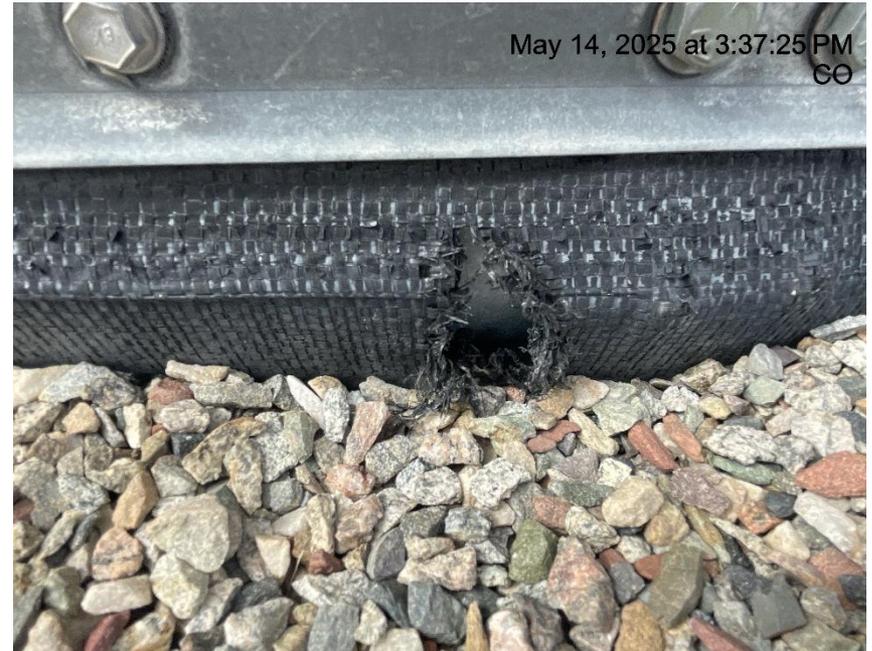
Photo # 1686 Hole in secondary containment liner/liner needs maintenance

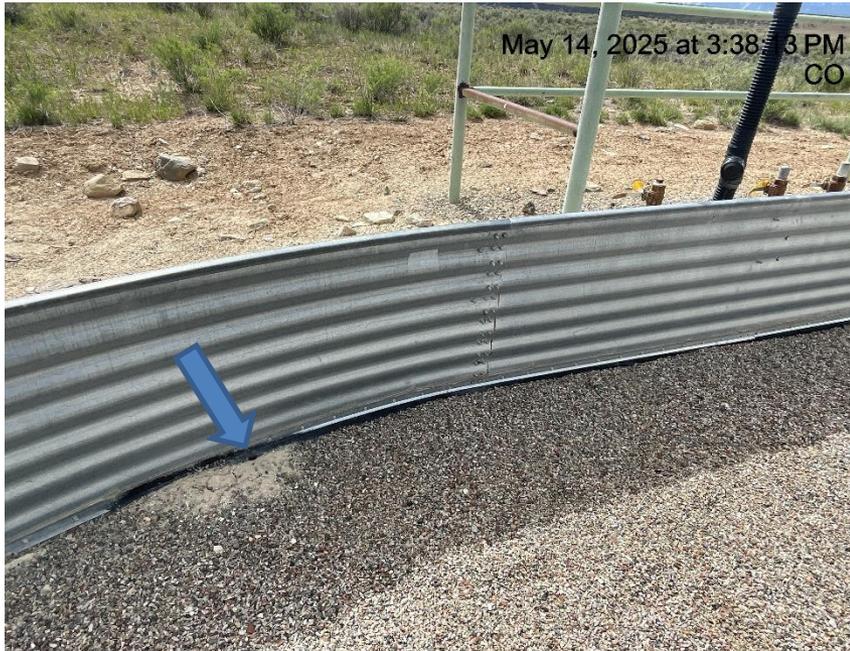
Photo # 1687 Hole in secondary containment liner/liner needs maintenance

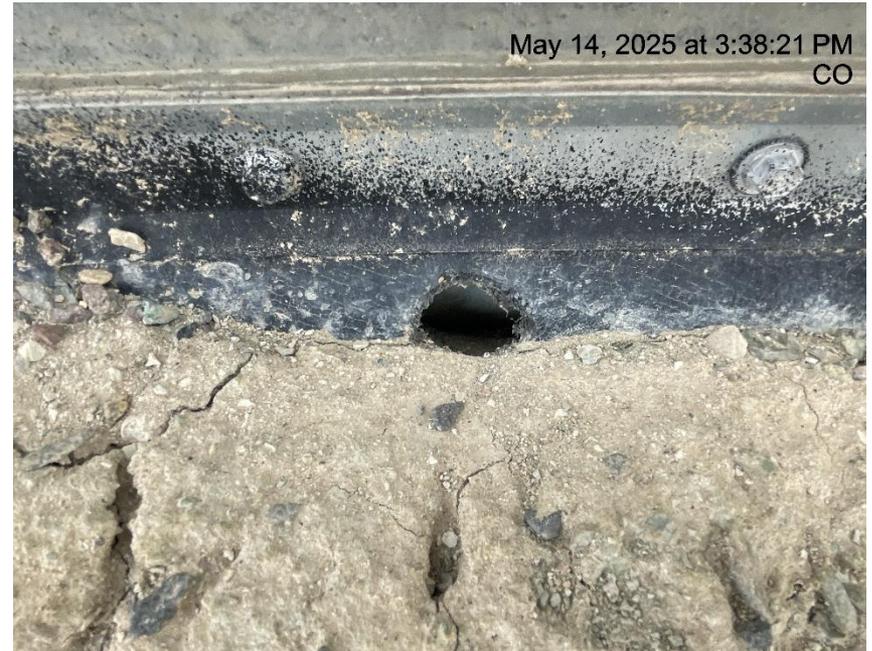
Photo # 1688 Hole in secondary containment liner/liner needs maintenance
