Inspection Photos

API: 017-07718

Operator: **VECTA OIL & GAS LTD**

Inspection Date: 5/19/2025

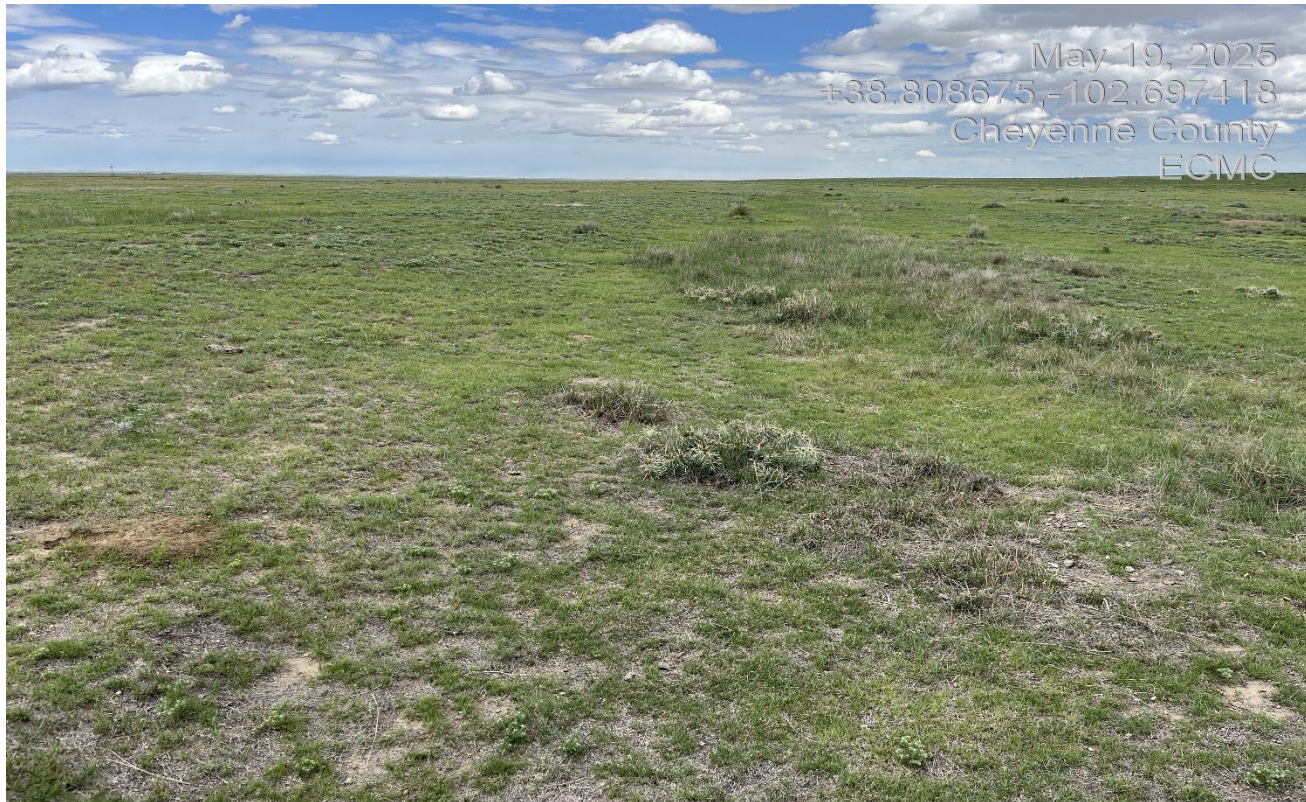
Photo 1. Facing north toward the access road which has revegetated.

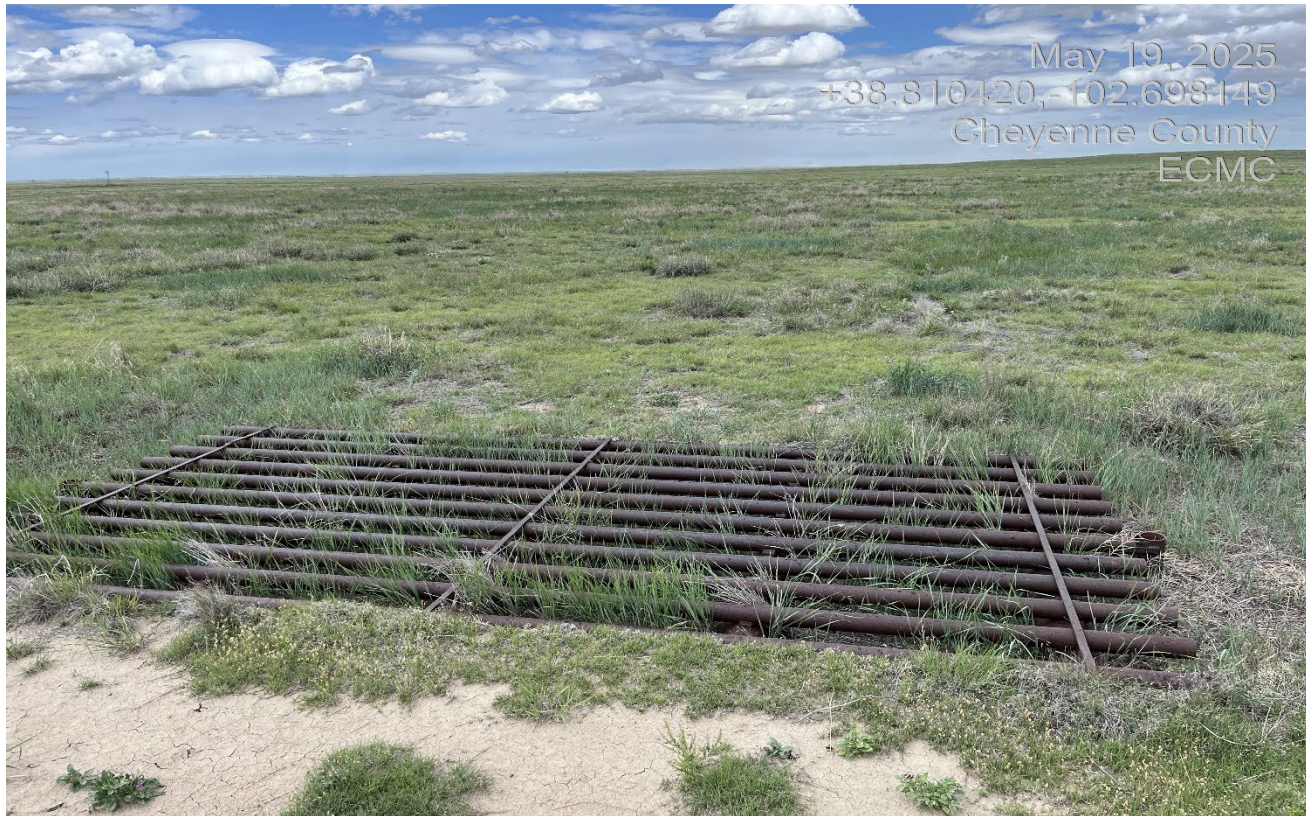
Photo 2. Facing north at the location. The cattleguard has not been removed from the location. The perimeter fence was removed but not the cattleguard.

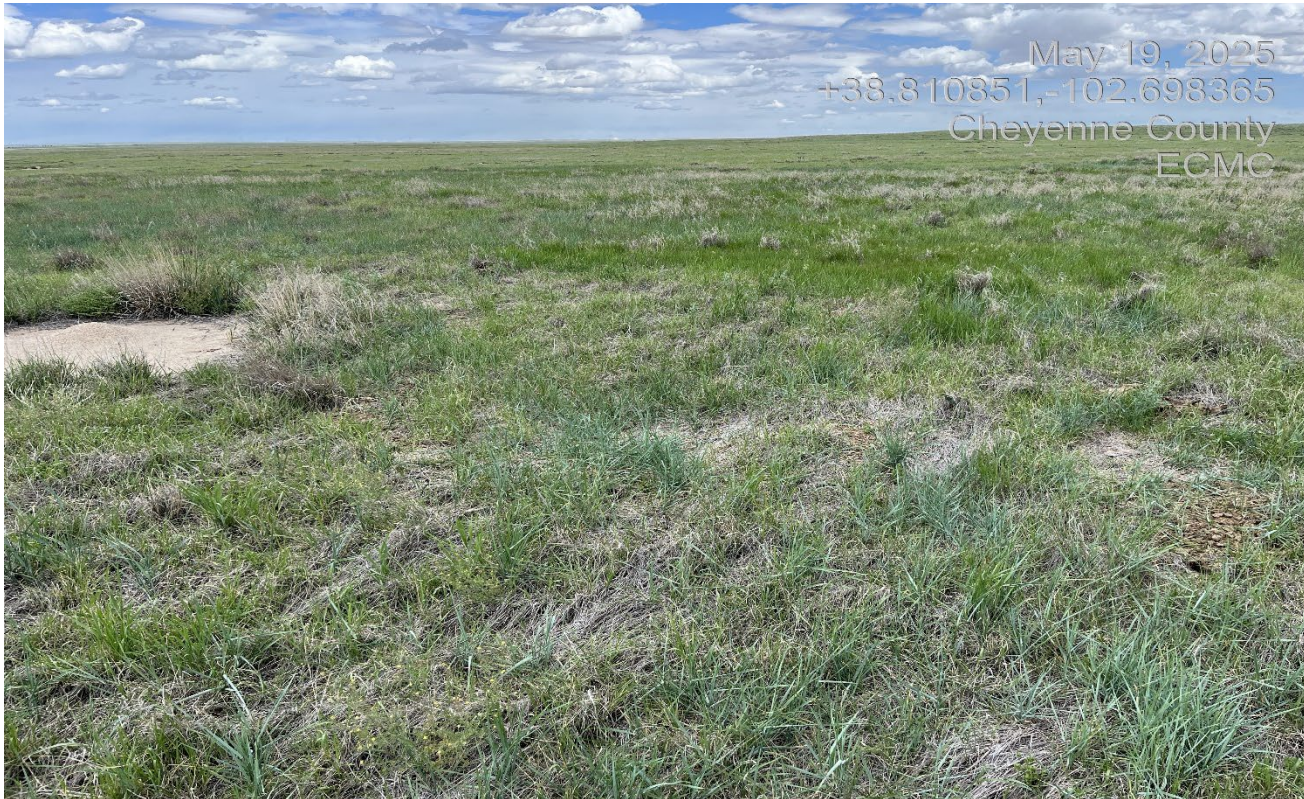
Photo 3. Center of the location facing north. Perennial vegetation is progressing throughout the location.

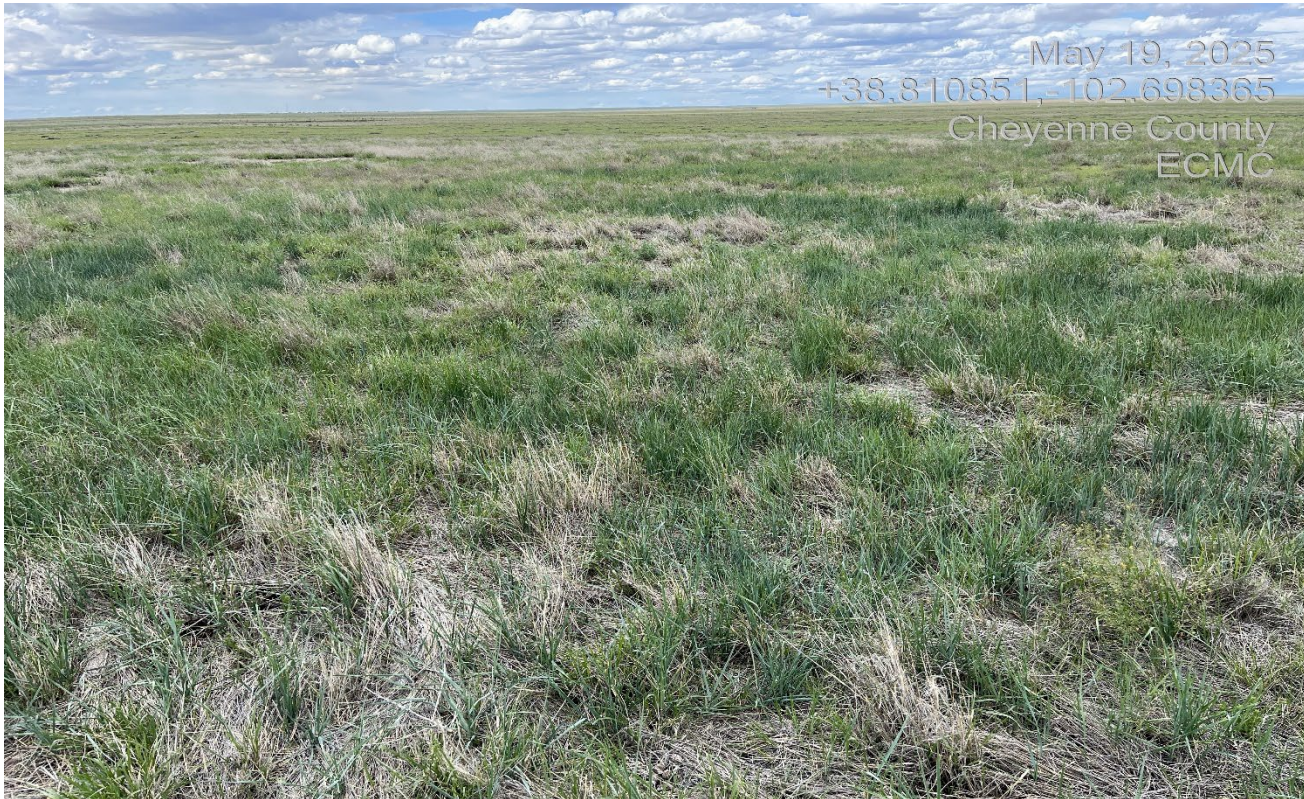
Photo 4. Center of the location facing west. Perennial vegetation is progressing throughout the location.

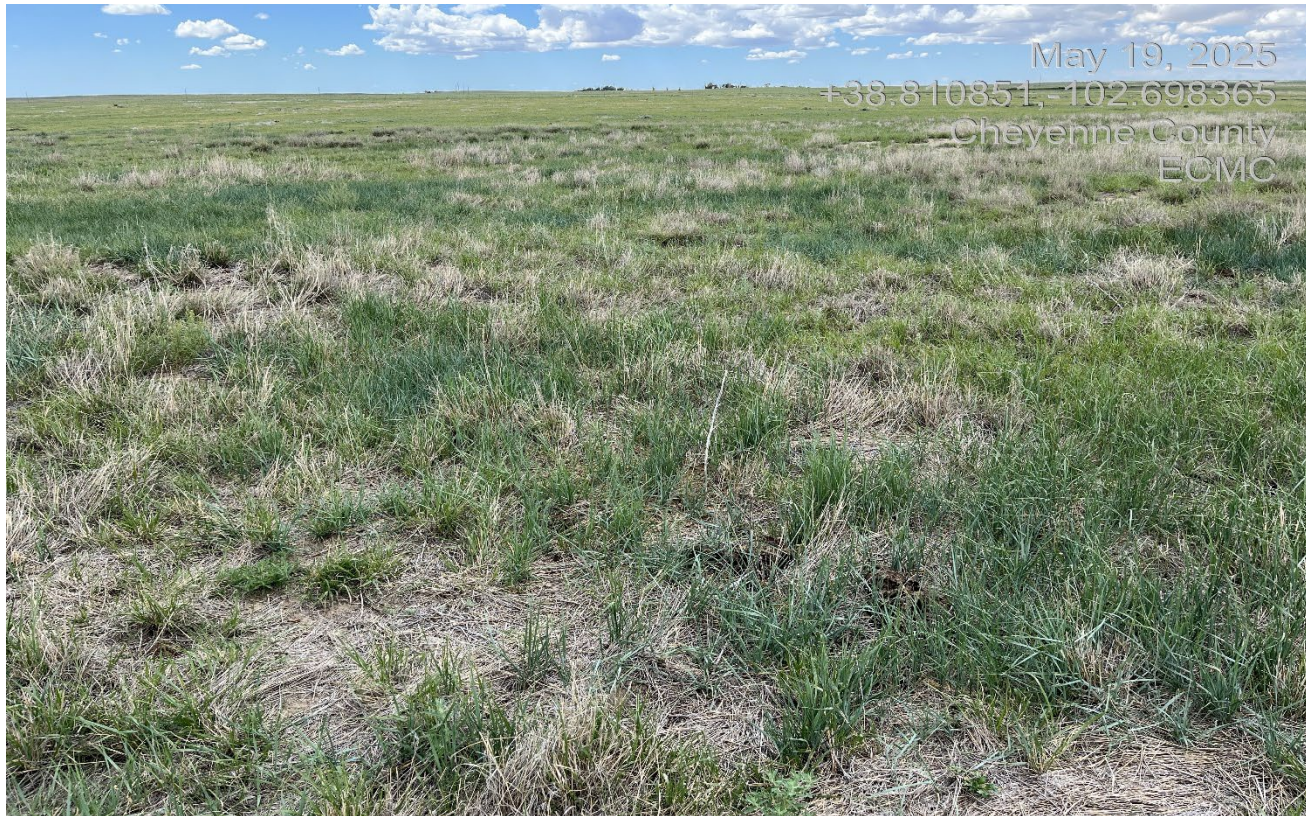
Photo 5. Center of the location facing south. Perennial vegetation is progressing throughout the location.

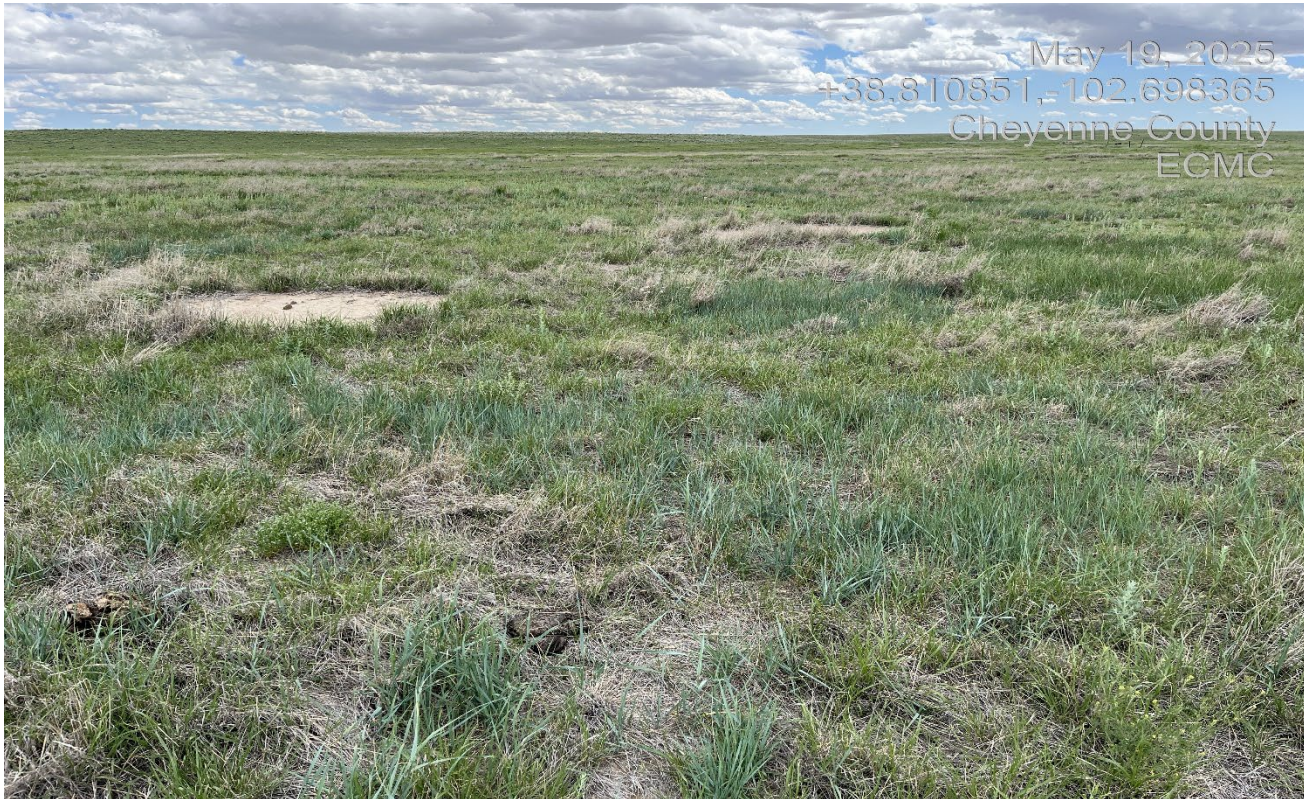
Photo 6. Center of the location facing east. Perennial vegetation is progressing throughout the location.
