Inspection Photos

API: 017-07031

Operator: ANADARKO E&P ONSHORE LLC

Inspection Date: 5/19/2025

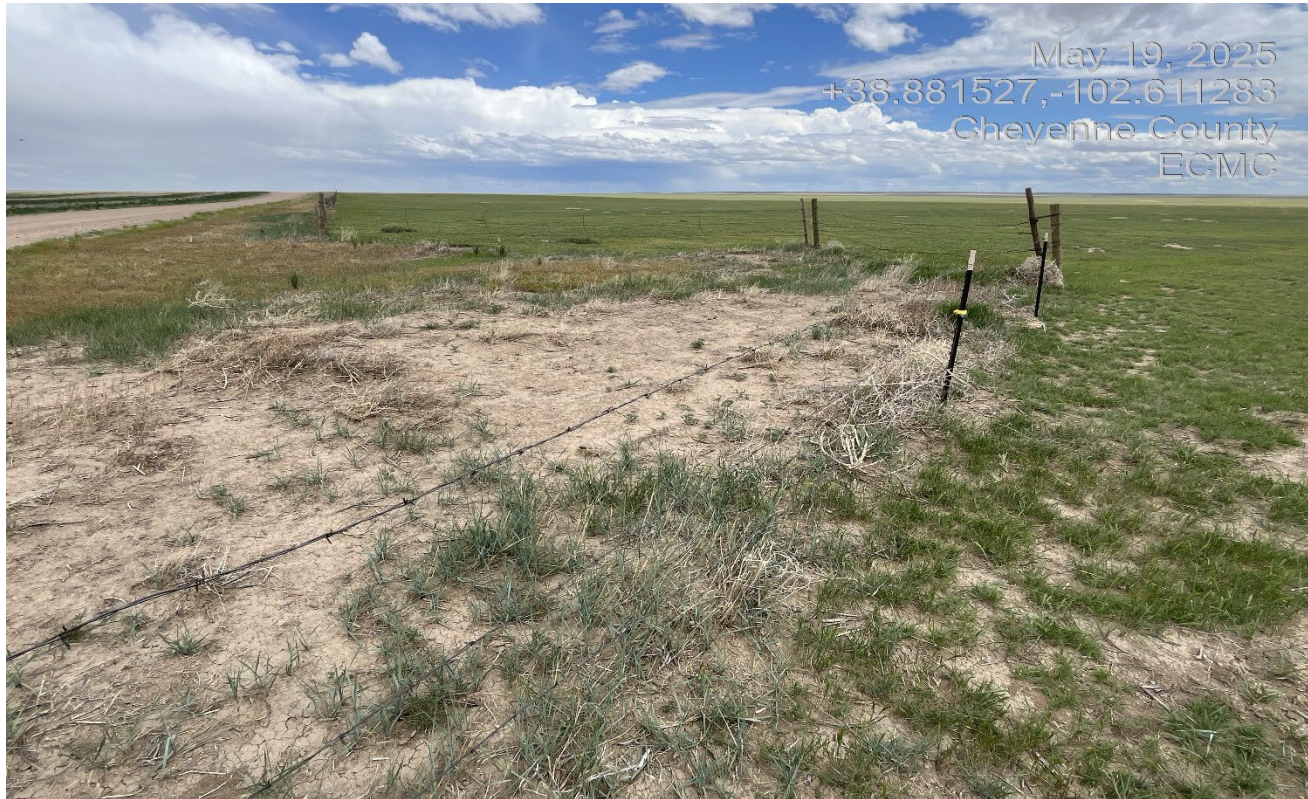
Photo 1. The fence at the entrance has not been installed back to the original position.

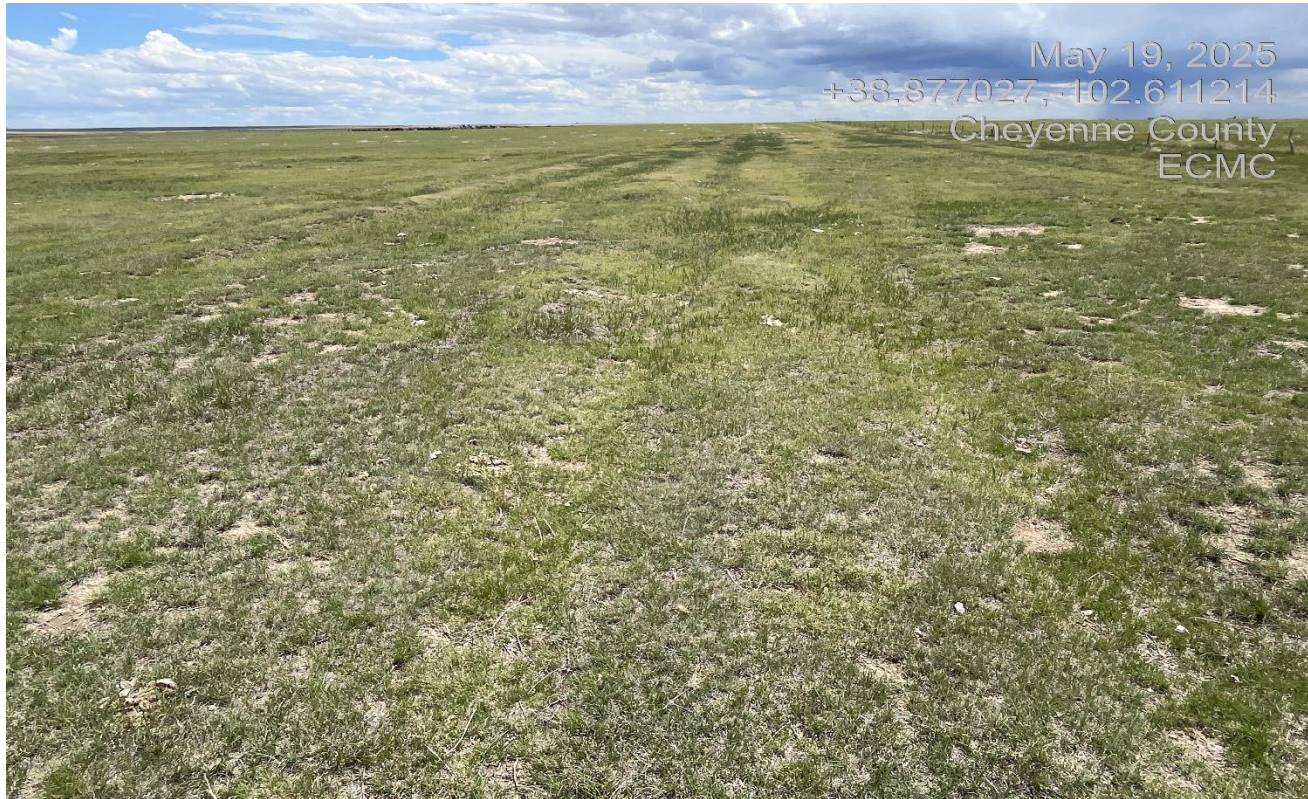
Photo 2. Facing south toward the former access road which has revegetated.

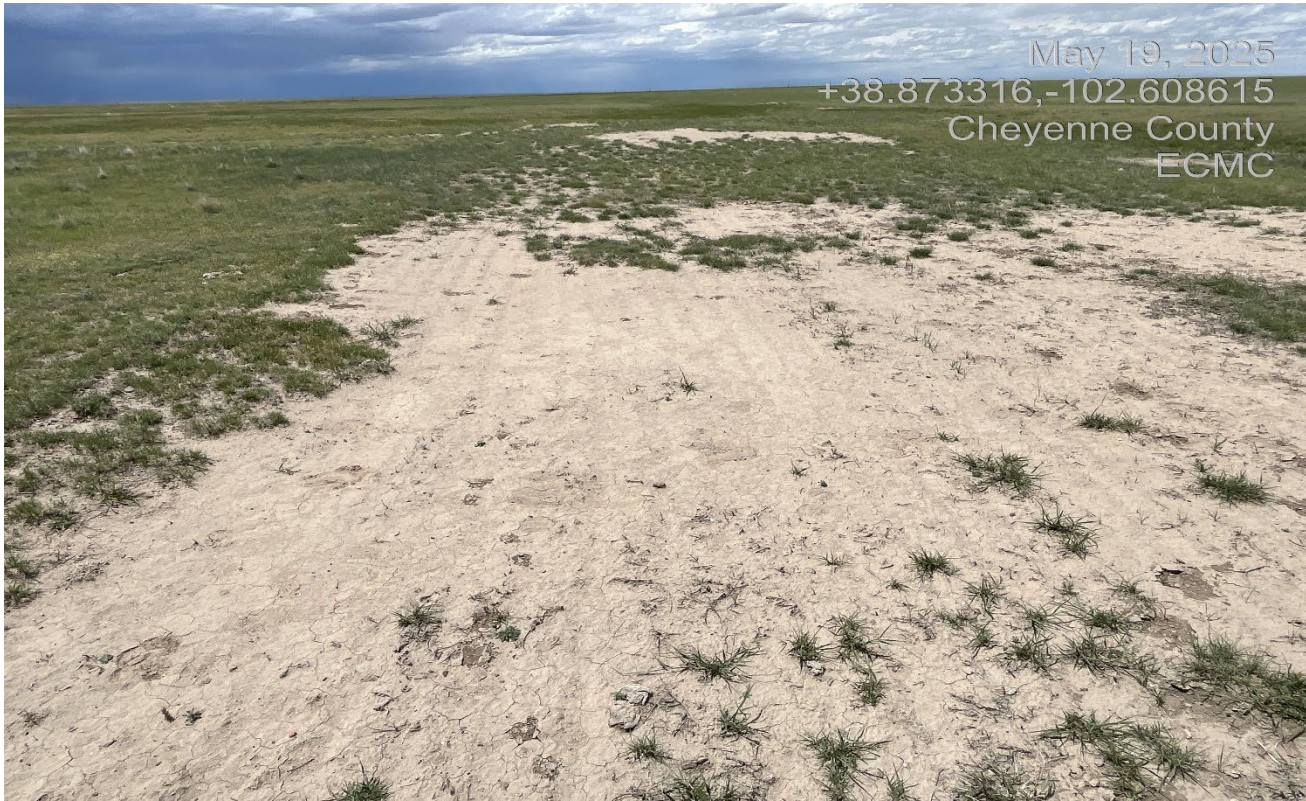
Photo 3. Facing east at the north side of the location. It appears this area was recently drill seeded due to visible drill rows. There was some germination observed.

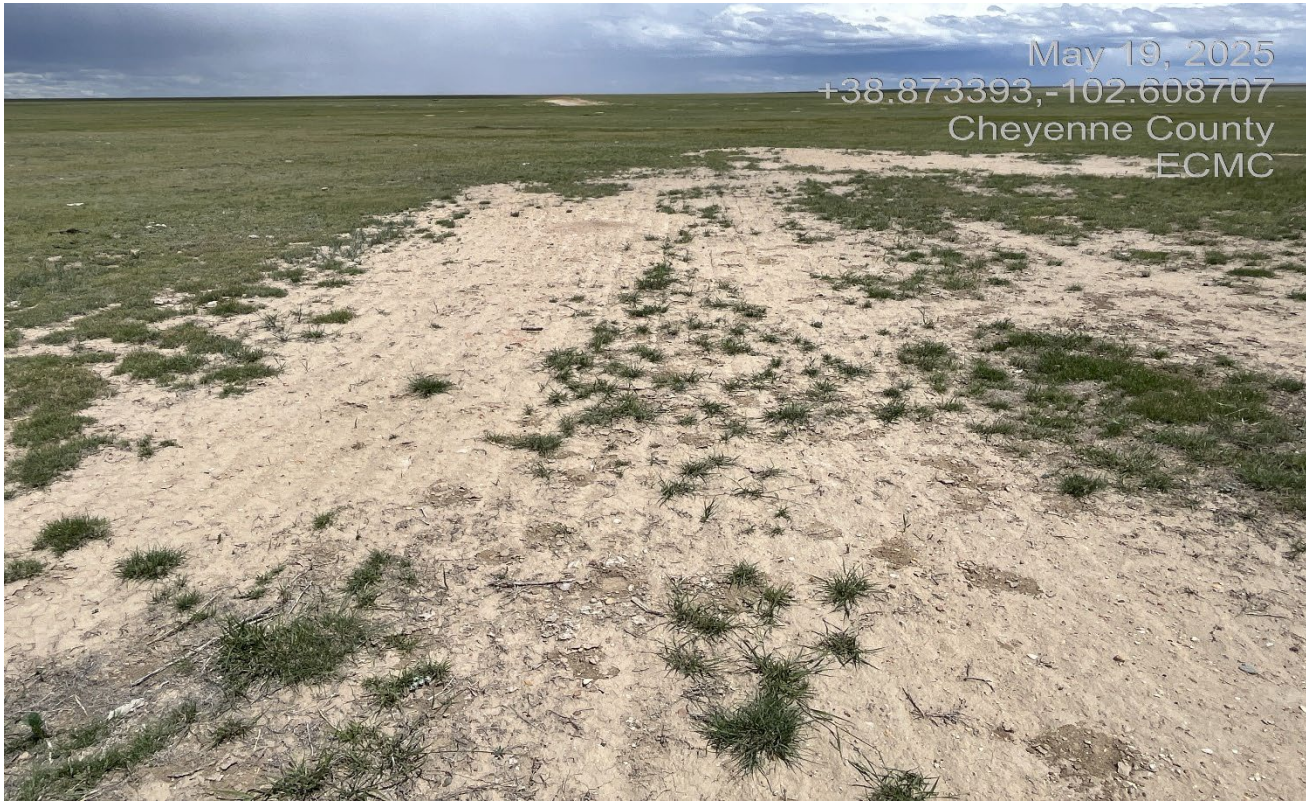
Photo 4. Facing east at the northeast side of the location. It appears this area was recently drill seeded due to visible drill rows. There was some germination observed.

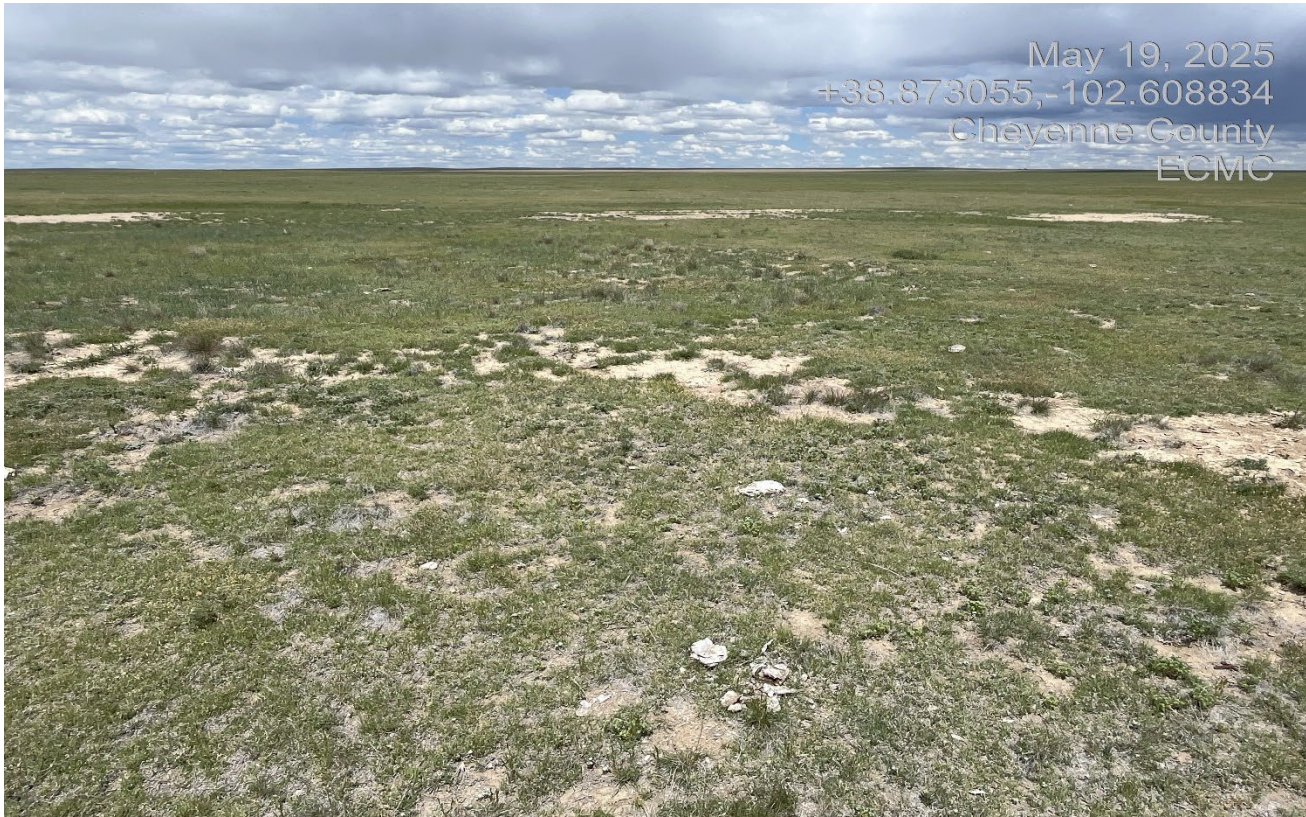
Photo 5. Center of the location facing north..

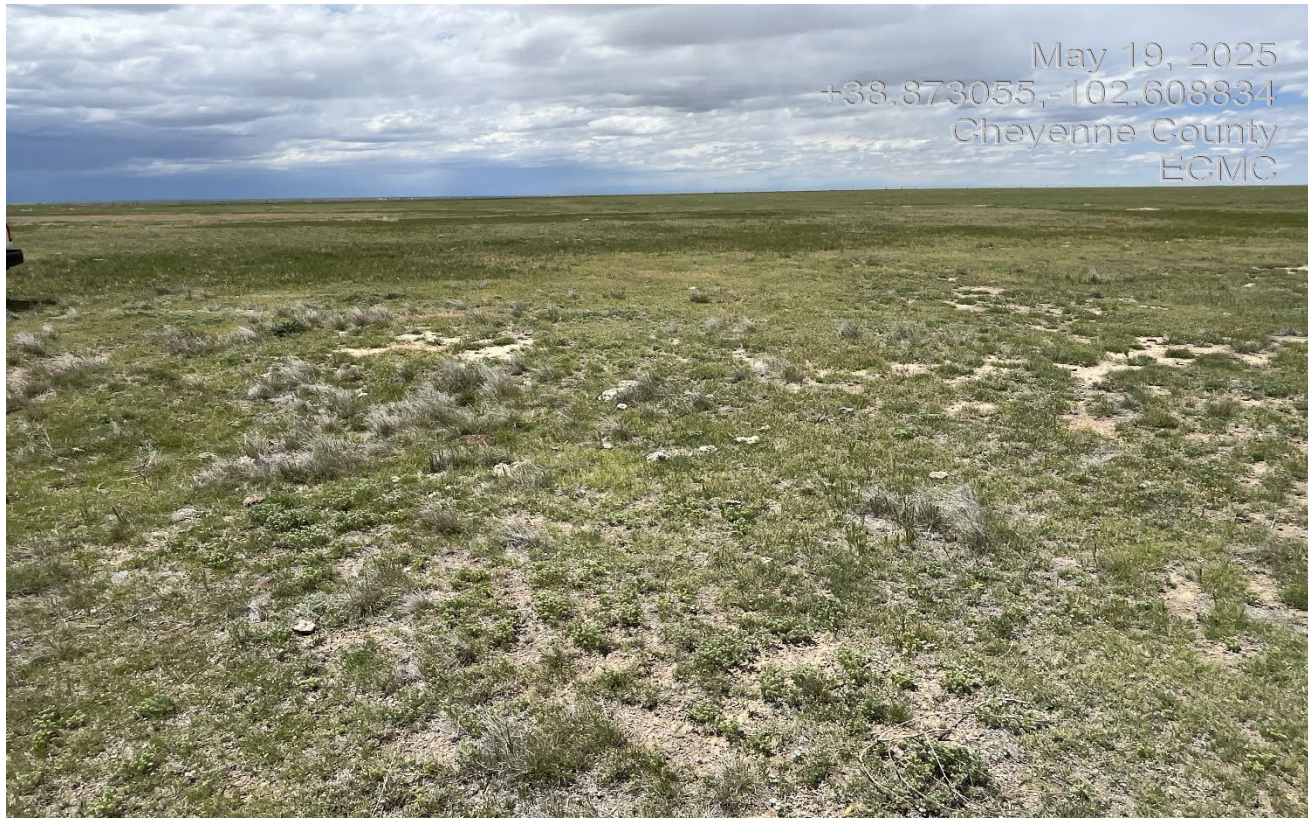
Photo 6. Center of the location facing south.
