ECMC  
Environmental  
Field Inspection

Miller 33-17J  
© 14-May-25 10:27:16 AM  
ECMC Environmental Inspection

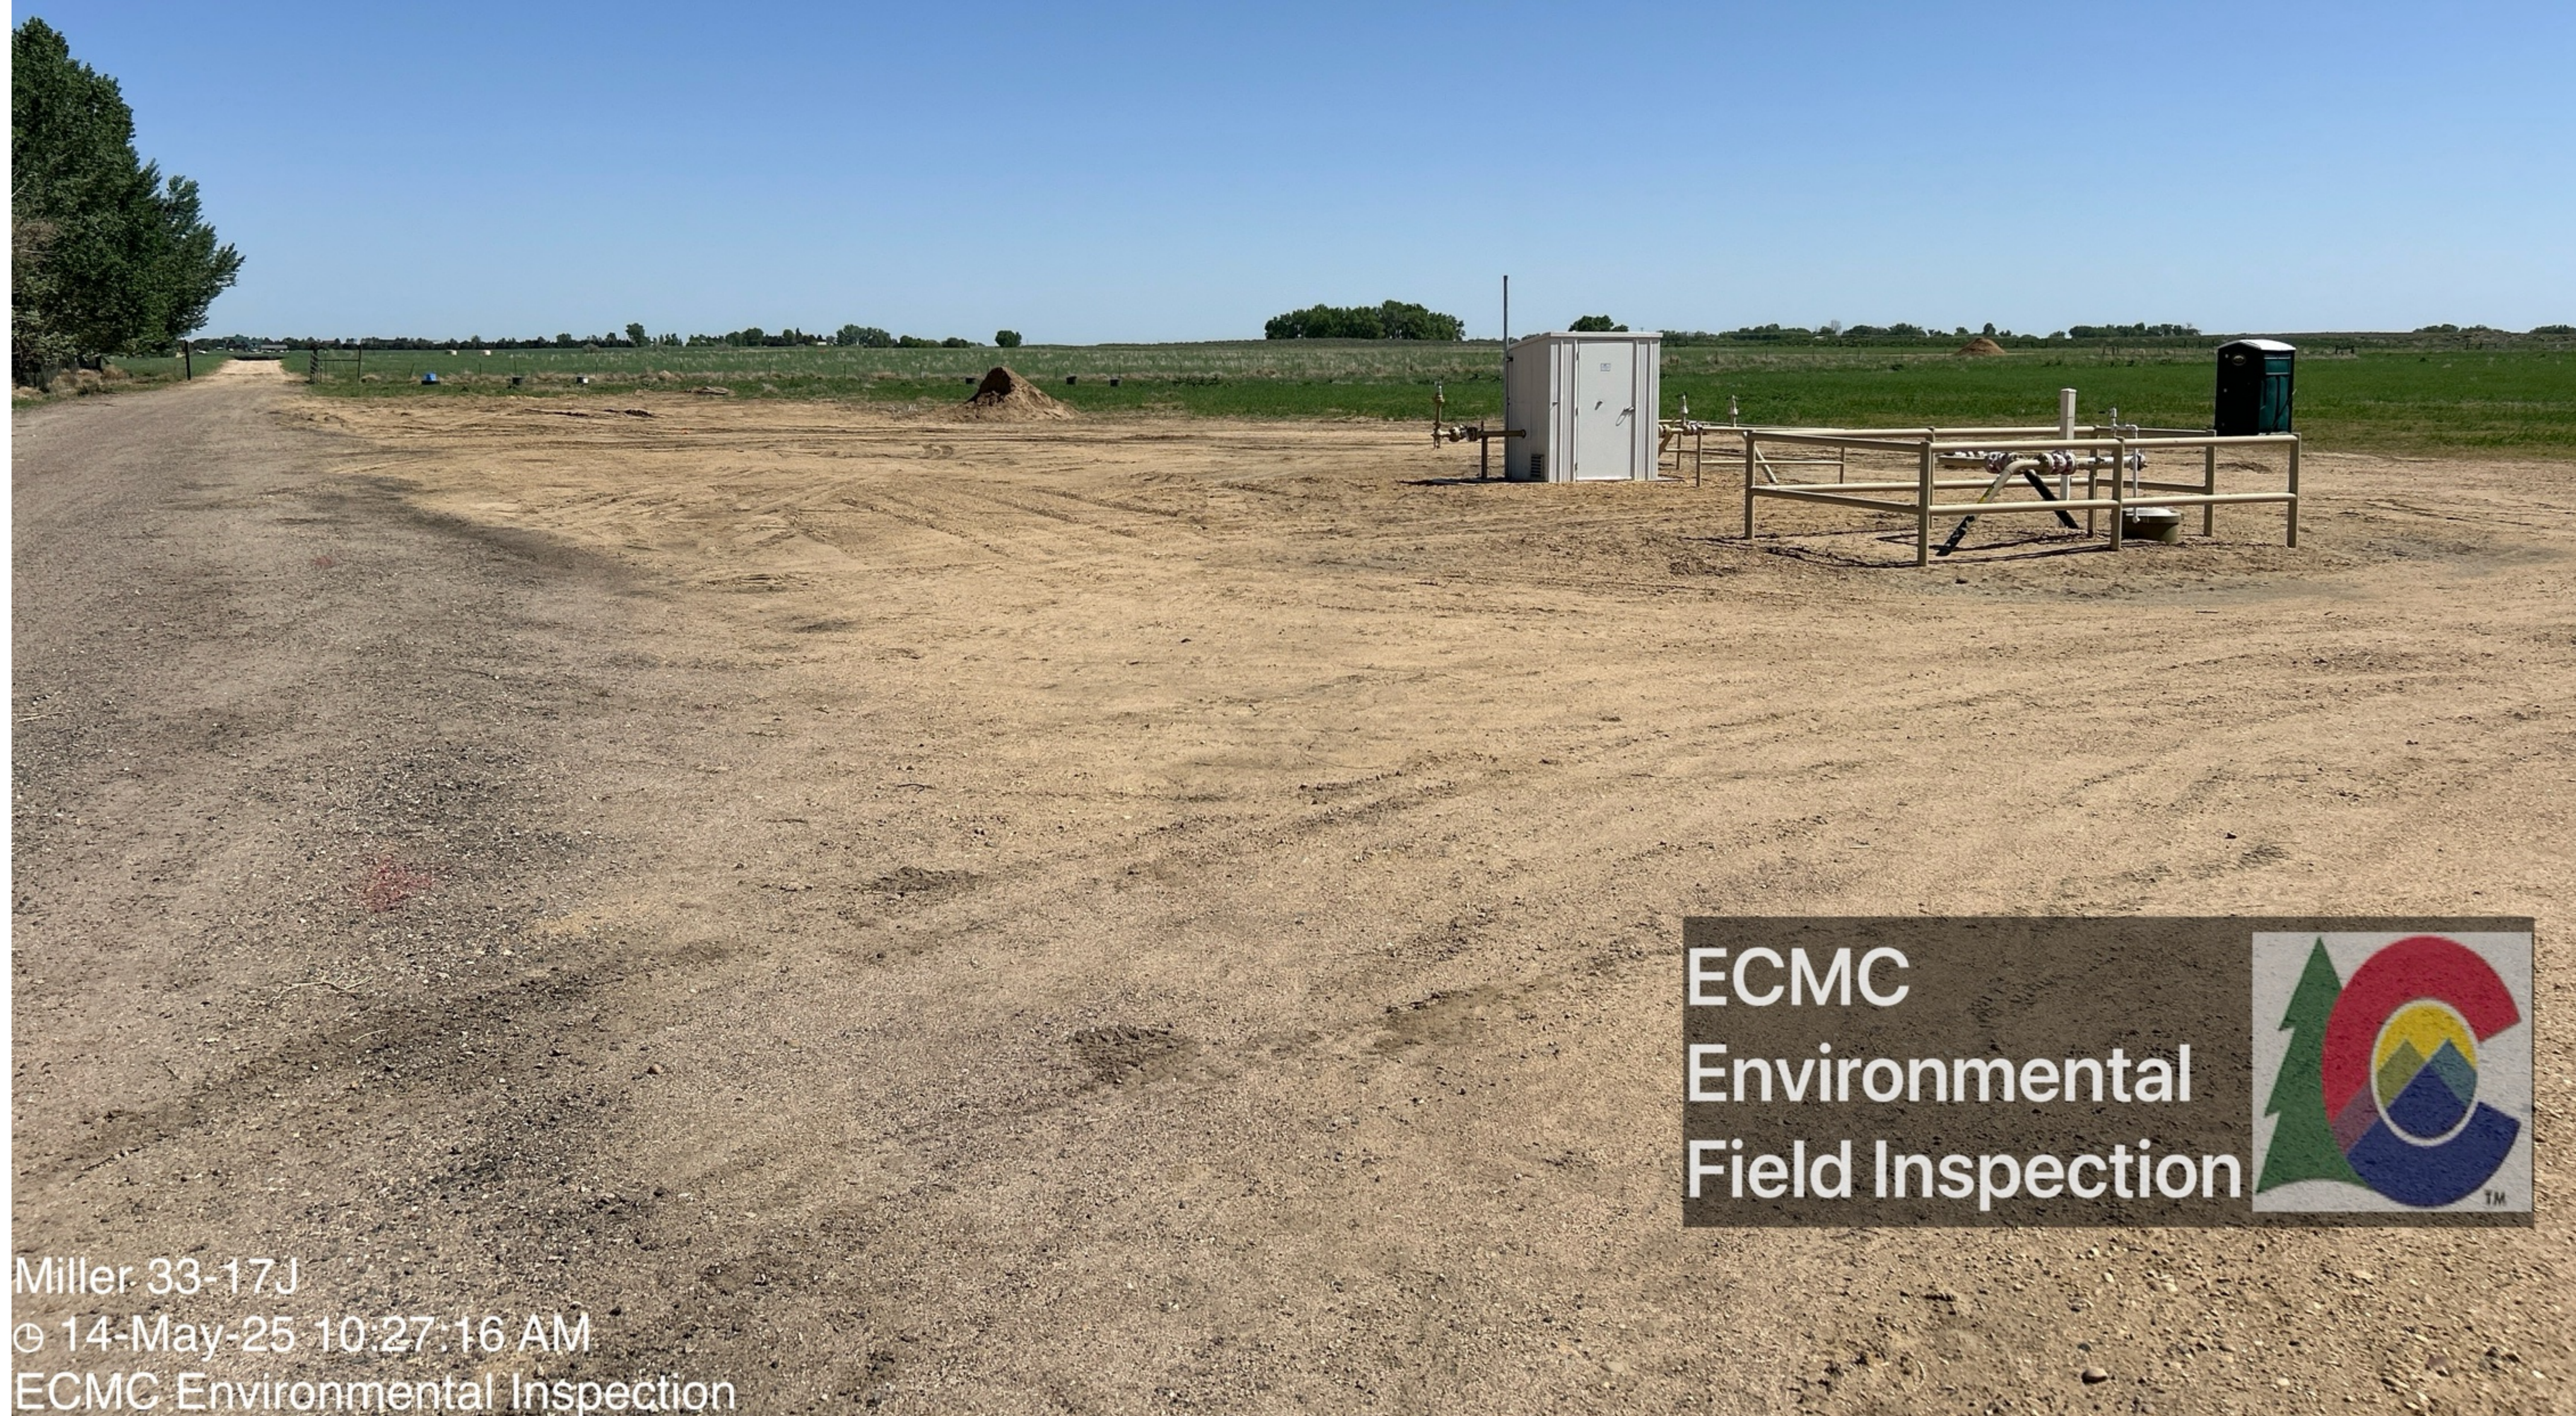
Former tank battery location. Meter house remains on location.

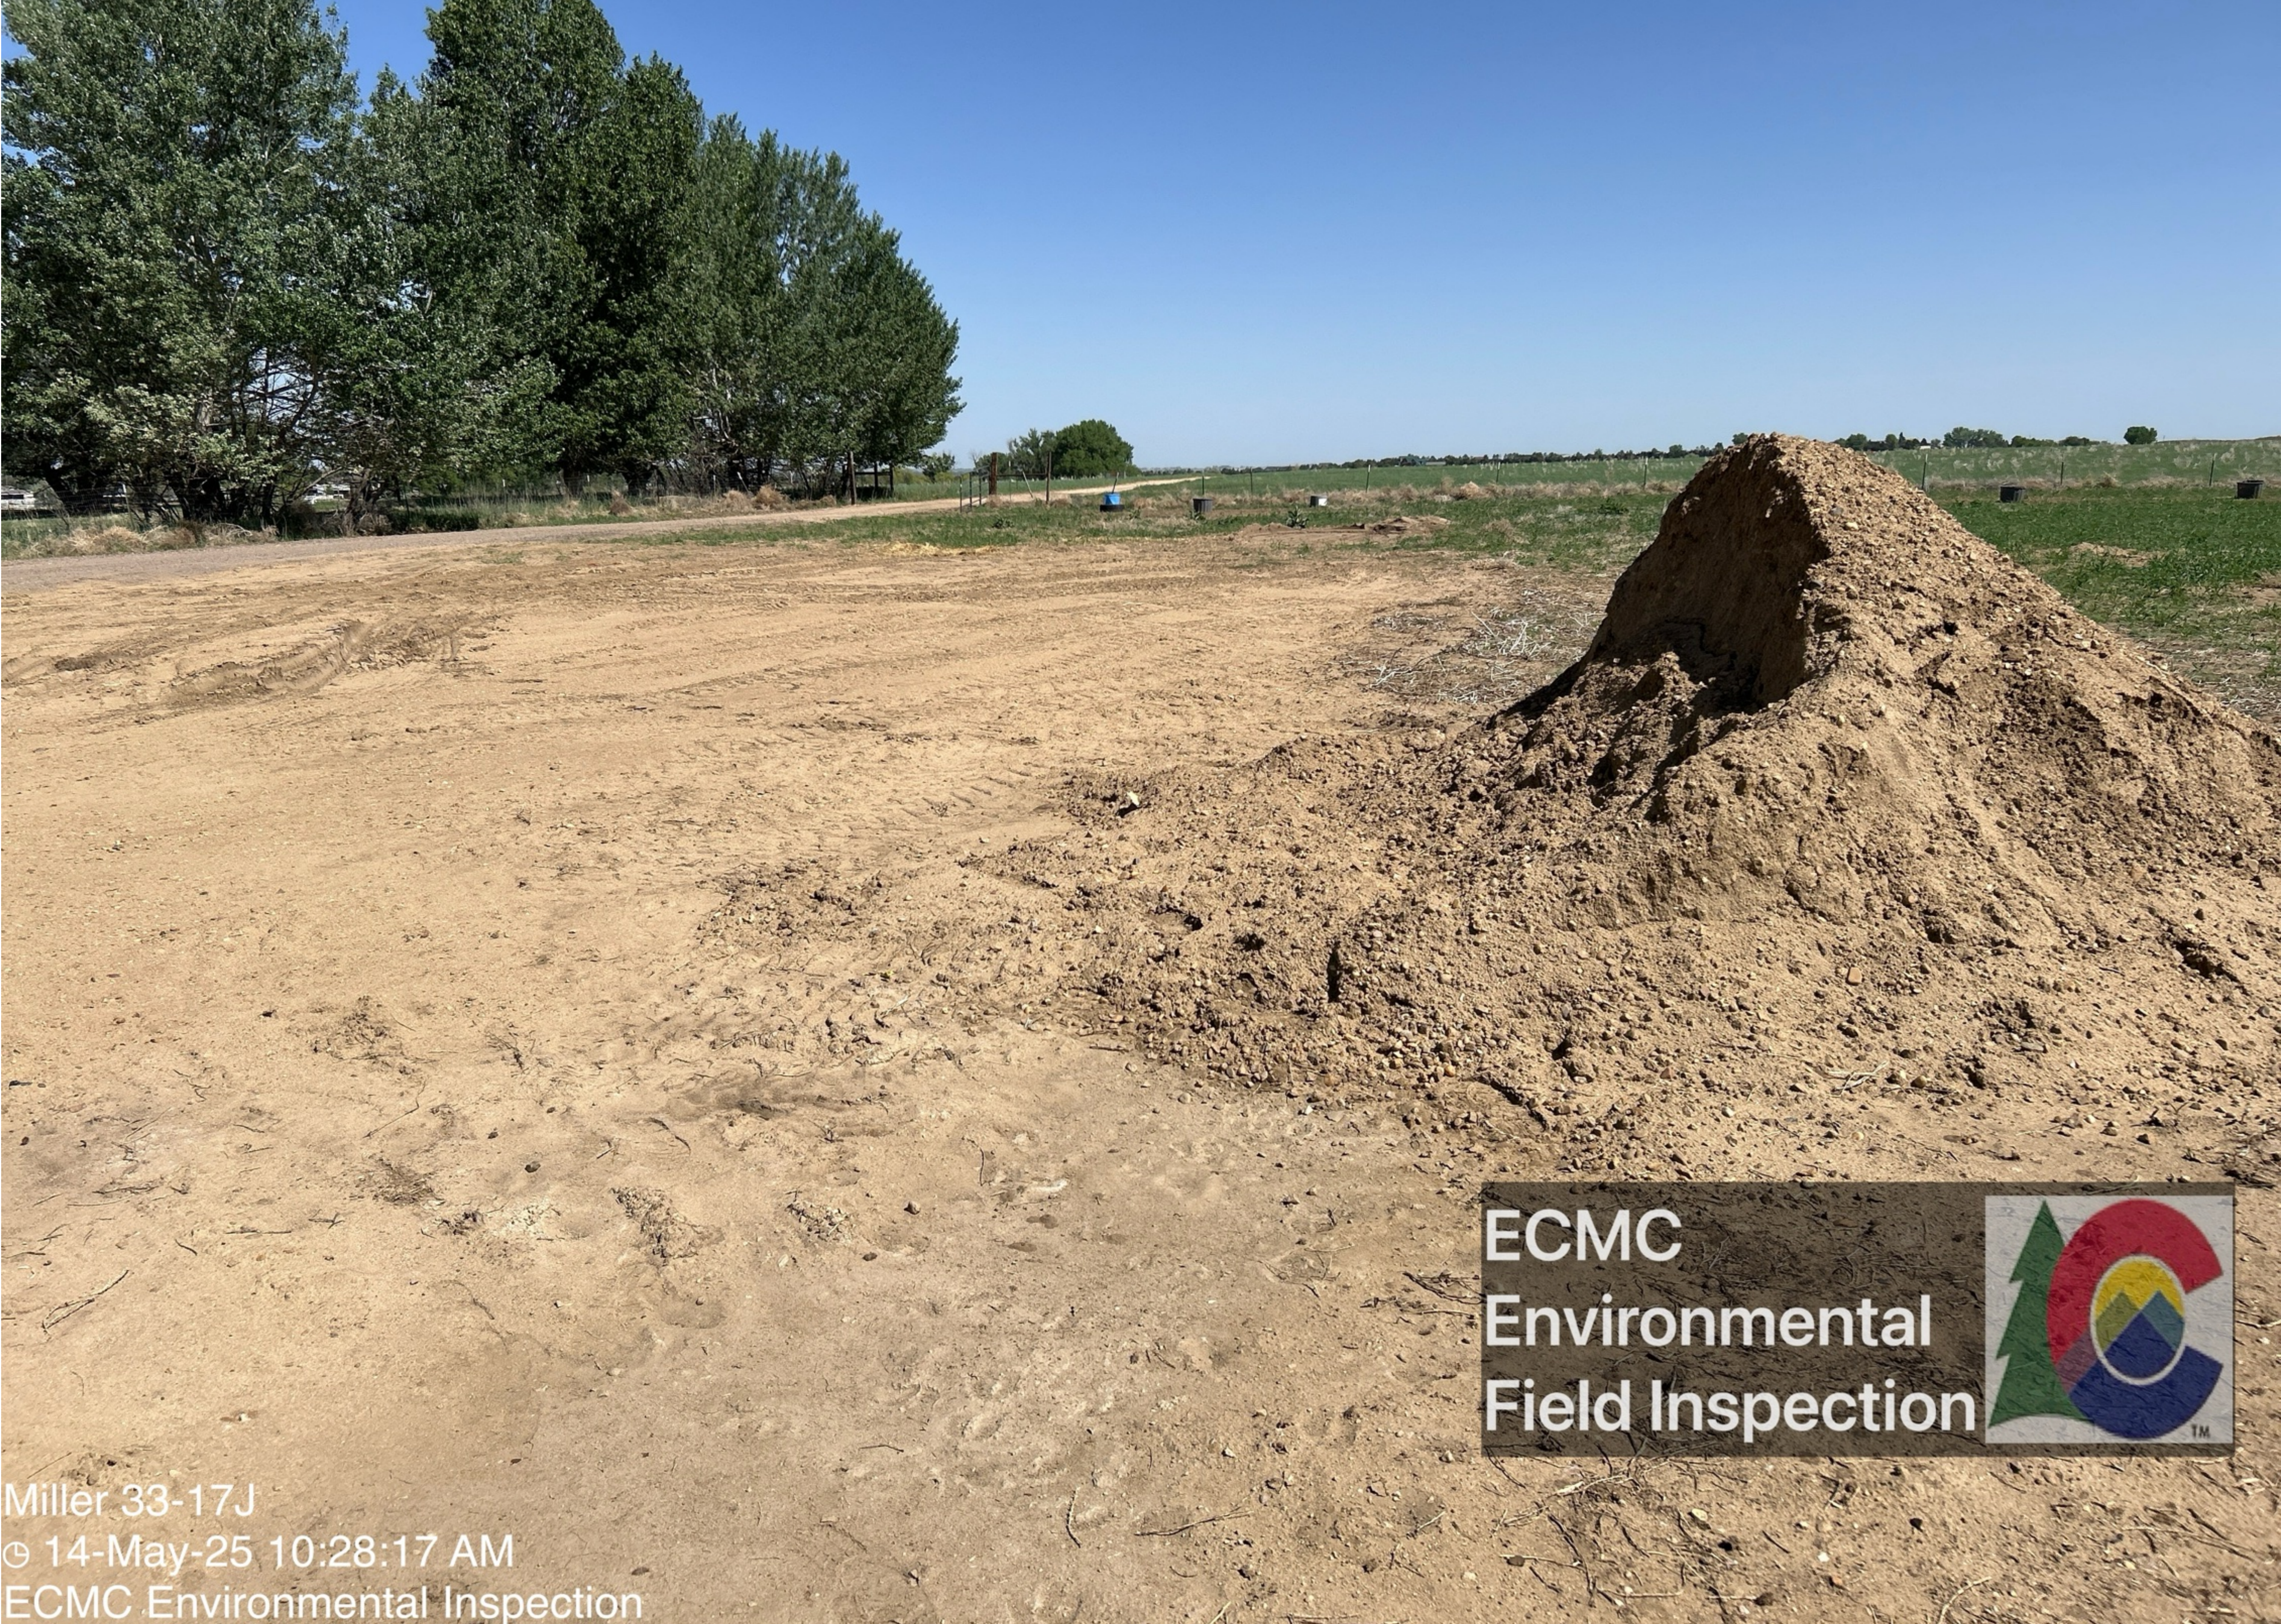
Unmarked soil stockpile was observed on location with no stormwater BMPs. No liner was visible.

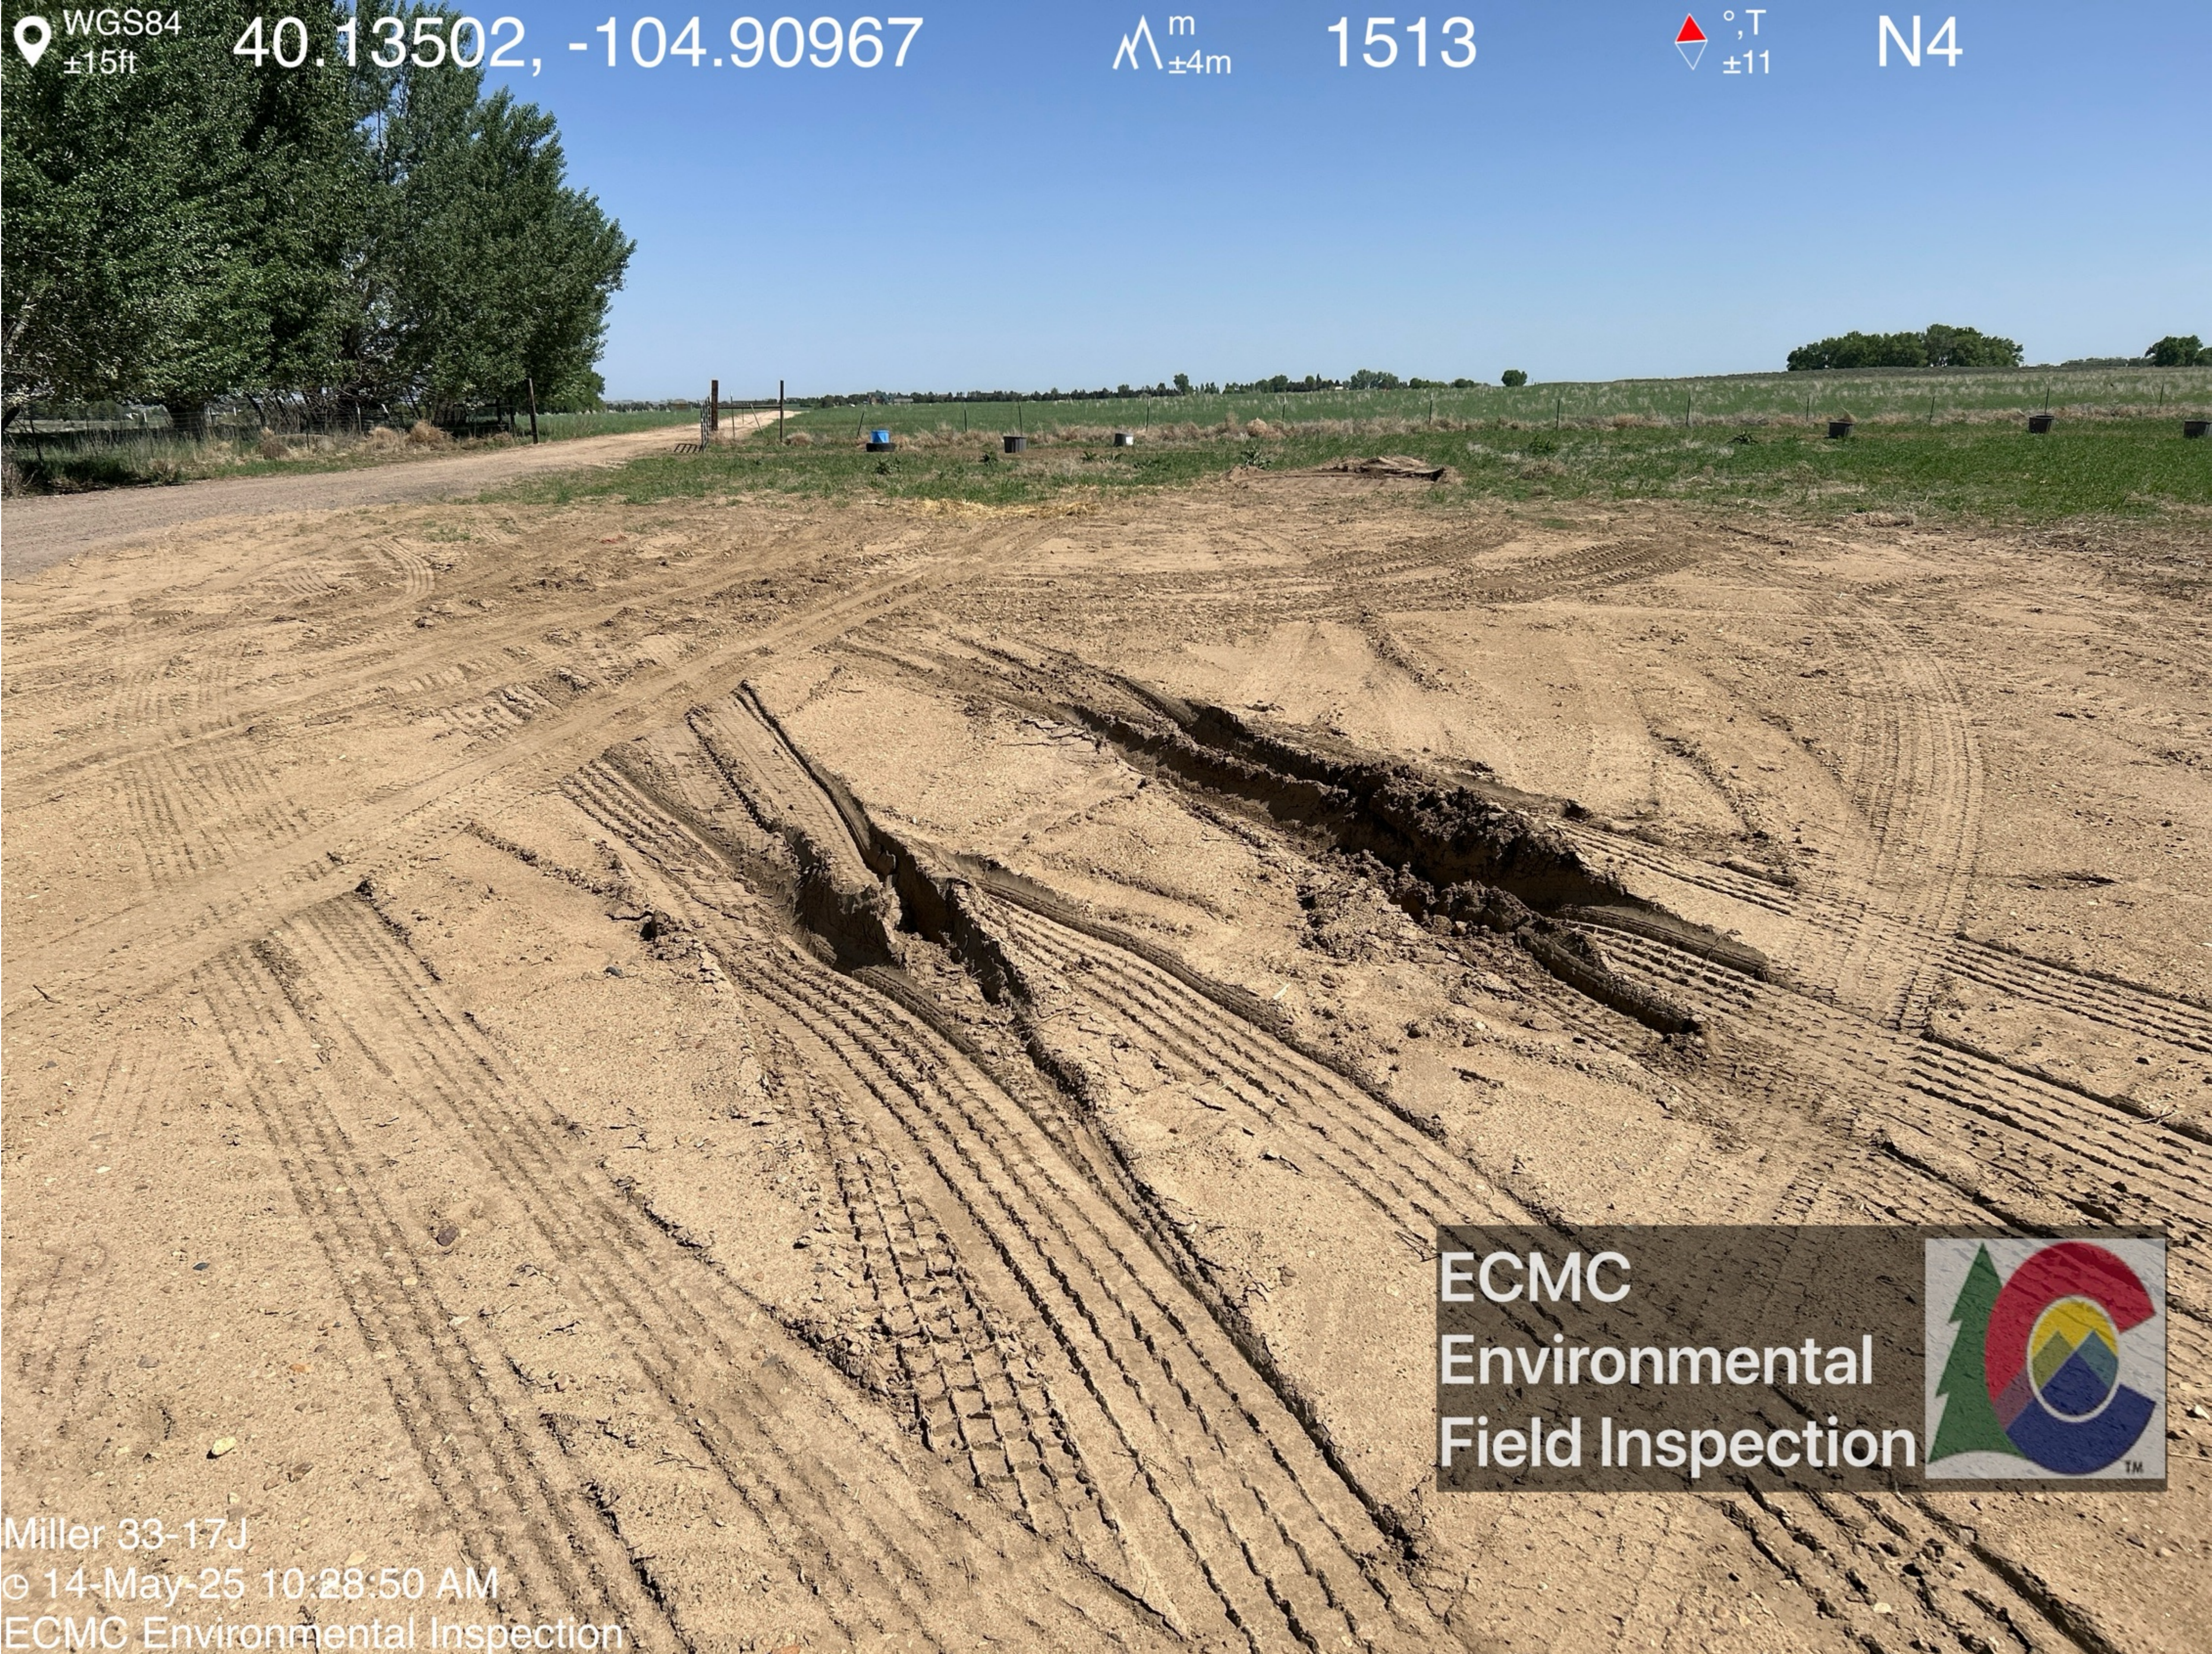
Ruts are visible at the approximate spill location. The produced water vessel excavation has been backfilled.
