# Inspection Photos

## 05/01/2025

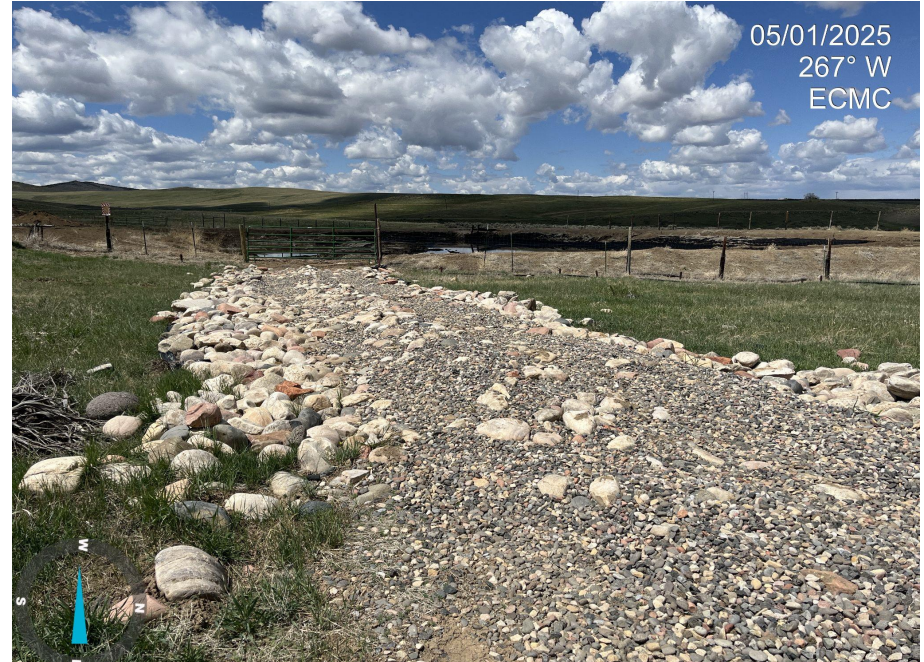
**Photo 4.** Photo taken from the east end of the pit facility outside of the fence, facing west. Photo illustrates track-out controls not installed per good engineering practices; BMP has been installed with small gravel material, rather than larger sized coarse aggregate. Repair/install tracking BMPs.

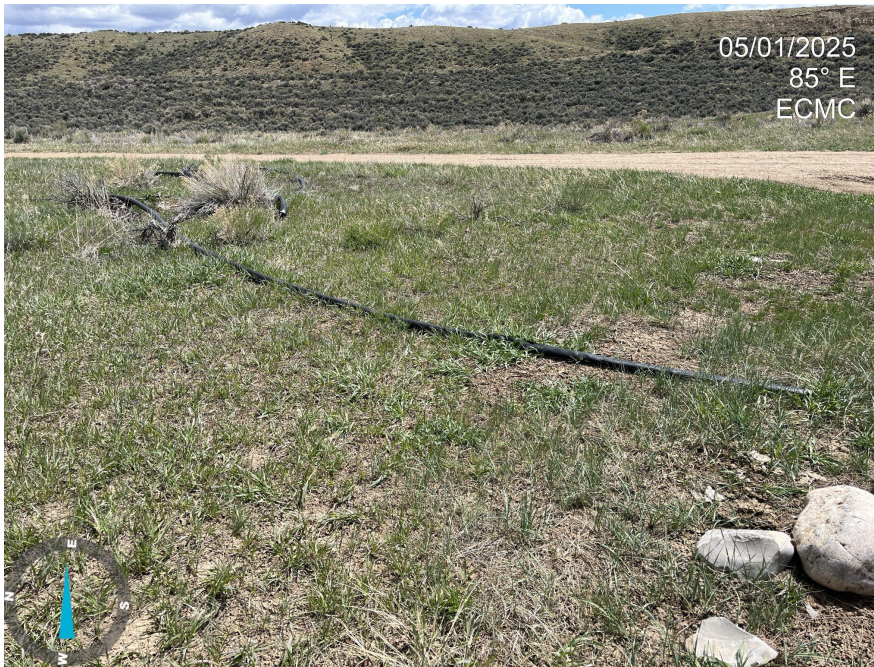
**Photo 5.** Photo taken from the east end of the pit facility outside of the fence, facing east. Photo illustrates an example of unused equipment/ trash.

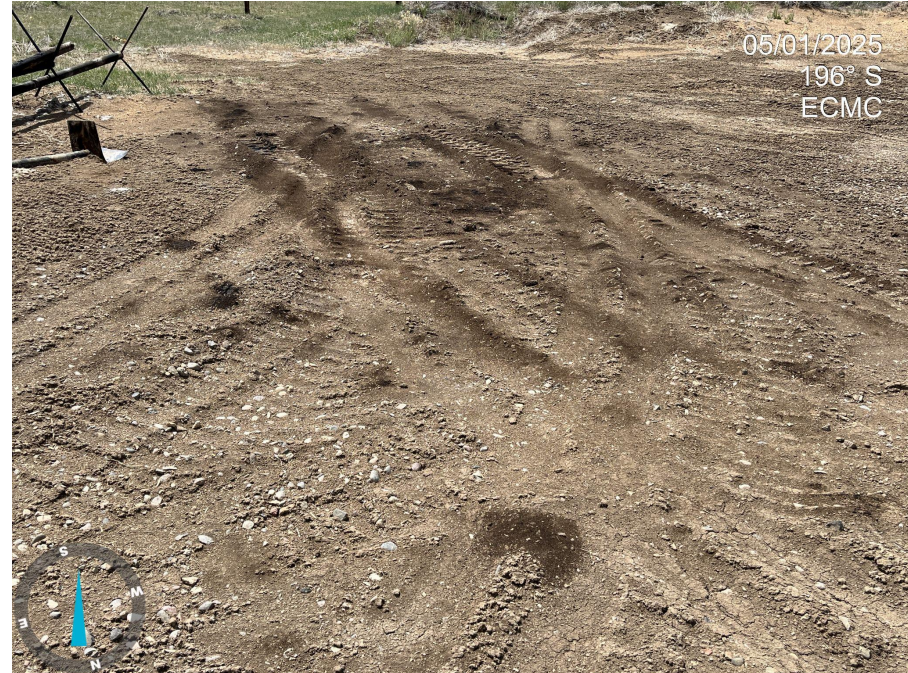
**Photo 14.** Photo taken from the south end of the pit facility, facing south. Photo example showing stained/impacted soils observed throughout areas of the pit facility.

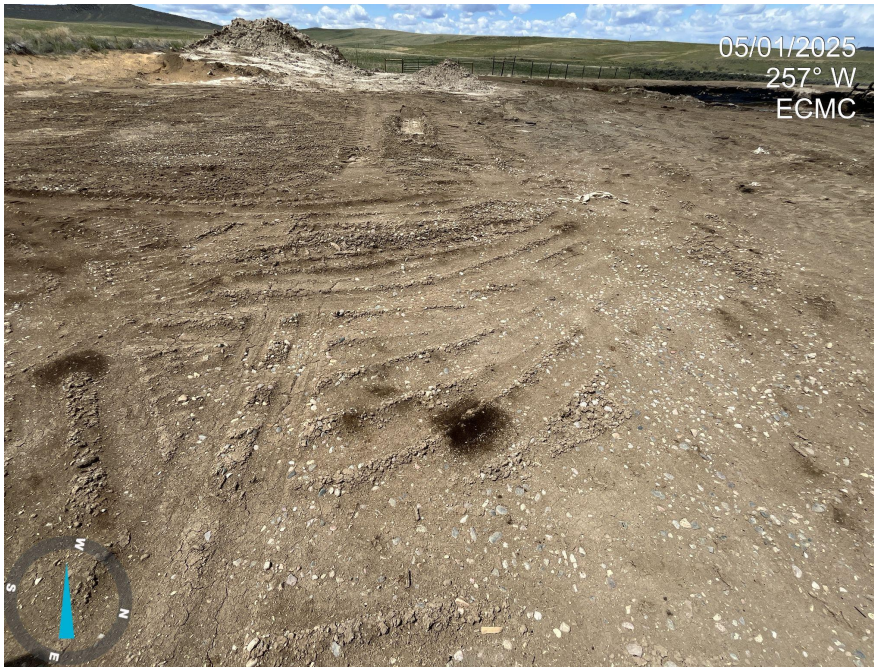
**Photo 15.** Photo taken from the south end of the pit facility, facing west. Photo example showing stained/impacted soils observed throughout areas of the pit facility.

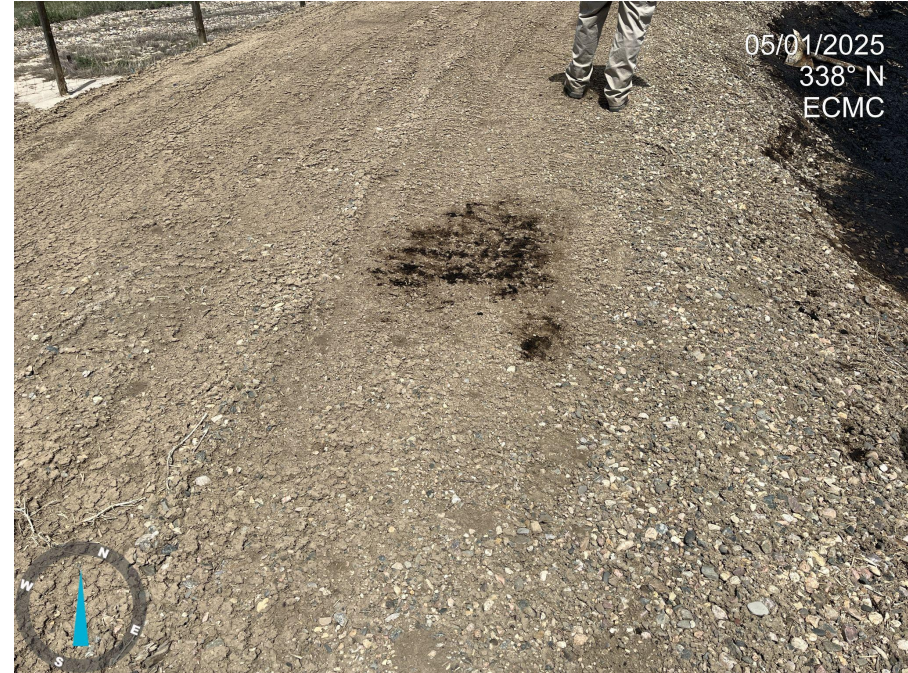
**Photo 16.** Photo taken from the west end of the pit facility, facing north. Photo example showing stained/impacted soils observed throughout areas of the pit facility.

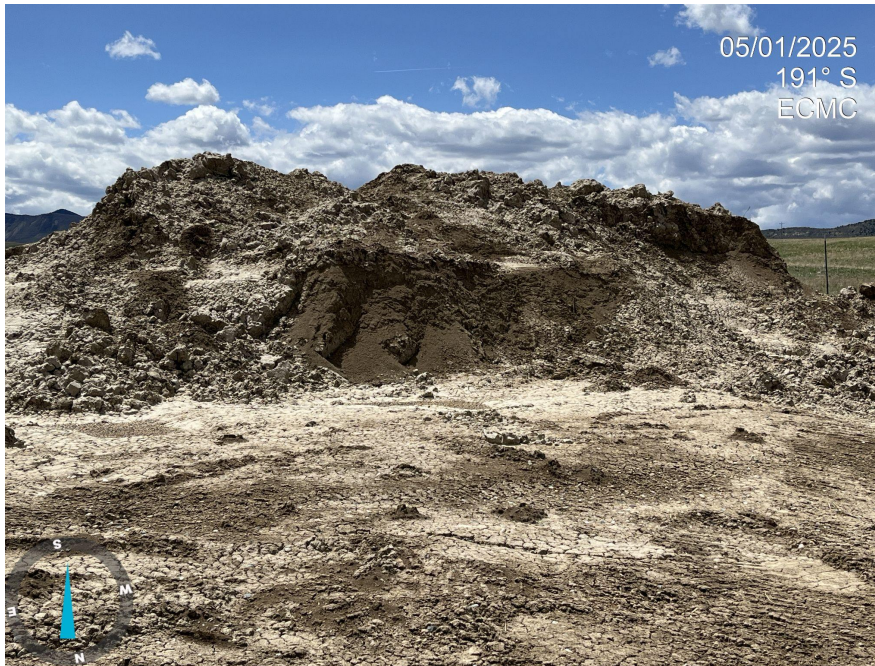
**Photo 17.** Photo taken from the south end of the pit facility, facing south. Photo illustrates stockpile soils. BMPs to protect the stockpile pursuant to Rule 1002.c are missing or insufficient.

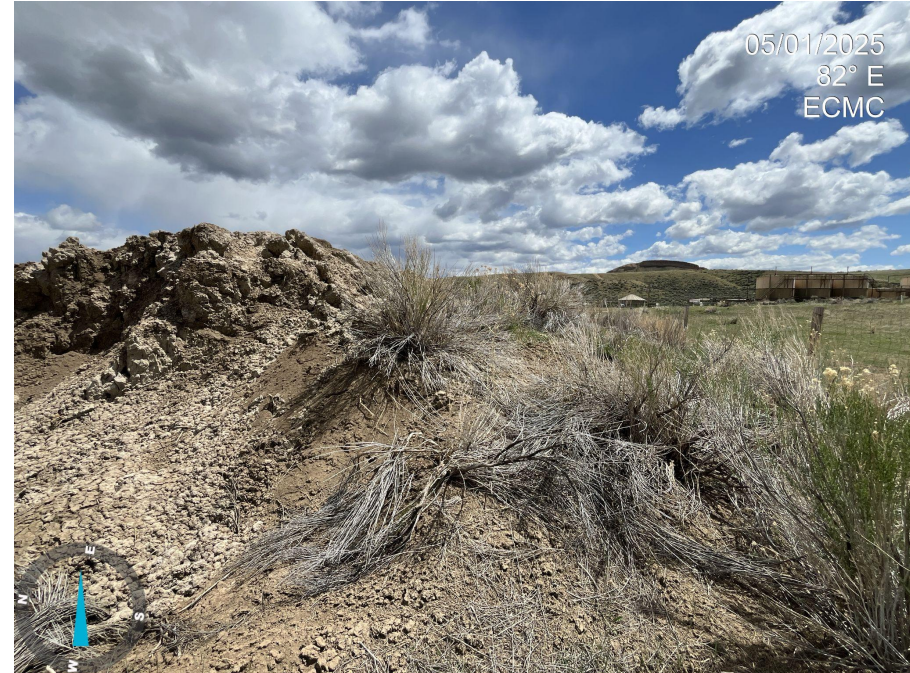
**Photo 18.** Photo taken from the south end of the pit facility, facing south. Photo illustrates stockpile soils. It appears this was previously topsoil based on vegetation growth on backside, but has since been partially removed and/or contaminated. BMPs to protect the stockpile pursuant to Rule 1002.c are missing or insufficient.

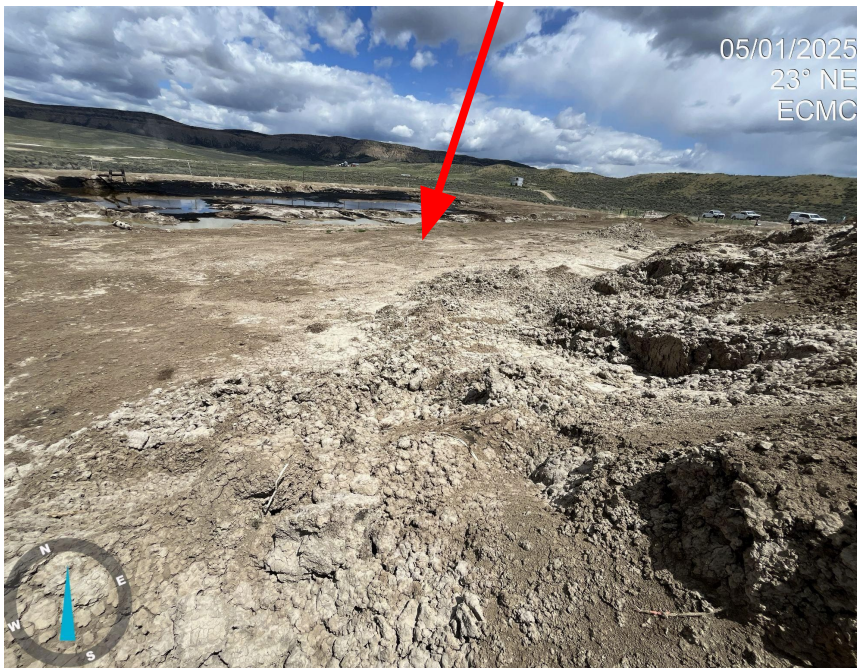
**Photo 19.** Photo taken from the south end of the pit facility, facing northeast. Photo shows erosion degradation at the pit facility and topsoil stockpile due to stormwater runoff; BMPs to minimize erosion, degradation and sediment transport are missing or insufficient.

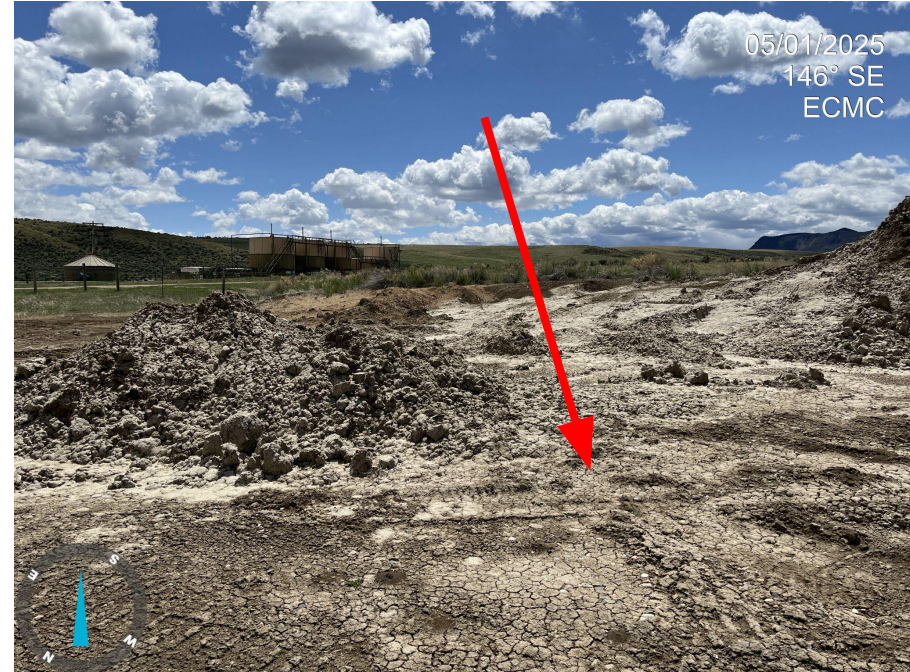
**Photo 20.** Photo taken from the south end of the pit facility, facing southeast. Photo shows erosion degradation at the pit facility and topsoil stockpile due to stormwater runoff; BMPs to minimize erosion, degradation and sediment transport are missing or insufficient.

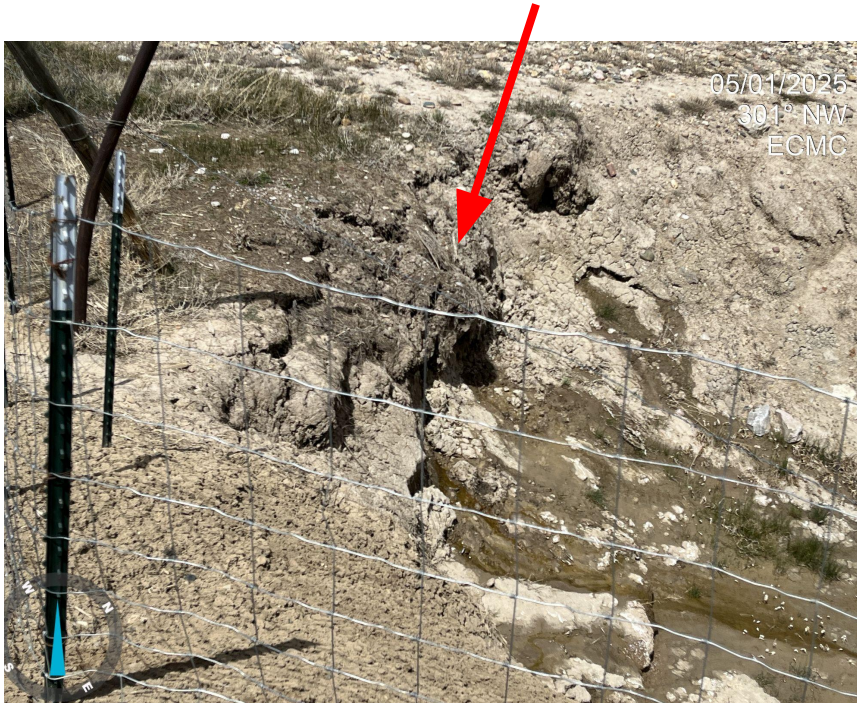
**Photo 21.** Photo taken from the north end of the pit facility, facing northwest. Photo illustrates seeping gulch and area surrounding sediment trap. Bank and gully erosion evident along gulch banks (red arrow demonstrates erosion).

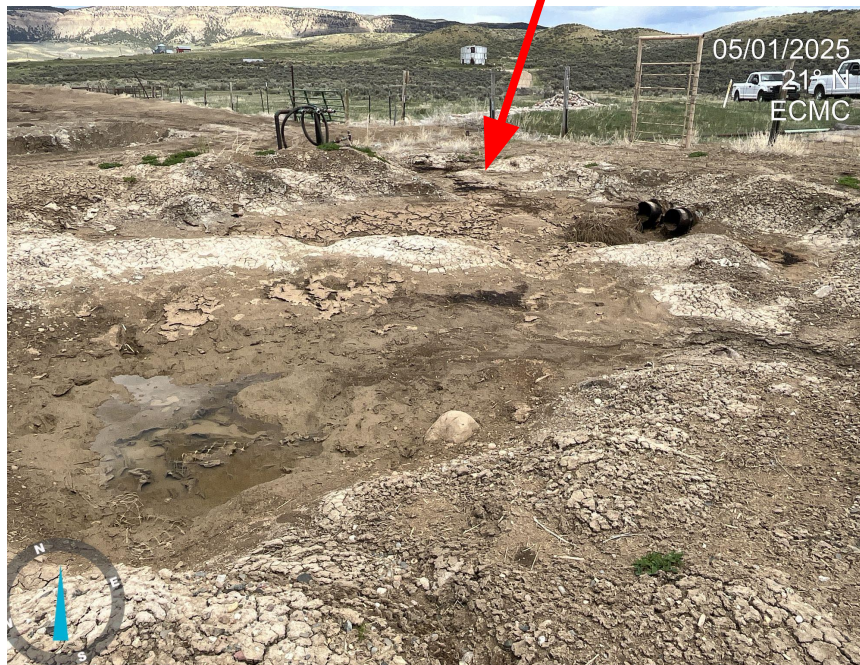
**Photo 26.** Photo taken from the south end of the pit facility, facing north. Impacted materials were also observed within areas of the pit and stormwater pathways, indicating impact stormwater is discharging from the Location (red arrow indicates where berm has eroded).

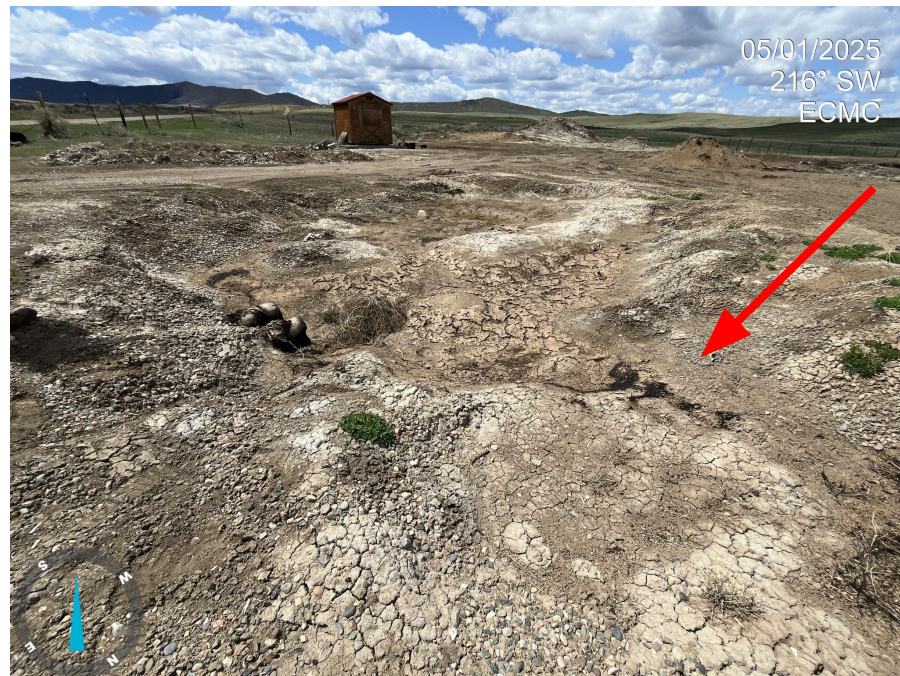
**Photo 27.** Photo taken from the south end of the pit facility, facing north. Photo illustrates impacted materials were also observed within areas of the pit and stormwater pathways, indicating impact stormwater is discharging from the Location (red arrow indicates where berm has eroded).

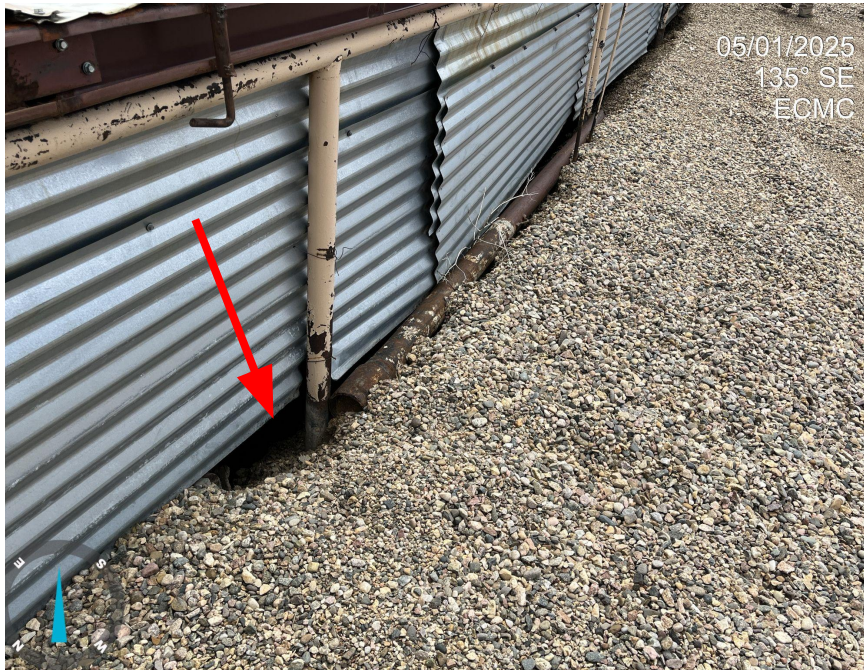
**Photo 34.** Photo taken from northern portion of Tank Battery facility, facing southeast. Photos examples showing gaps observed along the perimeter of the containment and pit; BMP has not been maintained in a manner that prevents wildlife access to the pit and facility.

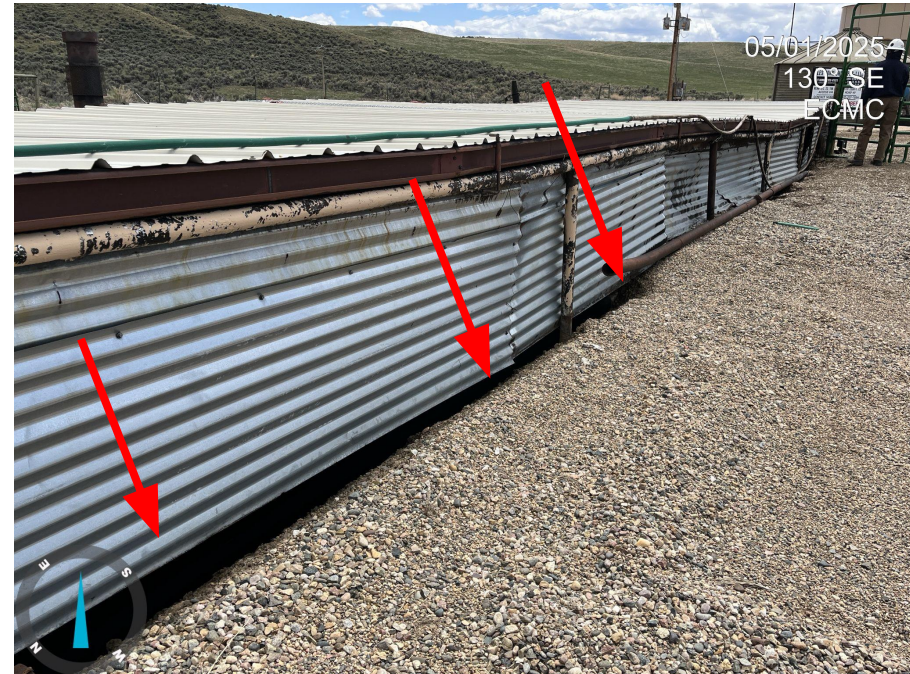
**Photo 35.** Photo taken from northern portion of Tank Battery facility, facing southeast. Photos examples showing gaps observed along the perimeter of the containment and pit; BMP has not been maintained in a manner that prevents wildlife access to the pit and facility.

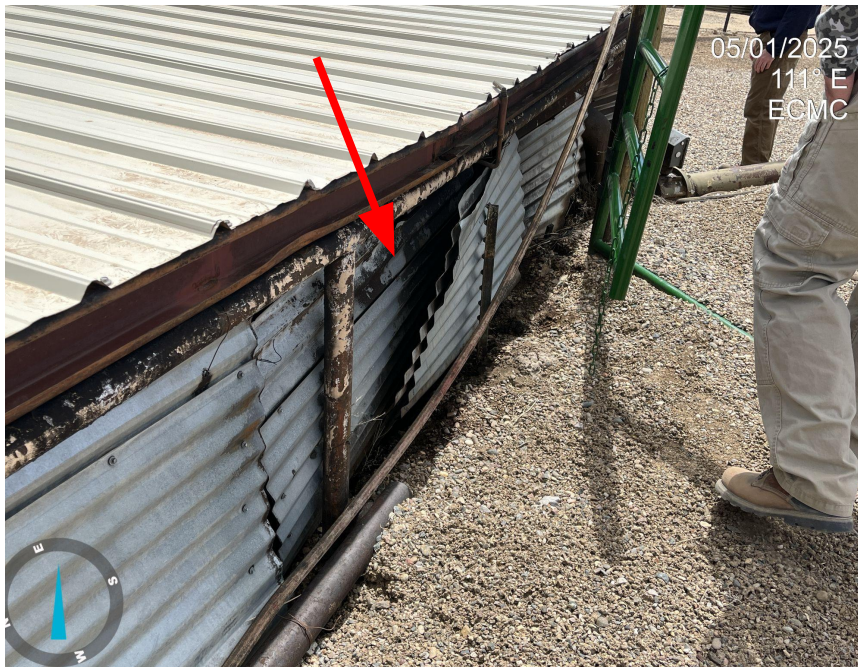
**Photo 36.** Photo taken from northern portion of Tank Battery facility, facing east. Photo shows paneling surrounding pit not maintained. Repair secondary containment.

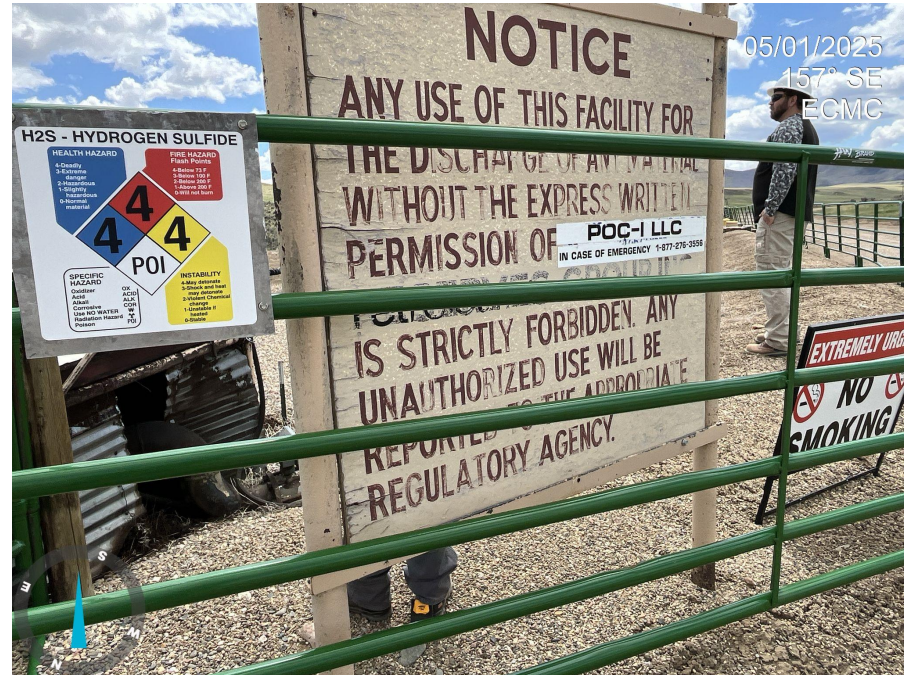
**Photo 37.** Photo taken from entrance of Tank Battery facility, facing southeast. Photo illustrates signage.

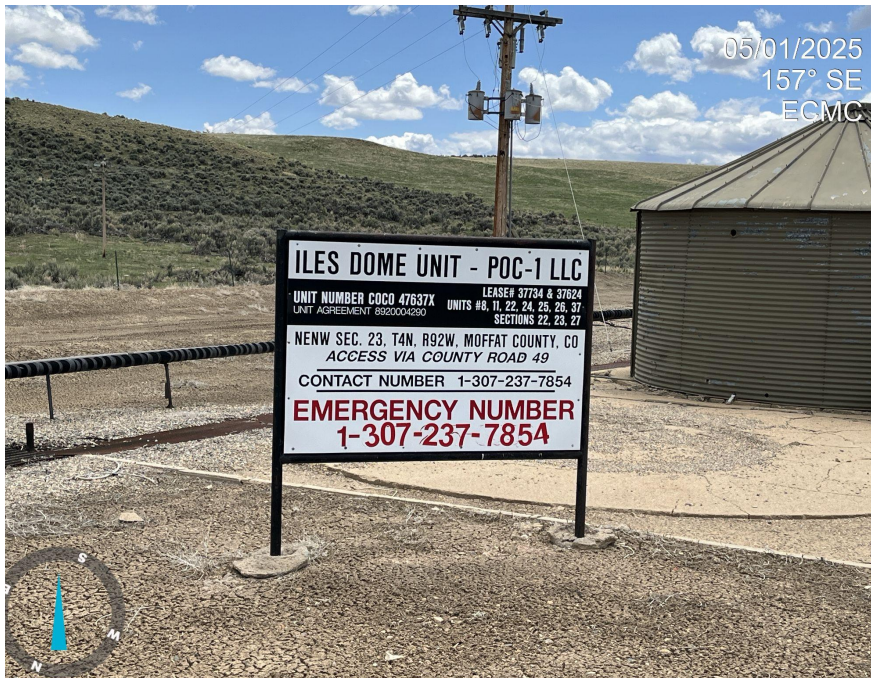
**Photo 38.** Photo taken from Tank Battery facility, facing southeast. Photo illustrates signage is missing wells, API numbers, and permit number.

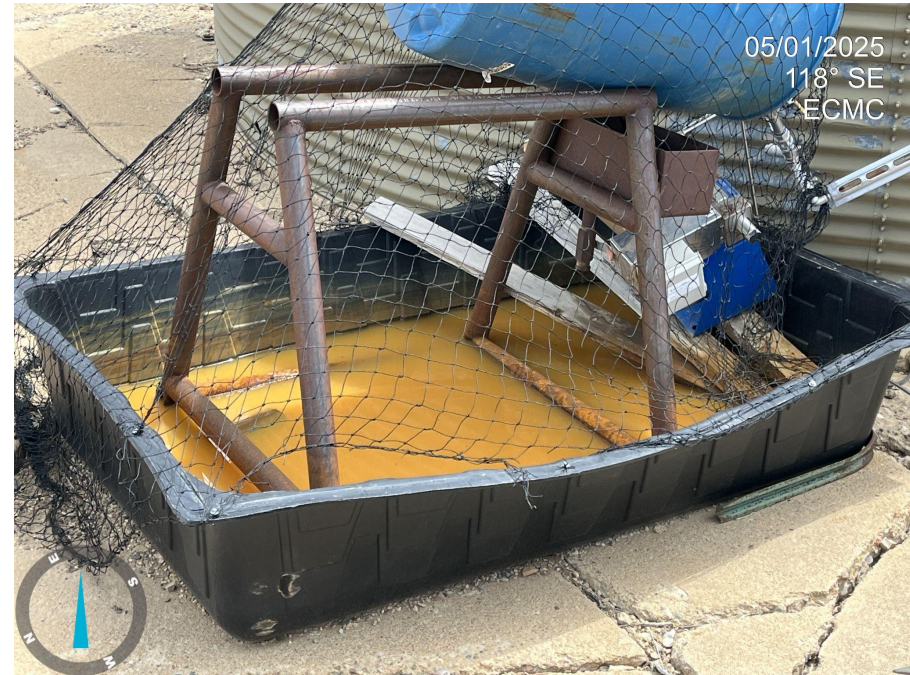
**Photo 39.** Photo taken at Tank Battery facility, facing southeast. Photo shows tank in secondary containment with fluids and inadequate wildlife protection BMPs. Fluids require removal and proper disposal; wildlife protection BMPs require maintenance to prevent wildlife access to the containment measure.

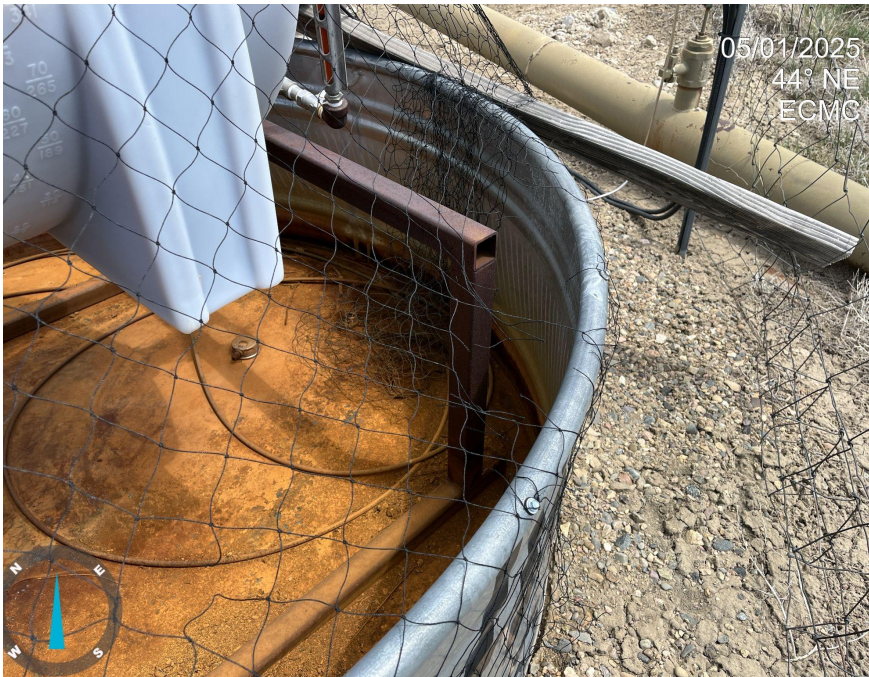
**Photo 40.** Photo taken at Tank Battery facility, facing northeast. Photo shows tank in secondary containment with inadequate wildlife protection BMPs.

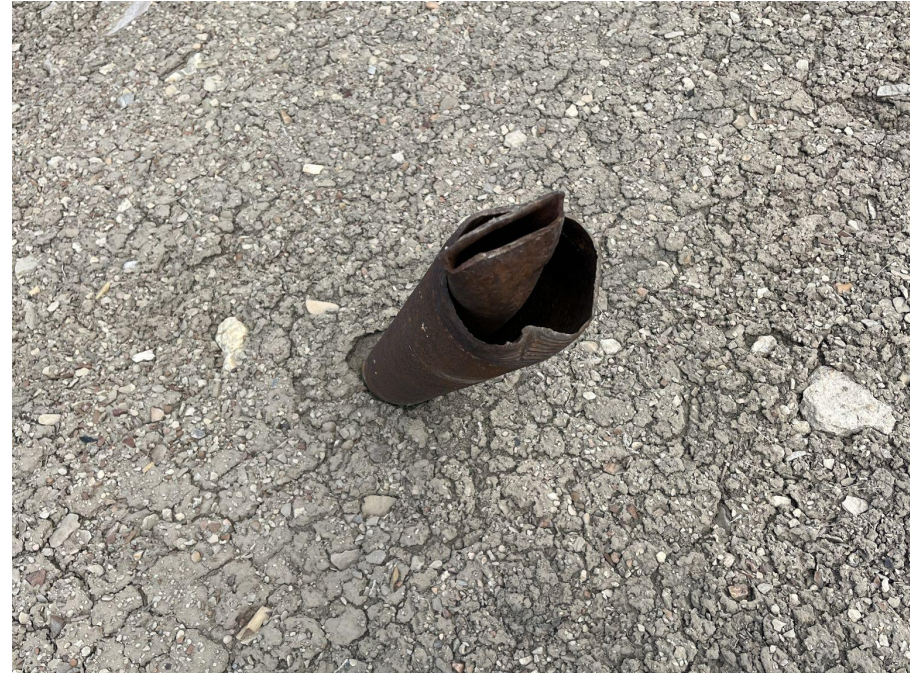
**Photo 41.** Photo taken at Tank Battery facility, facing north. Photo shows unused pipe equipment with inadequate wildlife protection BMPs.

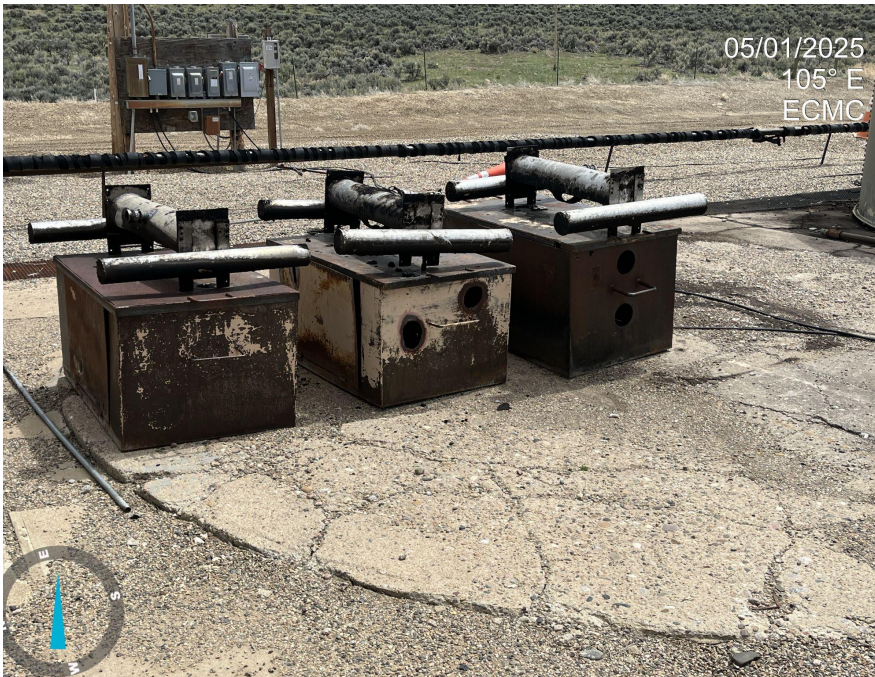
**Photo 42.** Photo taken from Tank Battery facility, facing east. Photo illustrates examples of unused equipment.

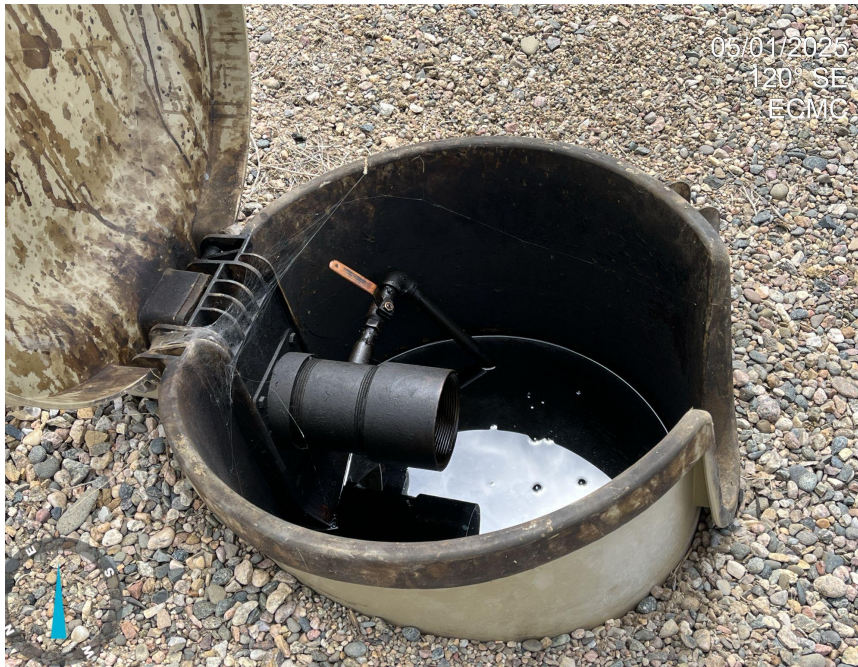
**Photo 44.** Photo taken from Tank Battery facility, facing southeast. Photo example showing fluids spilled within the containment measures at the loadlines; fluids require removal and proper disposal. Photo also example showing caps or plugs missing from the loadlines pursuant to Rule 603.i.

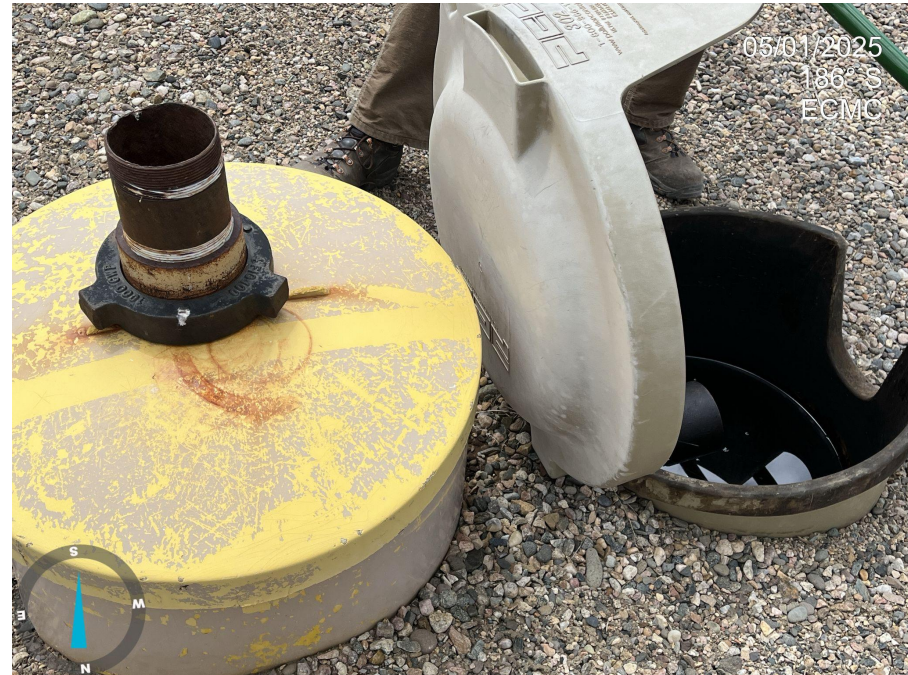
**Photo 45.** Photo taken from Tank Battery facility, facing southeast. Photo example showing fluids spilled within the containment measures at the loadlines; fluids require removal and proper disposal. Photo also example showing caps or plugs missing from the loadlines pursuant to Rule 603.i.

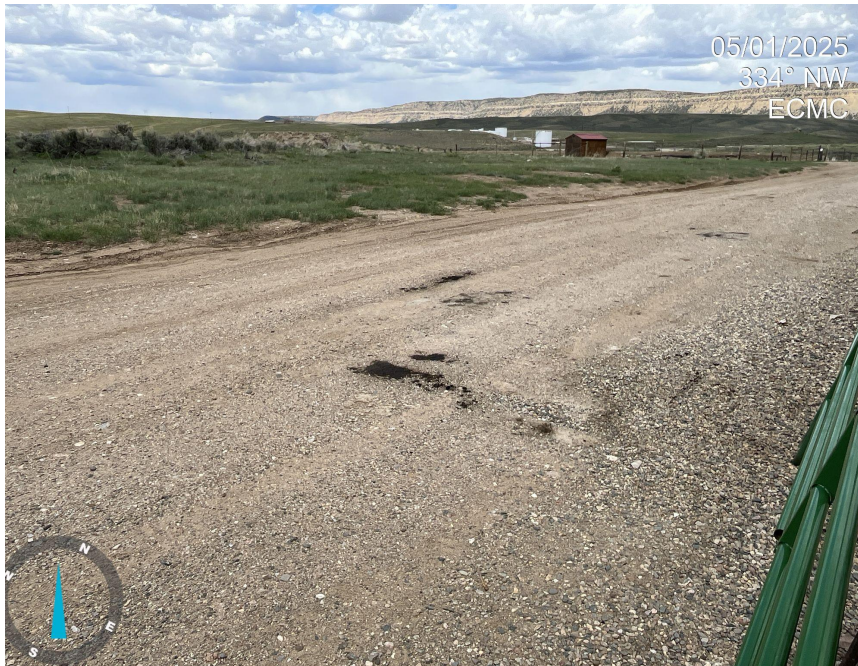
**Photo 46.** Photo taken from Tank Battery facility, facing northwest. Photo example showing stained soils observed at the access road and battery facility.

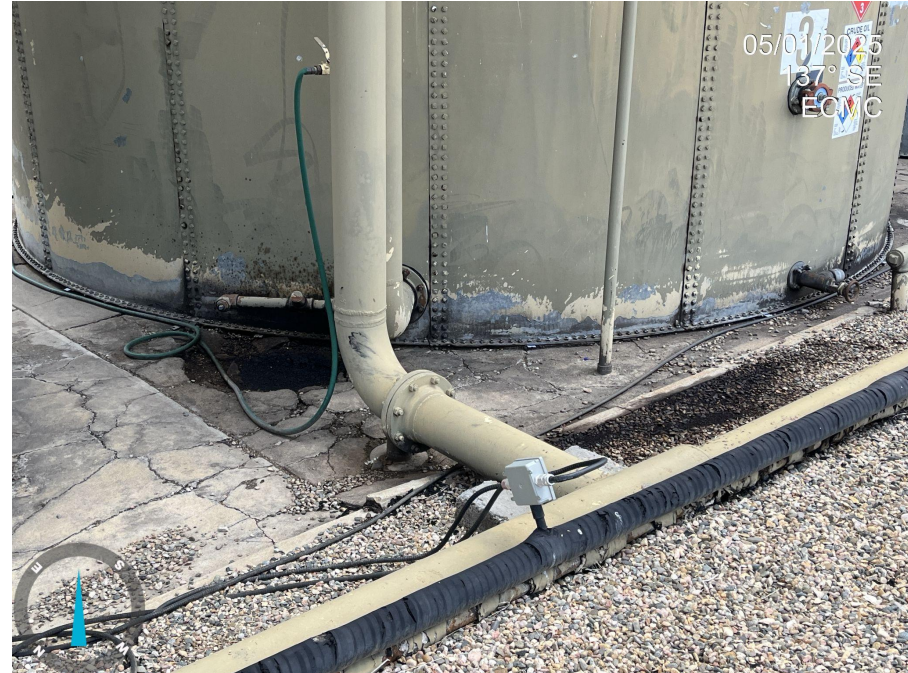
**Photo 47.** Photo taken from Tank Battery facility, facing southeast. Photo example showing stained soils observed at the access road, and battery facility.

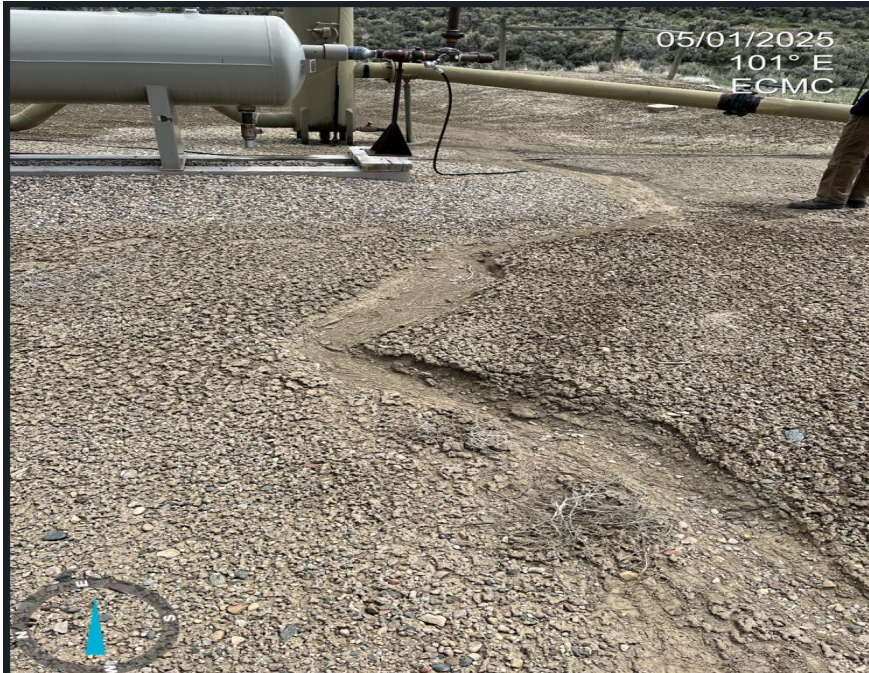
**Photo 48.** Photo taken from Tank Battery facility, facing east. Photo example showing erosion degradation at the south end of the battery facility due to stormwater runoff; BMPs to manage runoff are missing or insufficient.

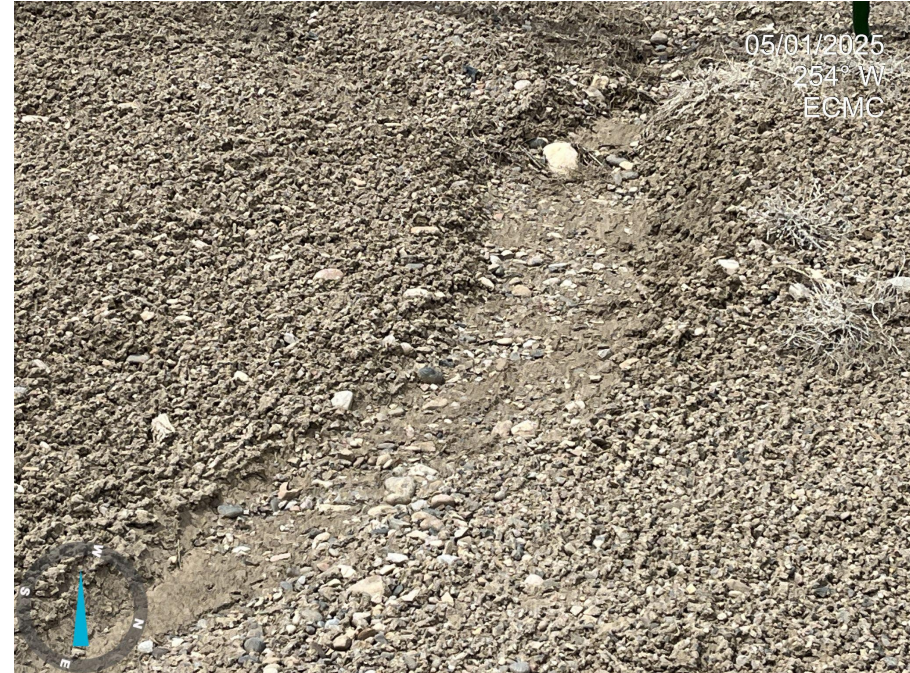
**Photo 49.** Photo taken from Tank Battery facility, facing west. Photo example showing erosion degradation at the south end of the battery facility due to stormwater runoff; BMPs to manage runoff are missing or insufficient.

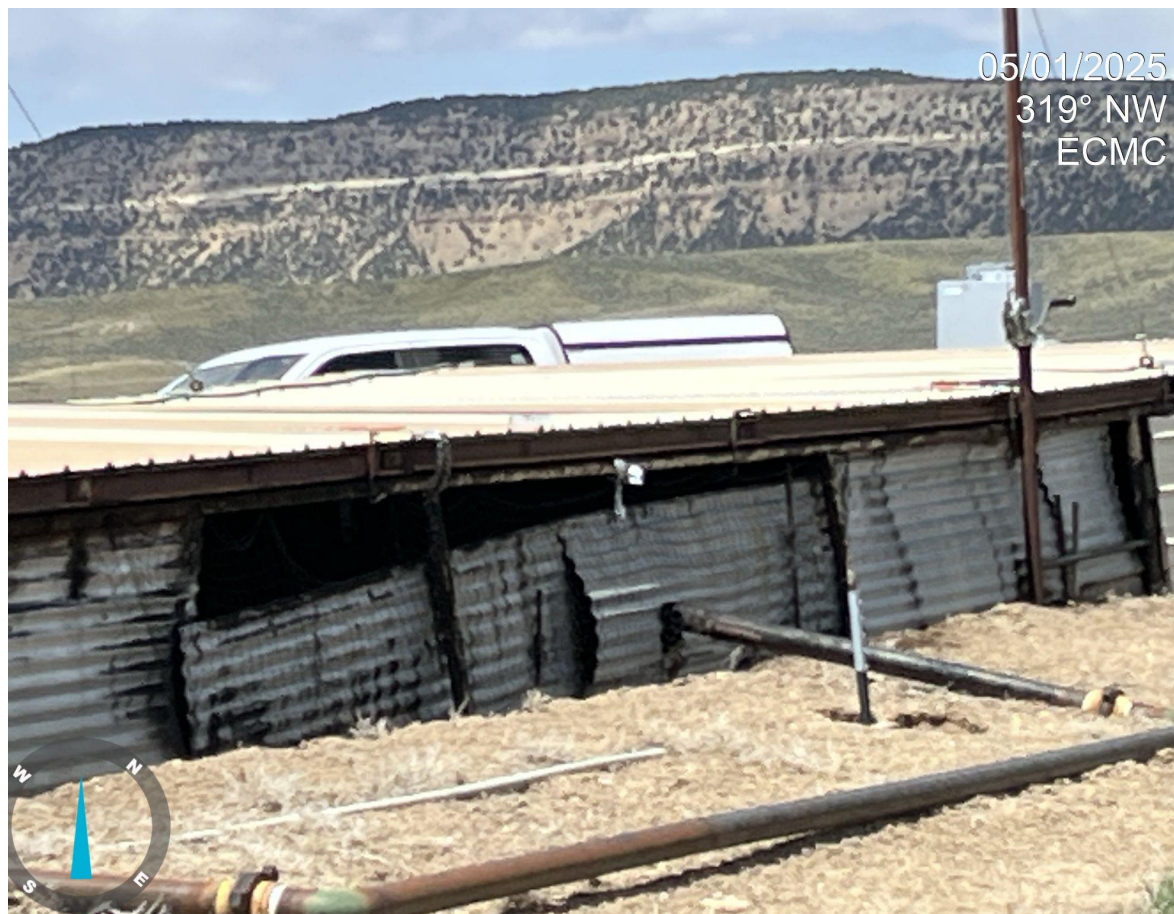
**Photo 50.** Photo taken from Tank Battery facility, facing northwest. Photo illustrates paneling on containment structure falling off. Maintain equipment.

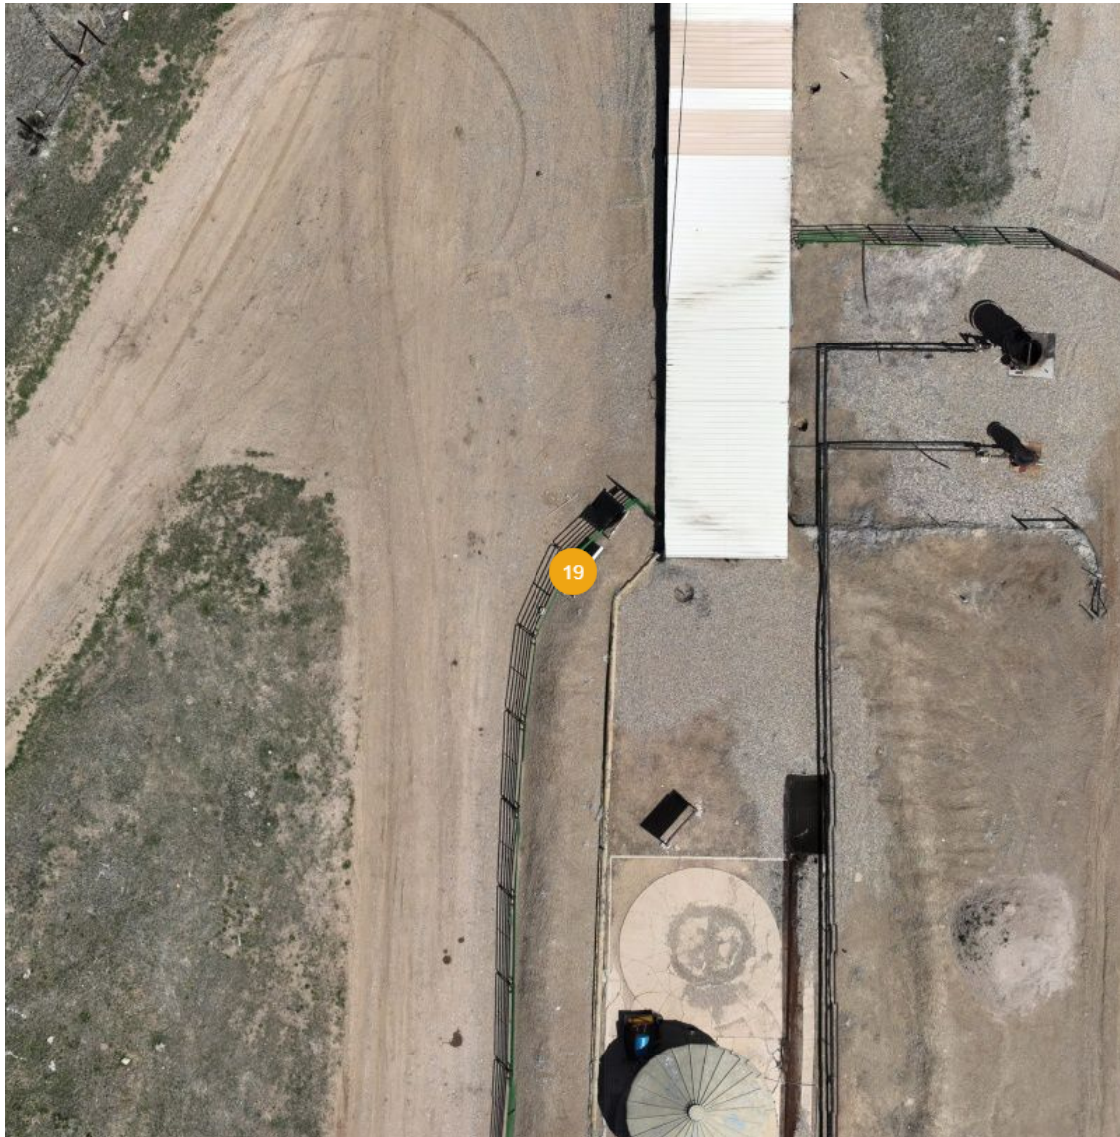
May 1, 2025 at 11:34am

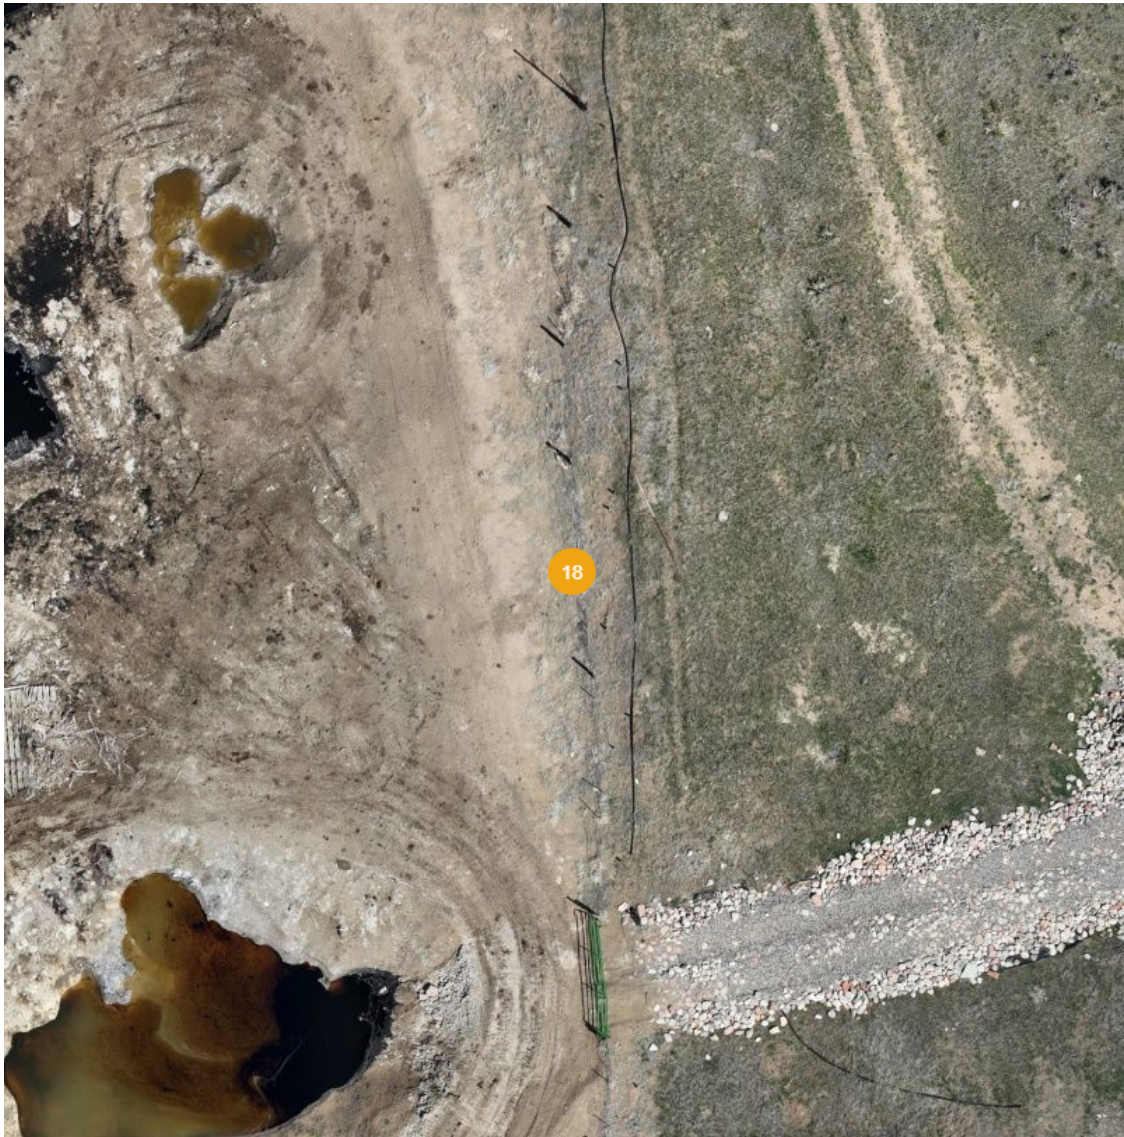
May 1, 2025 at 11:34am

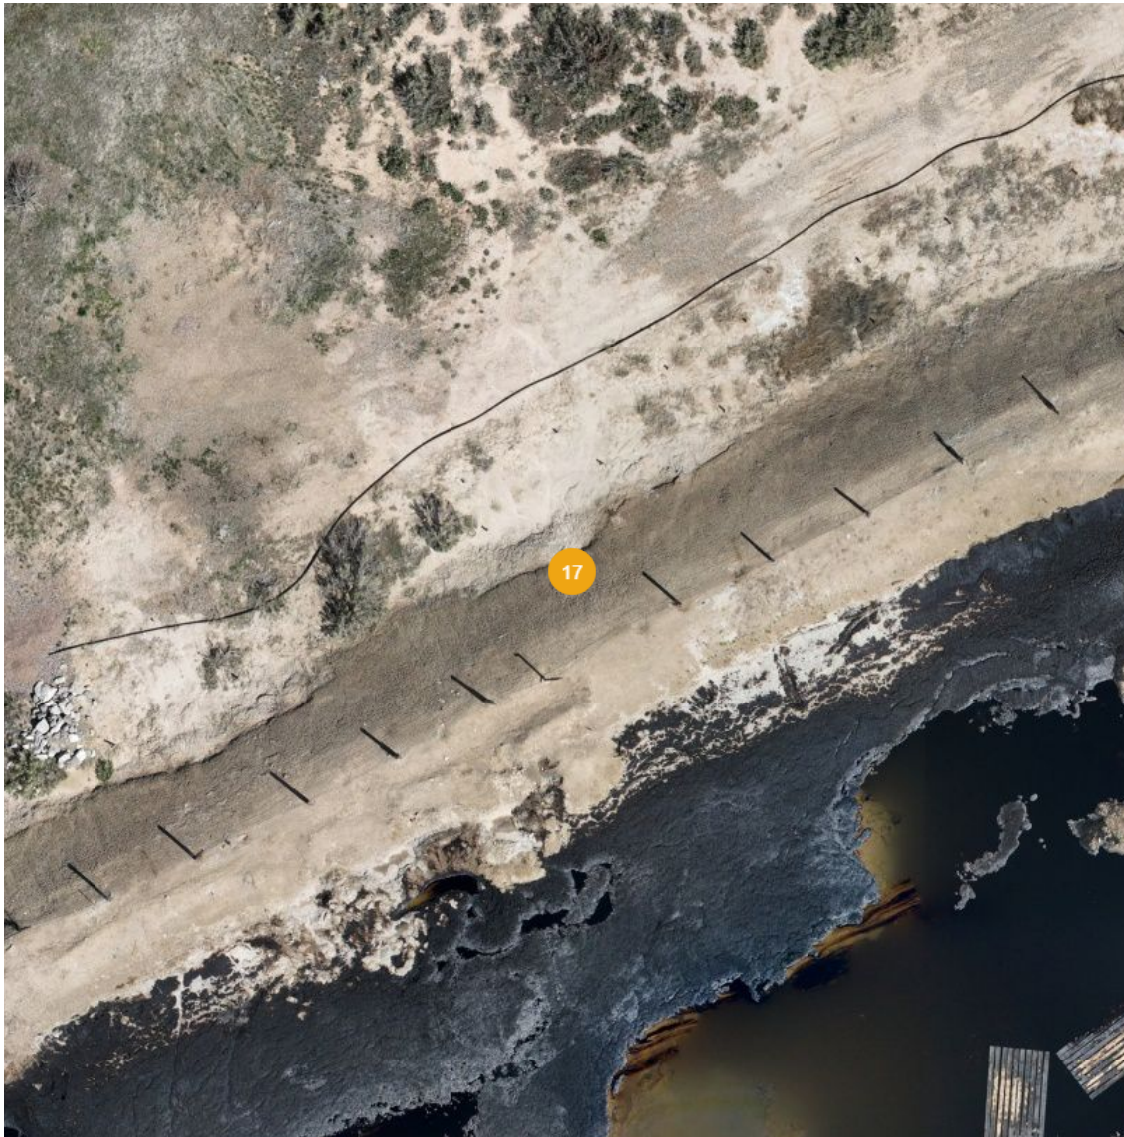
May 1, 2025 at 11:34am
