# Inspection Photos

## 05/01/2025

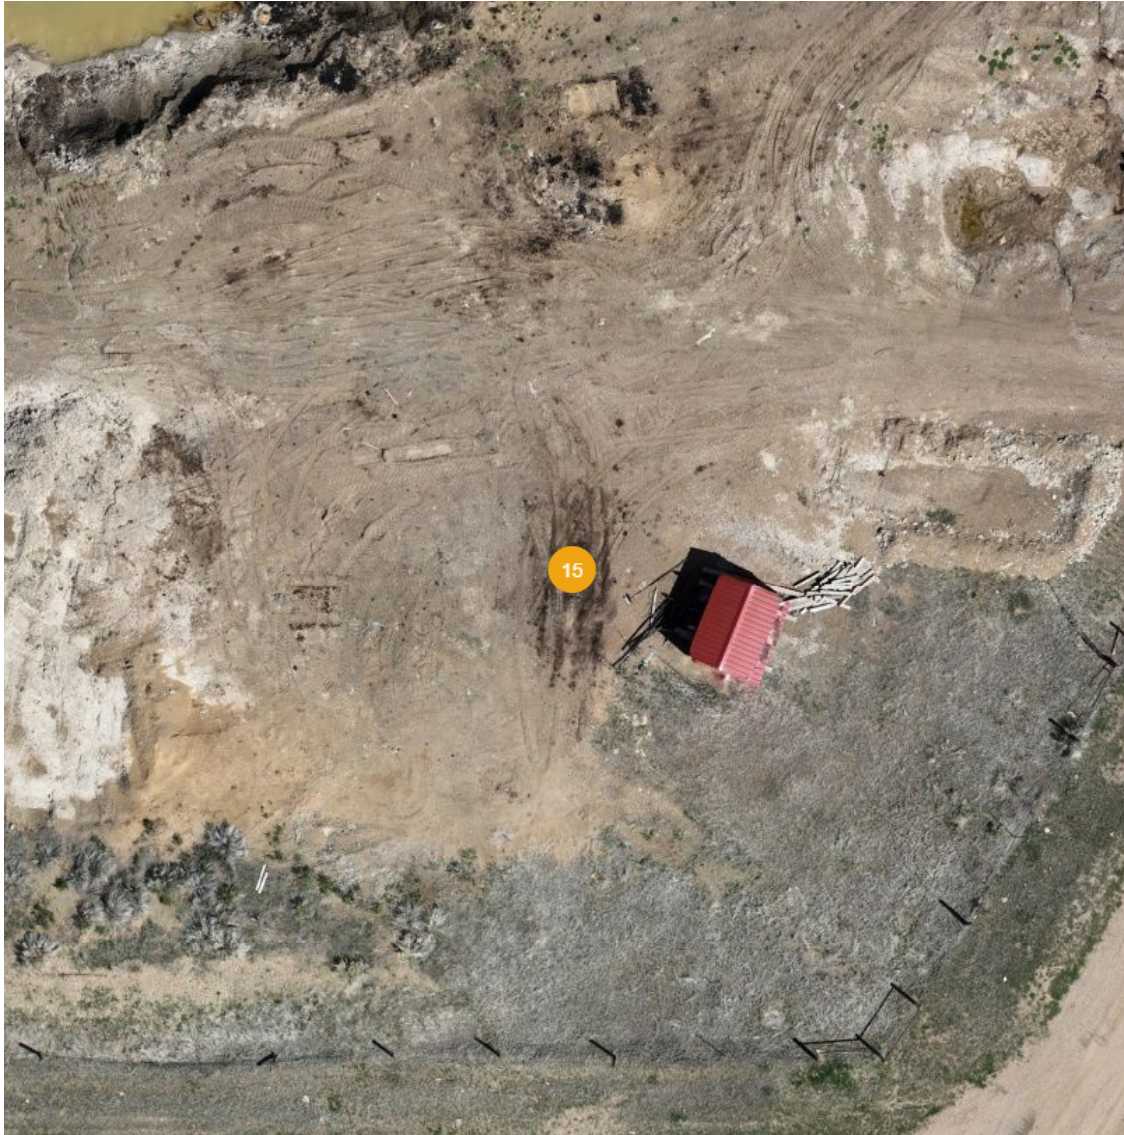
May 1, 2025 at 11:34am

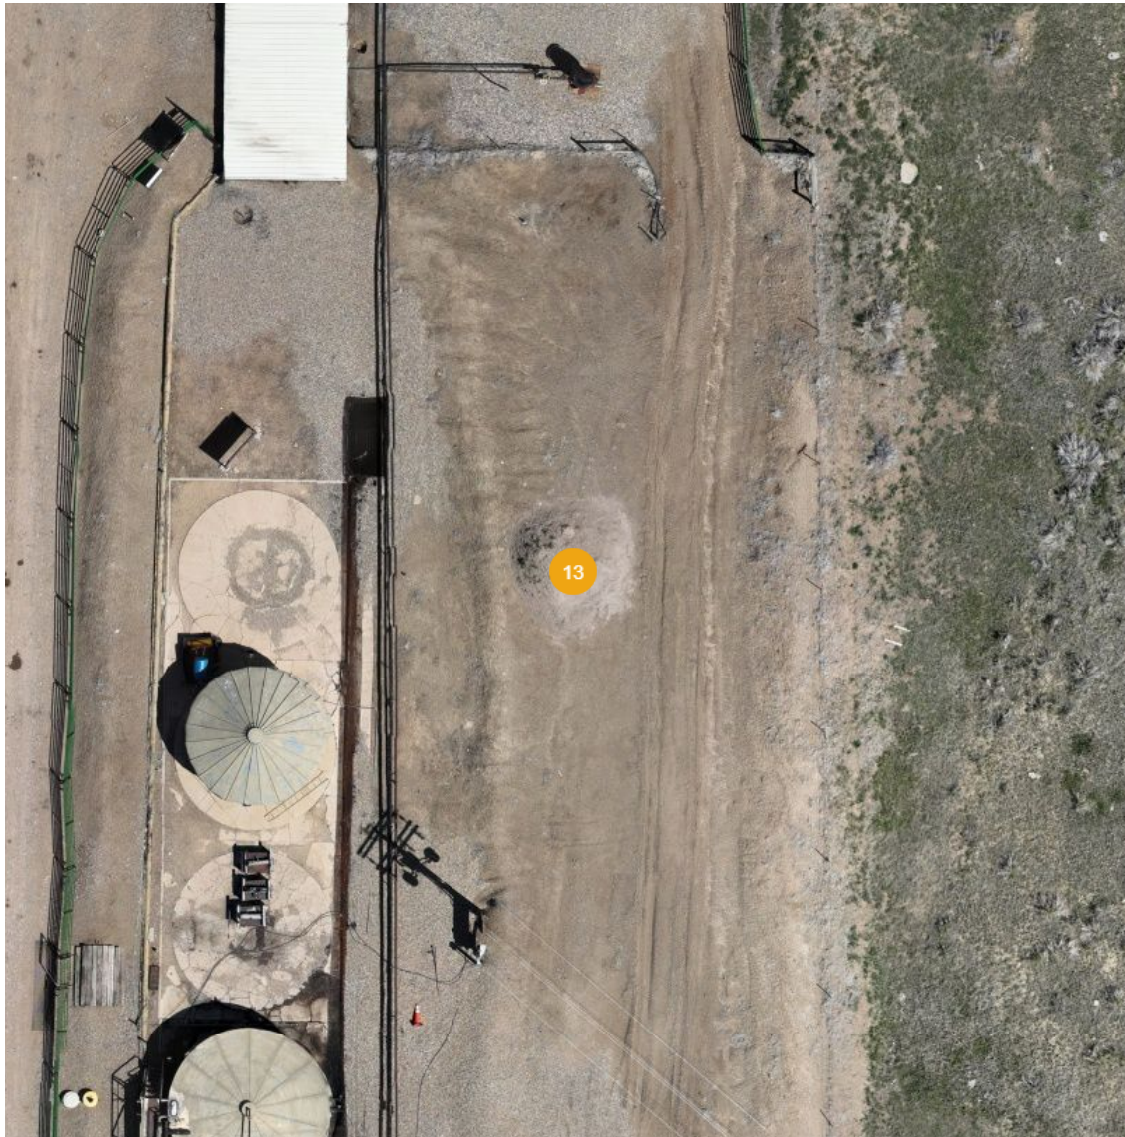
May 1, 2025 at 11:34am

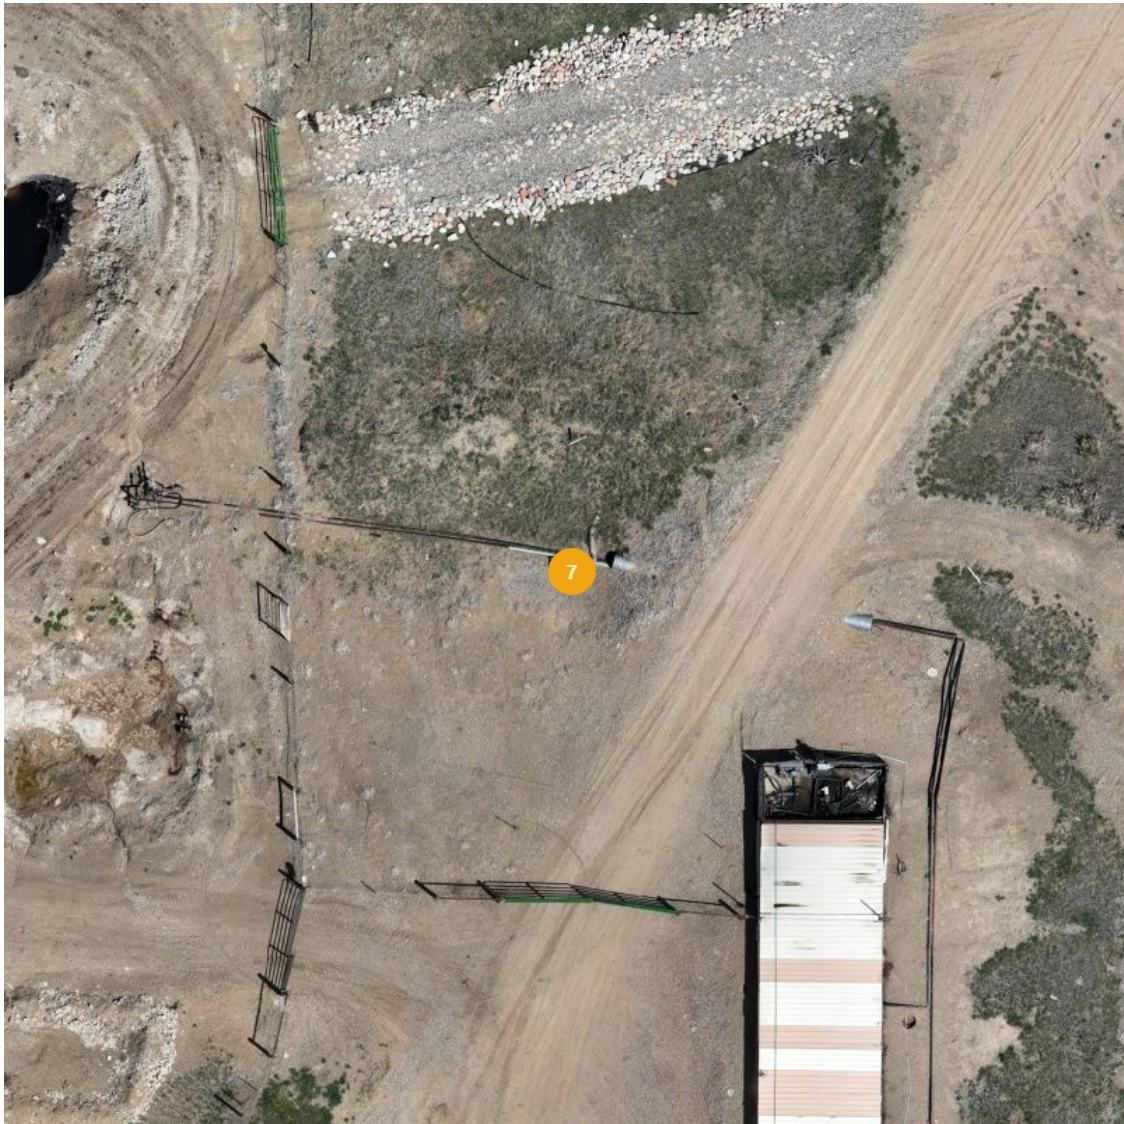
May 1, 2025 at 11:34am

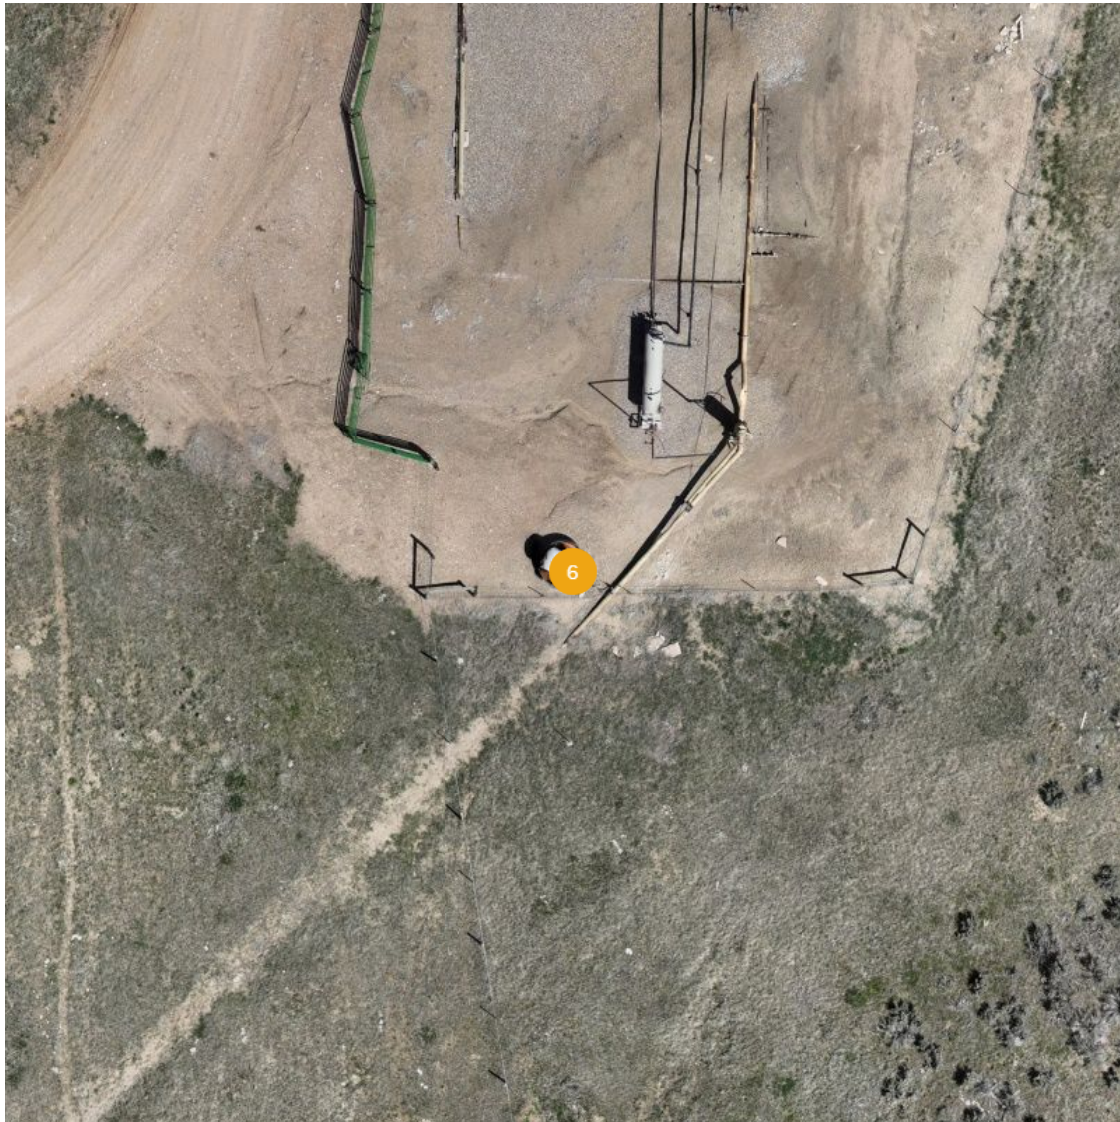
May 1, 2025 at 11:34am

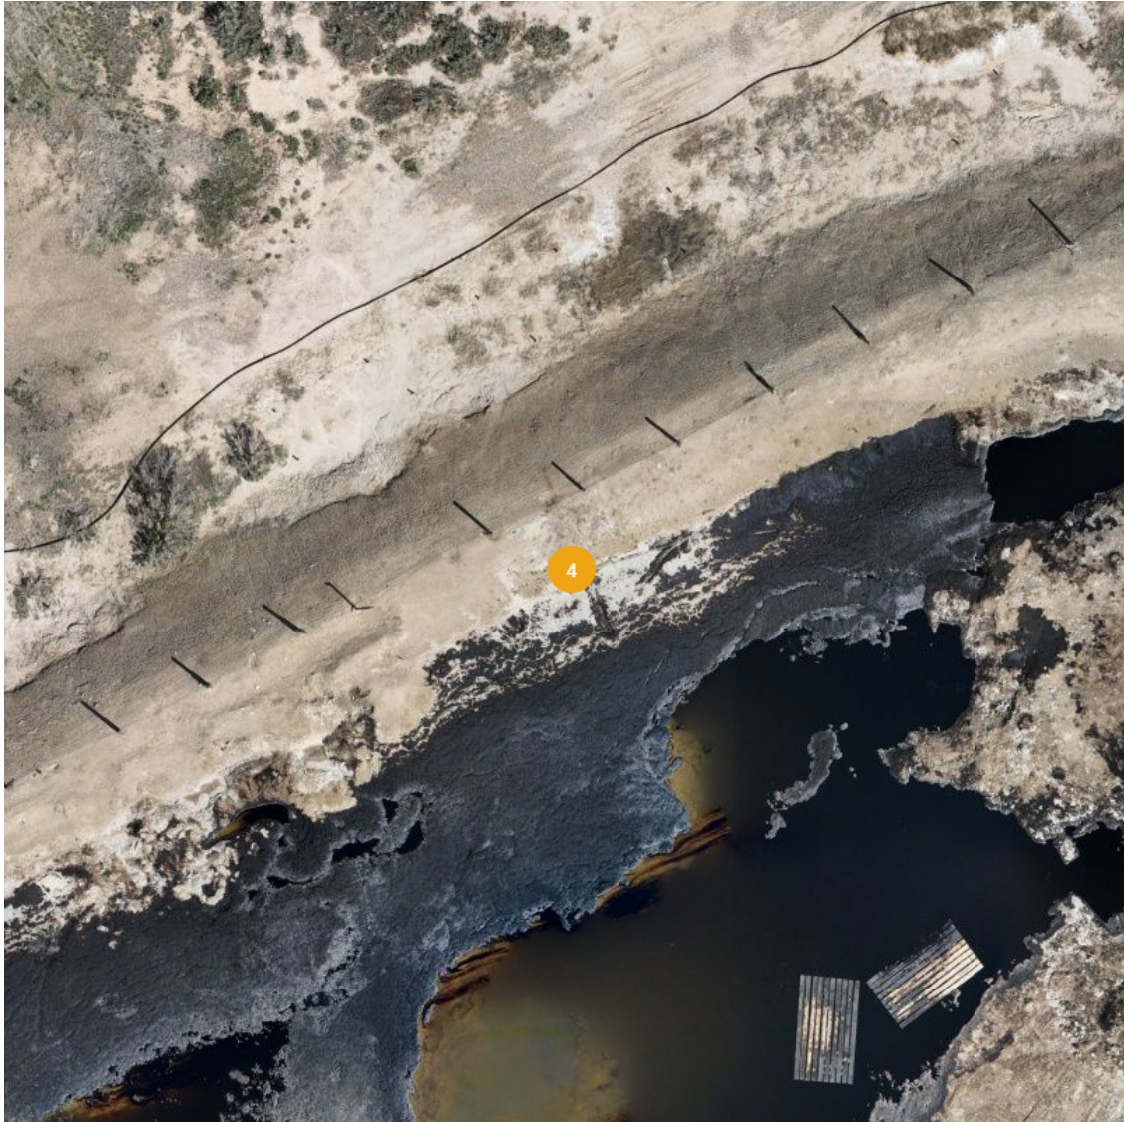
May 1, 2025 at 11:34am

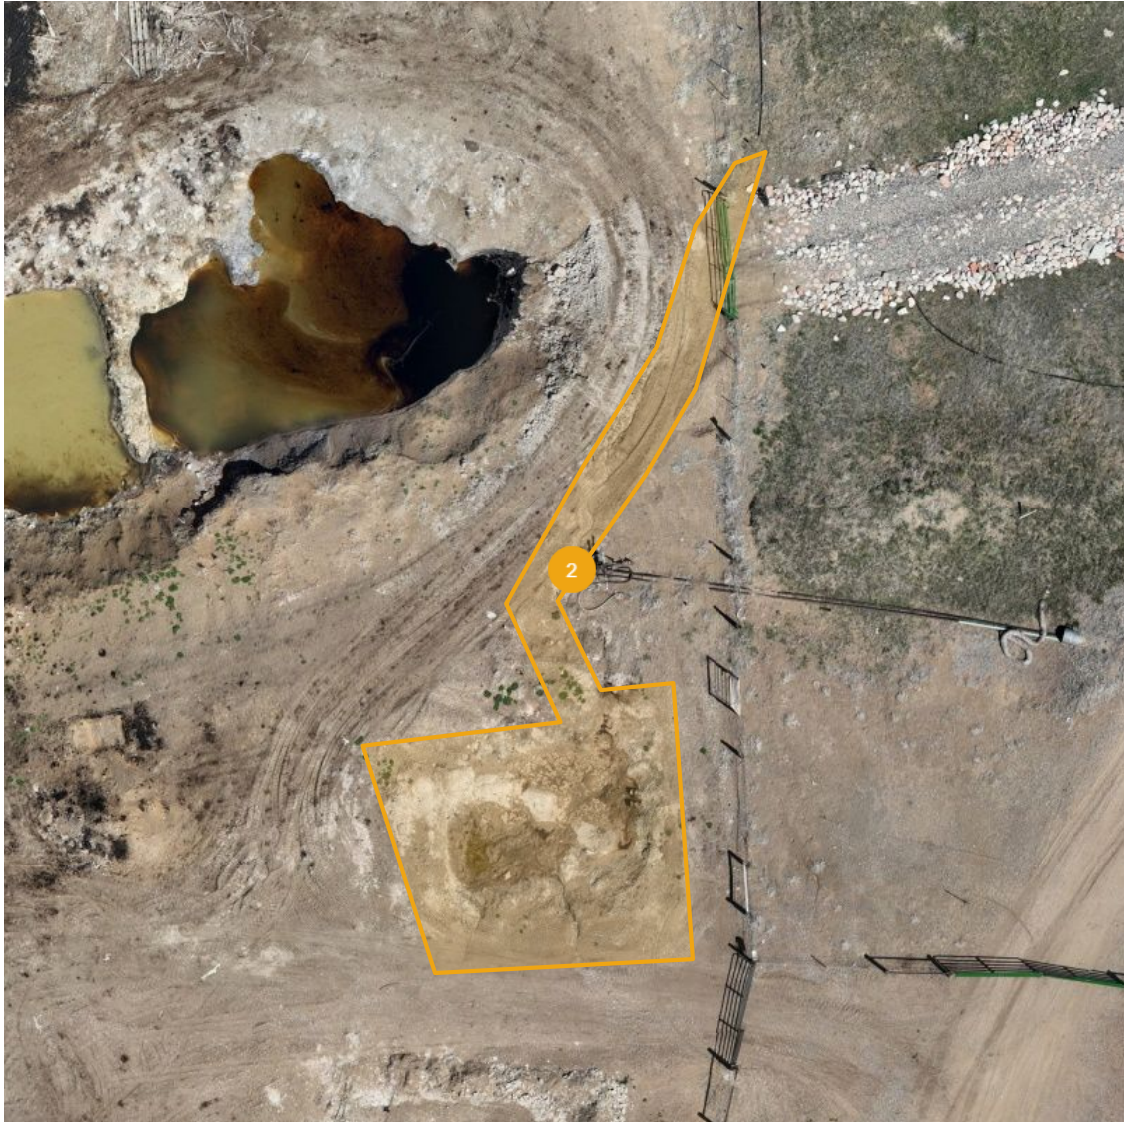
May 1, 2025 at 11:34am

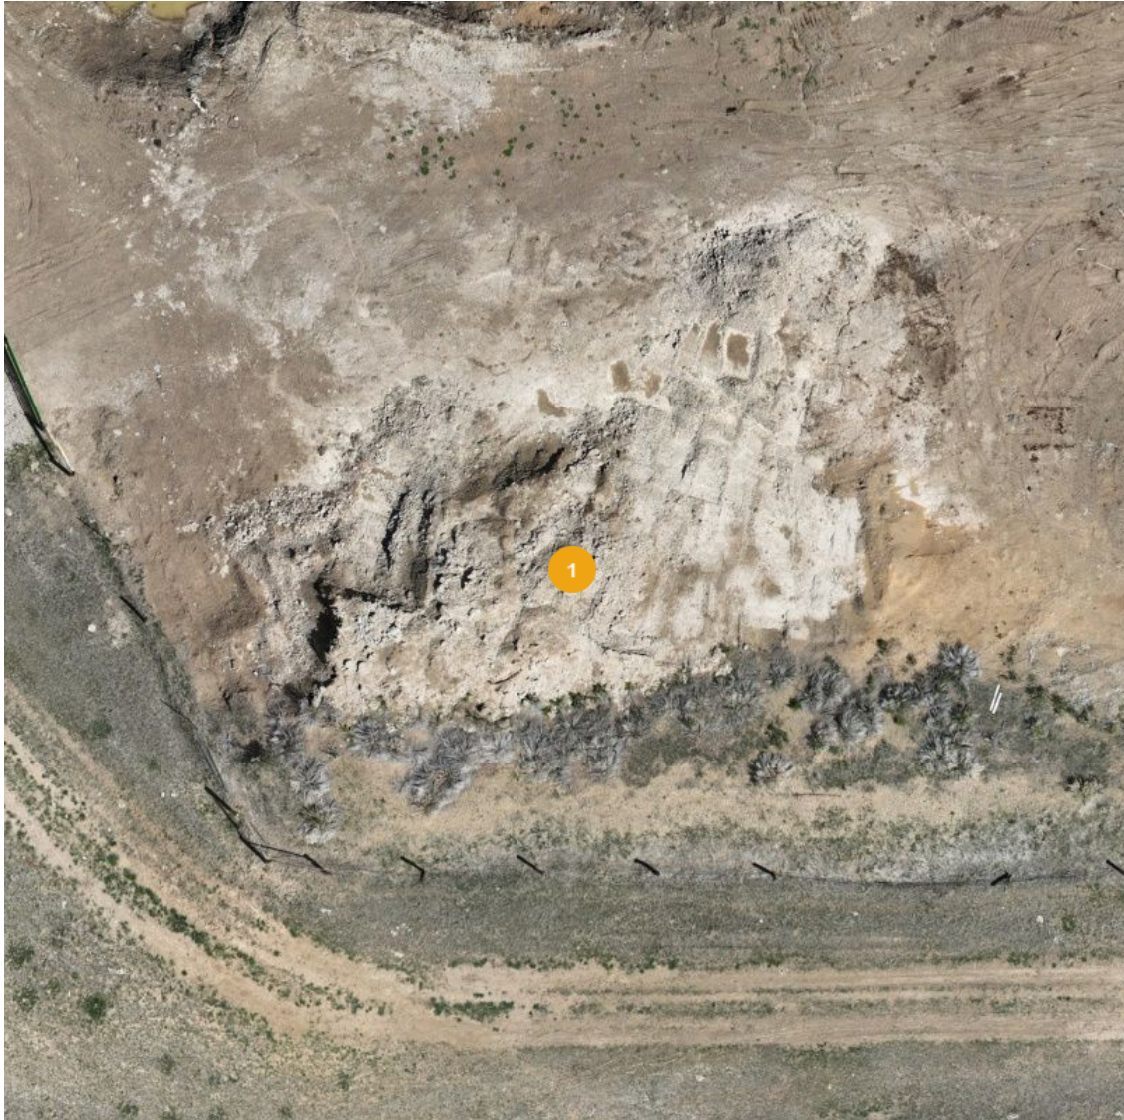
May 1, 2025 at 11:34am
