Inspection/Audit Photos

Location Name: TEP ROCKY MOUNTAIN LLC GIBSON GULCH UNIT 6-29 Pad

Location ID: 335202

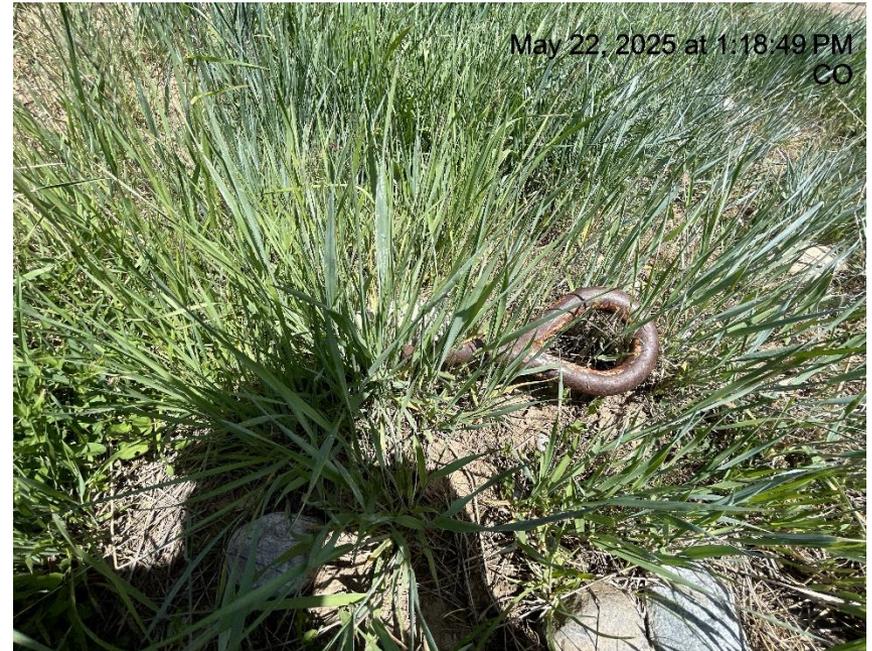
Photo # 2454 Unmarked deadman

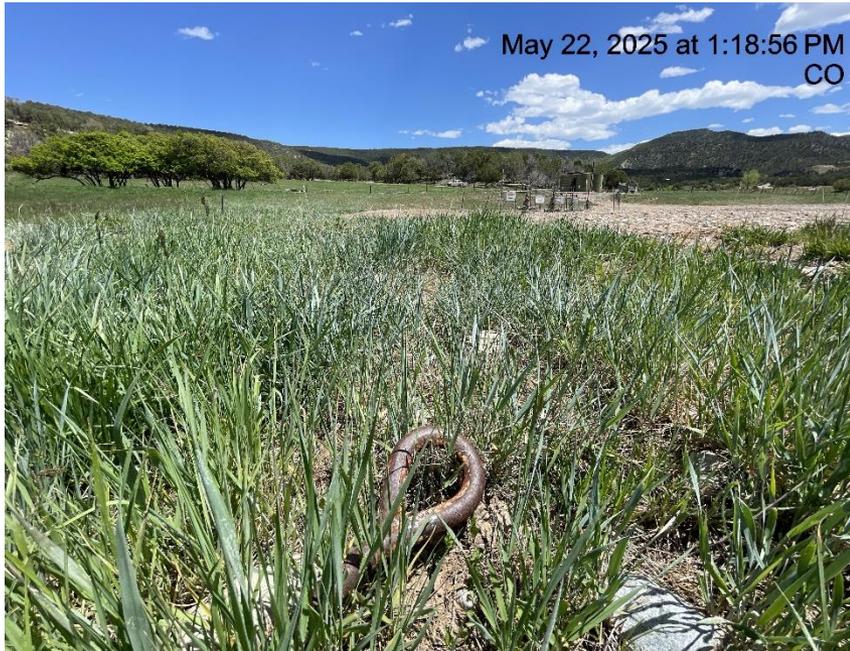
Photo # 2455 Same unmarked deadman

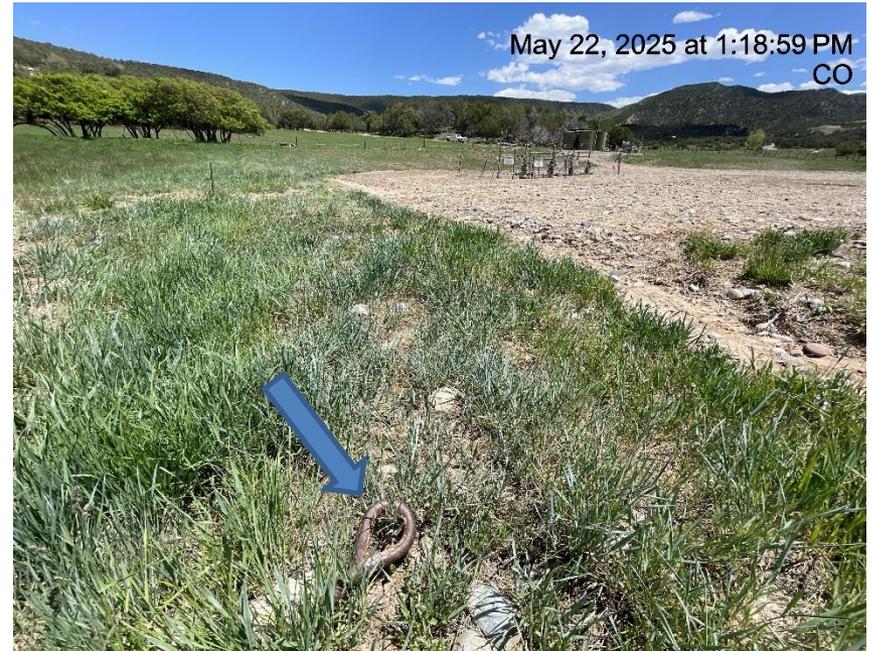
Photo # 2456 Same unmarked deadman

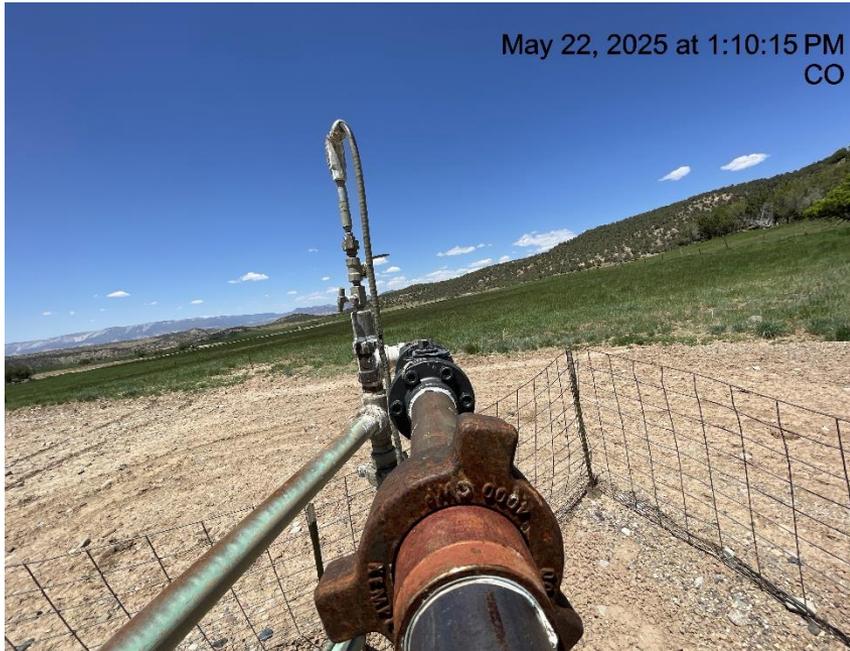
Photo # 2459 GIBSON GULCH UNIT 6-29 well - Ball valve on line connecting BH line to flowline appears to be shut

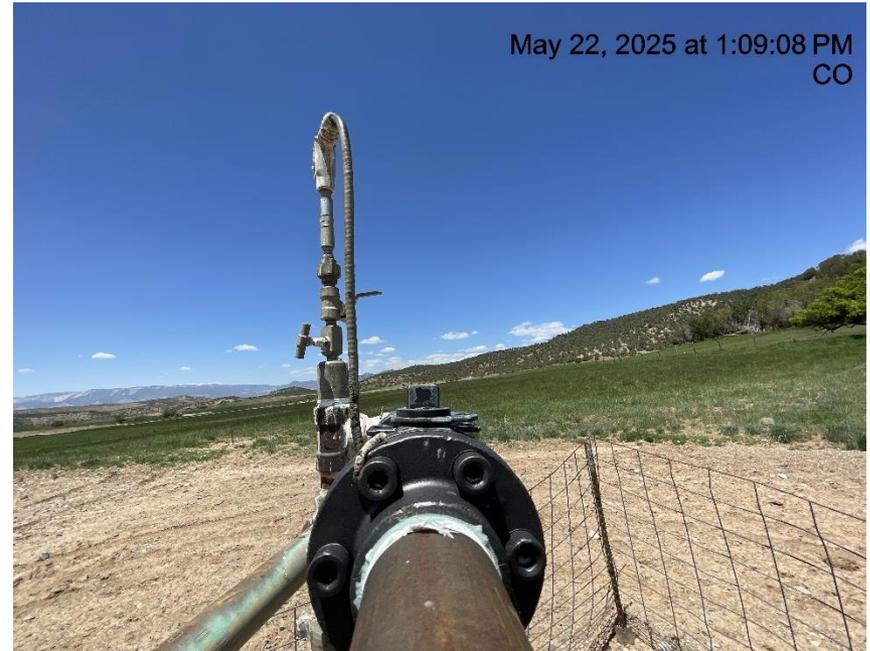
Photo # 2460 GIBSON GULCH UNIT 6-29 well - Ball valve on line connecting BH line to flowline appears to be shut

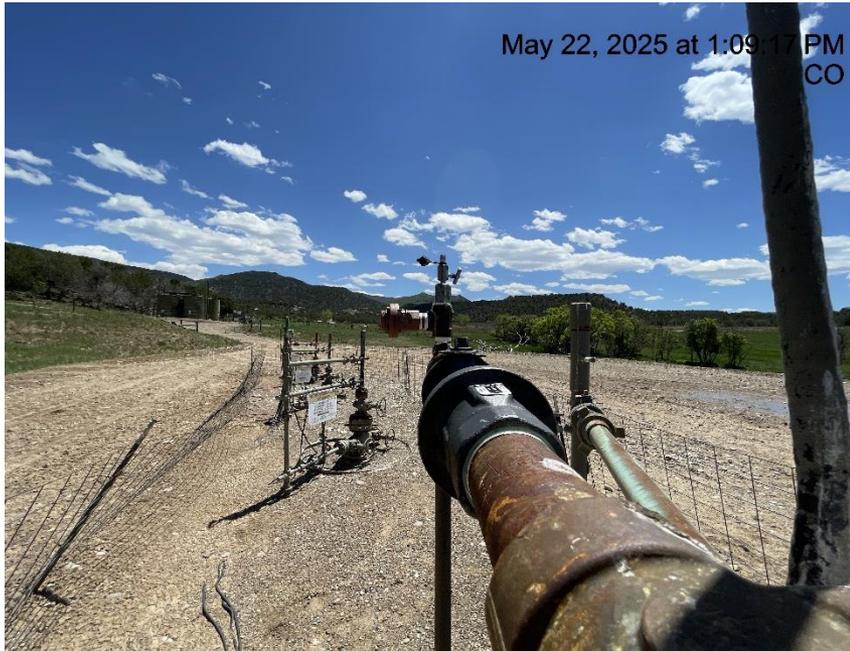
Photo # 2461 GIBSON GULCH UNIT 6-29 well - Ball valve on line connecting BH line to flowline appears to be shut

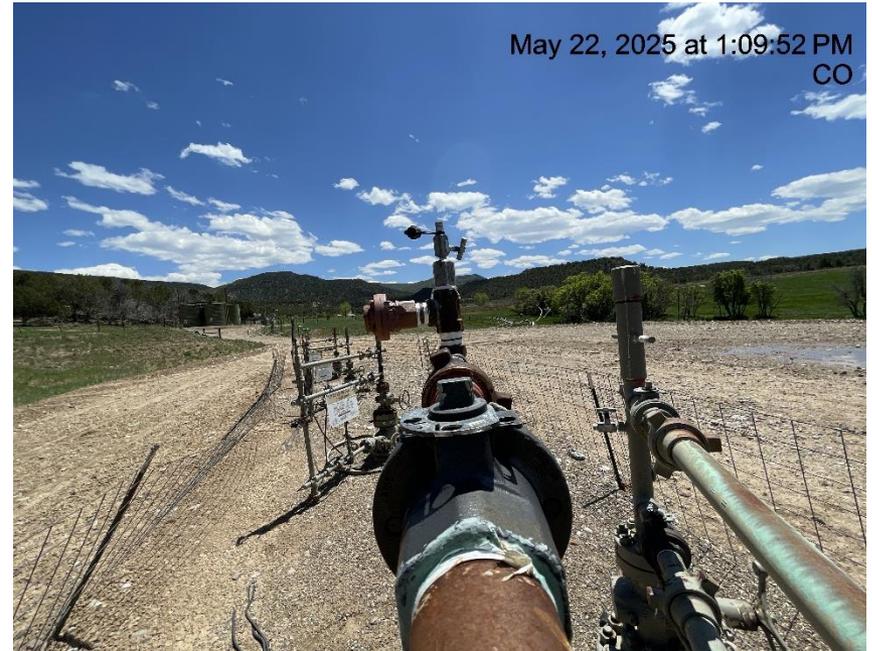
Photo # 2462 GIBSON GULCH UNIT 6-29 well - Ball valve on line connecting BH line to flowline appears to be shut

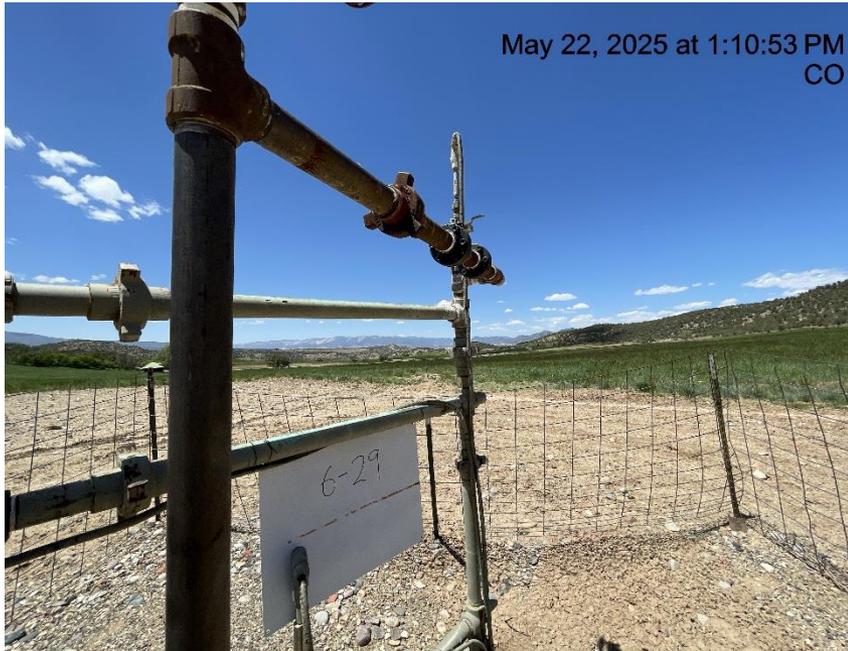
Photo # 2463 GIBSON GULCH UNIT 6-29 well - Ball valve on line connecting BH line to flowline appears to be shut

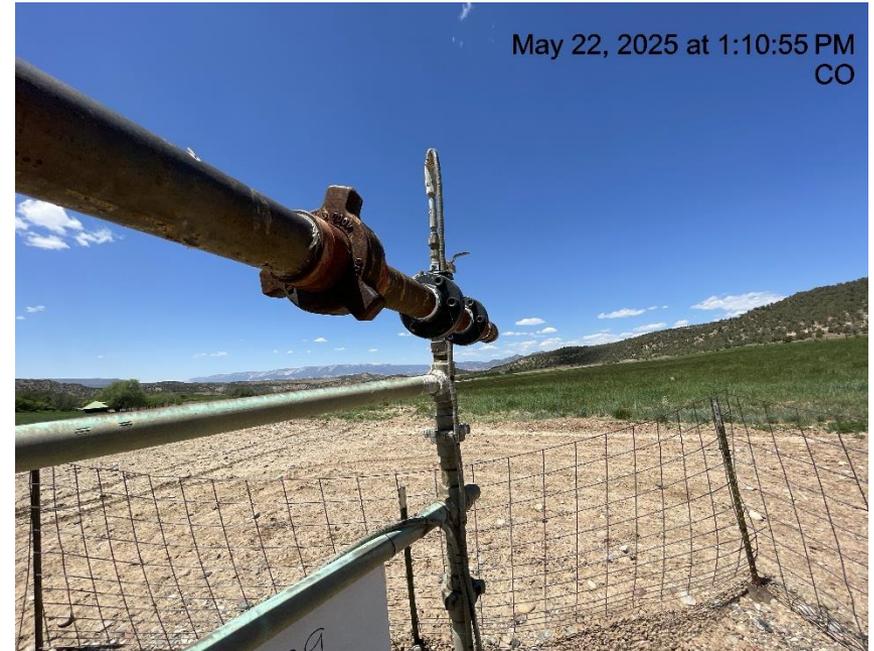
Photo # 2464 GIBSON GULCH UNIT 6-29 well - Ball valve on line connecting BH line to flowline appears to be shut

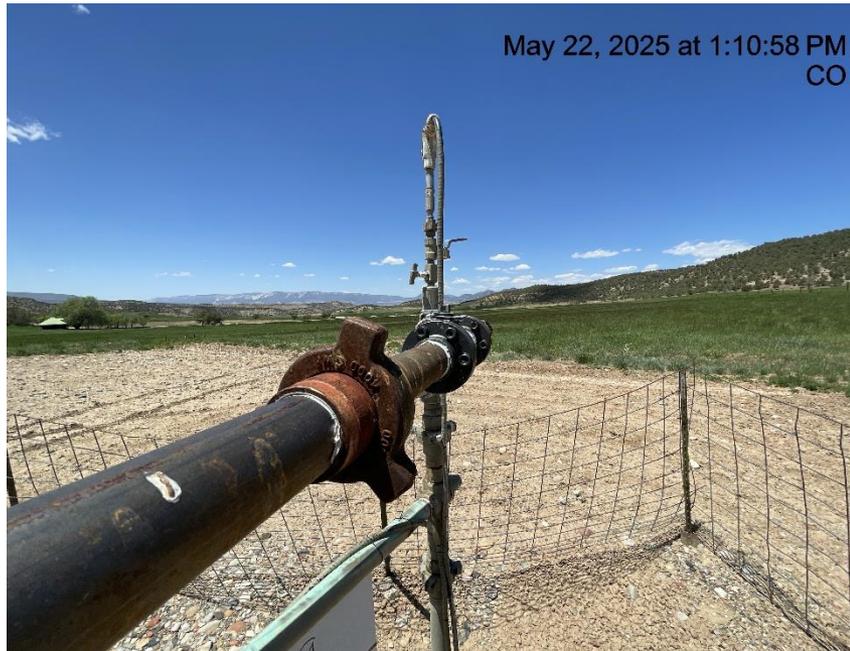
Photo # 2465 GIBSON GULCH UNIT 6-29 well - Ball valve on line connecting BH line to flowline appears to be shut

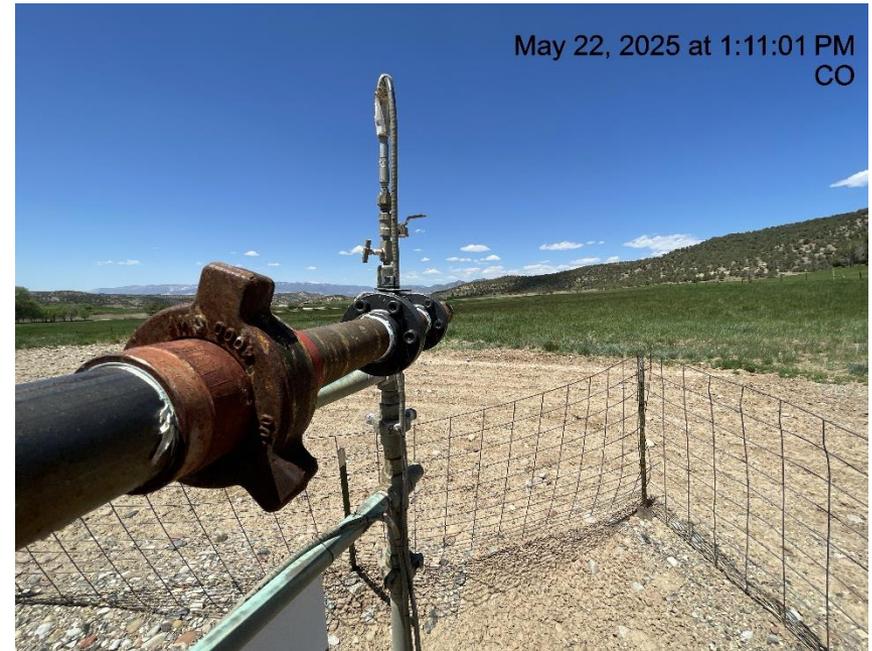
Photo # 2466 GIBSON GULCH UNIT 6-29 well - Ball valve on line connecting BH line to flowline appears to be shut

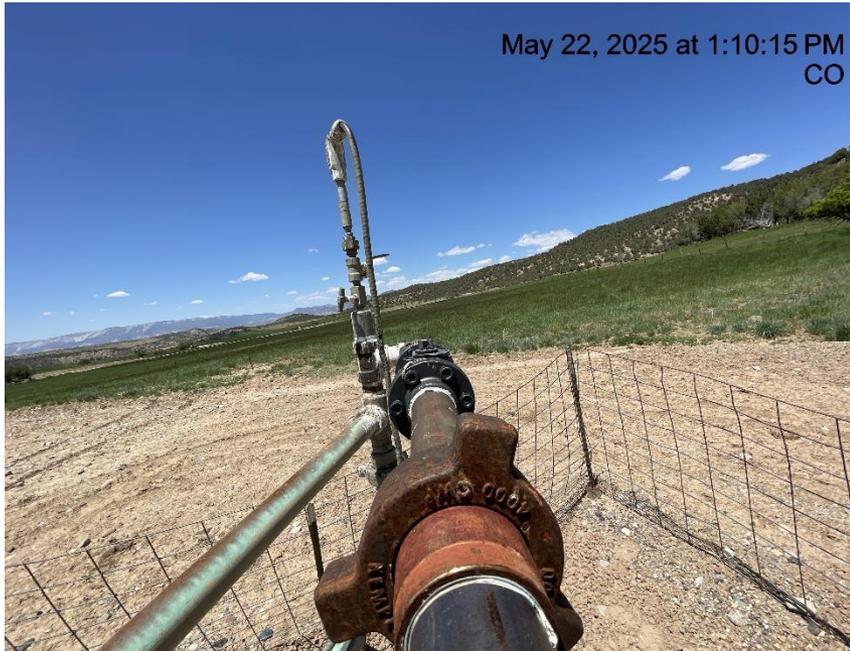
Photo # 2467 GIBSON GULCH UNIT 6-29 well - Ball valve on line connecting BH line to flowline appears to be shut

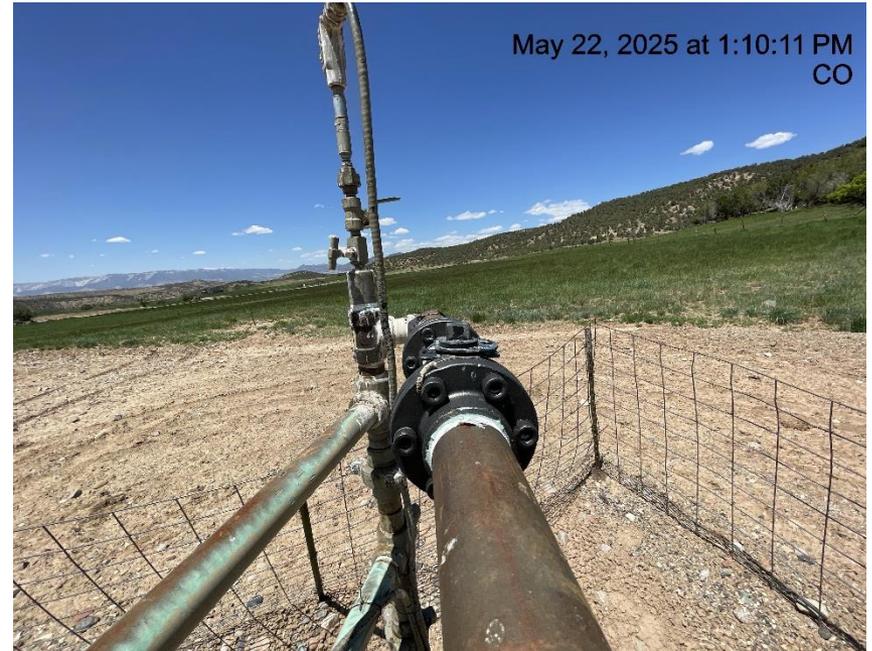
Photo # 2468 GIBSON GULCH UNIT 6-29 well - Ball valve on line connecting BH line to flowline appears to be shut

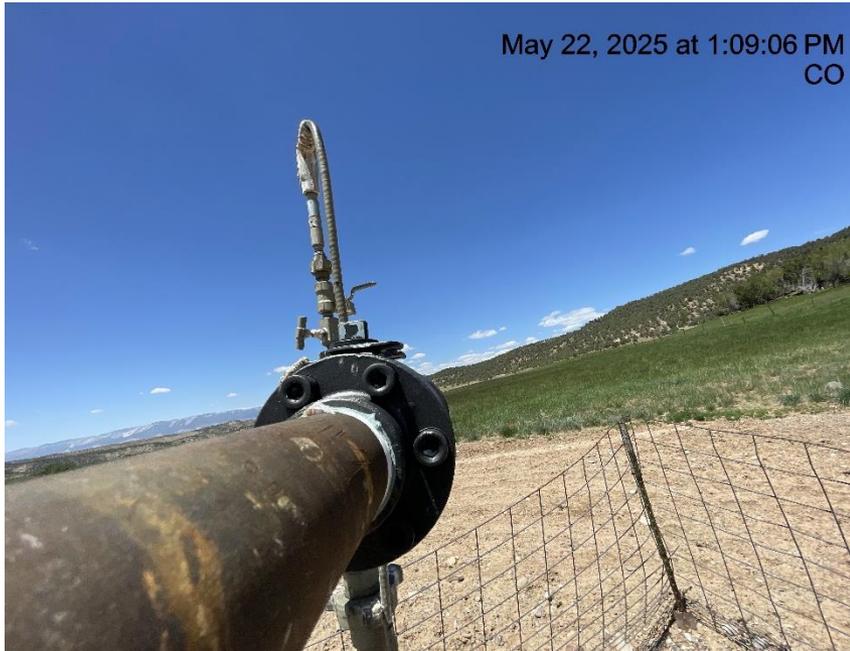
Photo # 2469 GIBSON GULCH UNIT 6-29 well - Ball valve on line connecting BH line to flowline appears to be shut

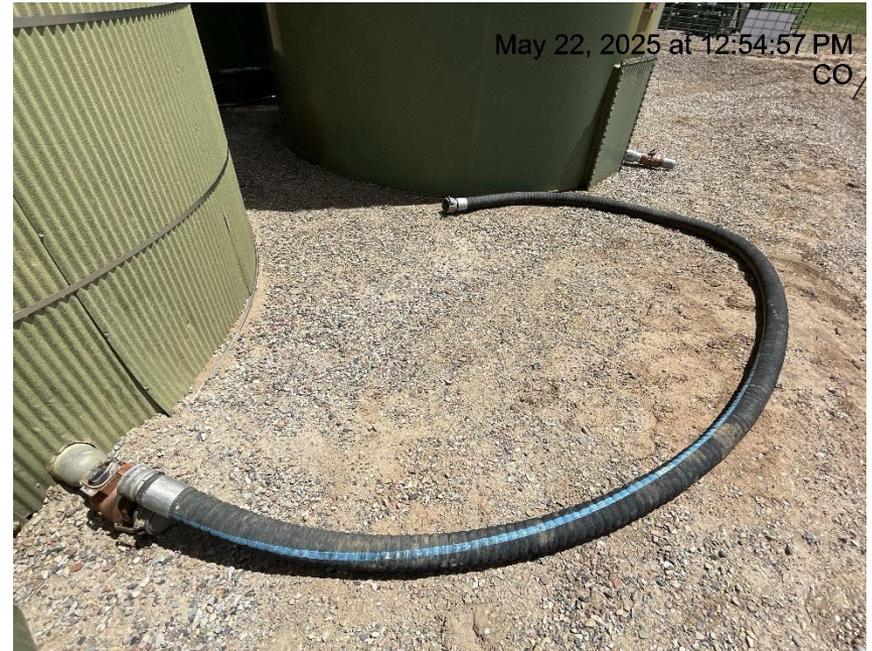
Photo # 2470 Unused hose in secondary containment

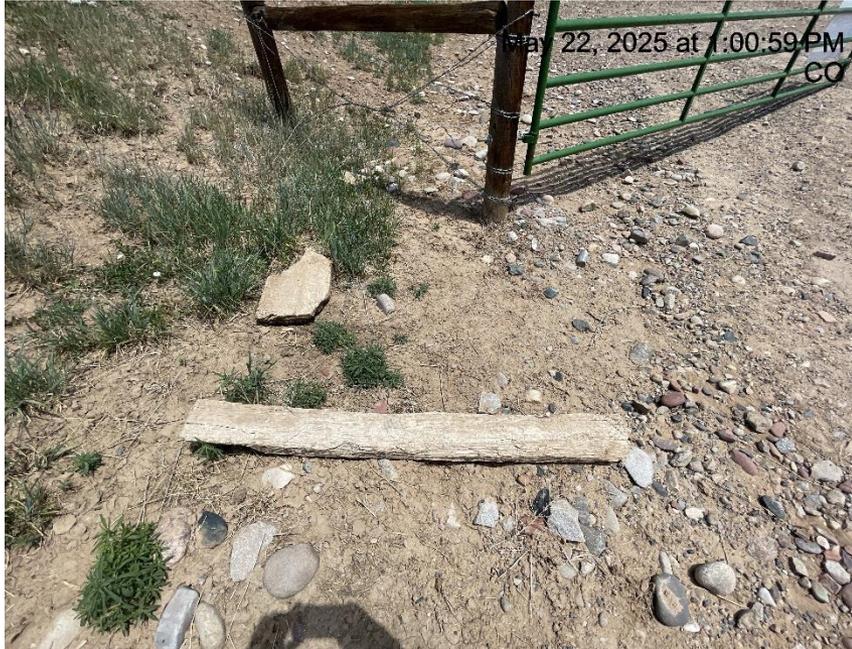
Photo # 2471 Debris

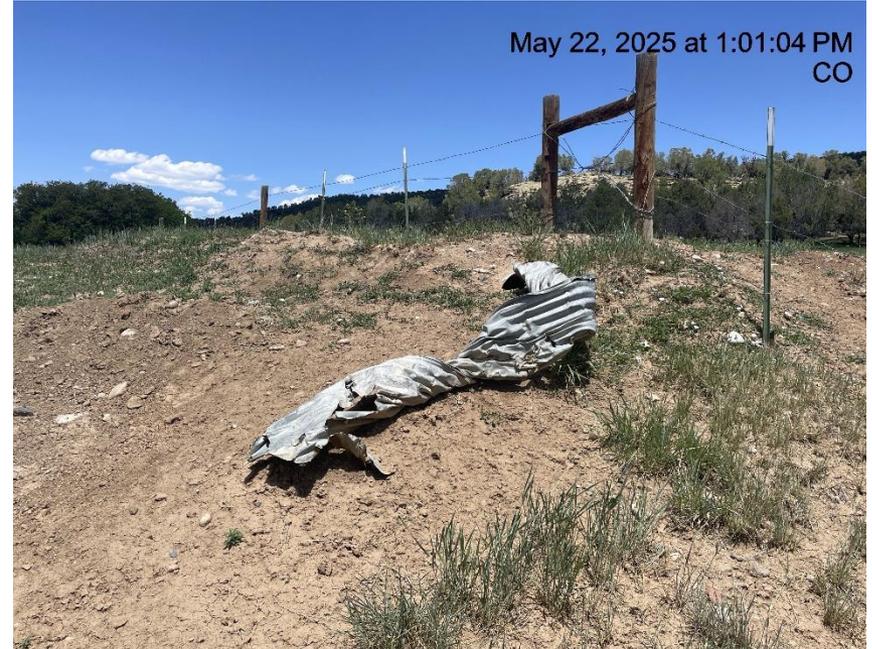
Photo # 2472 Debris
