## Inspection/Audit Photos

Location Name: TEP ROCKY MOUNTAIN LLC Dry Hollow Interconnect

Location ID: 479290

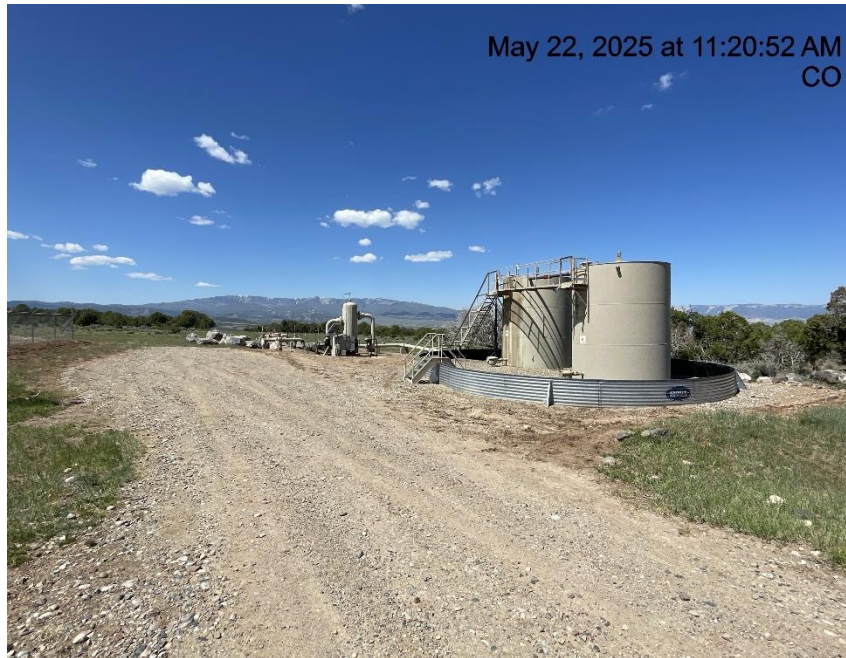
Photo # 2296 From entrance to location

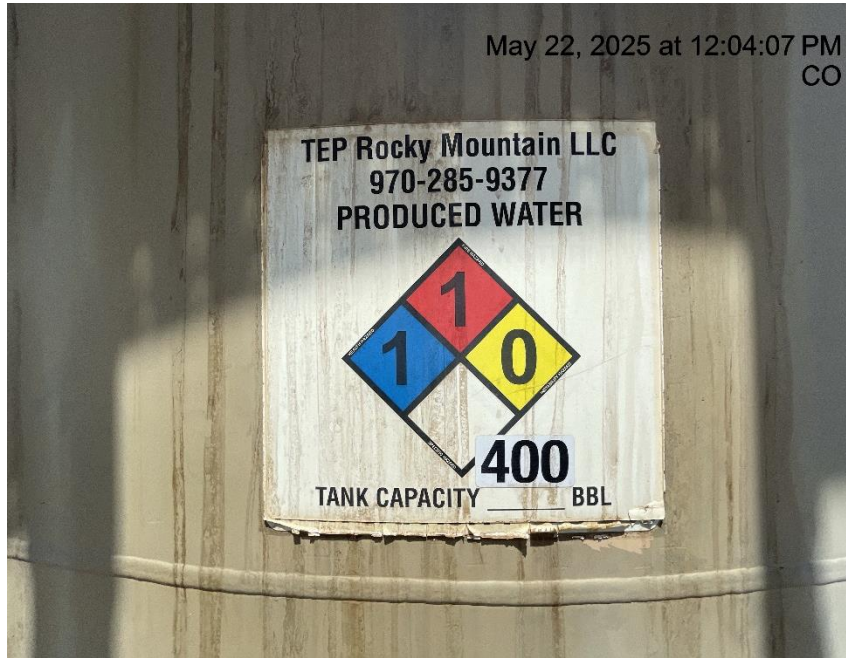
Photo # 2306 Tank capacity incorrect

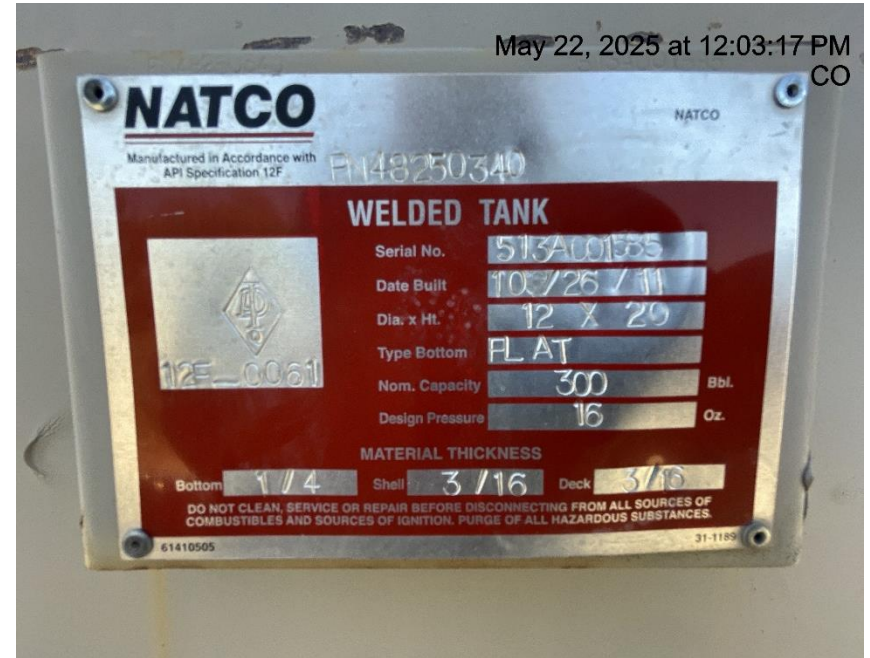
Photo # 2307 Tank capacity

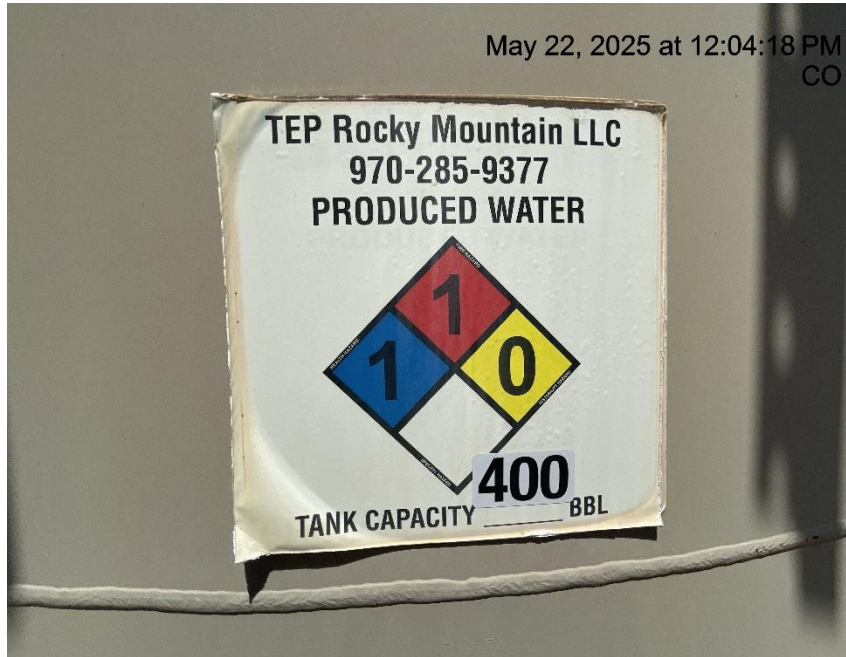
Photo # 2308 Tank capacity incorrect

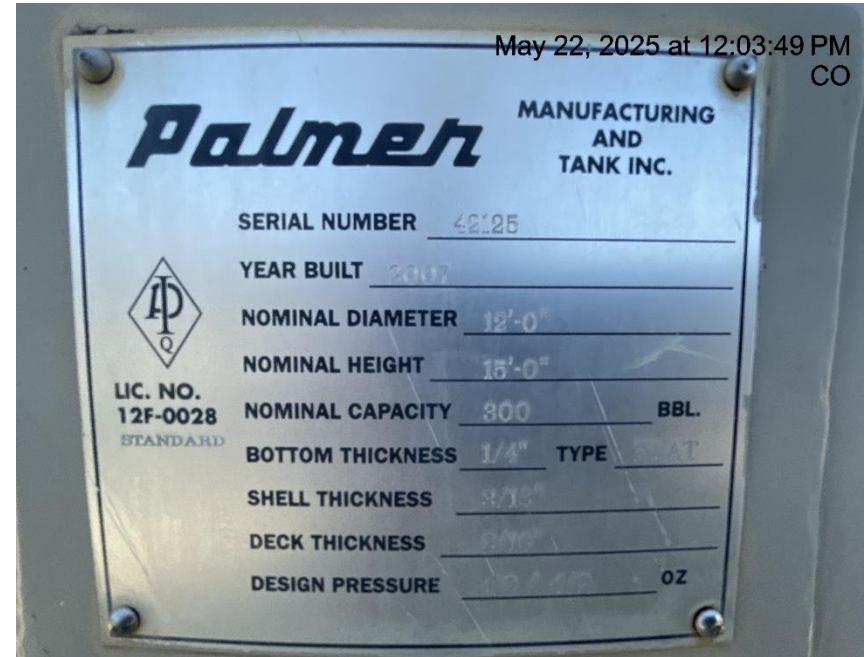
Photo # 2309 Tank capacity
