ECMC
Environmental
Field Inspection

1415 Corp Gas Unit 2 Wellhead
20-May-25 03:36:18 PM
ECMC Environmental Inspection

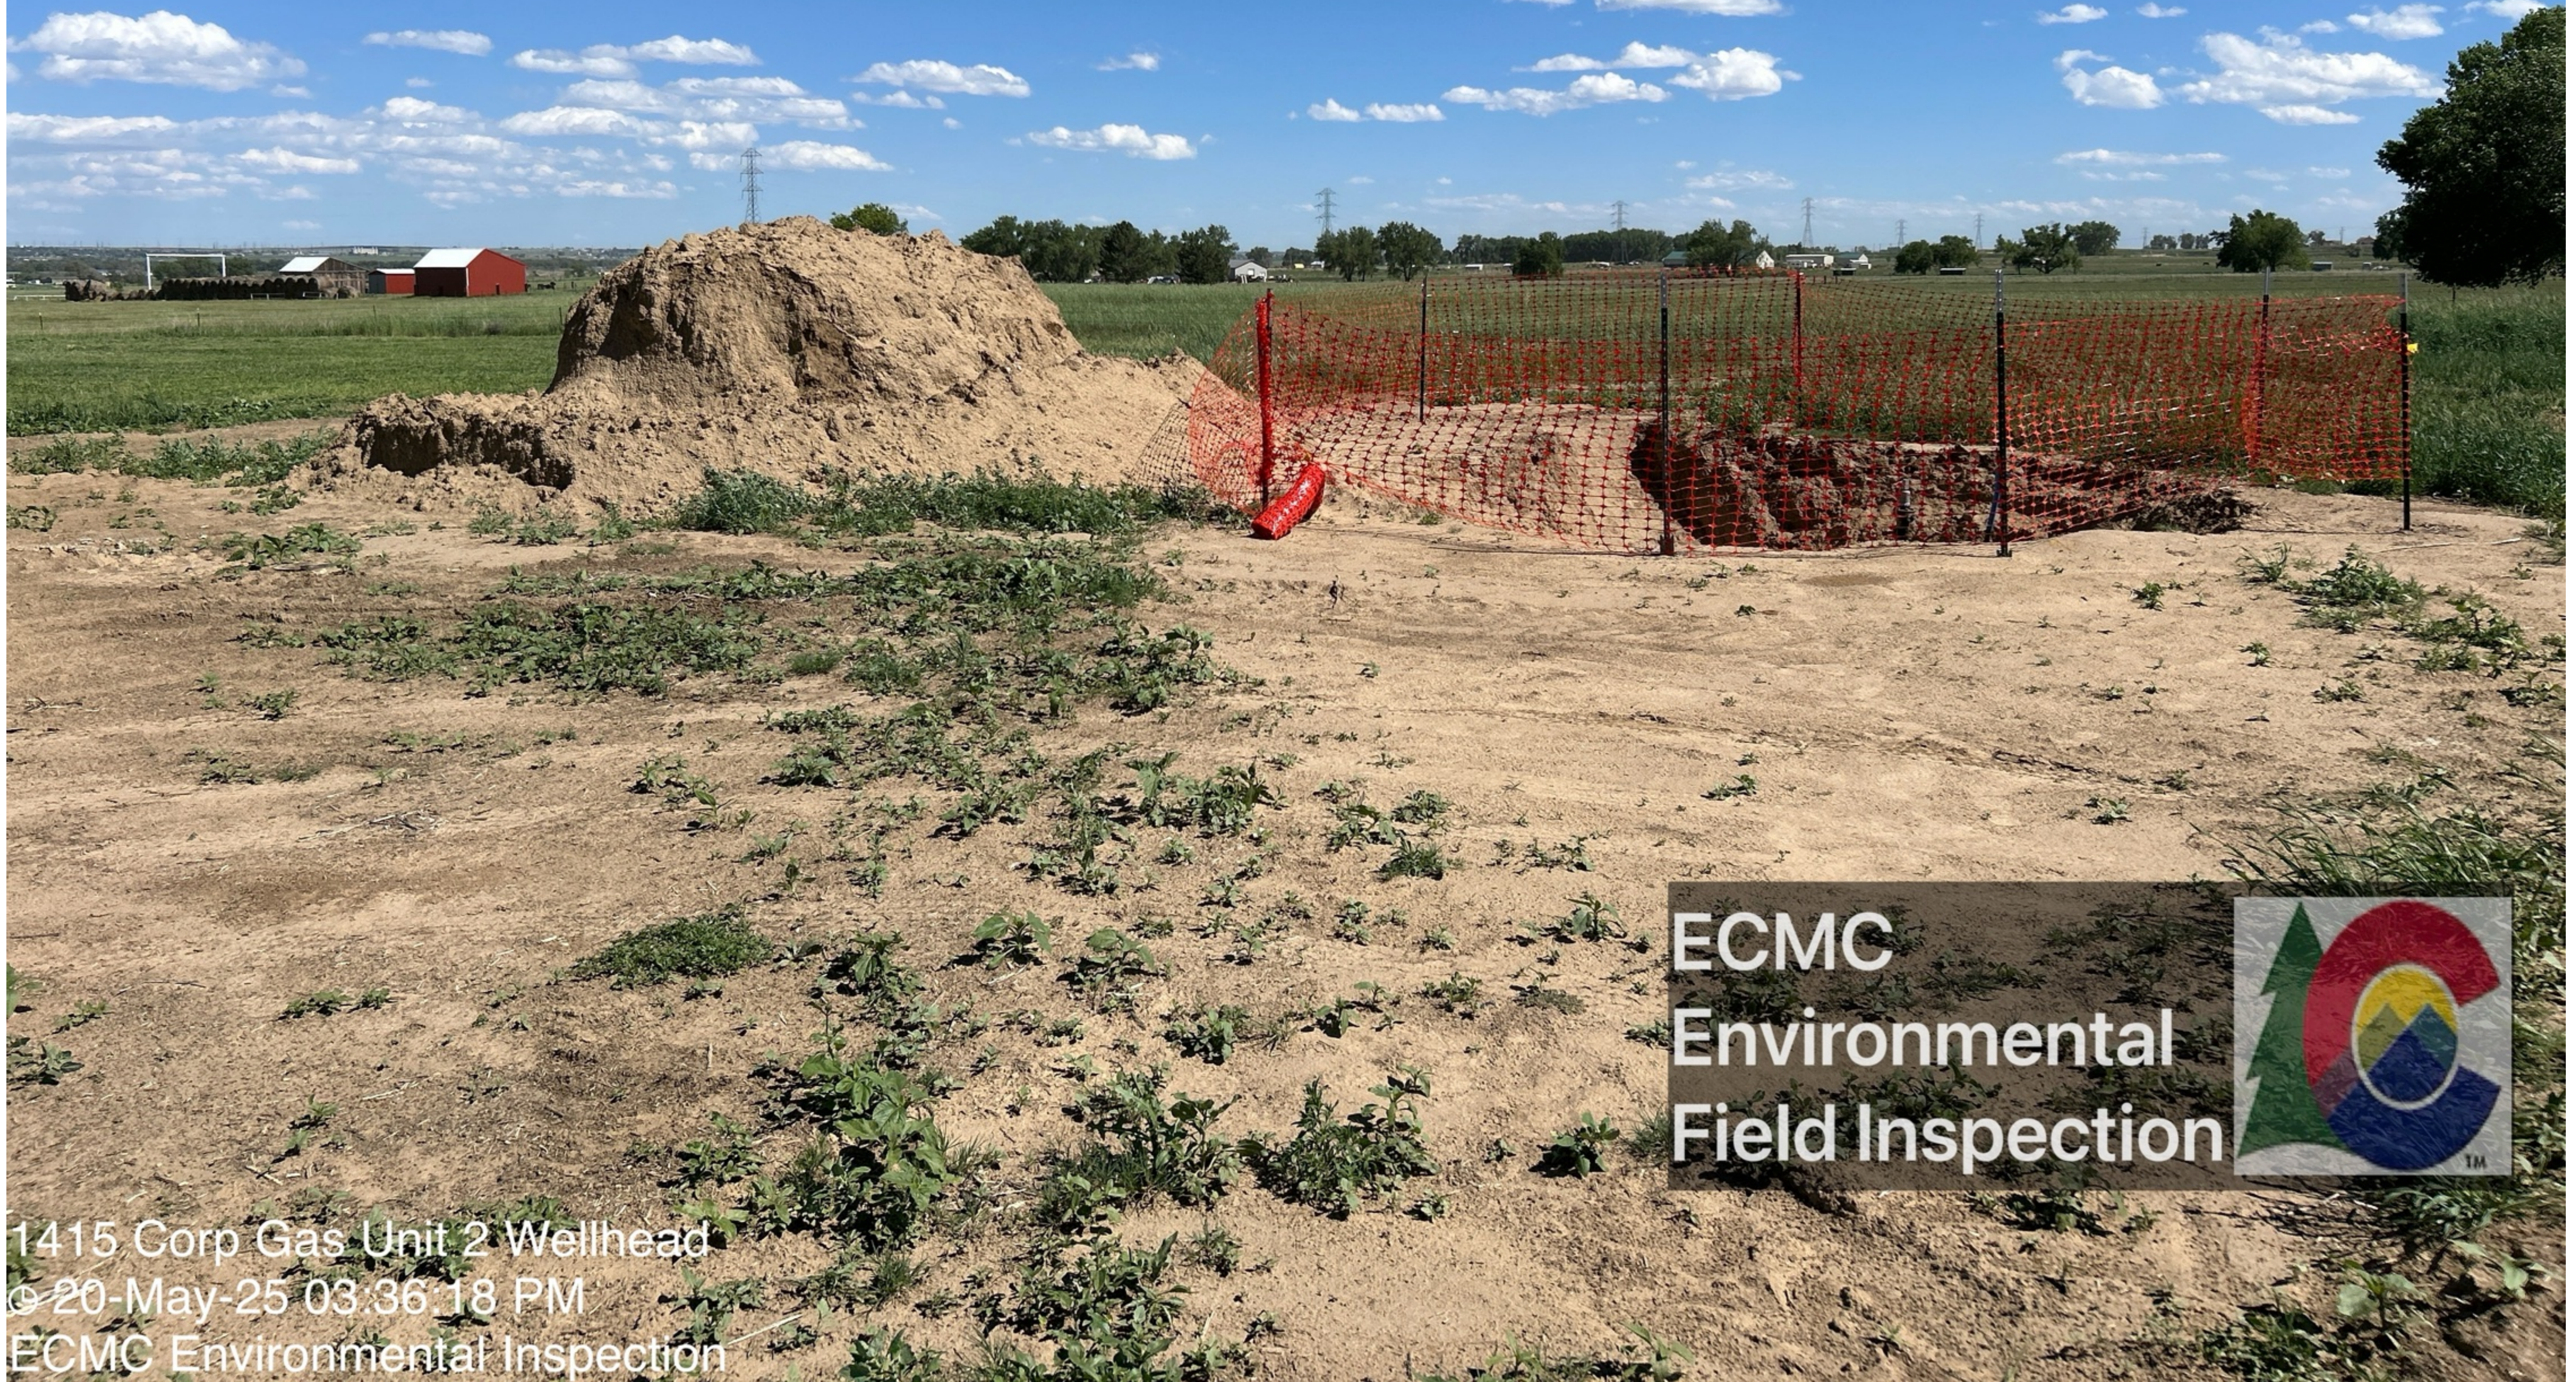
An excavation remains open in the area of the former wellhead. Orange construction fencing surrounds the open excavation. An unmarked soil stockpile was observed on location; no liner was visible.

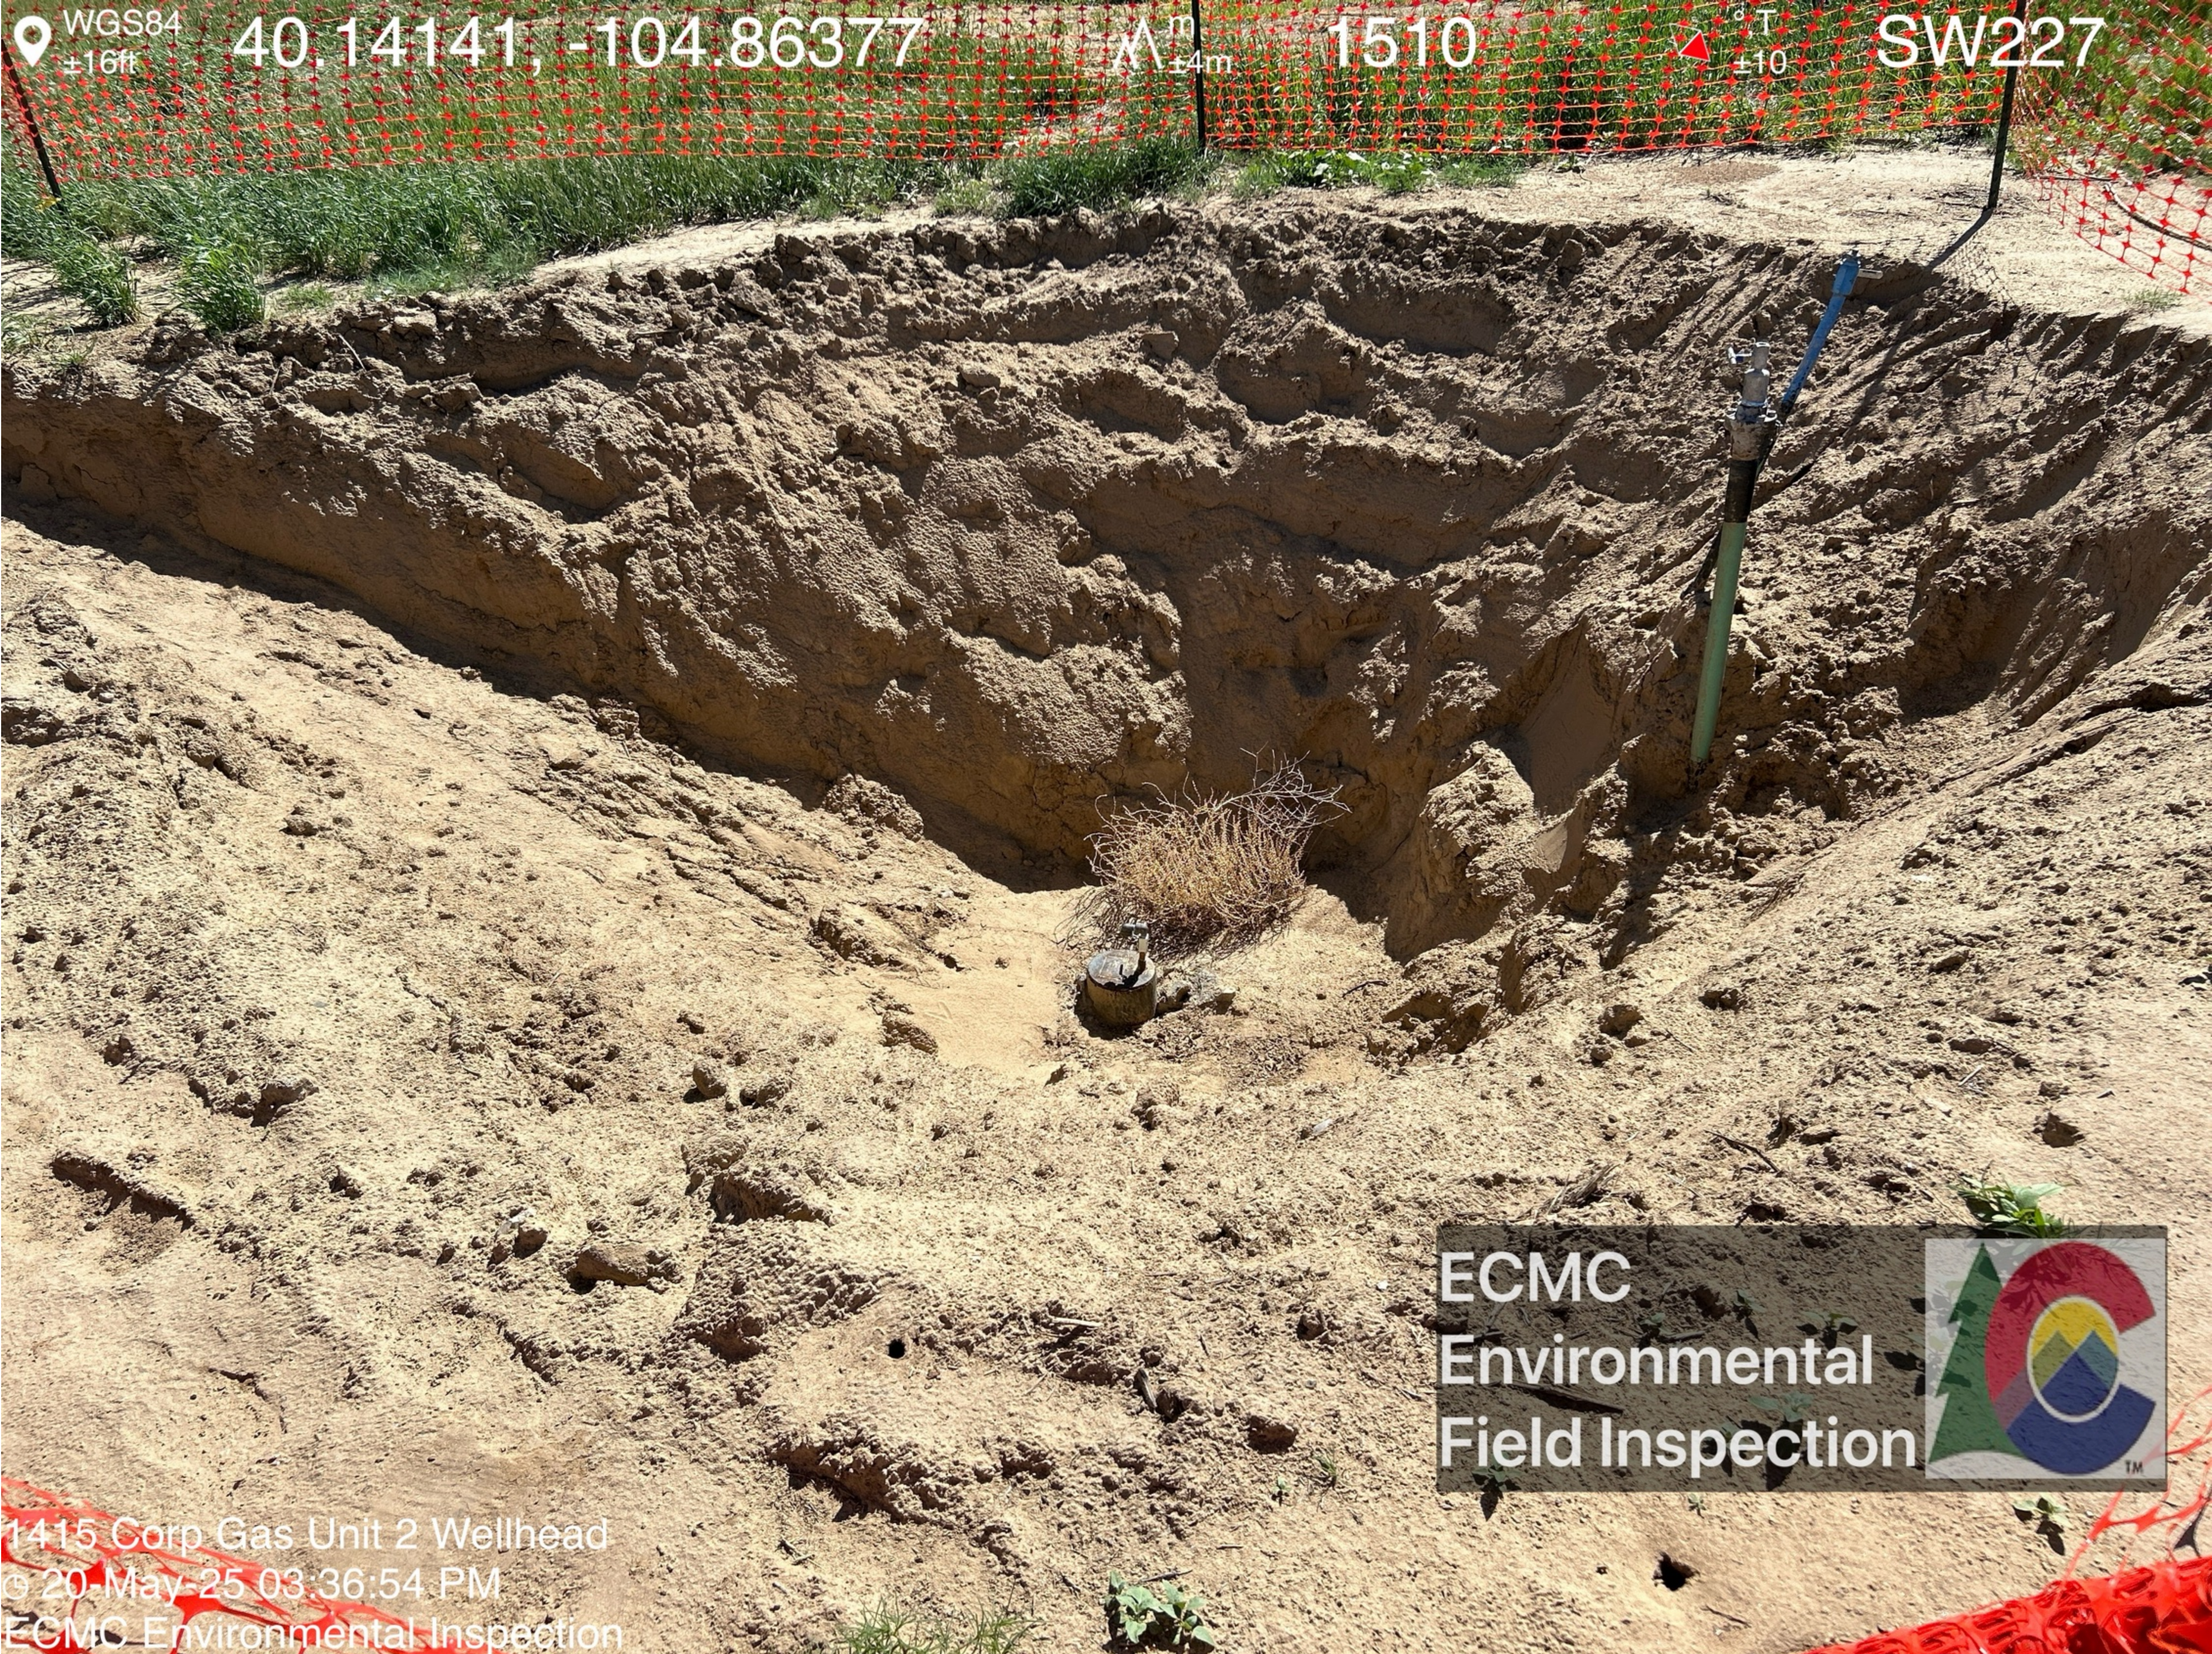
1415 Corp Gas Unit 2 Wellhead
© 20-May-25 03:36:54 PM
ECMC Environmental Inspection

Two risers are visible within the excavation. Debris is visible at the base of the excavation.

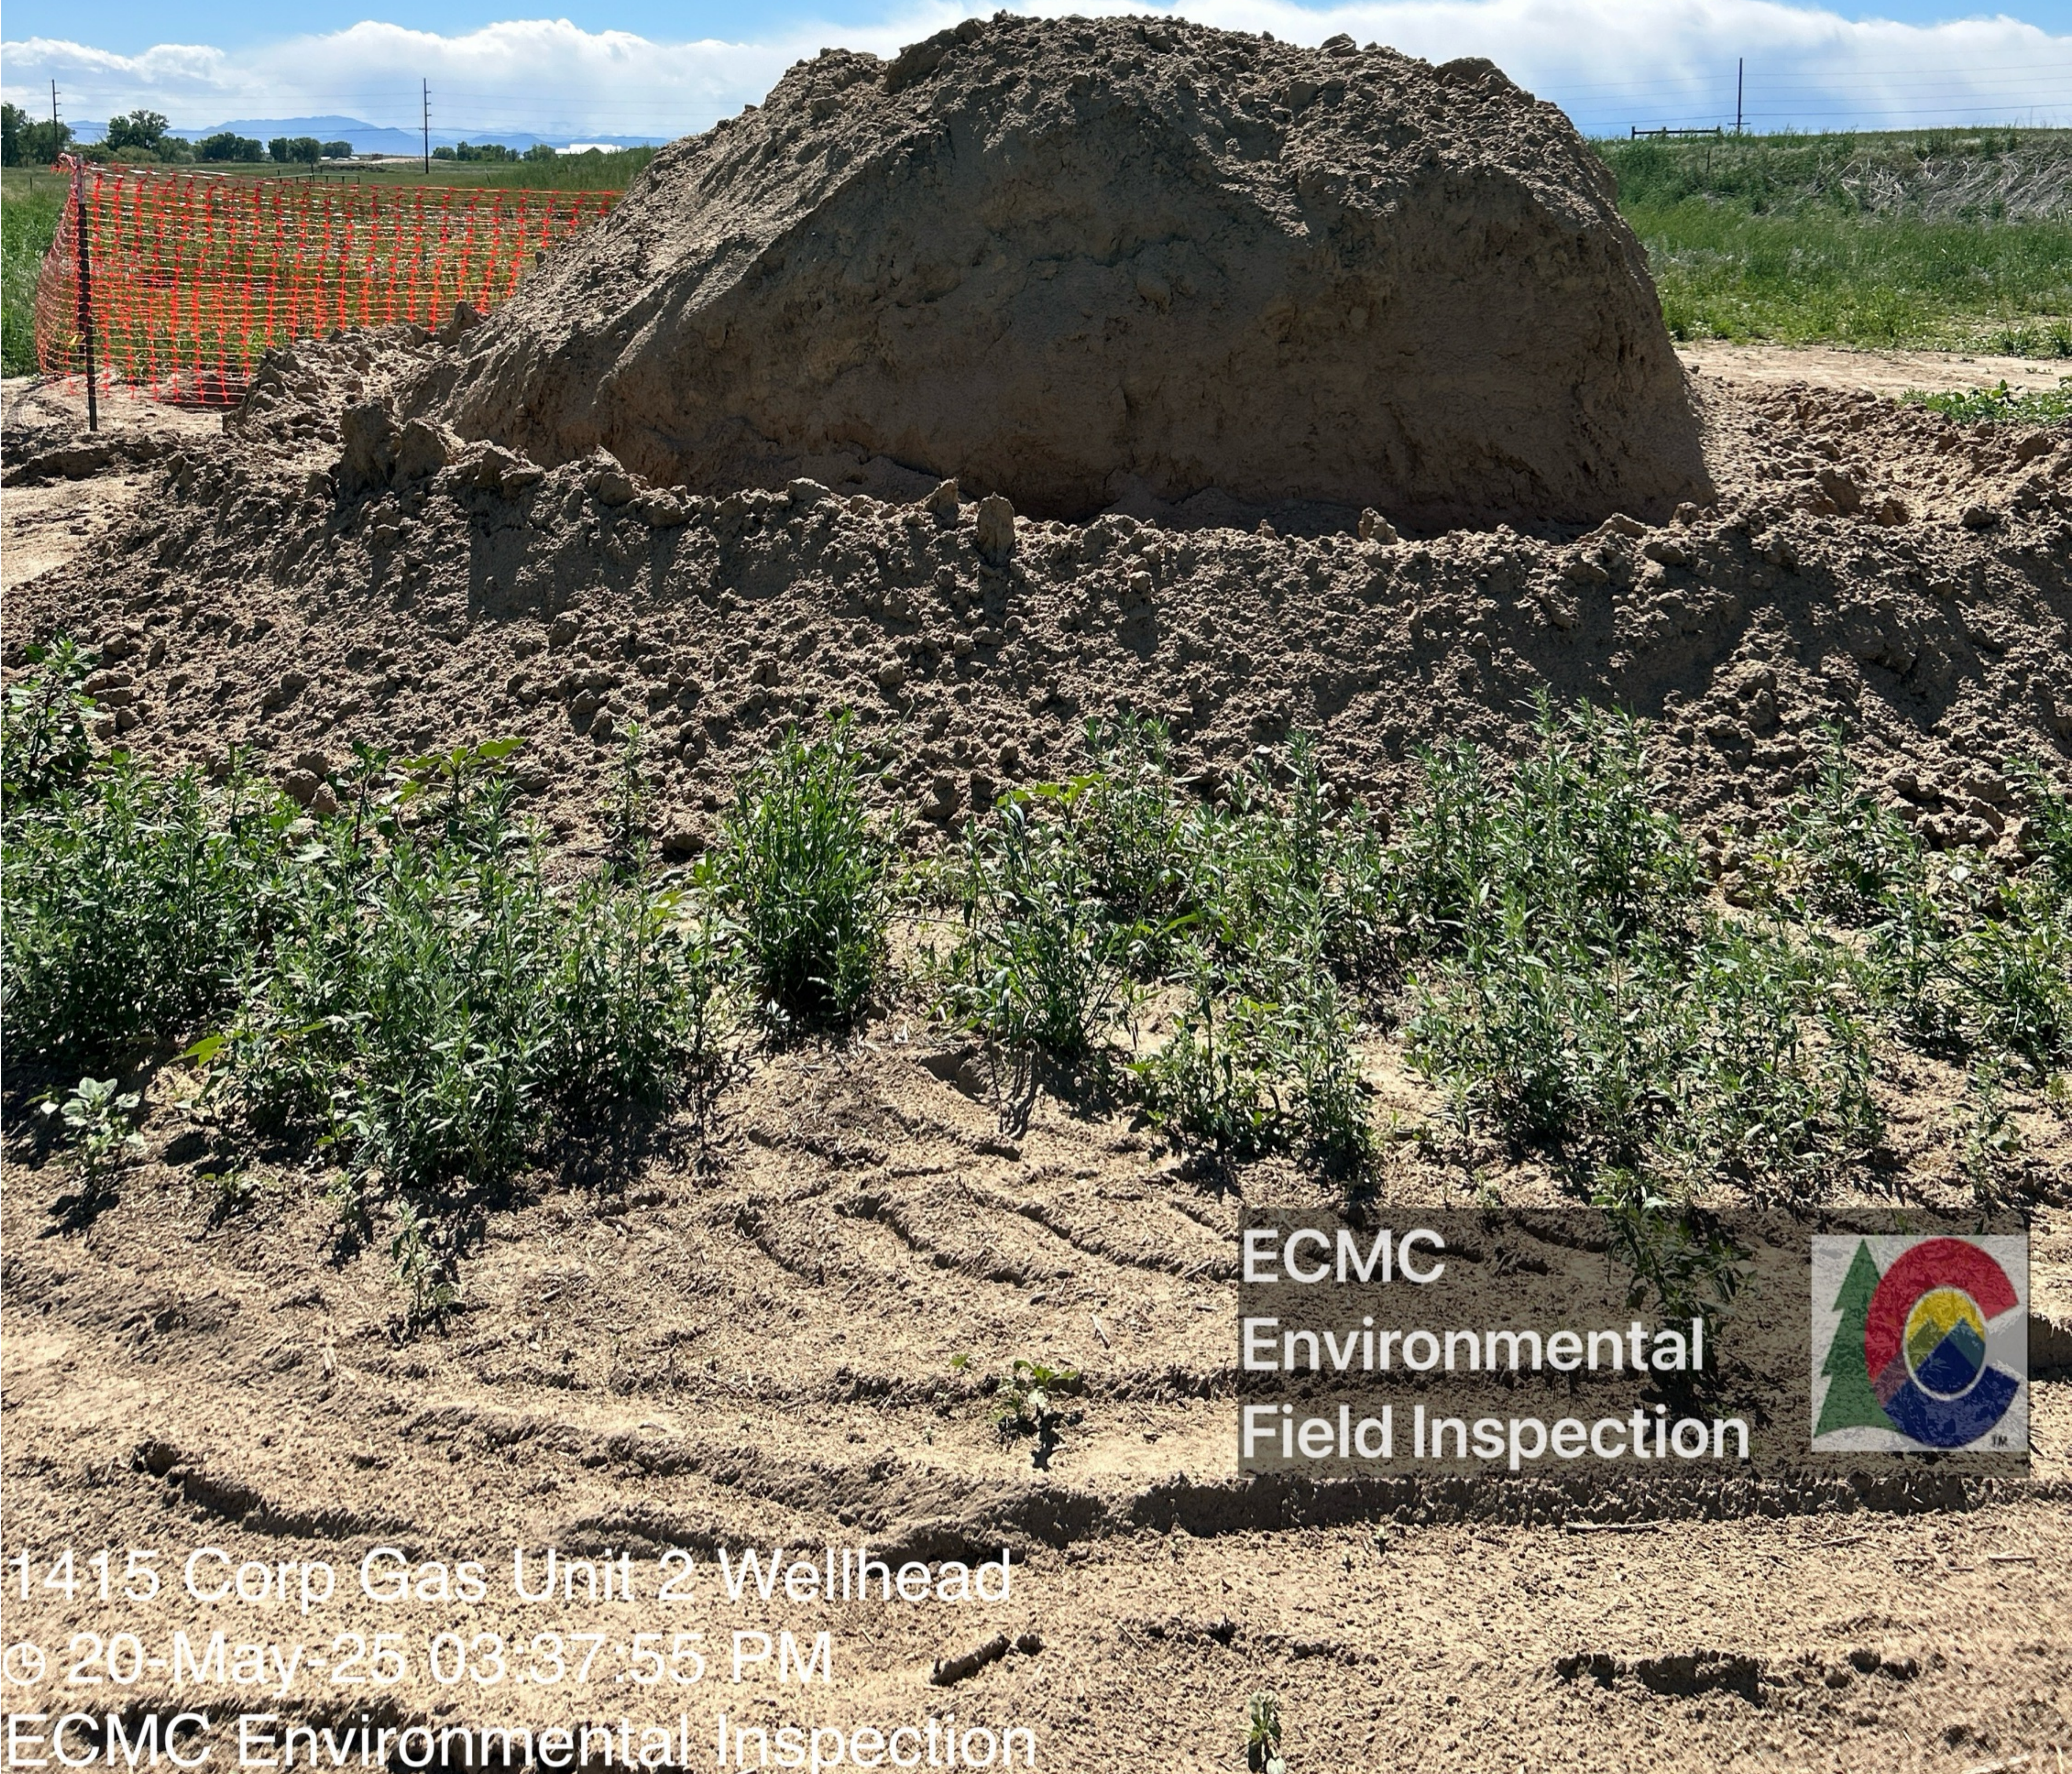
1415 Corp Gas Unit 2 Wellhead
© 20-May-25 03:37:55 PM
ECMC Environmental Inspection

An unmarked soil stockpile was observed on location; no liner was visible.
