ECMC
Environmental
Field Inspection

Sidney Strear Well No. 1
© 16-May-25 12:51:04 PM
ECMC Environmental Inspection

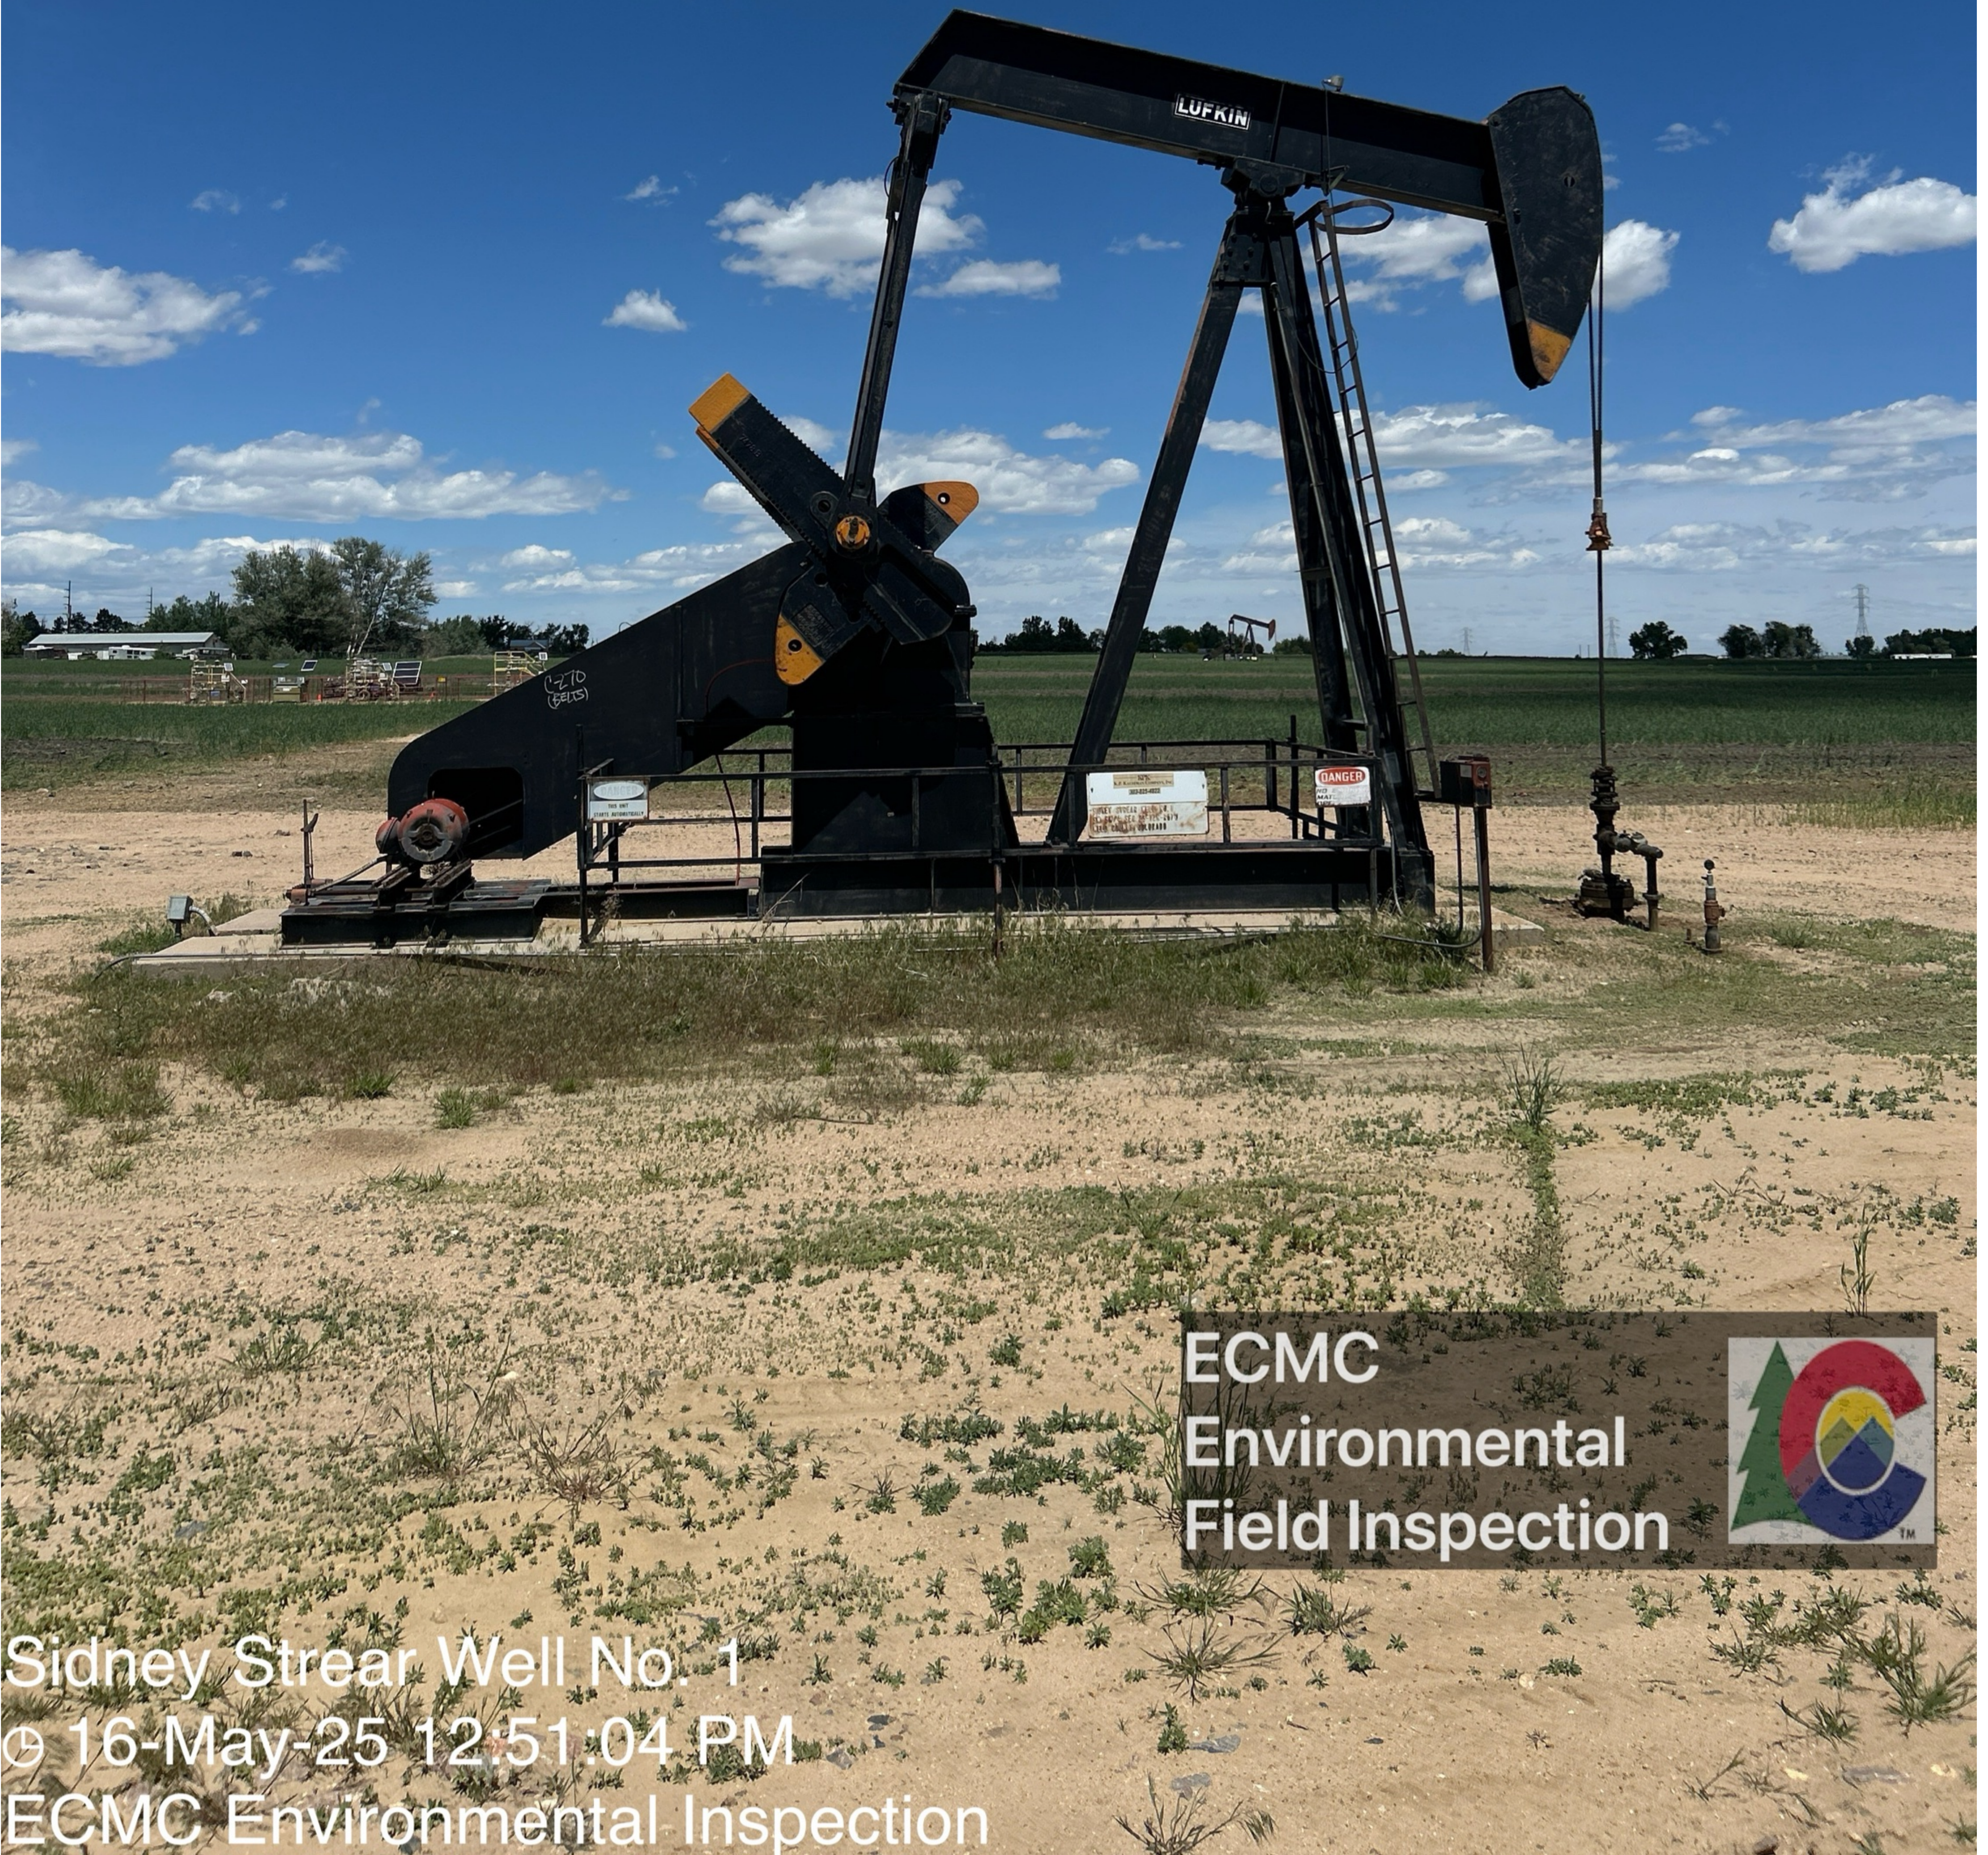
Signage with emergency contact number is visible. Weeds are visible adjacent to the wellhead.

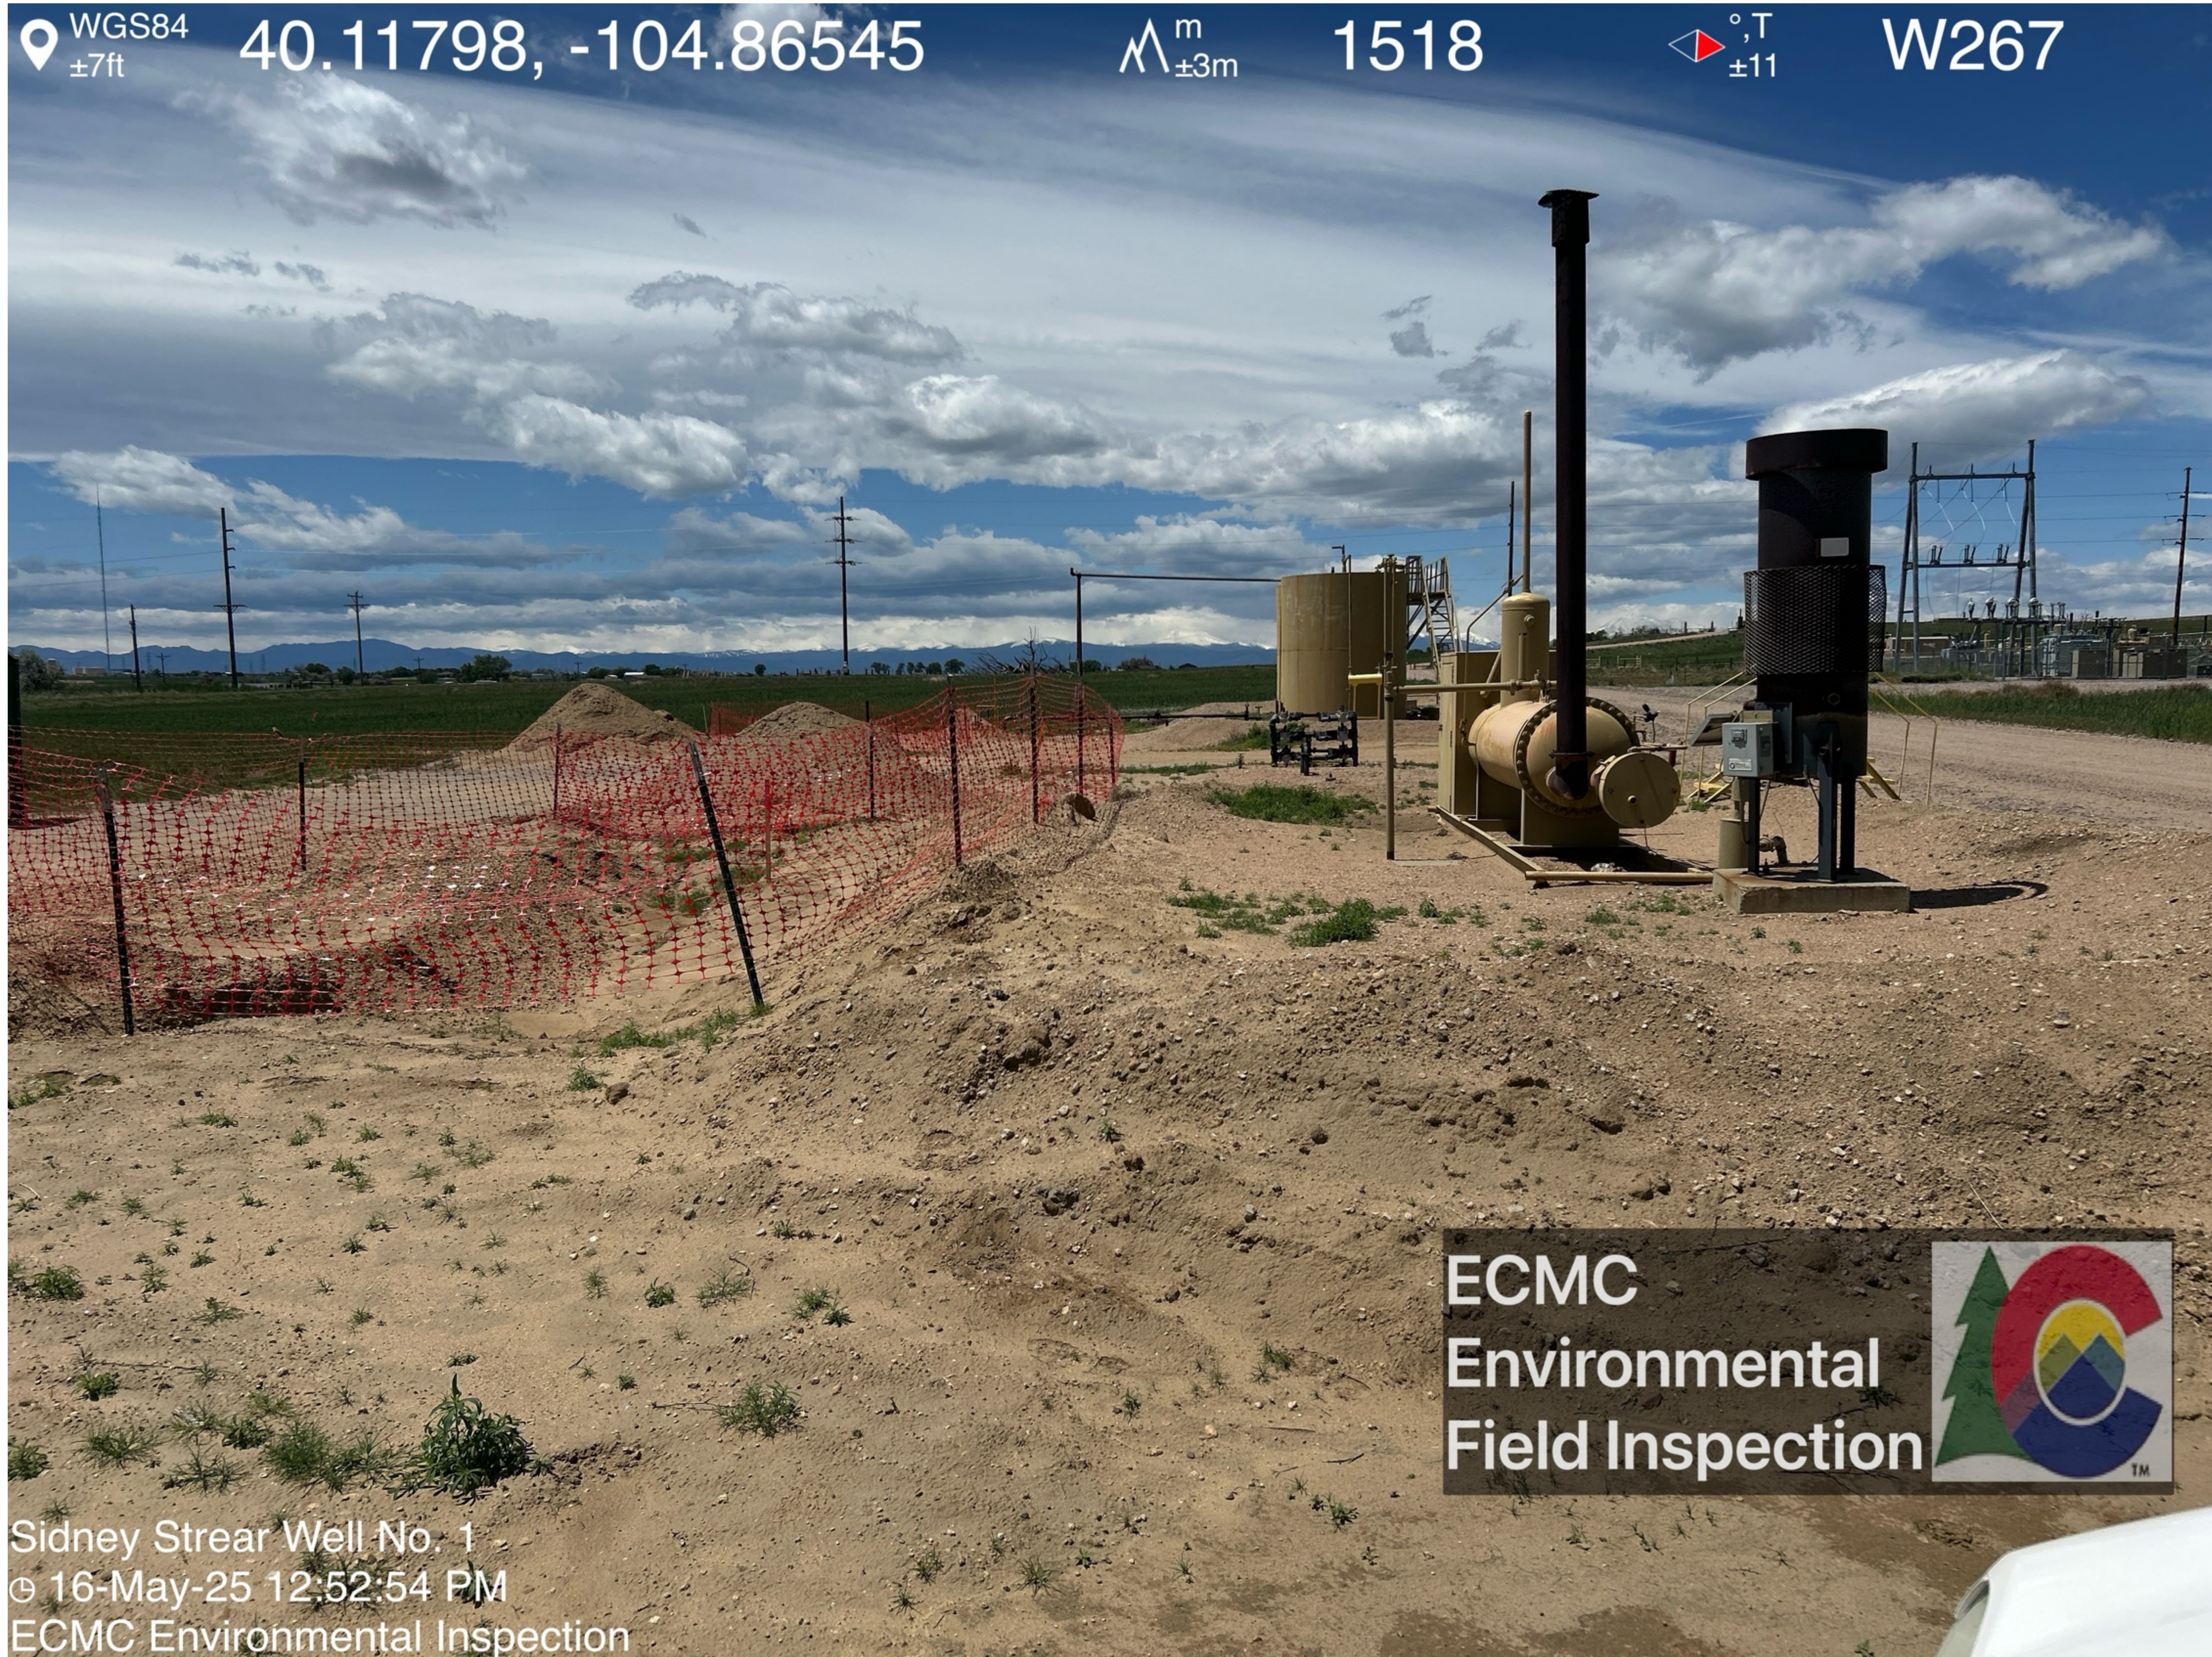
Separator and ECD visible in the foreground on the right side of the picture. The production tank is visible in the background on the right side of the picture.

The excavation and stockpiles on the left side of the picture correspond to another facility and will be addressed in a separate inspection.

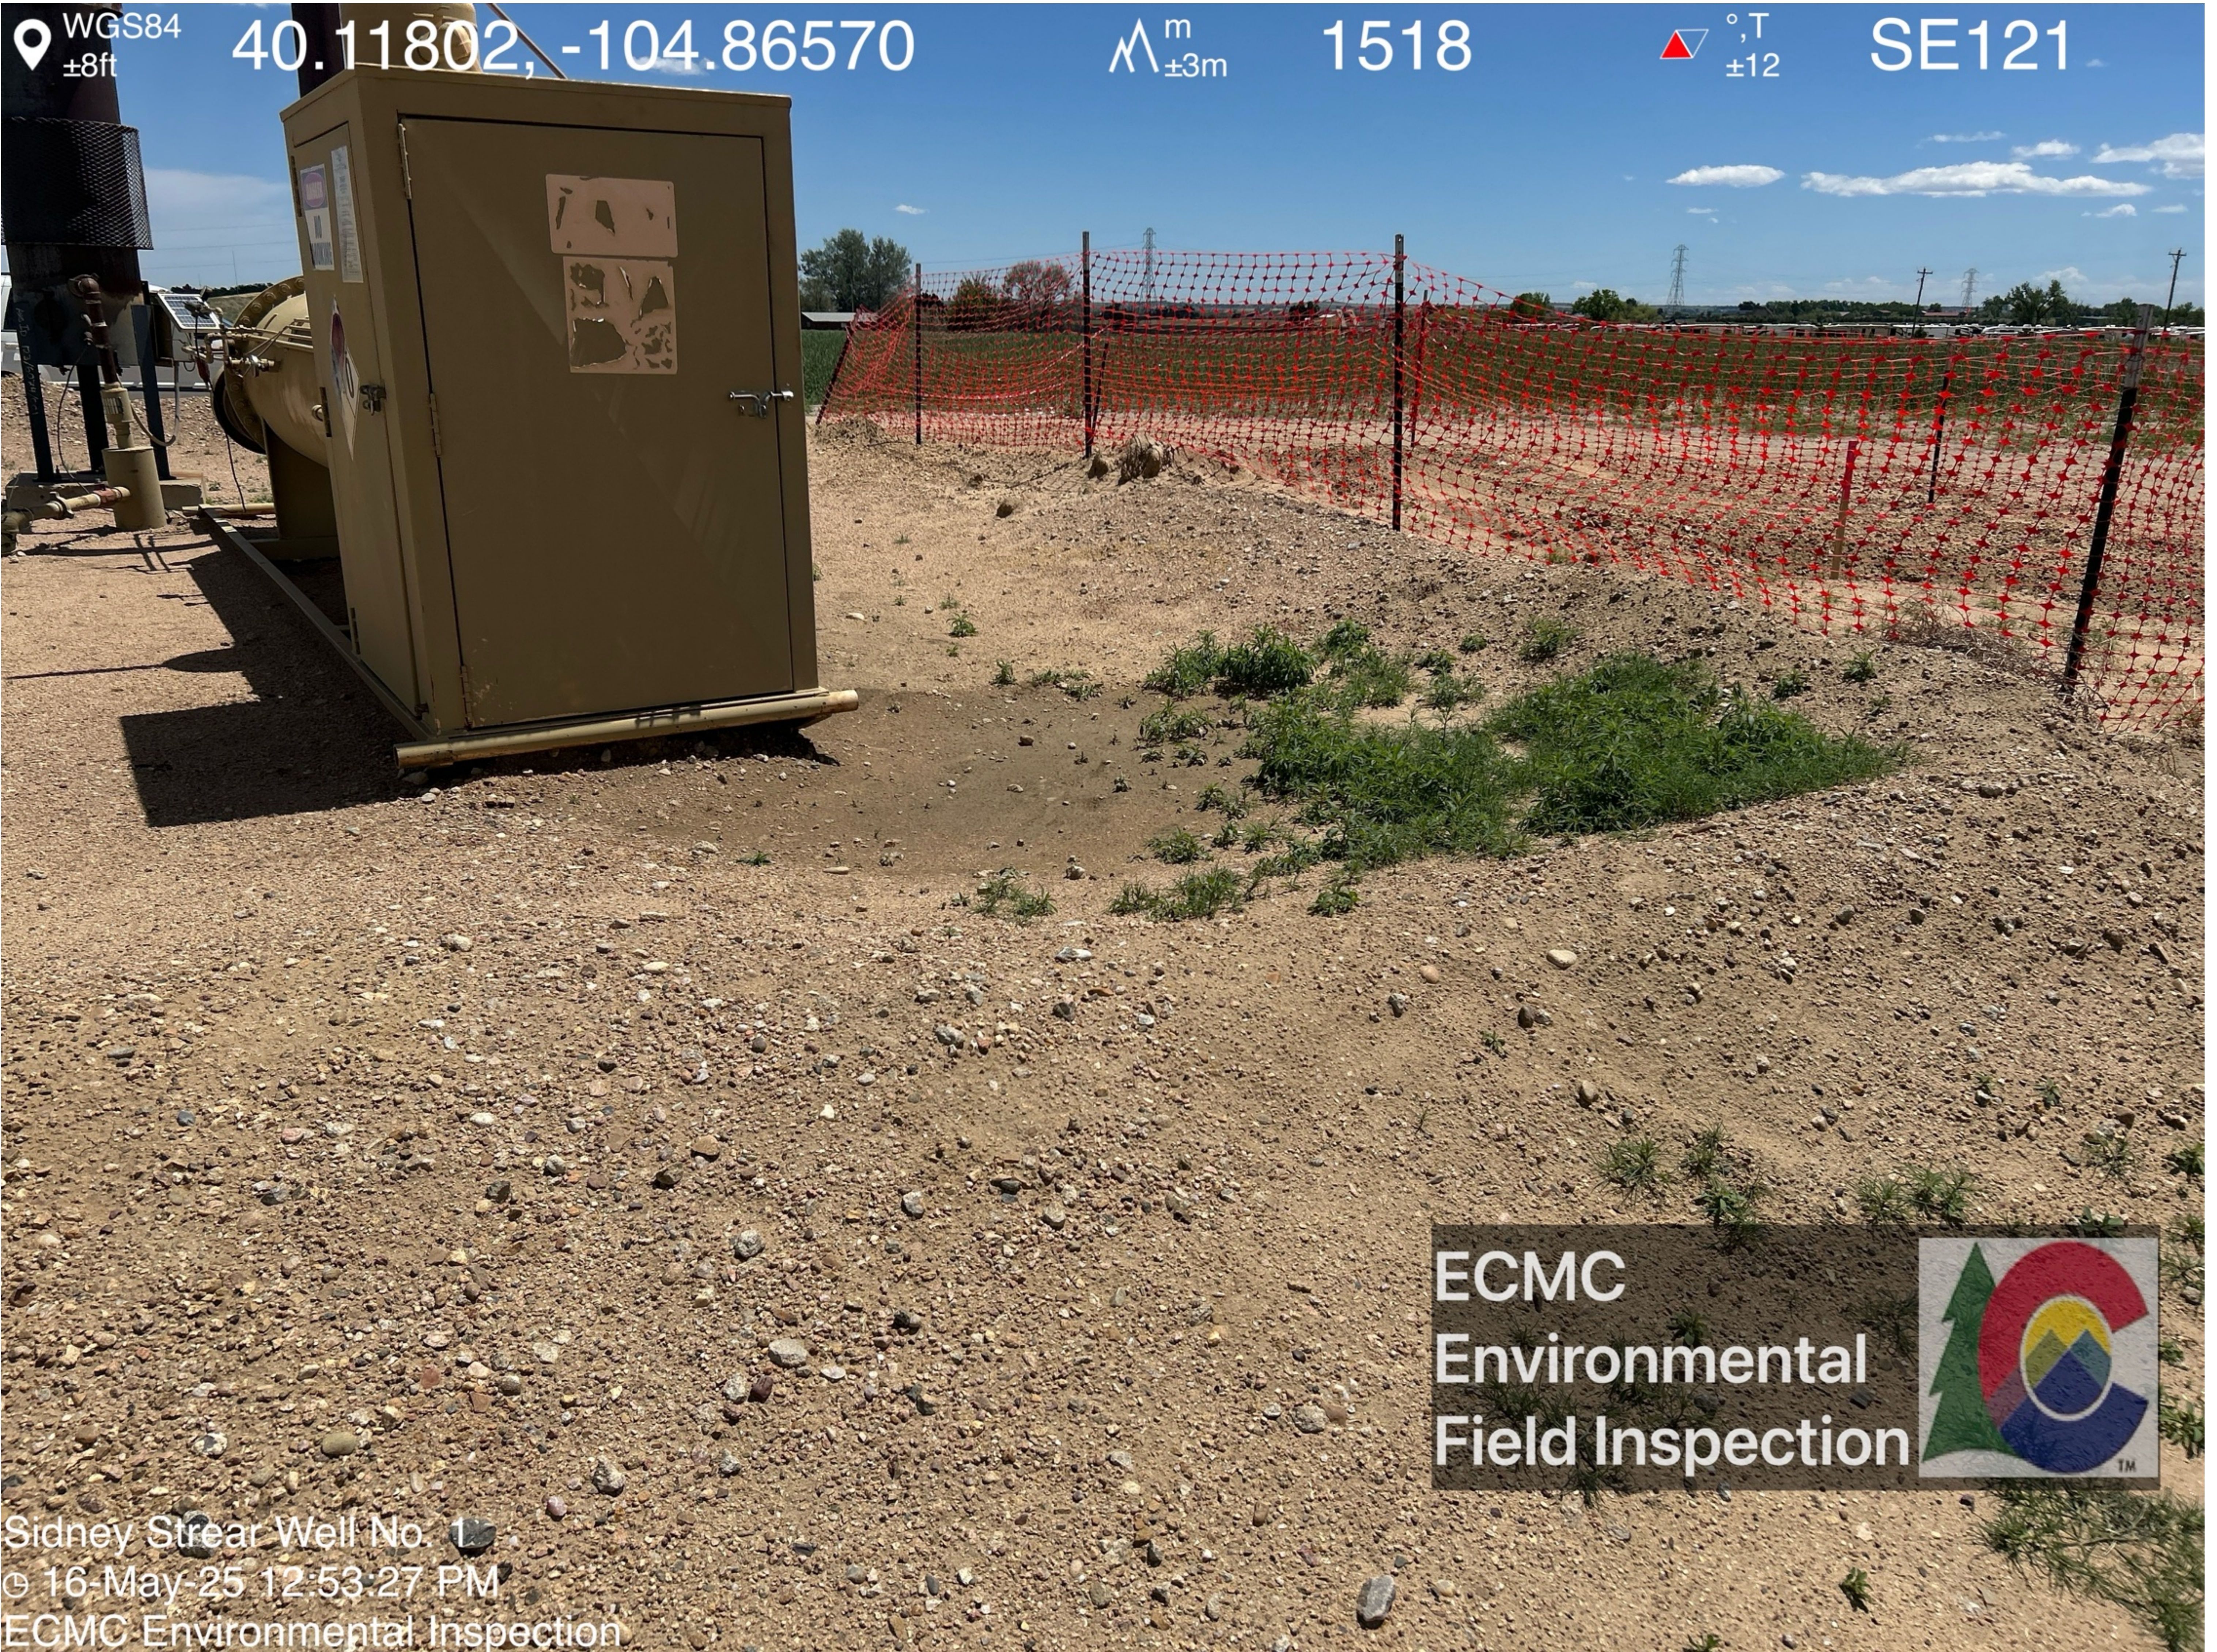
Separator and ECD visible on the left side of the picture. Weeds are visible within the separator berm.

The excavation on the right side of the picture corresponds to another facility and will be addressed in a separate inspection.

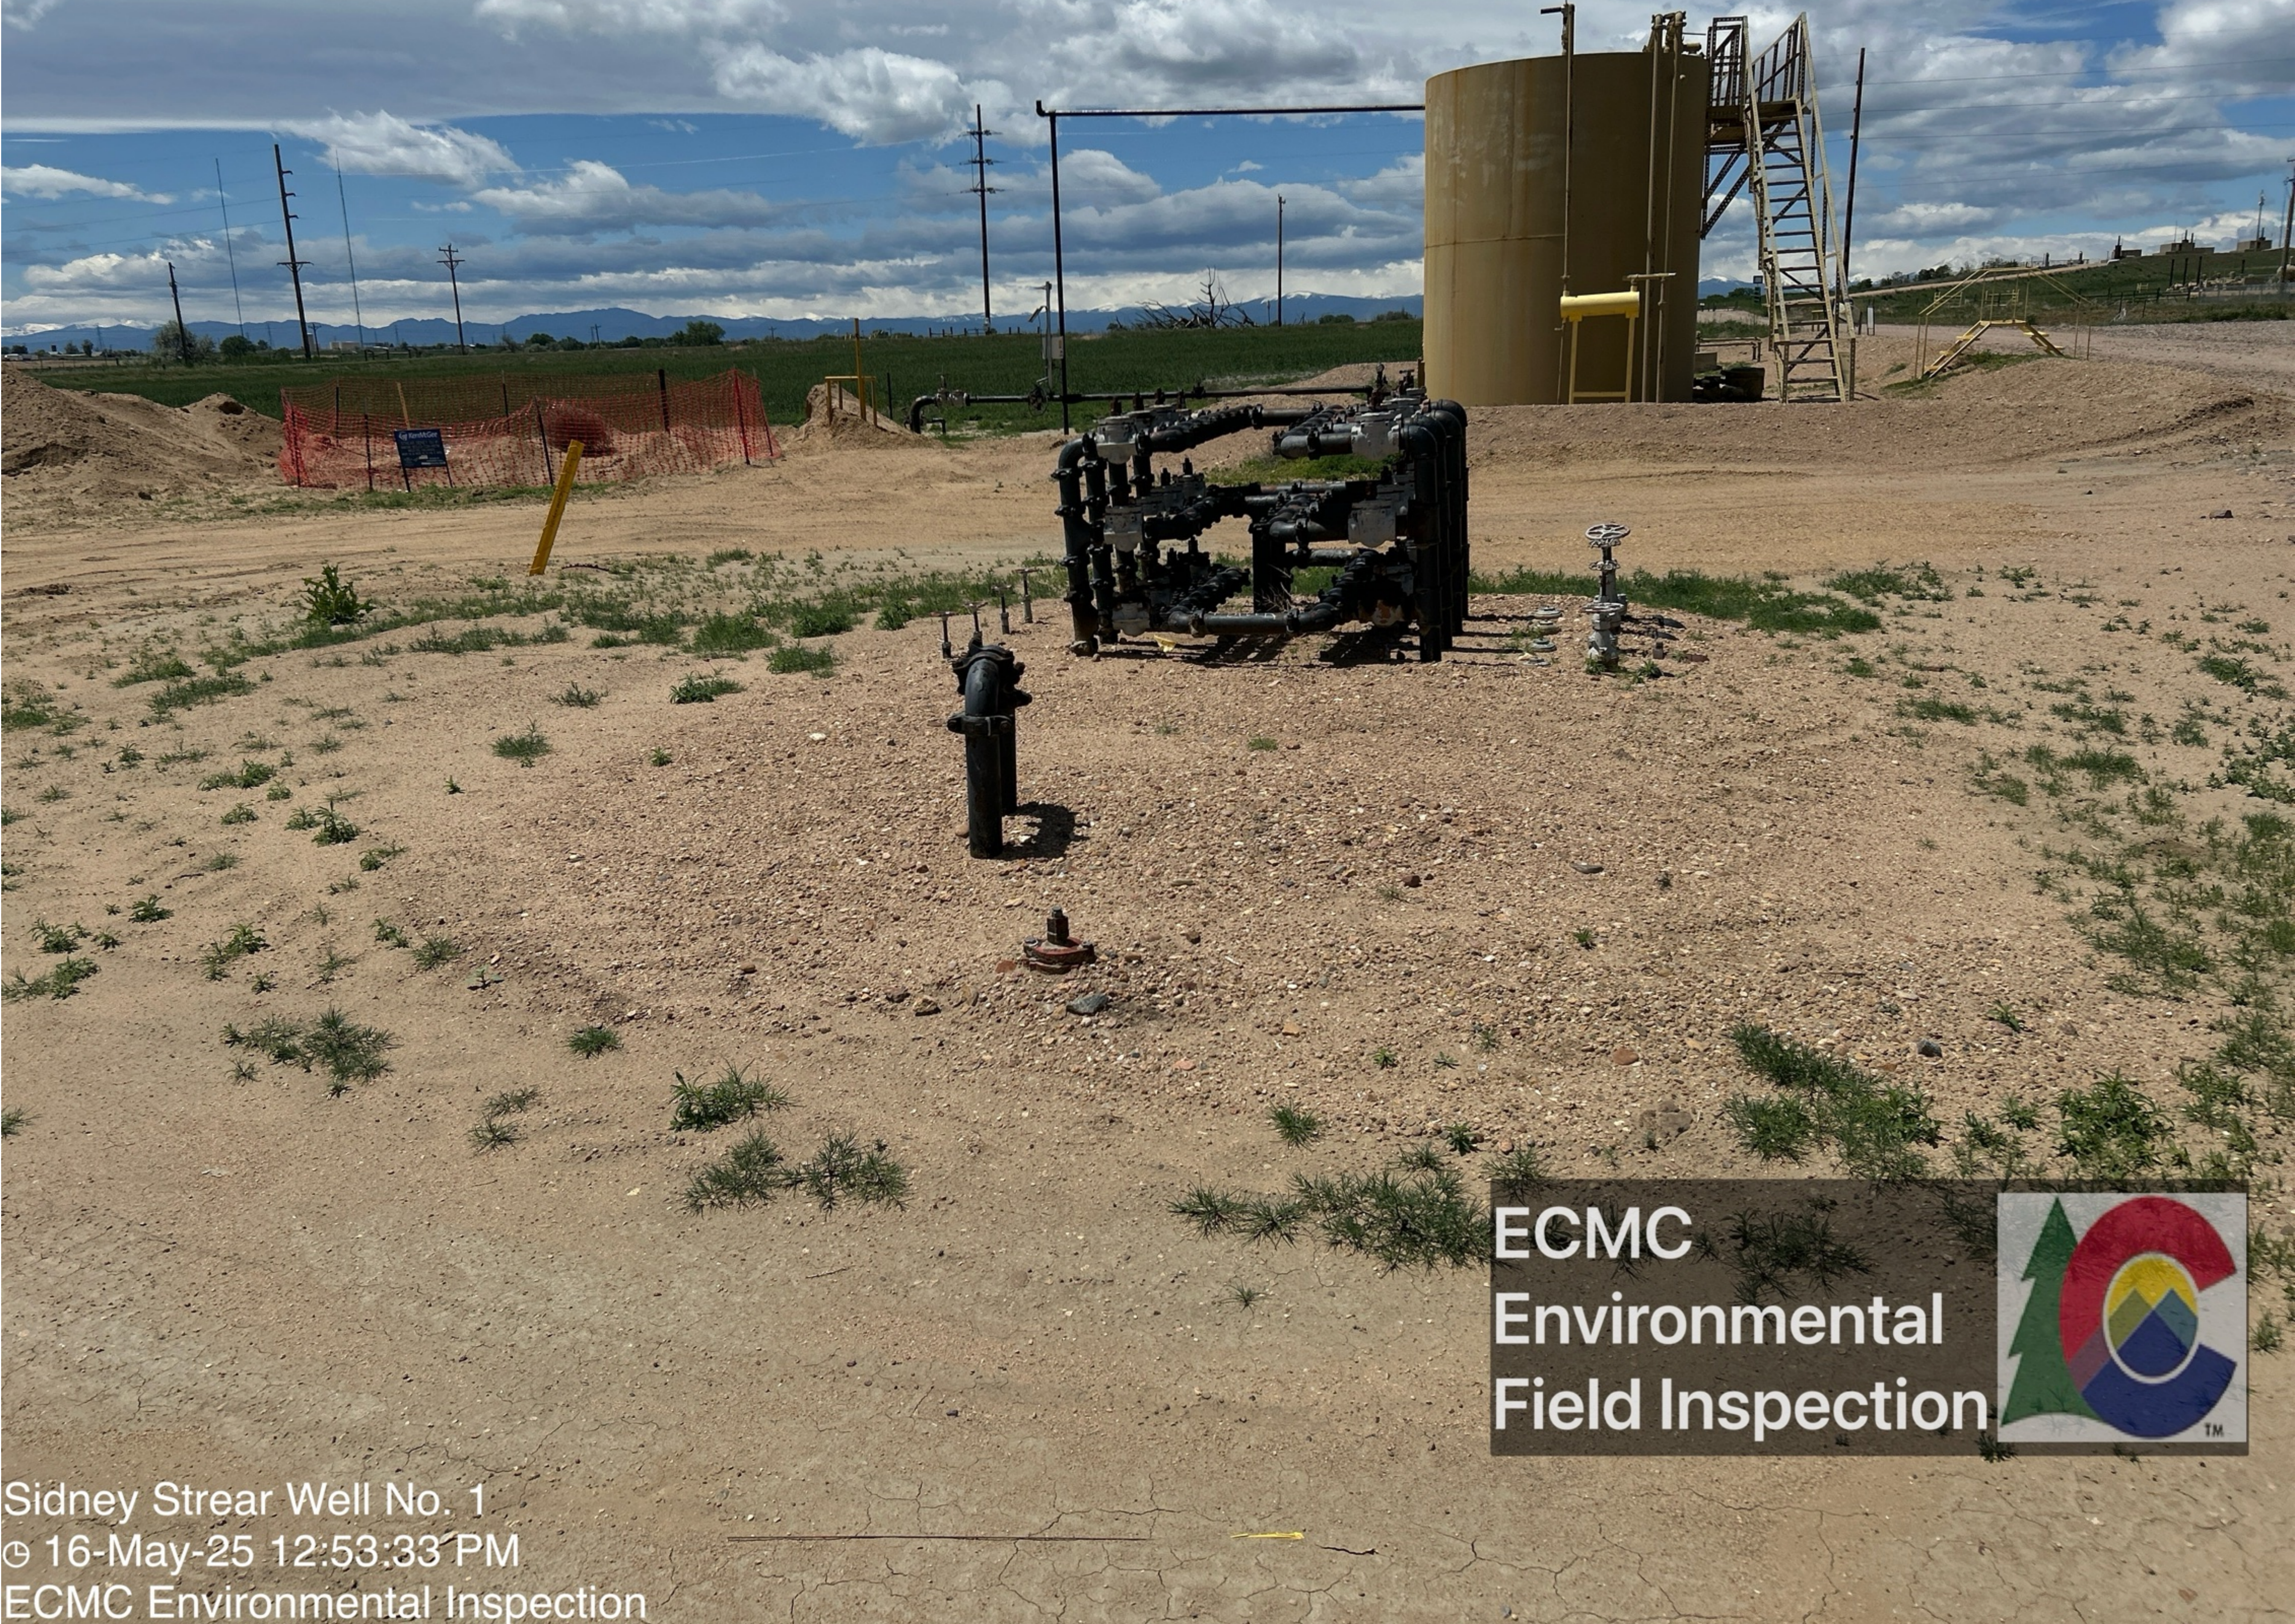
Manifolds are visible in the center of the picture.

The excavation on the left side of the picture corresponds to another facility and will be addressed in a separate inspection..

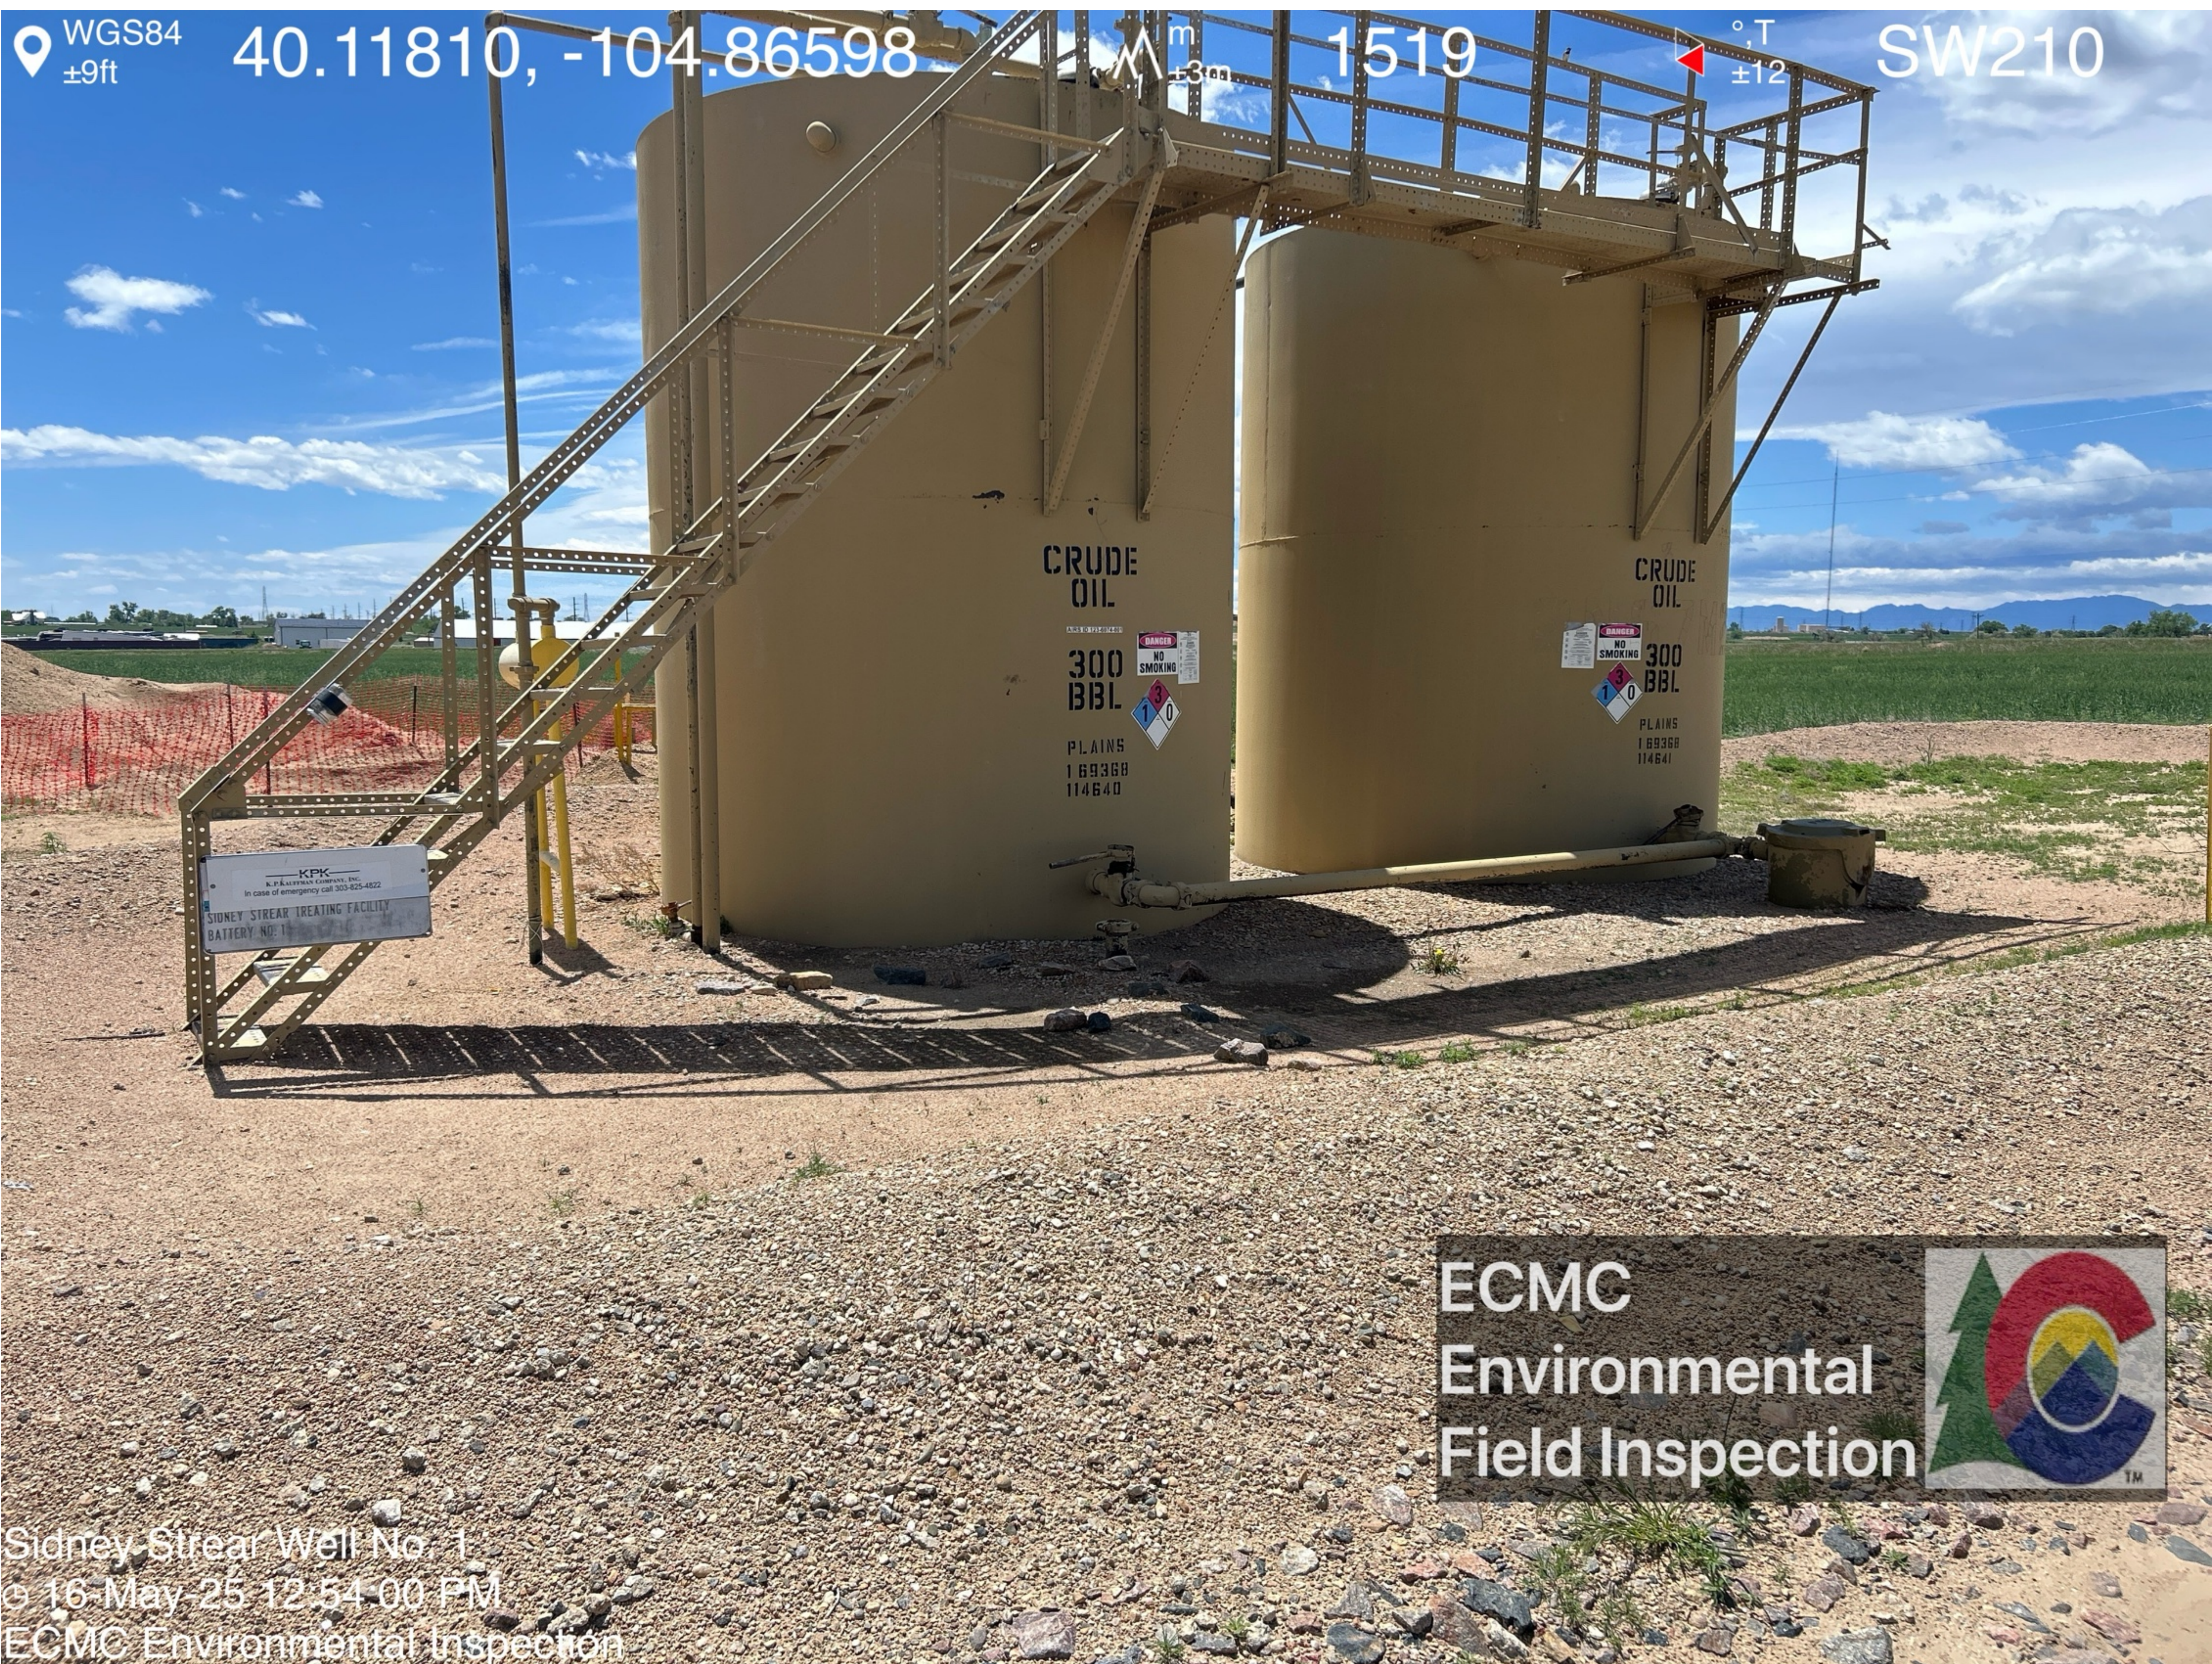
Placards/labels are visible on two production tanks. Signage with emergency contact number is visible.

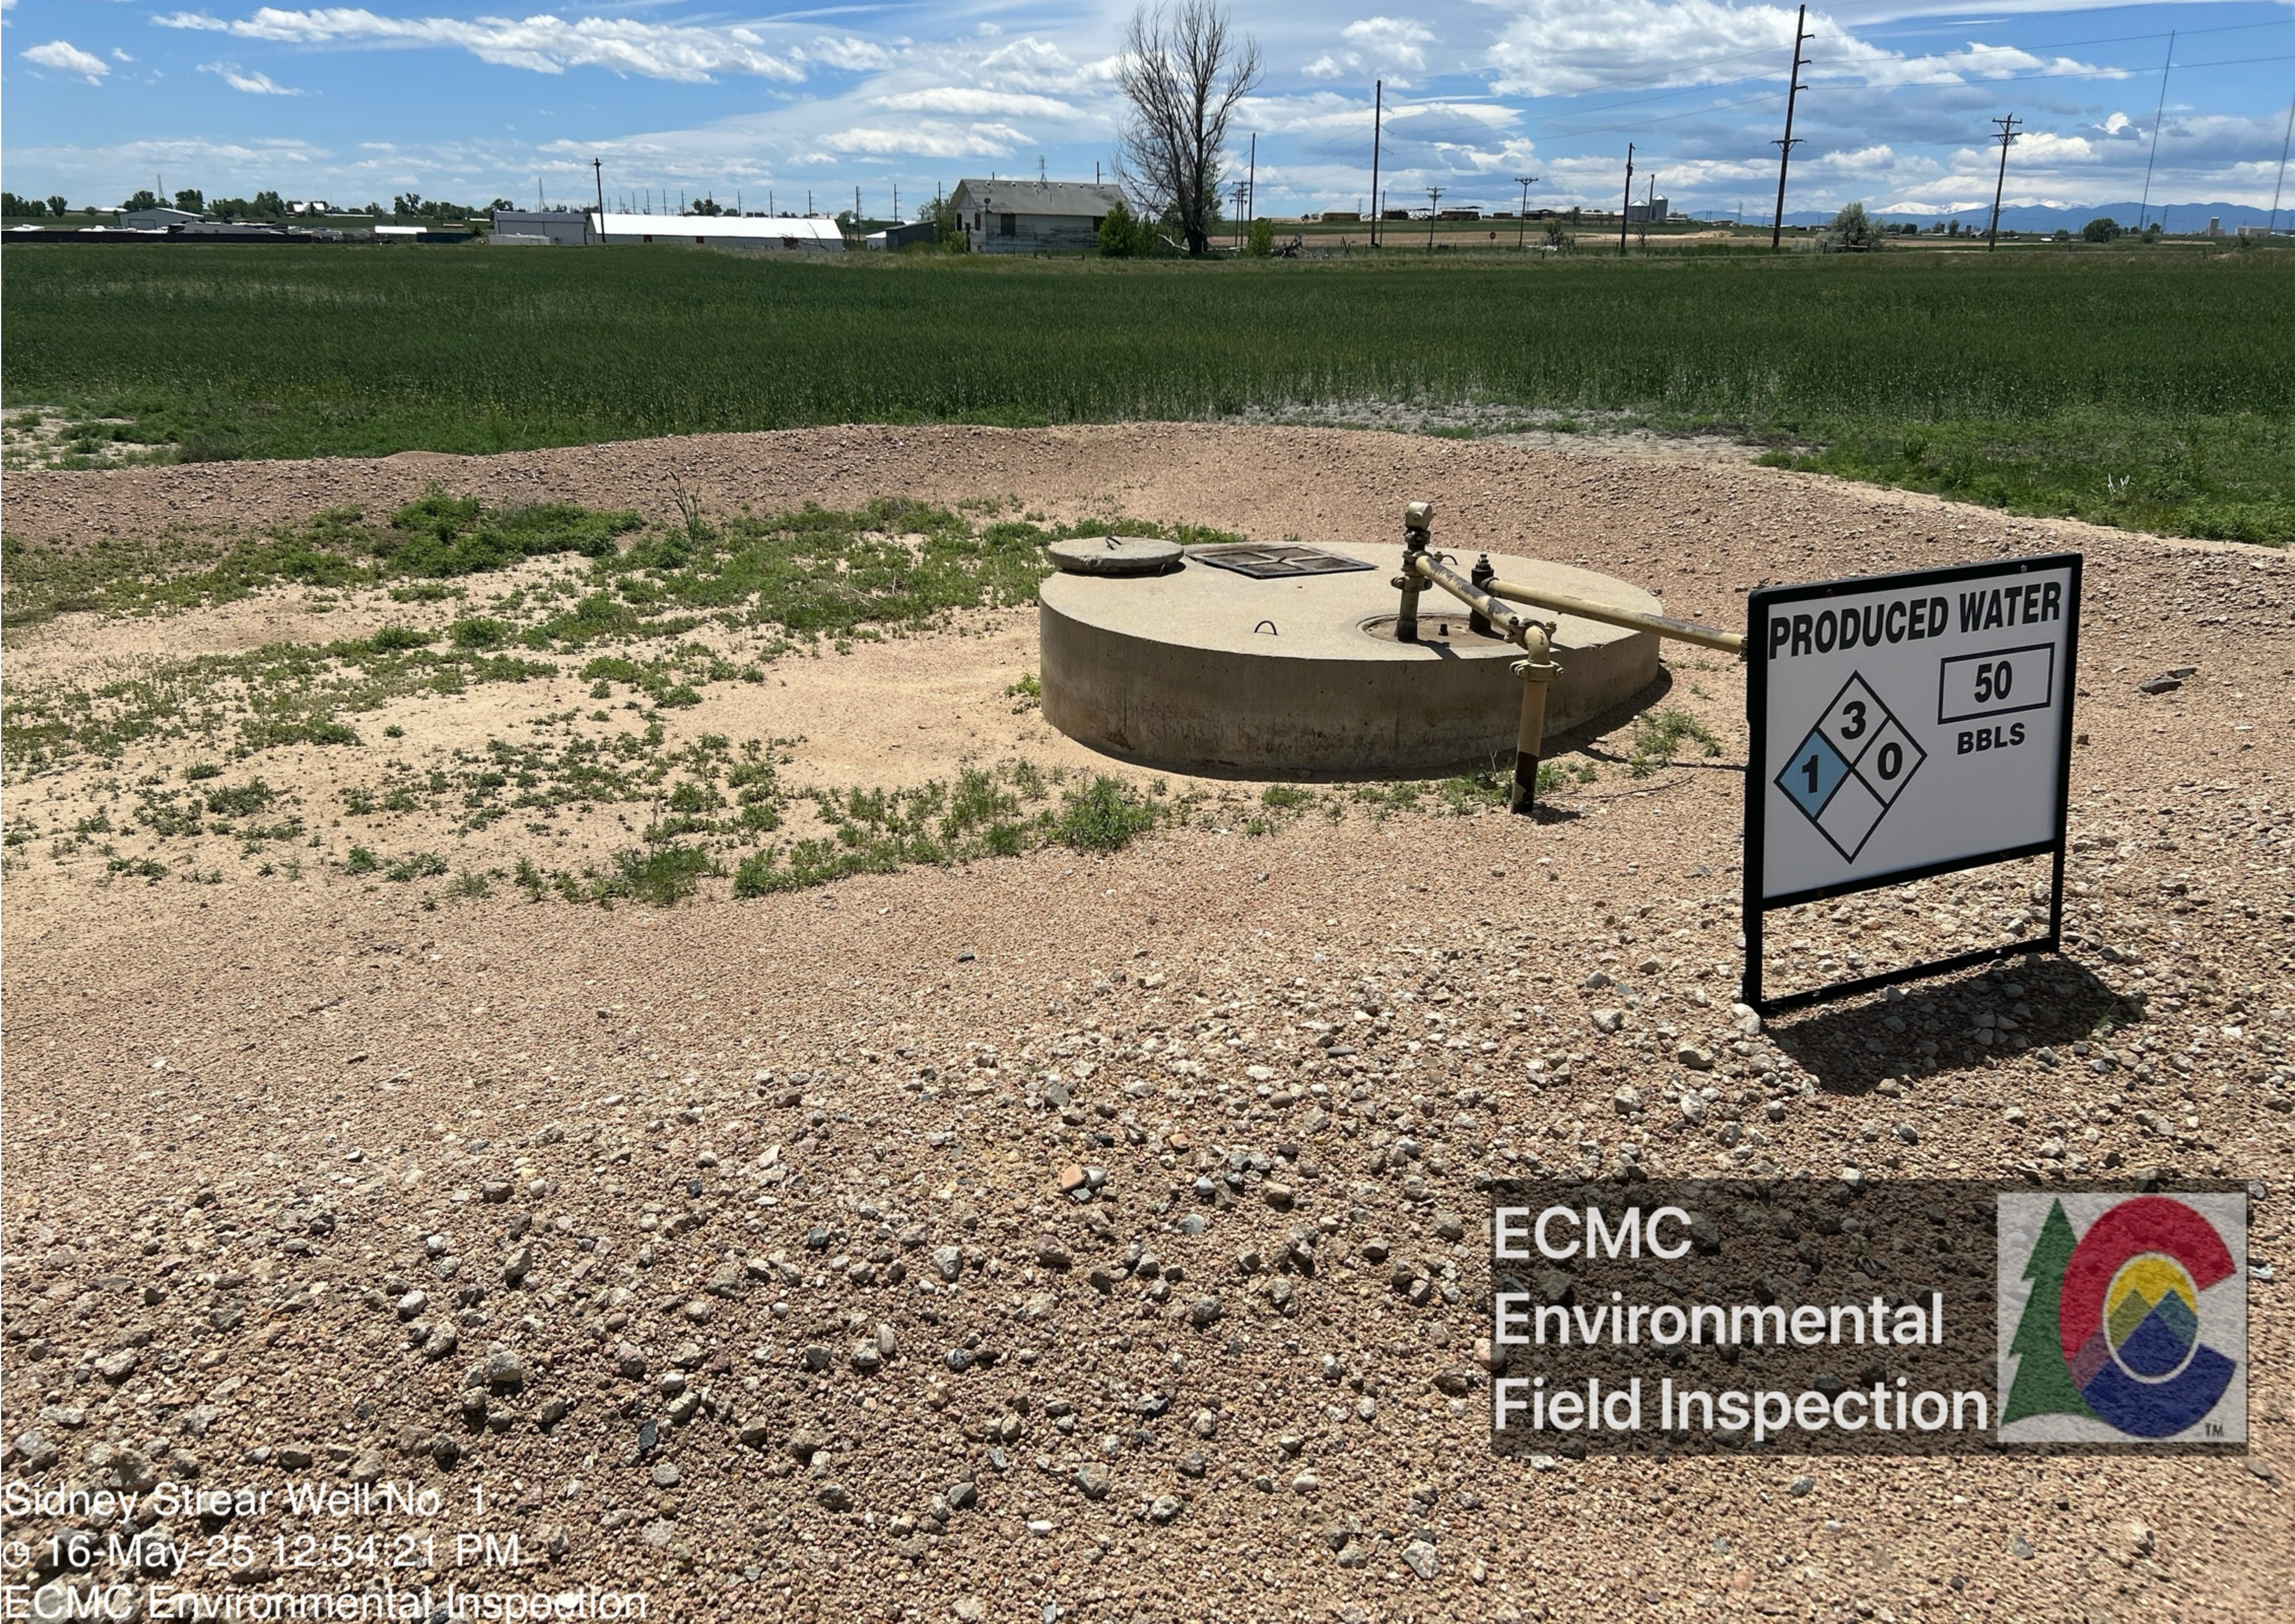
Weeds are visible within the shared production tank and produced water vessel berm.
