Donald B Smith Unit 1 Flowline
© 16-May-25 10:35:15 AM
ECMC Environmental Inspection

ECMC
Environmental
Field Inspection

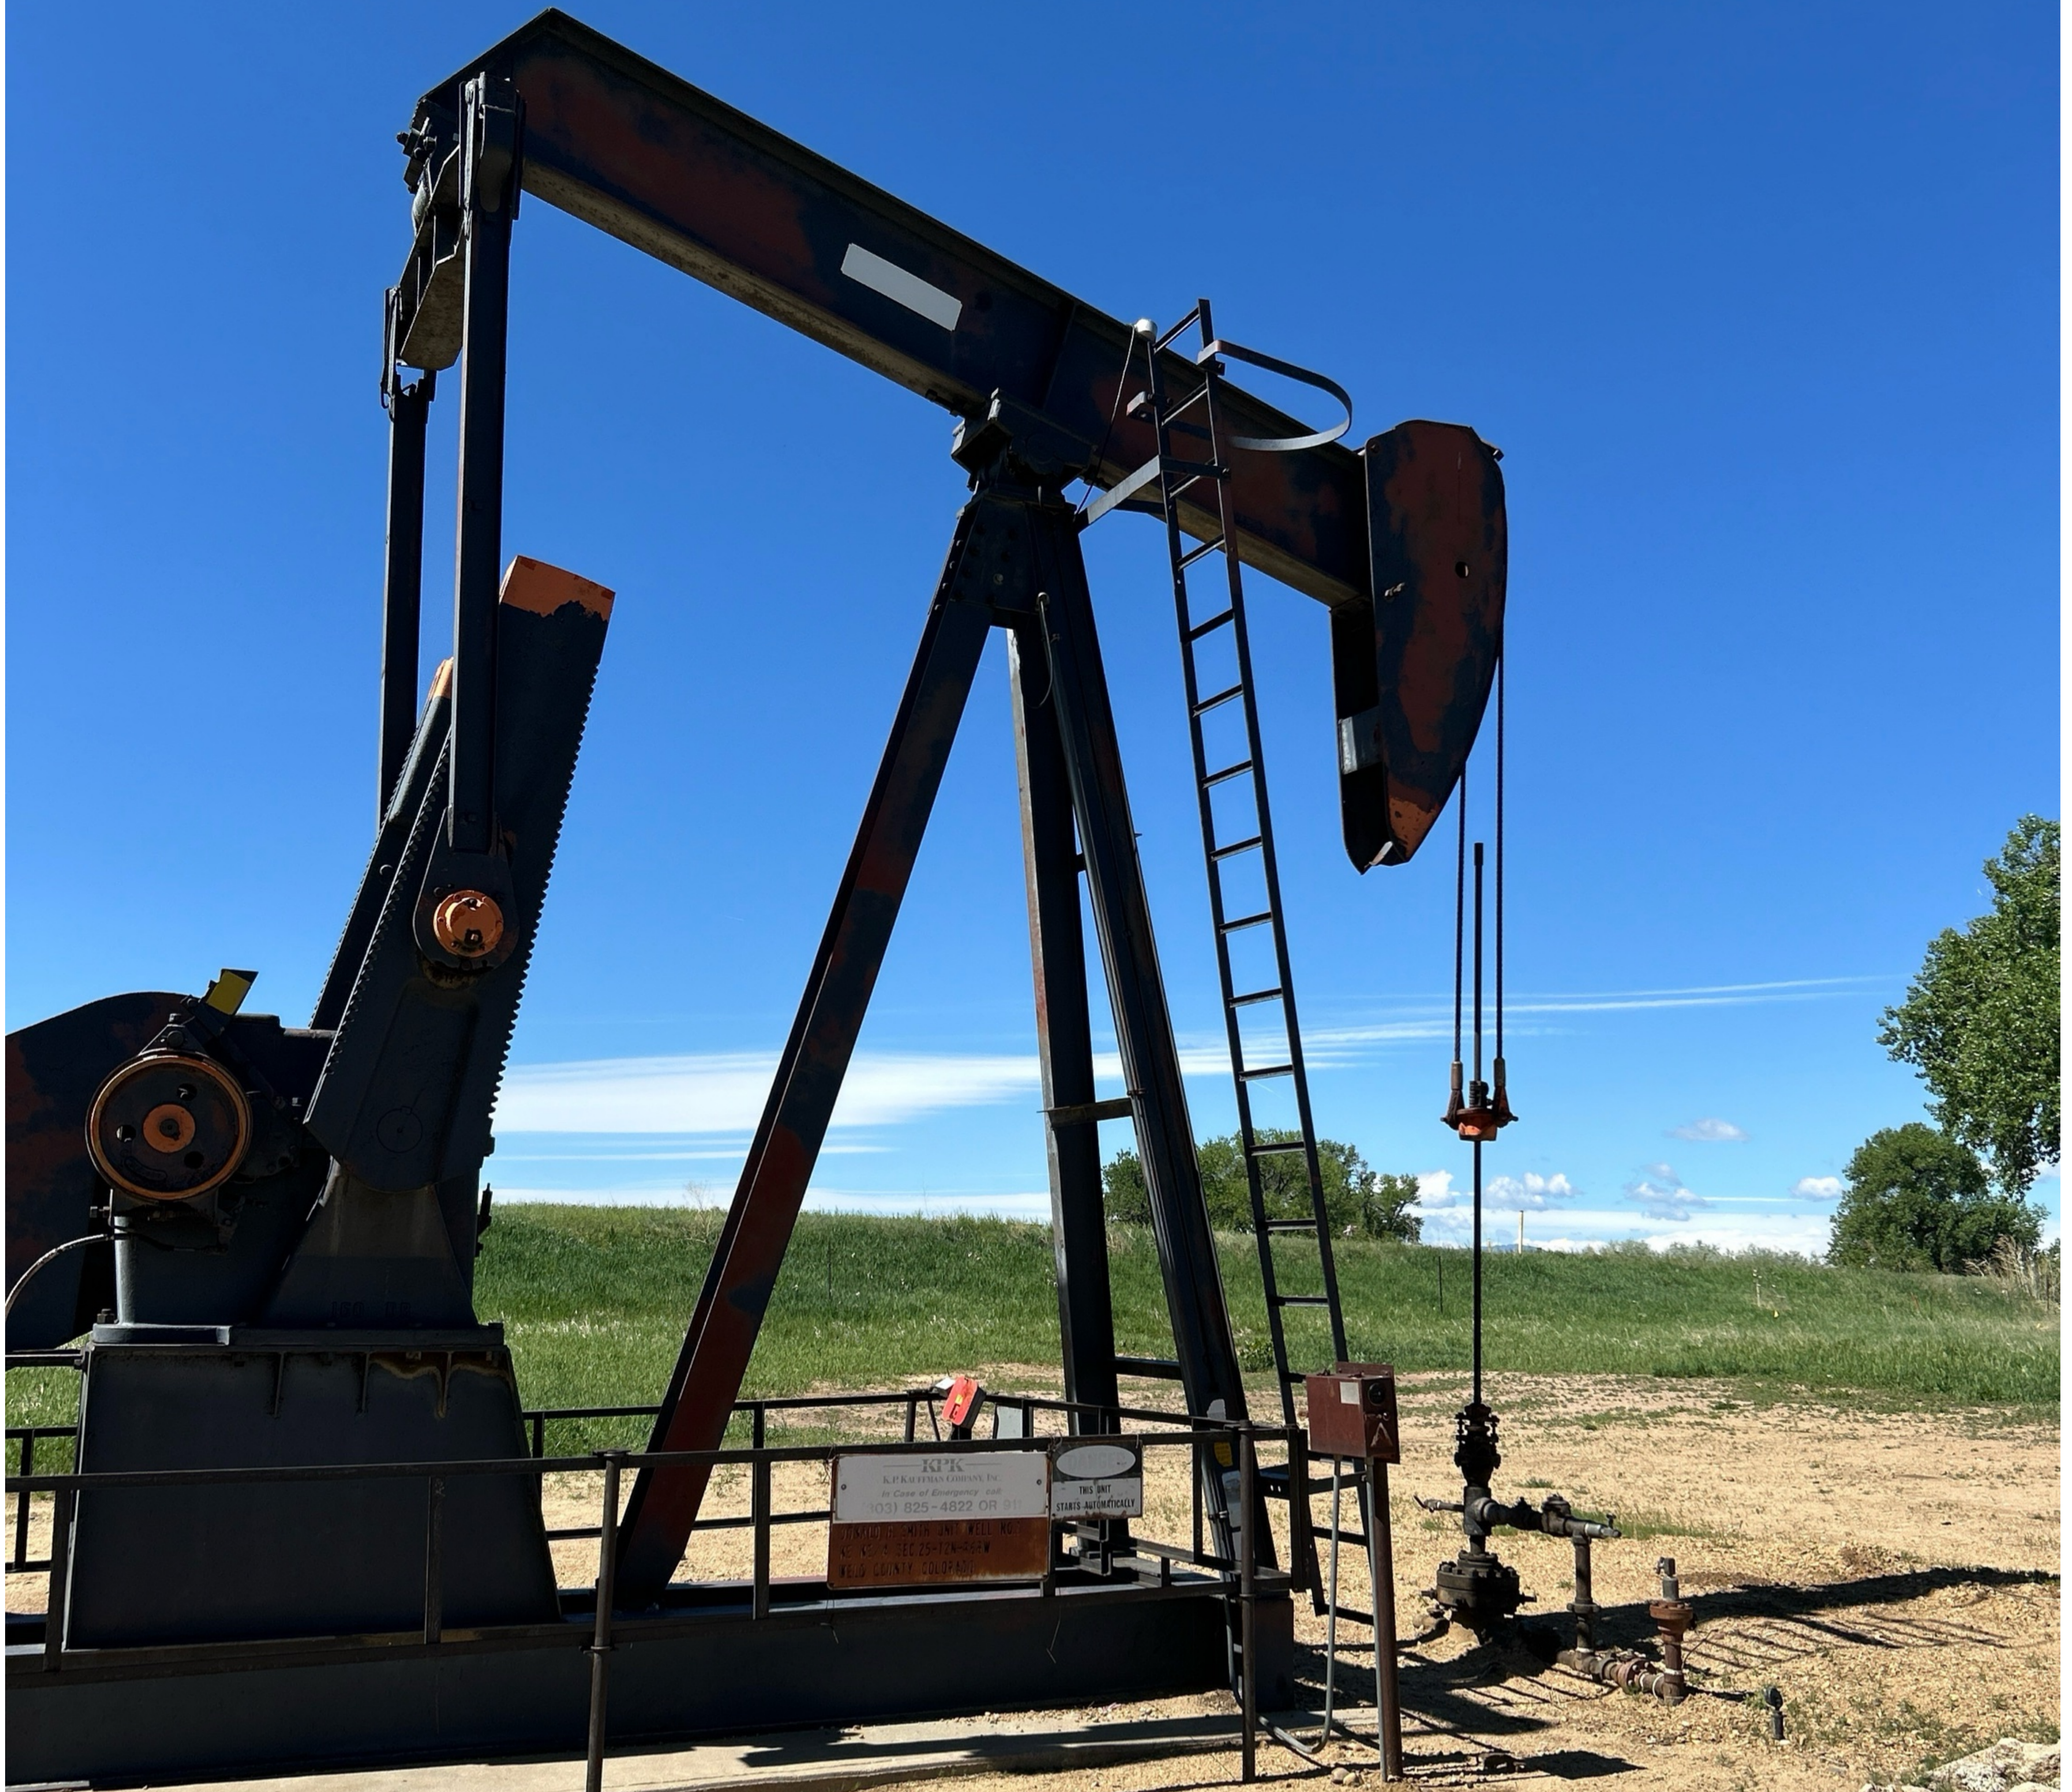
Approximate spill location. Excavation has been backfilled.

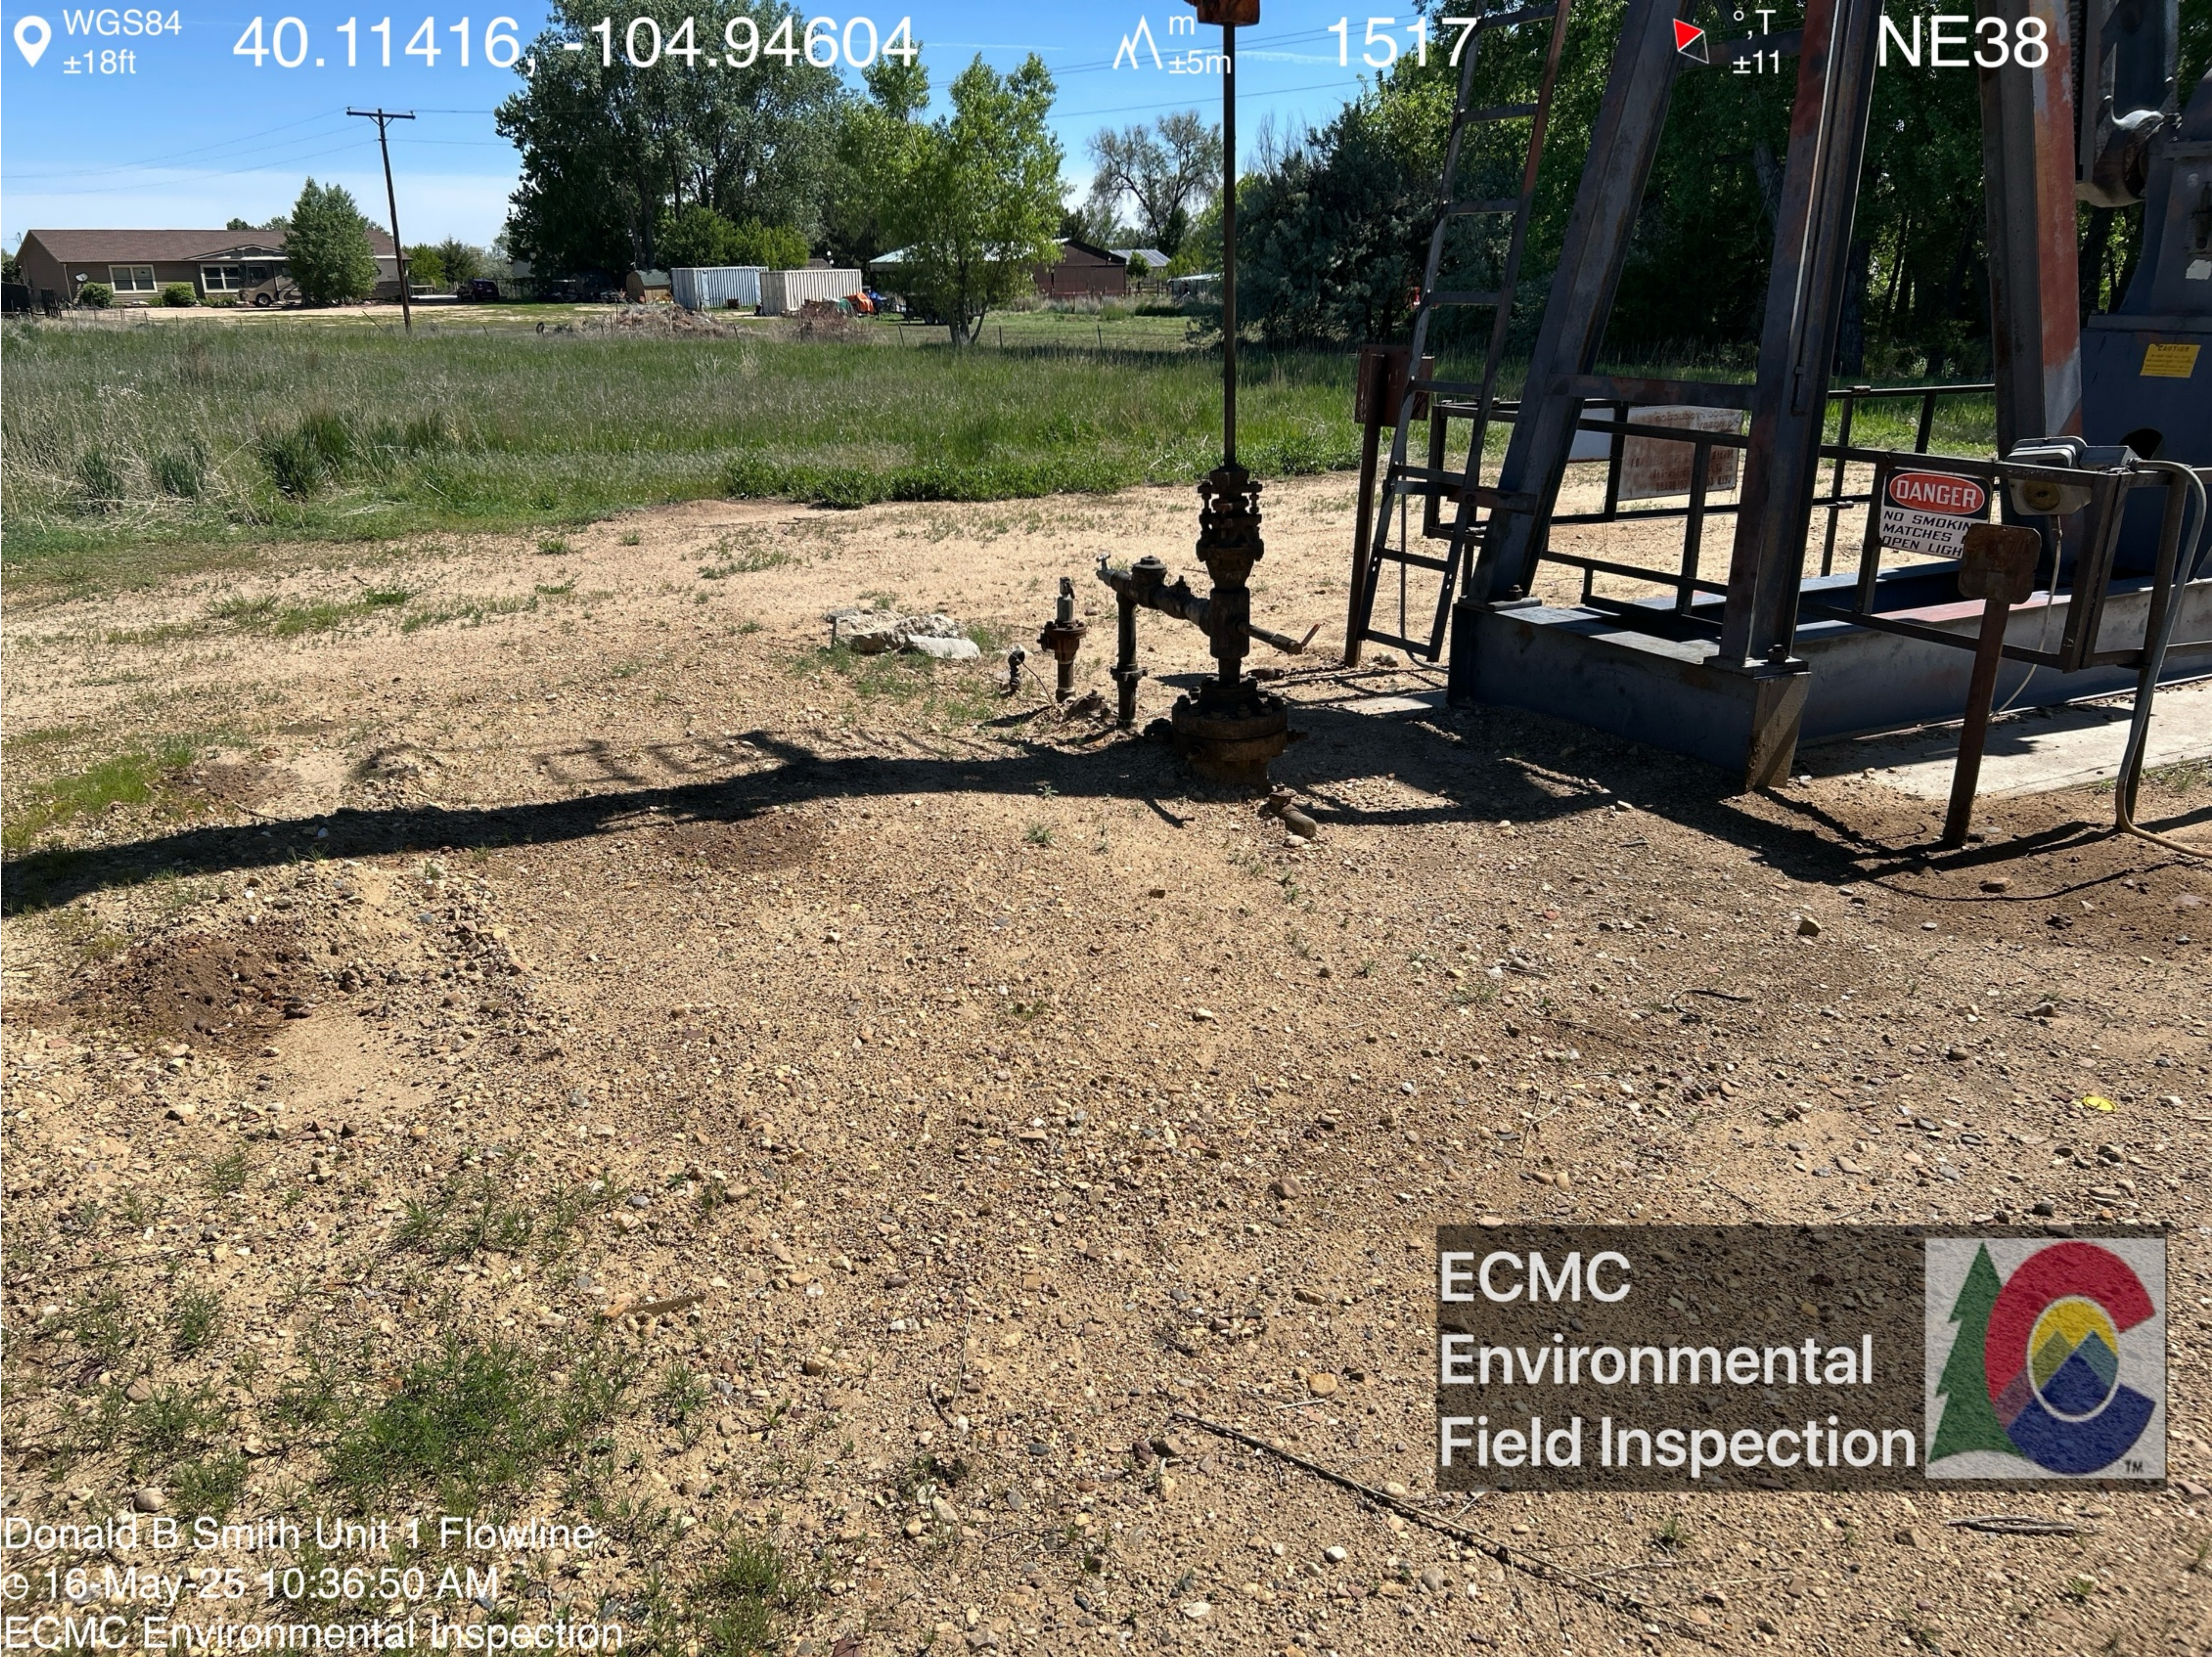
Signage with emergency contact number is visible

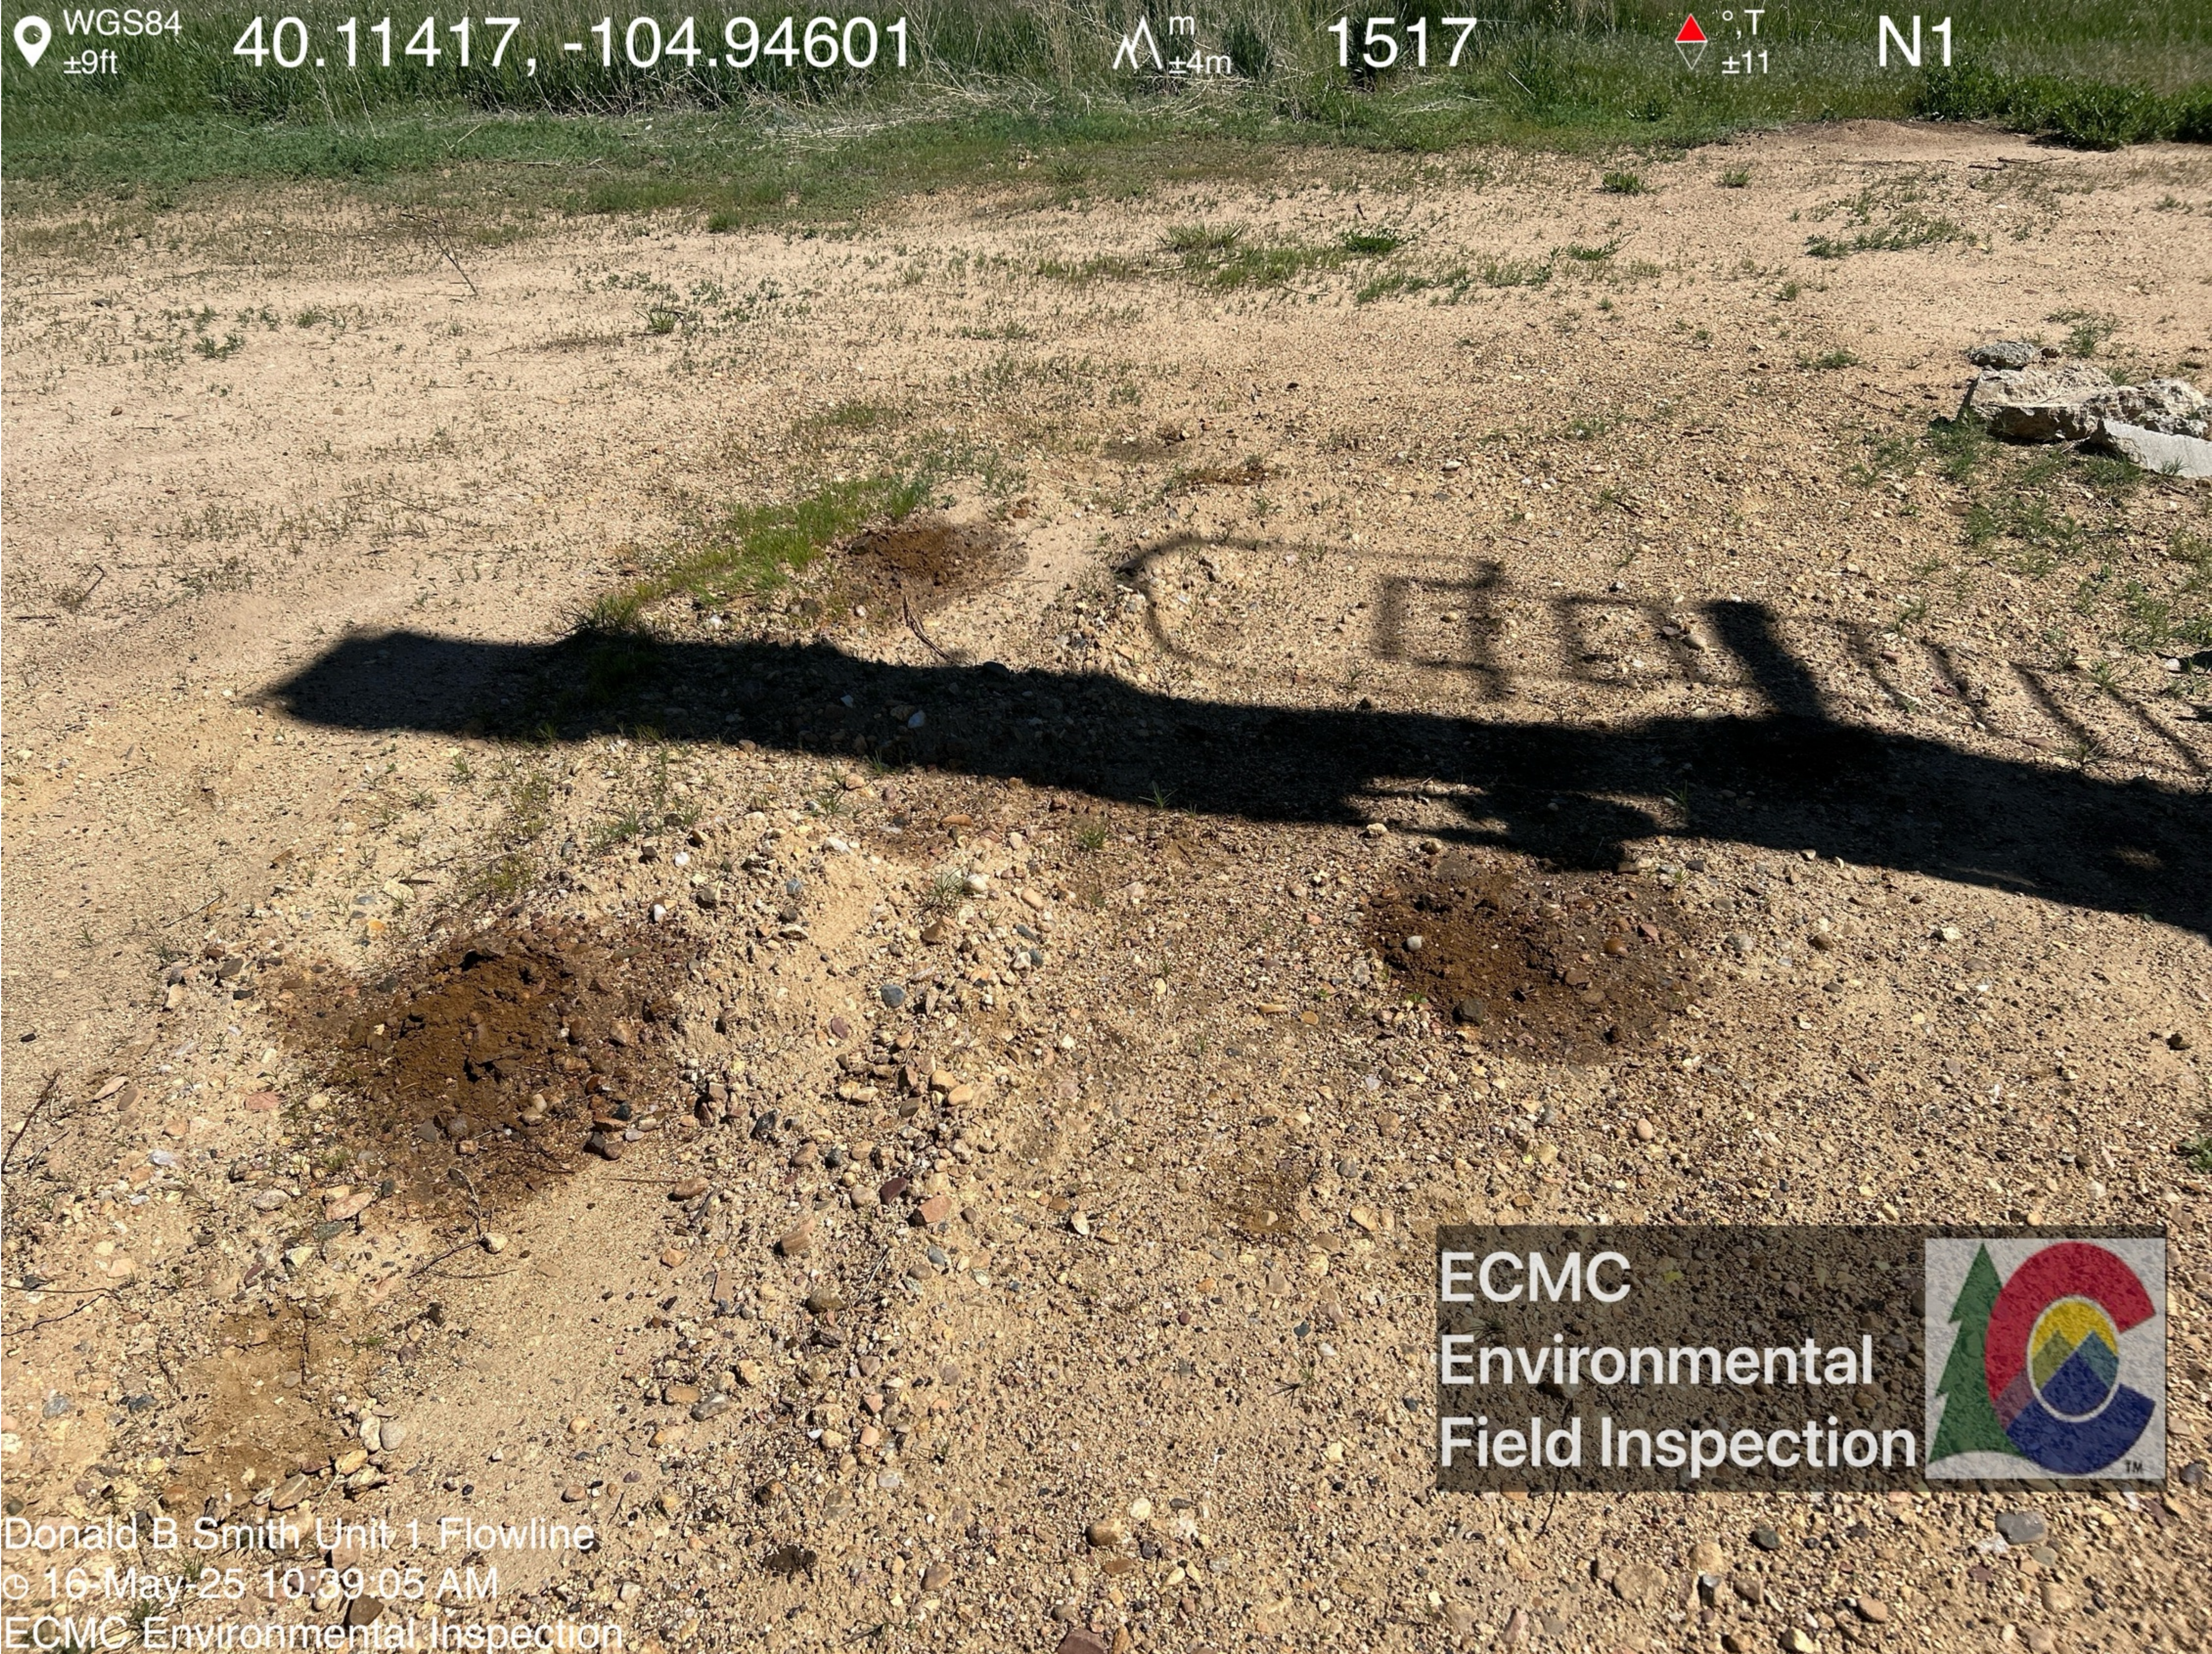
A strong petroleum hydrocarbon odor was observed when the stained soil was disturbed.

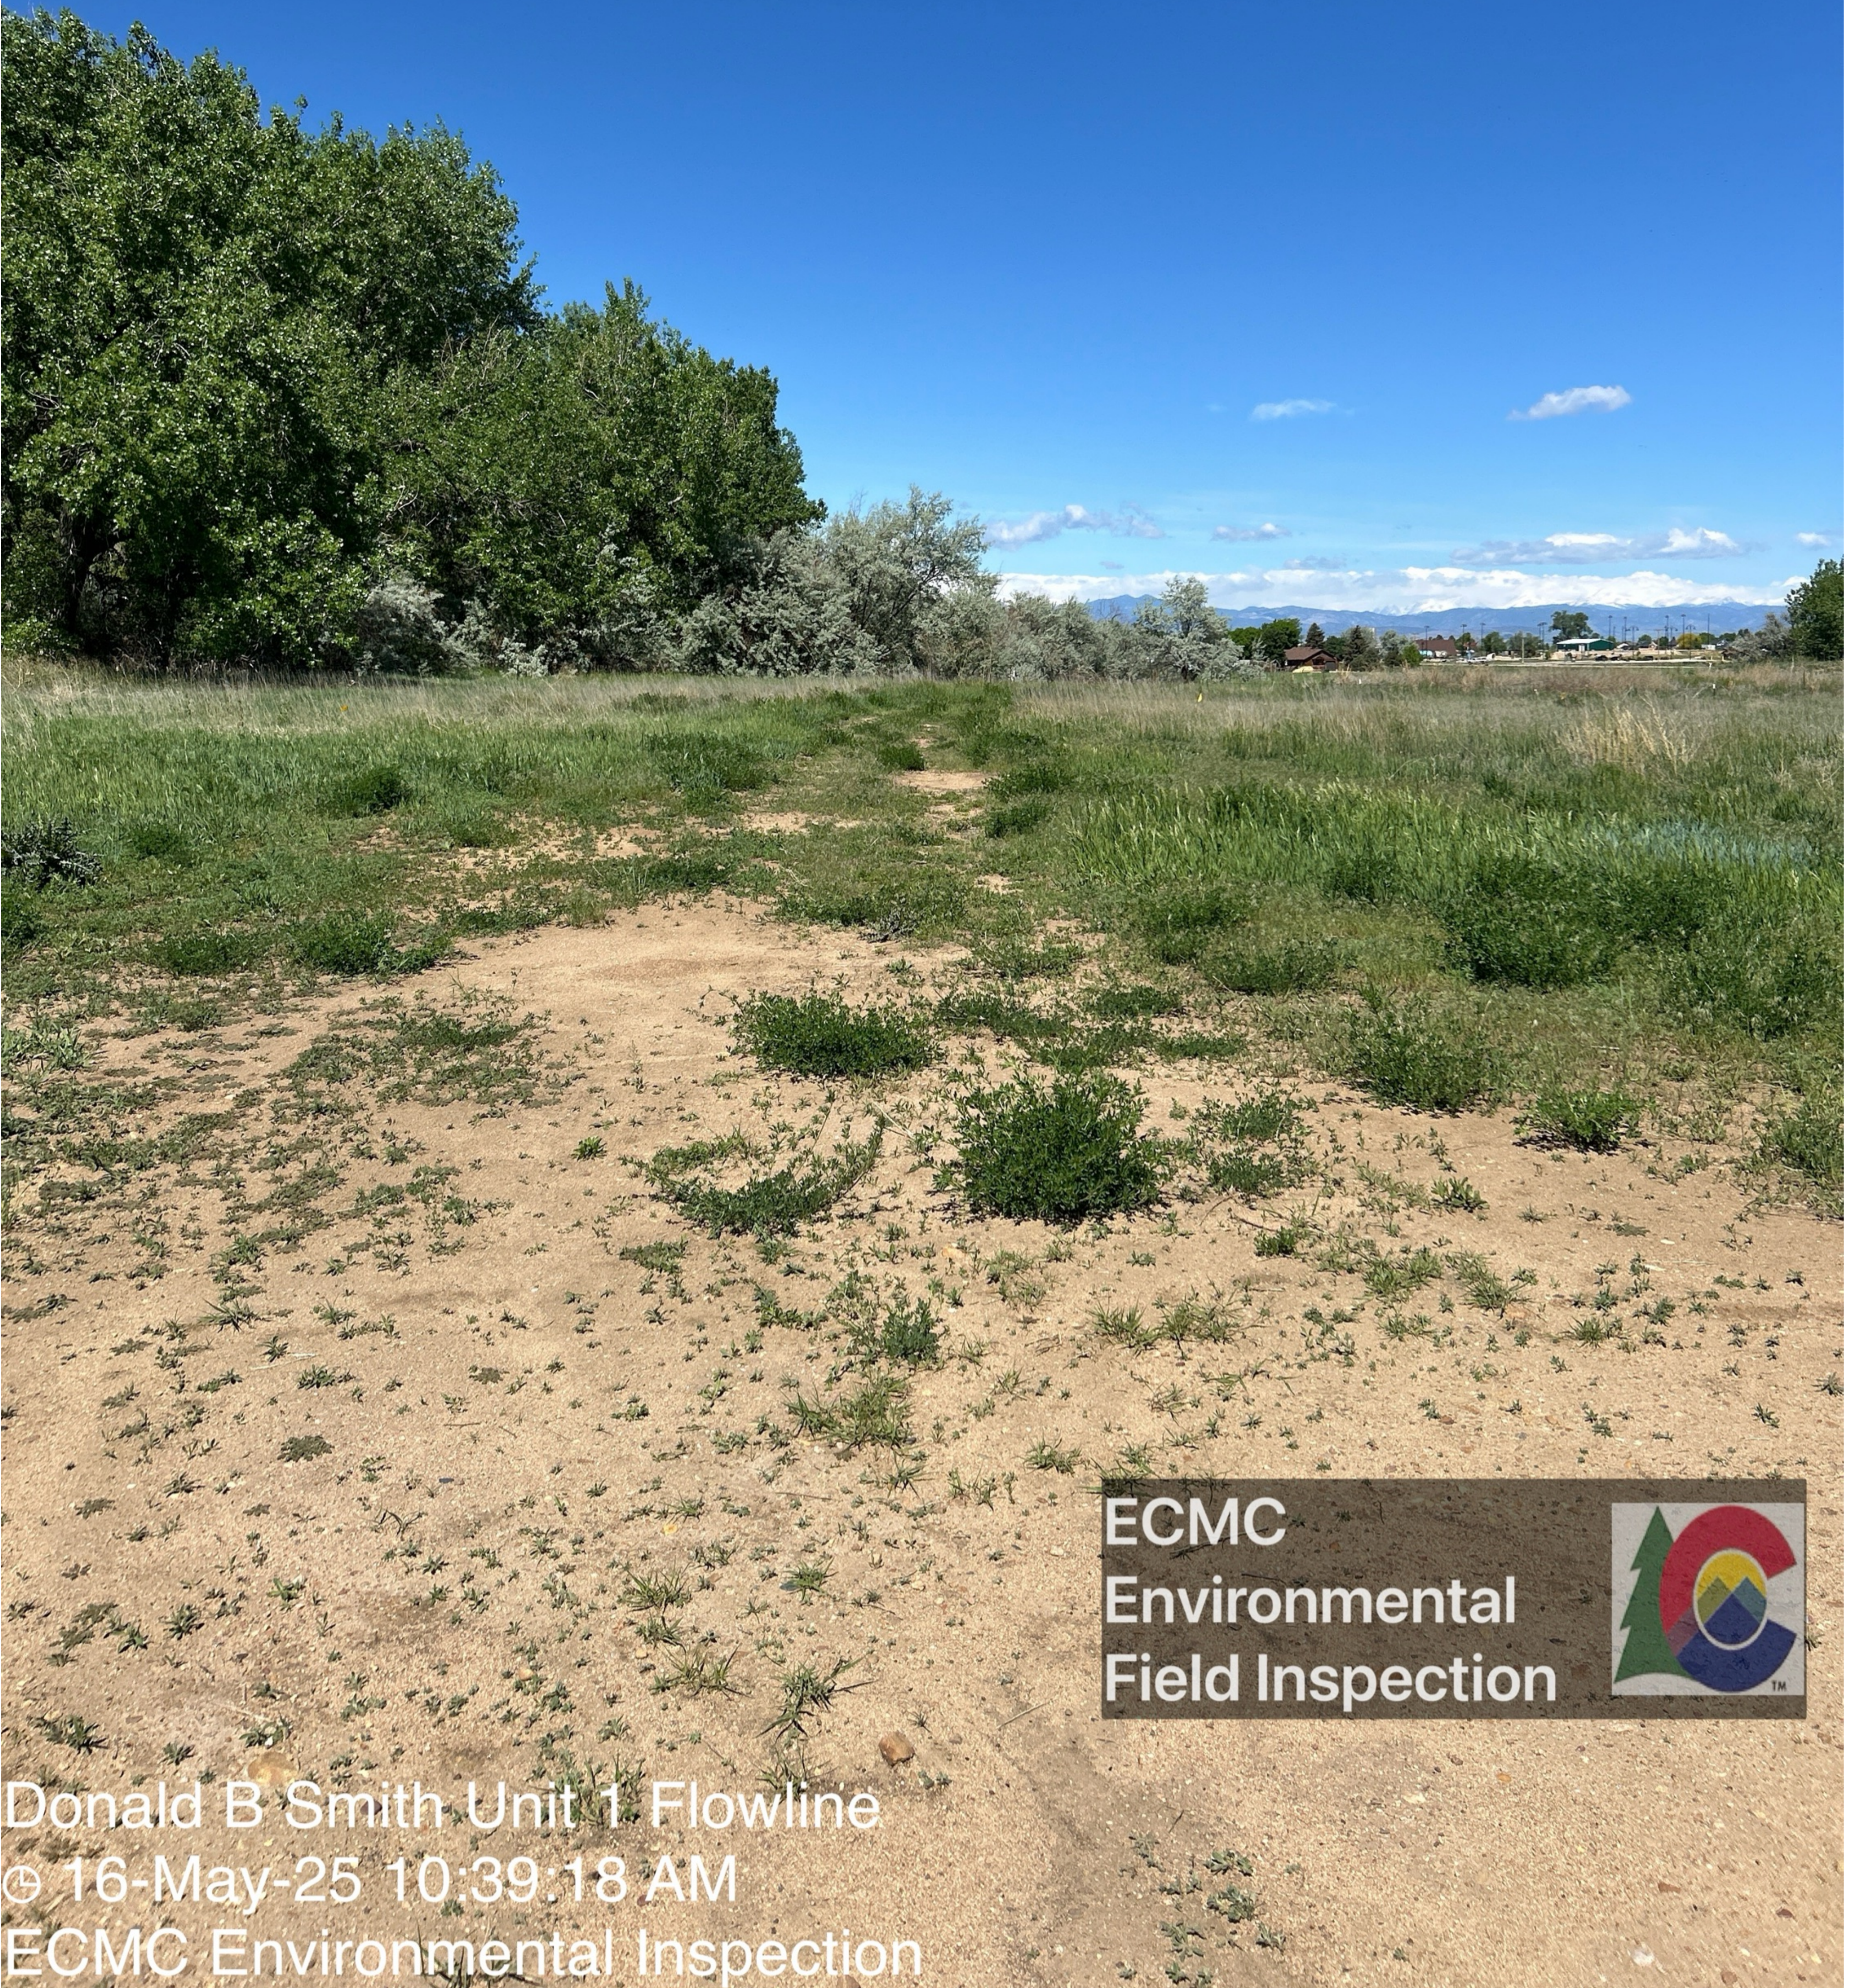
A strong petroleum hydrocarbon odor was observed when the stained soil was disturbed.
