ECMC  
Environmental  
Field Inspection

Pete Montoya B1-#2  
© 16-May-25 01:09:00 PM  
ECMC Environmental Inspection

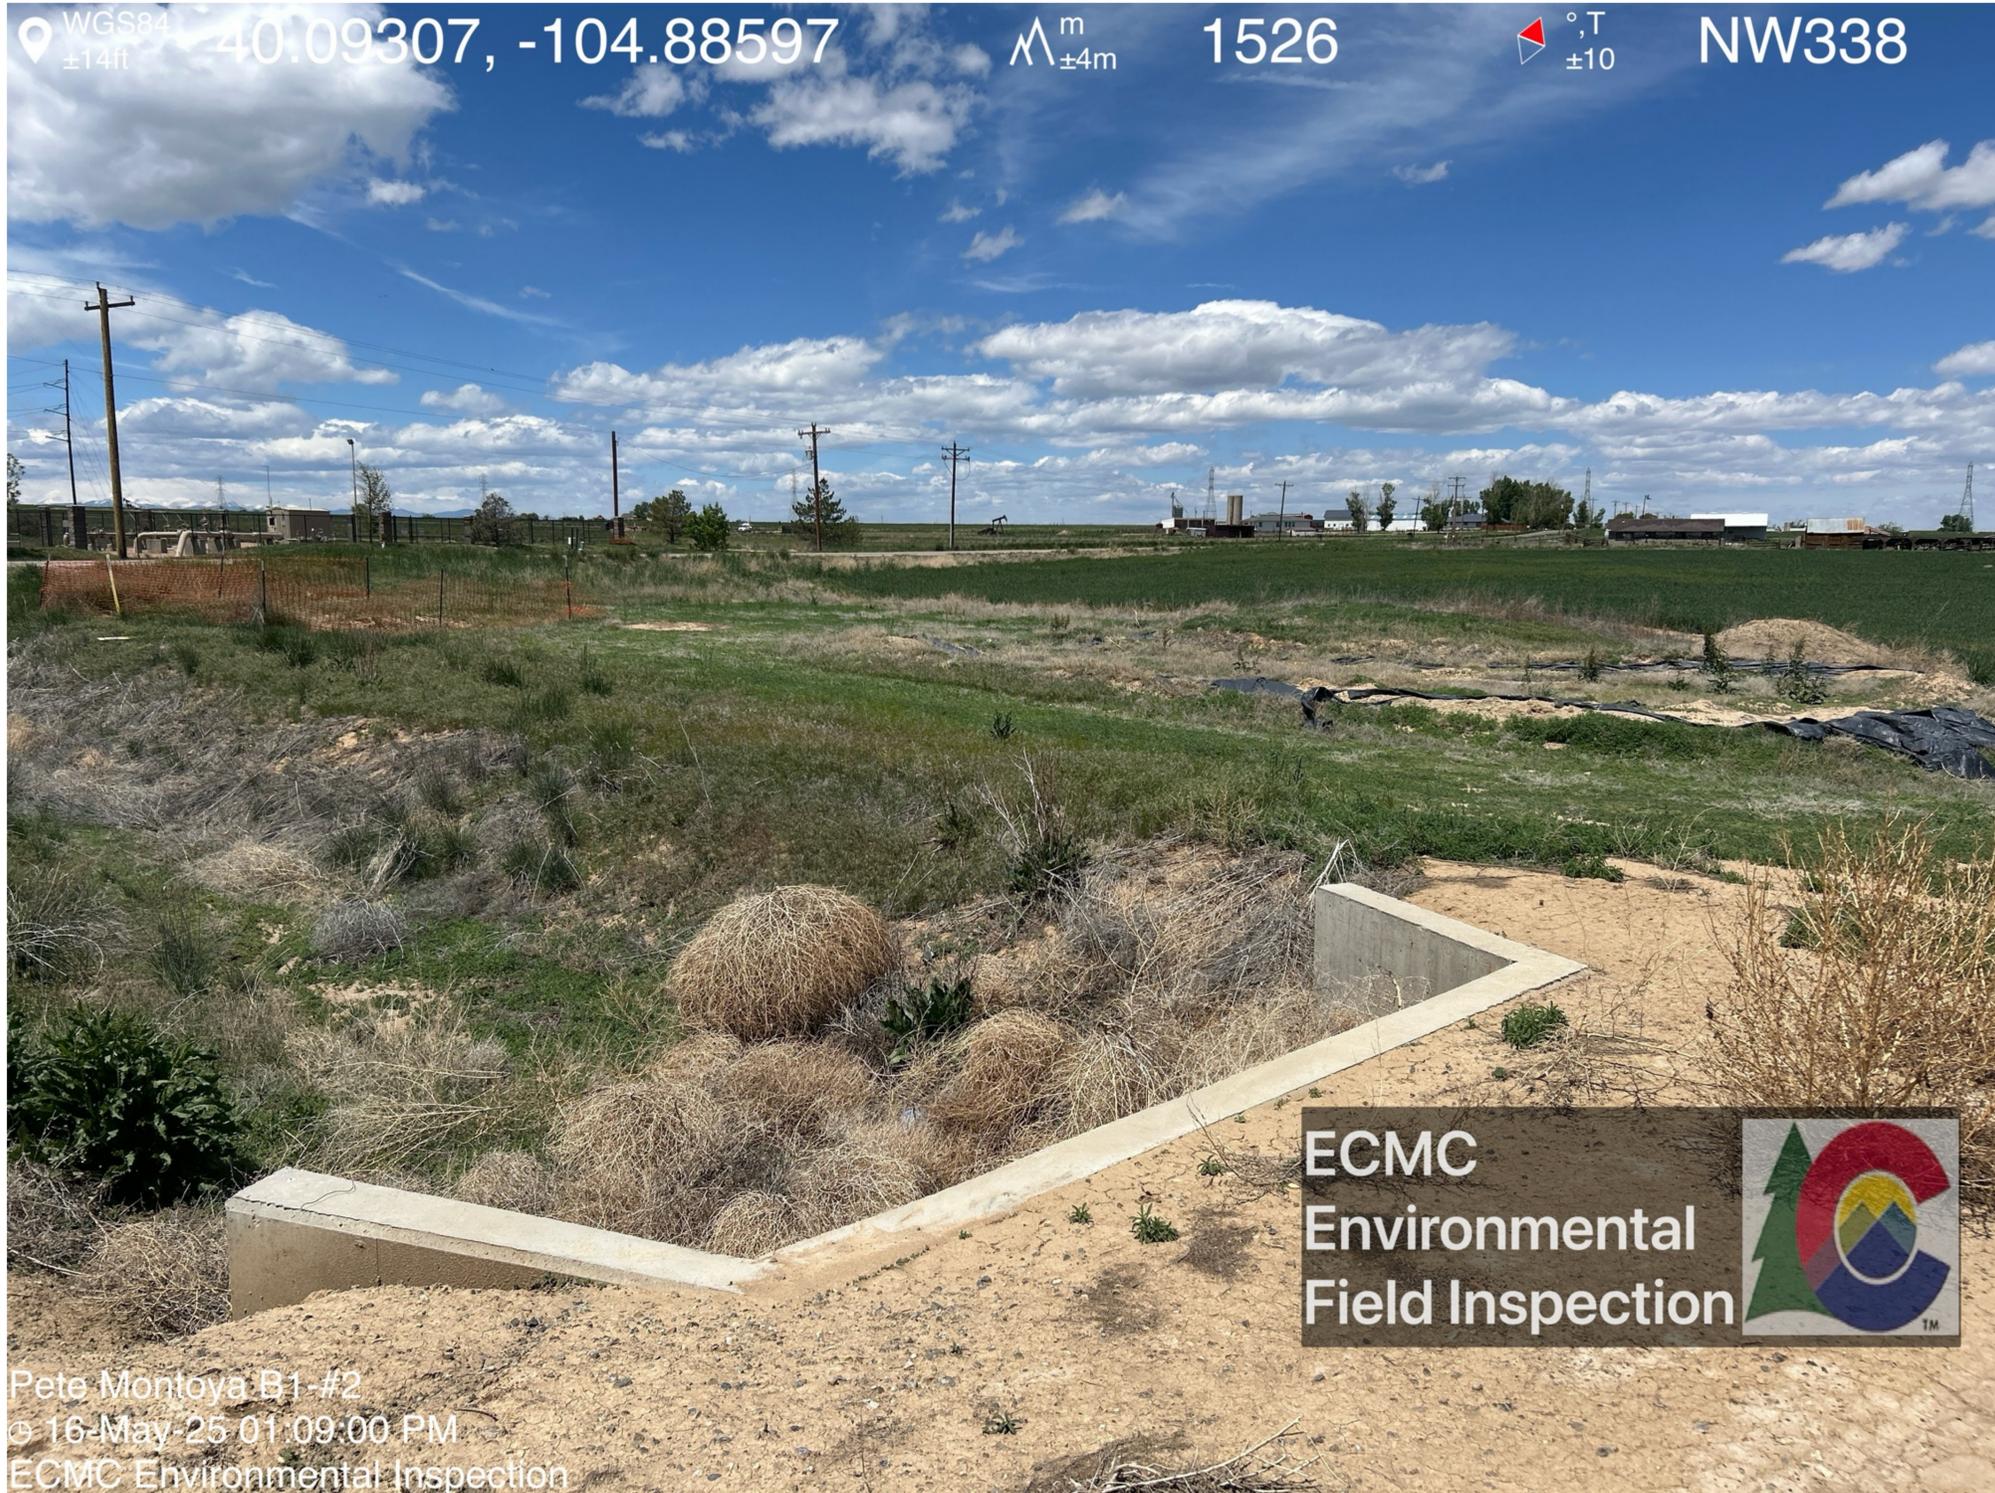
A drainage ditch is visible in the foreground. The open excavation is visible in the background on the left side of the picture; the stockpile liner is visible in the background on the right side of the picture.

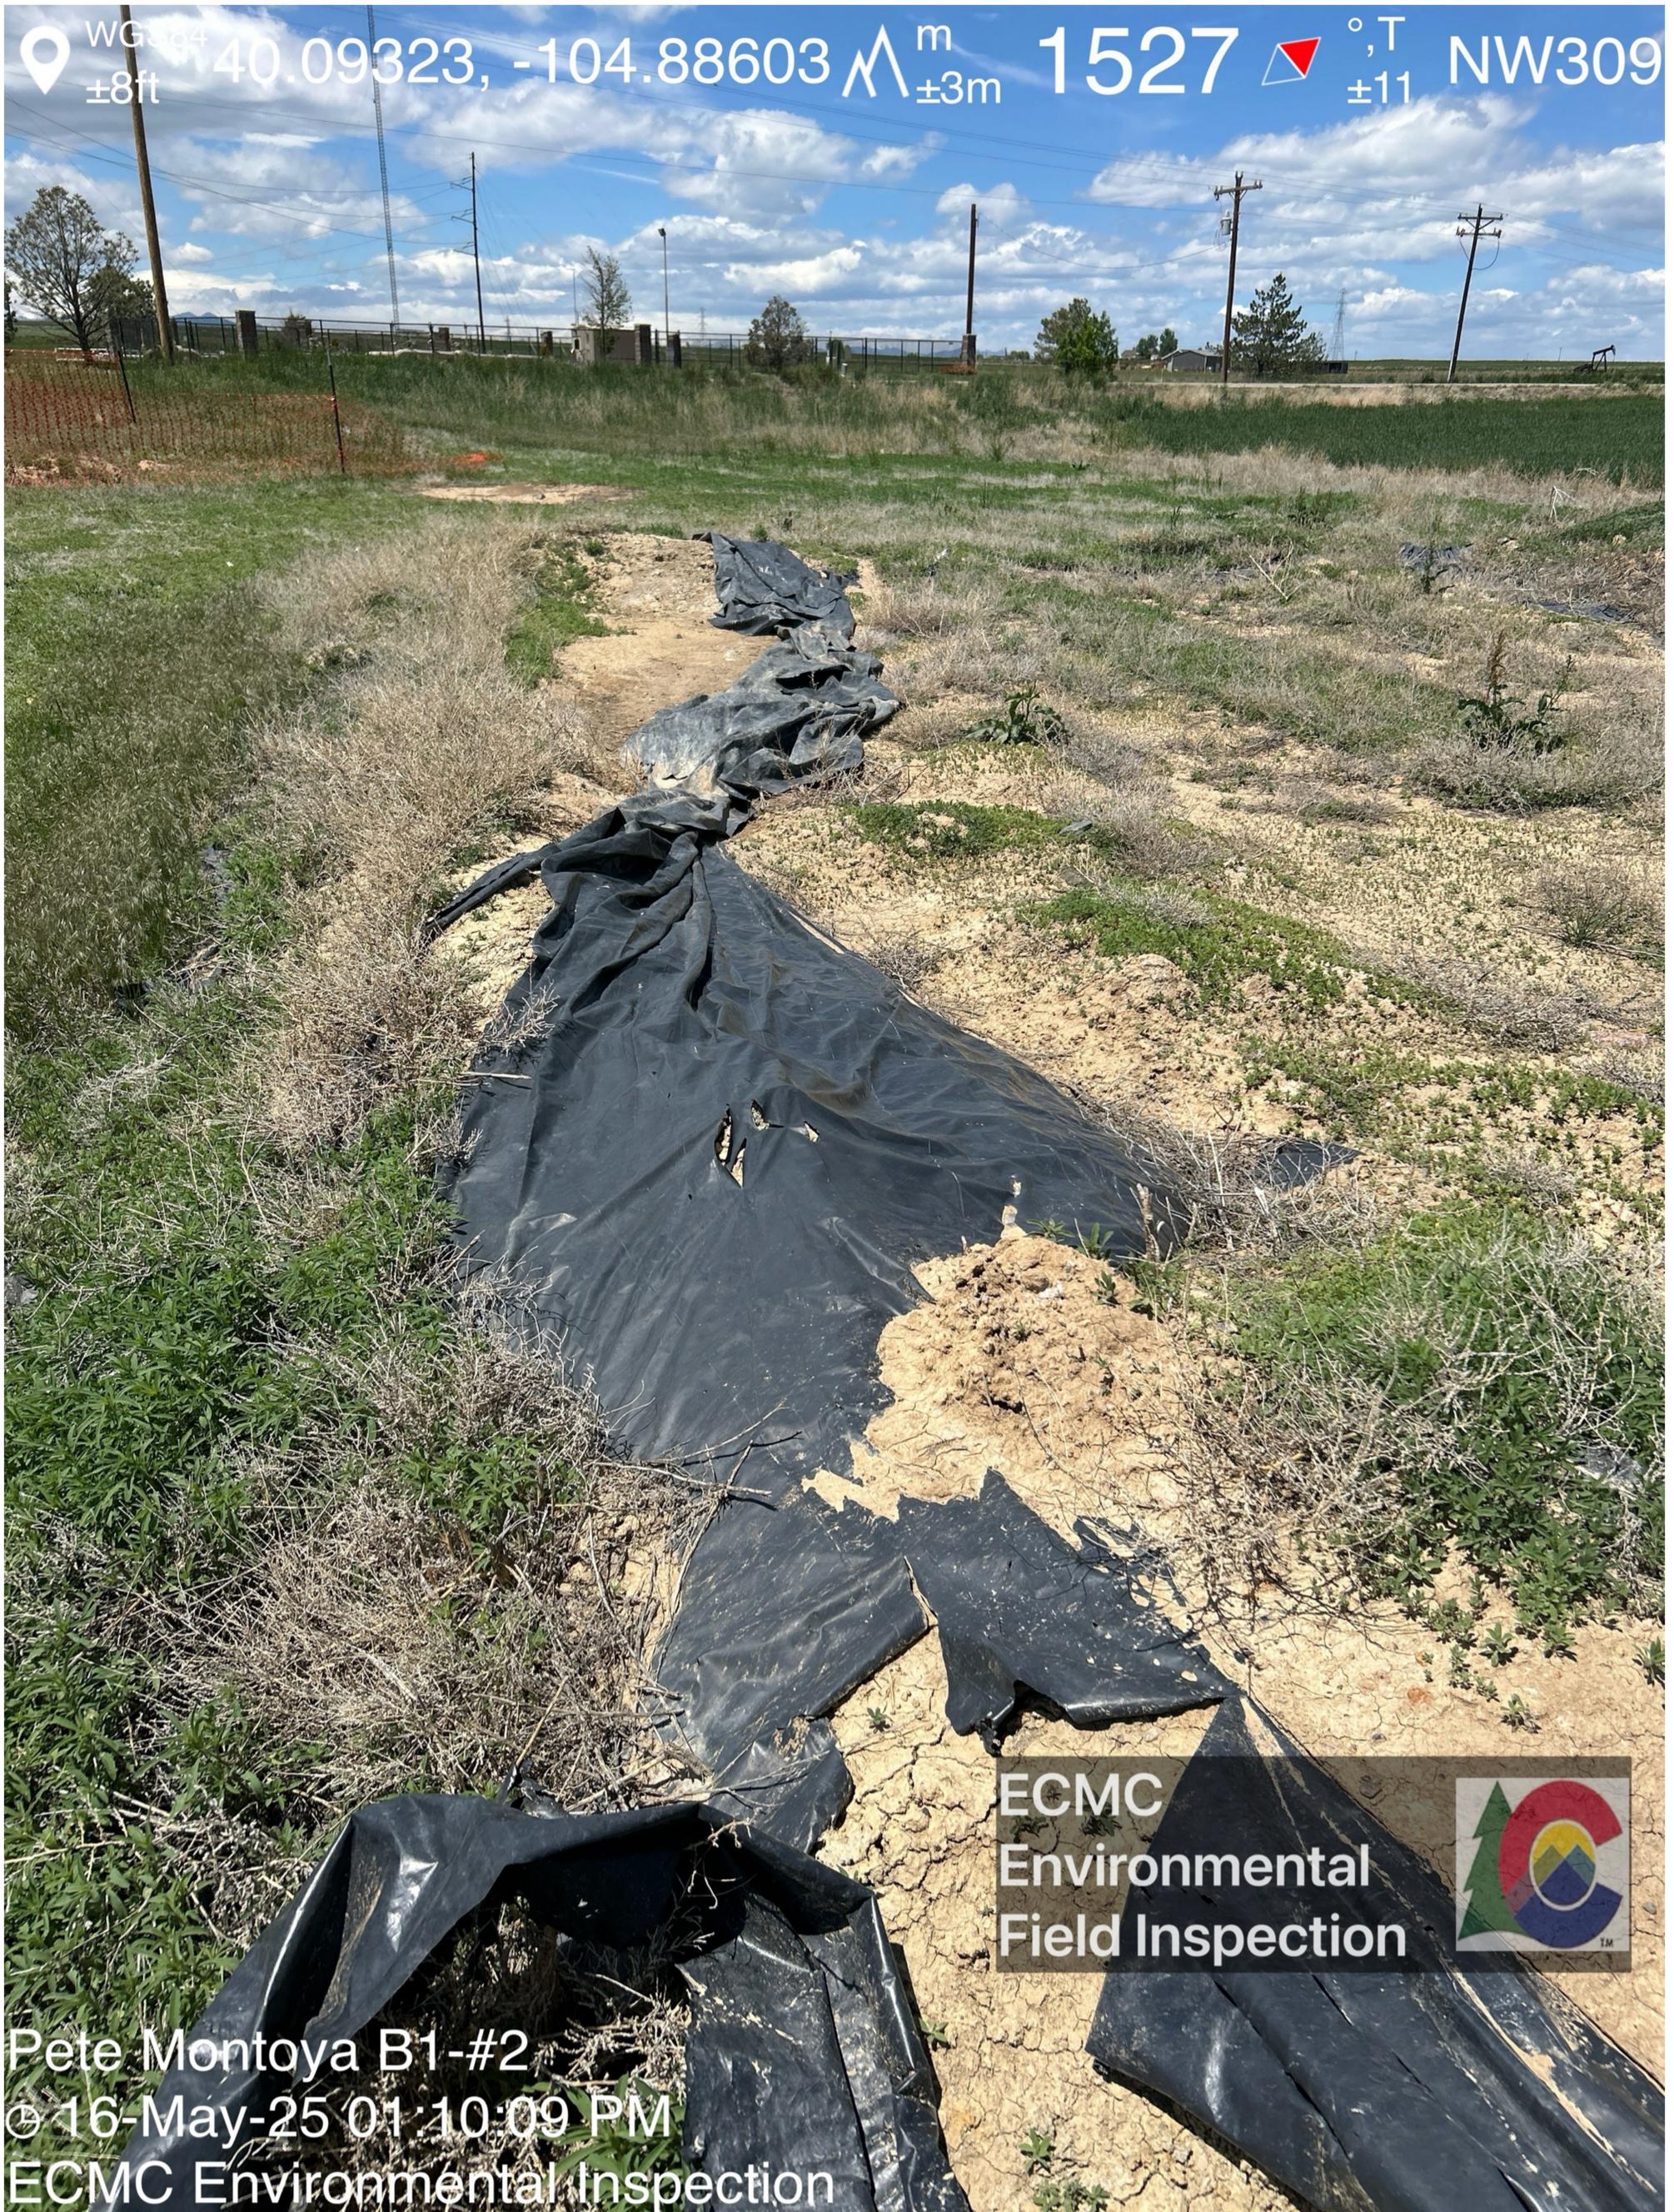
The previously observed stockpile has been removed from location; however, the liner under the stockpile remains on location.

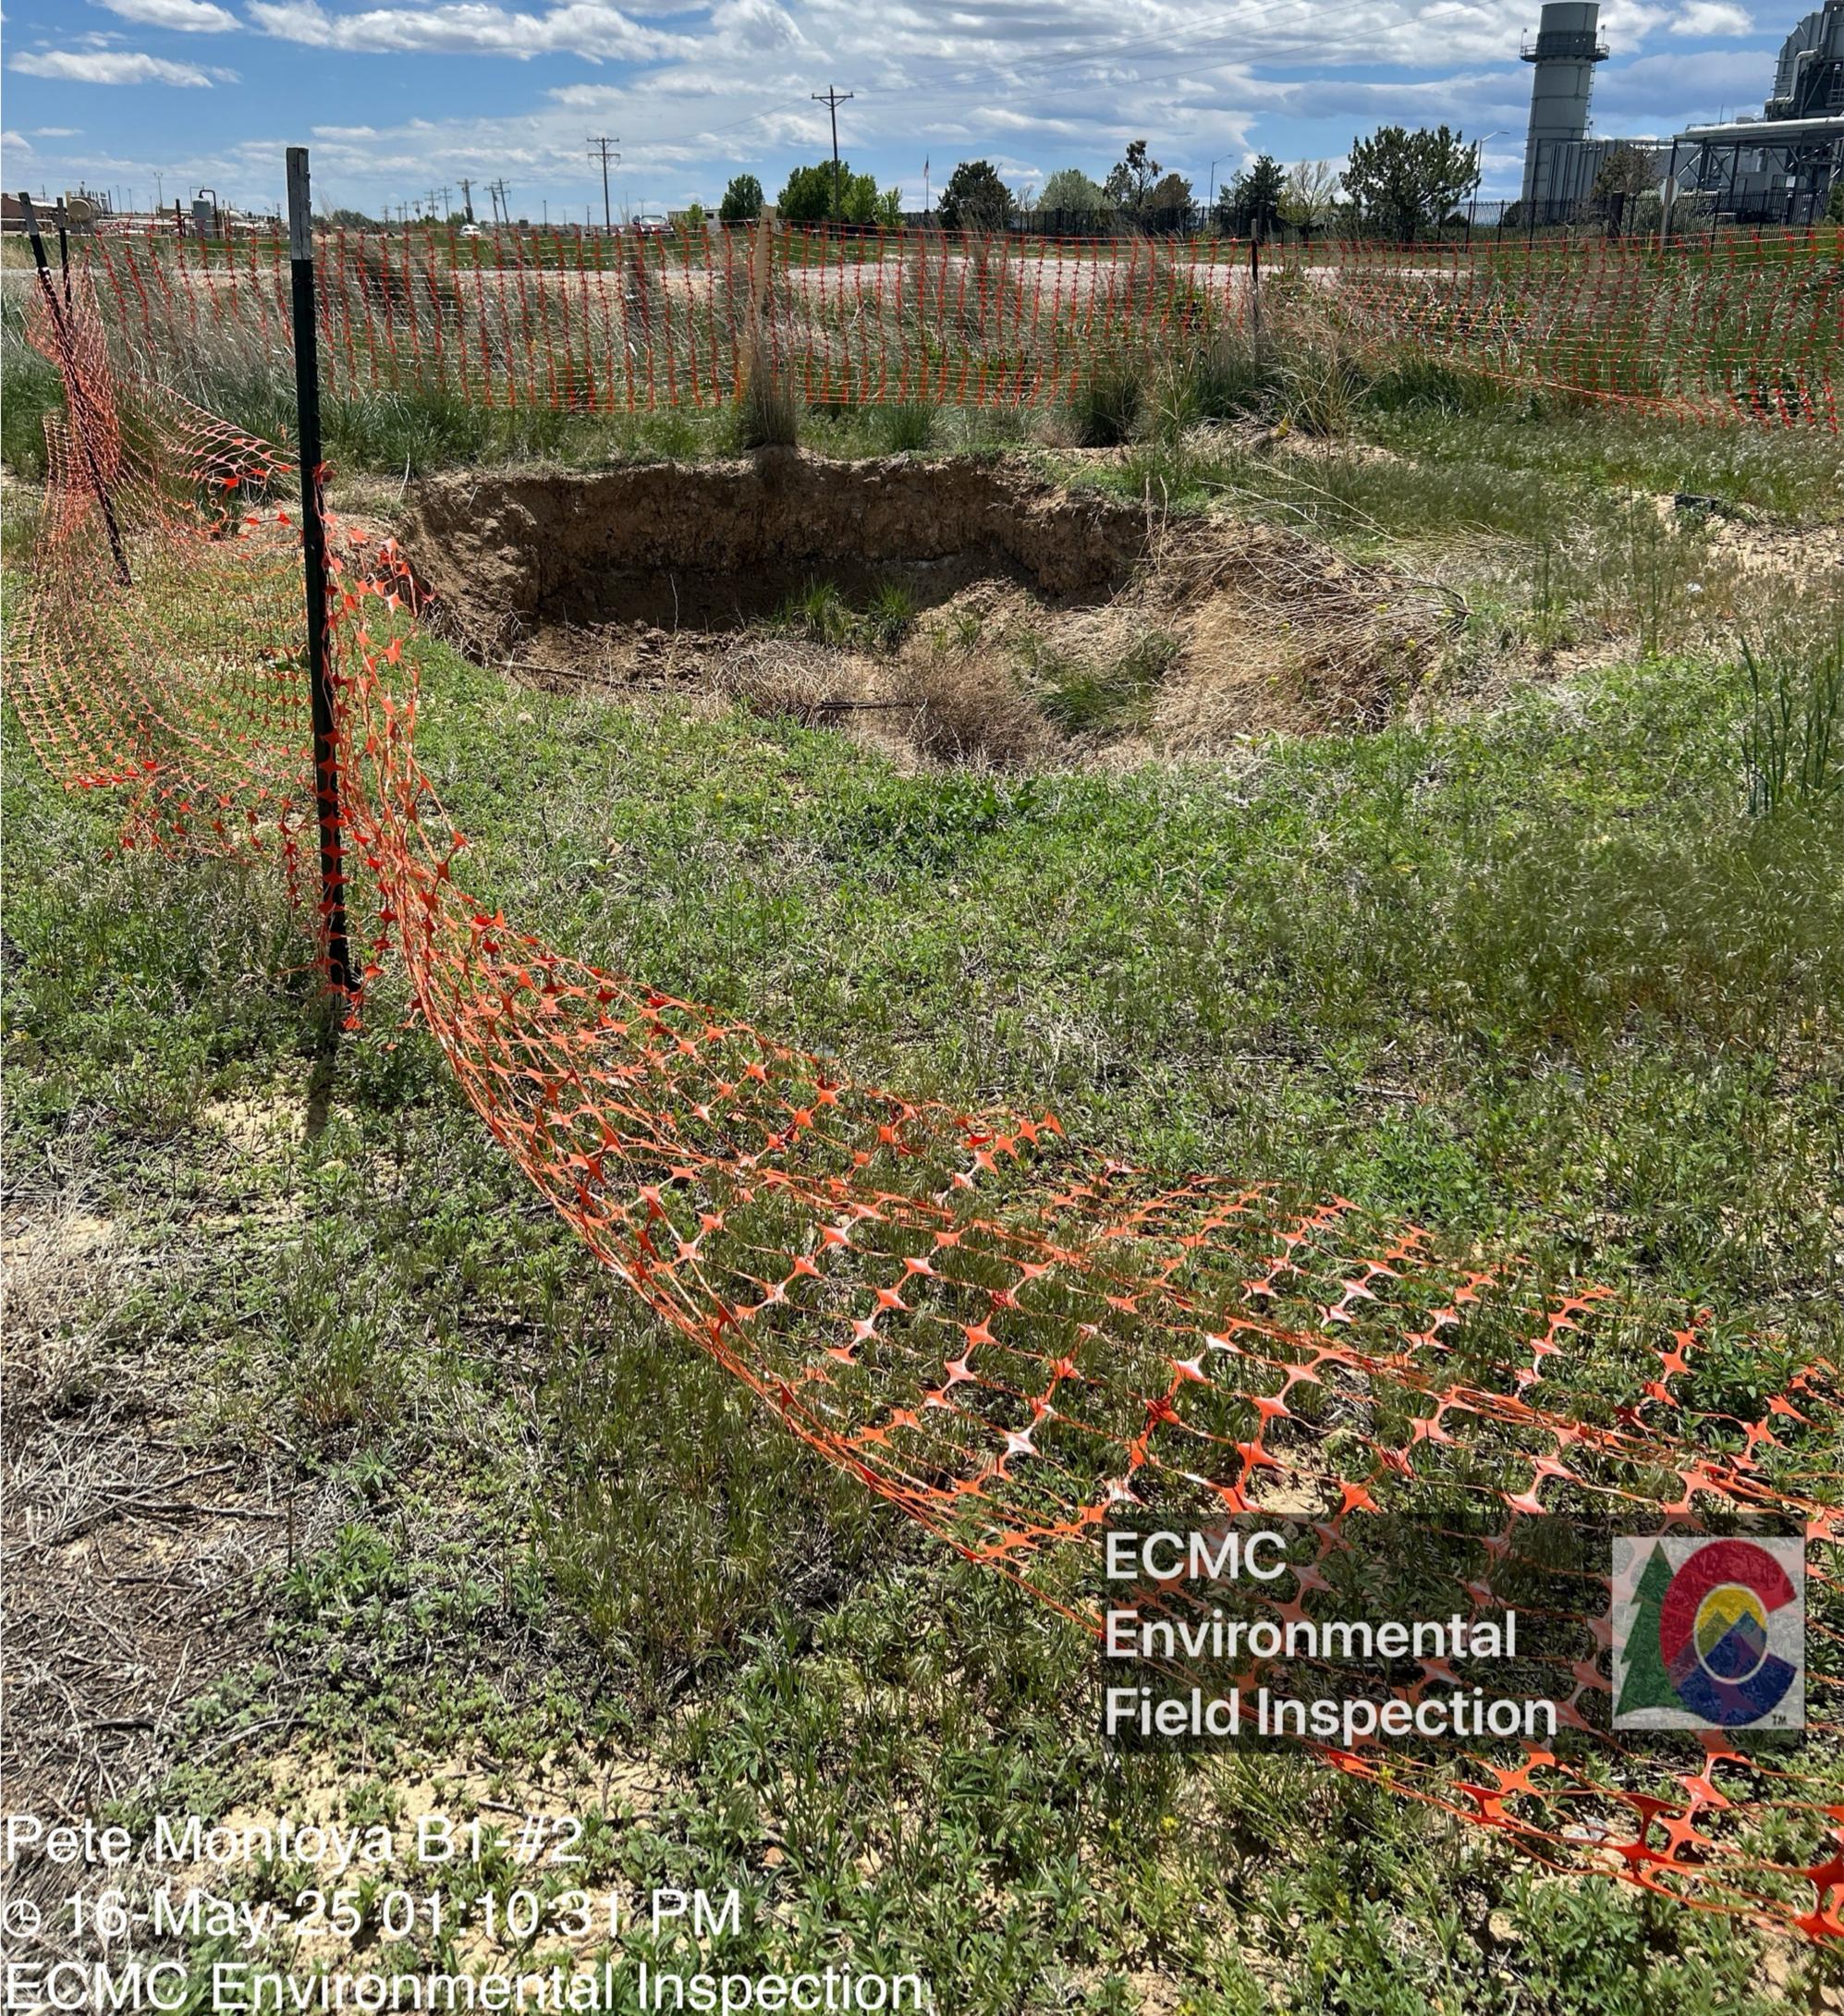
An excavation remains open at the spill location. Salt crusting is visible. Debris has collected within the excavation and obscures visibility of the floor and portions of the sidewalls. Weeds are visible within the excavation. Orange construction fencing has been installed but has fallen and does not surround the entire perimeter of the excavation.

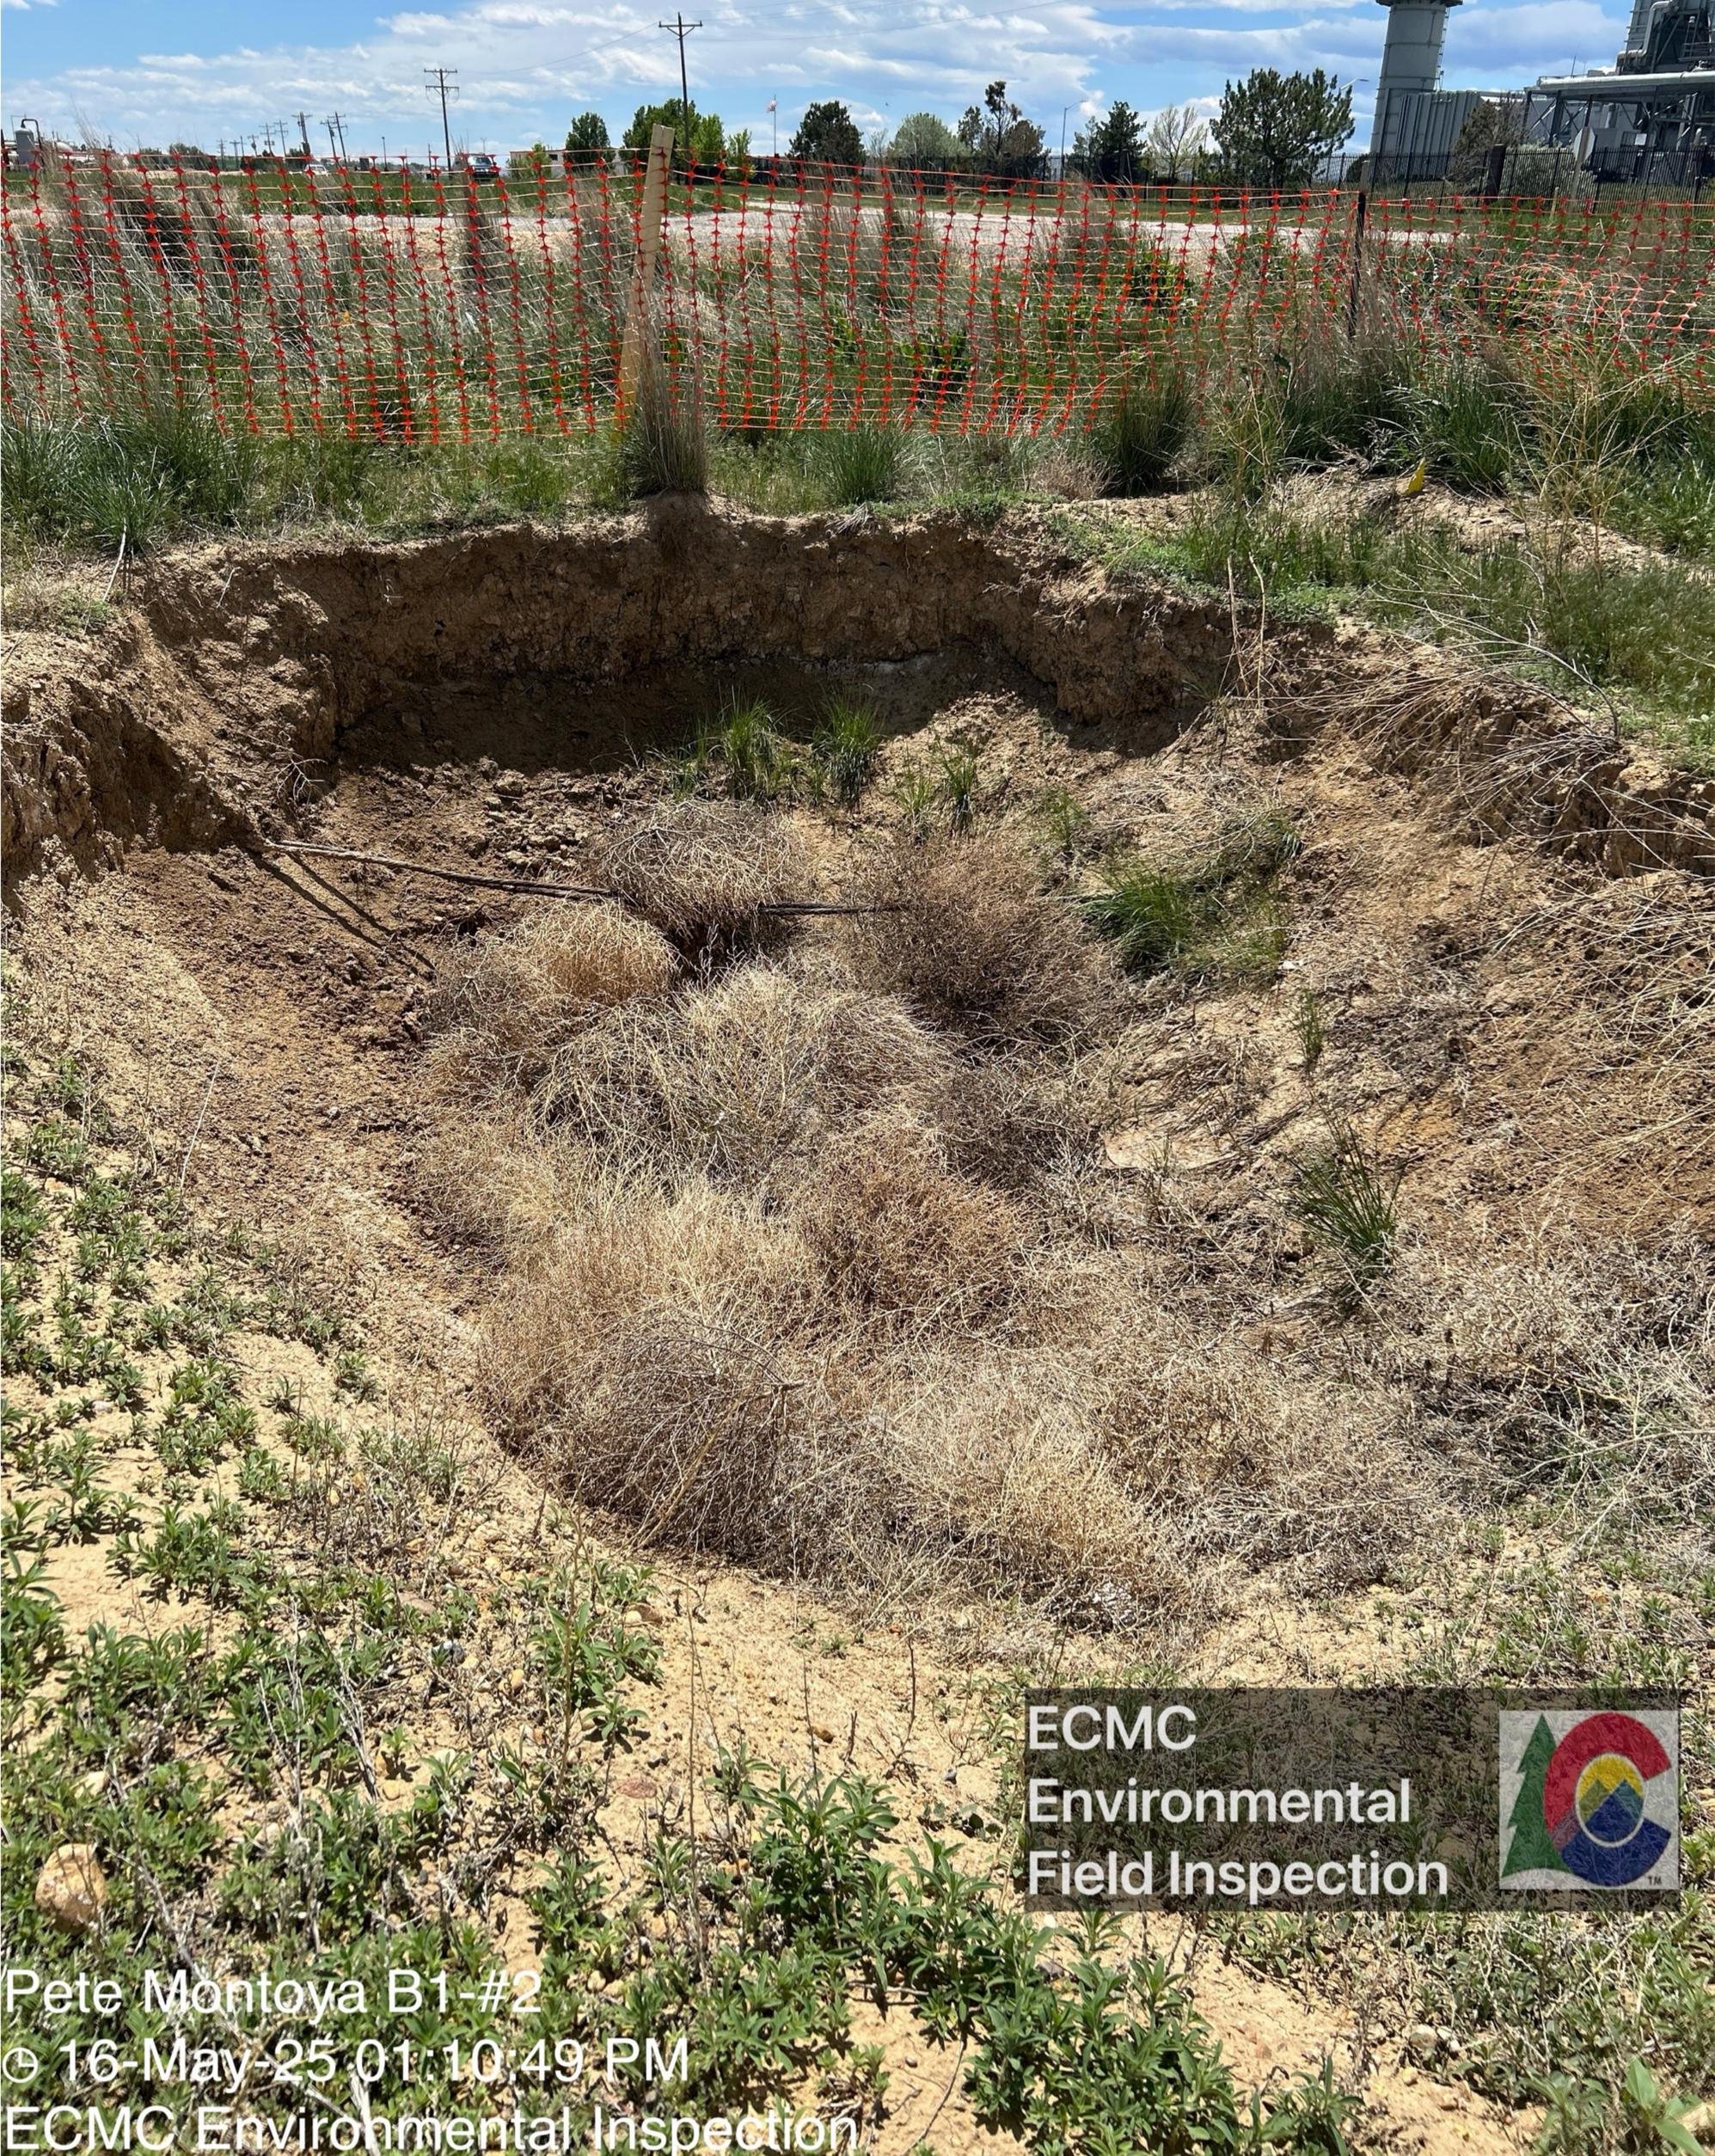
Salt crusting is visible on the excavation sidewalls. Debris has collected within the excavation and obscures visibility of the floor and portions of the sidewalls.

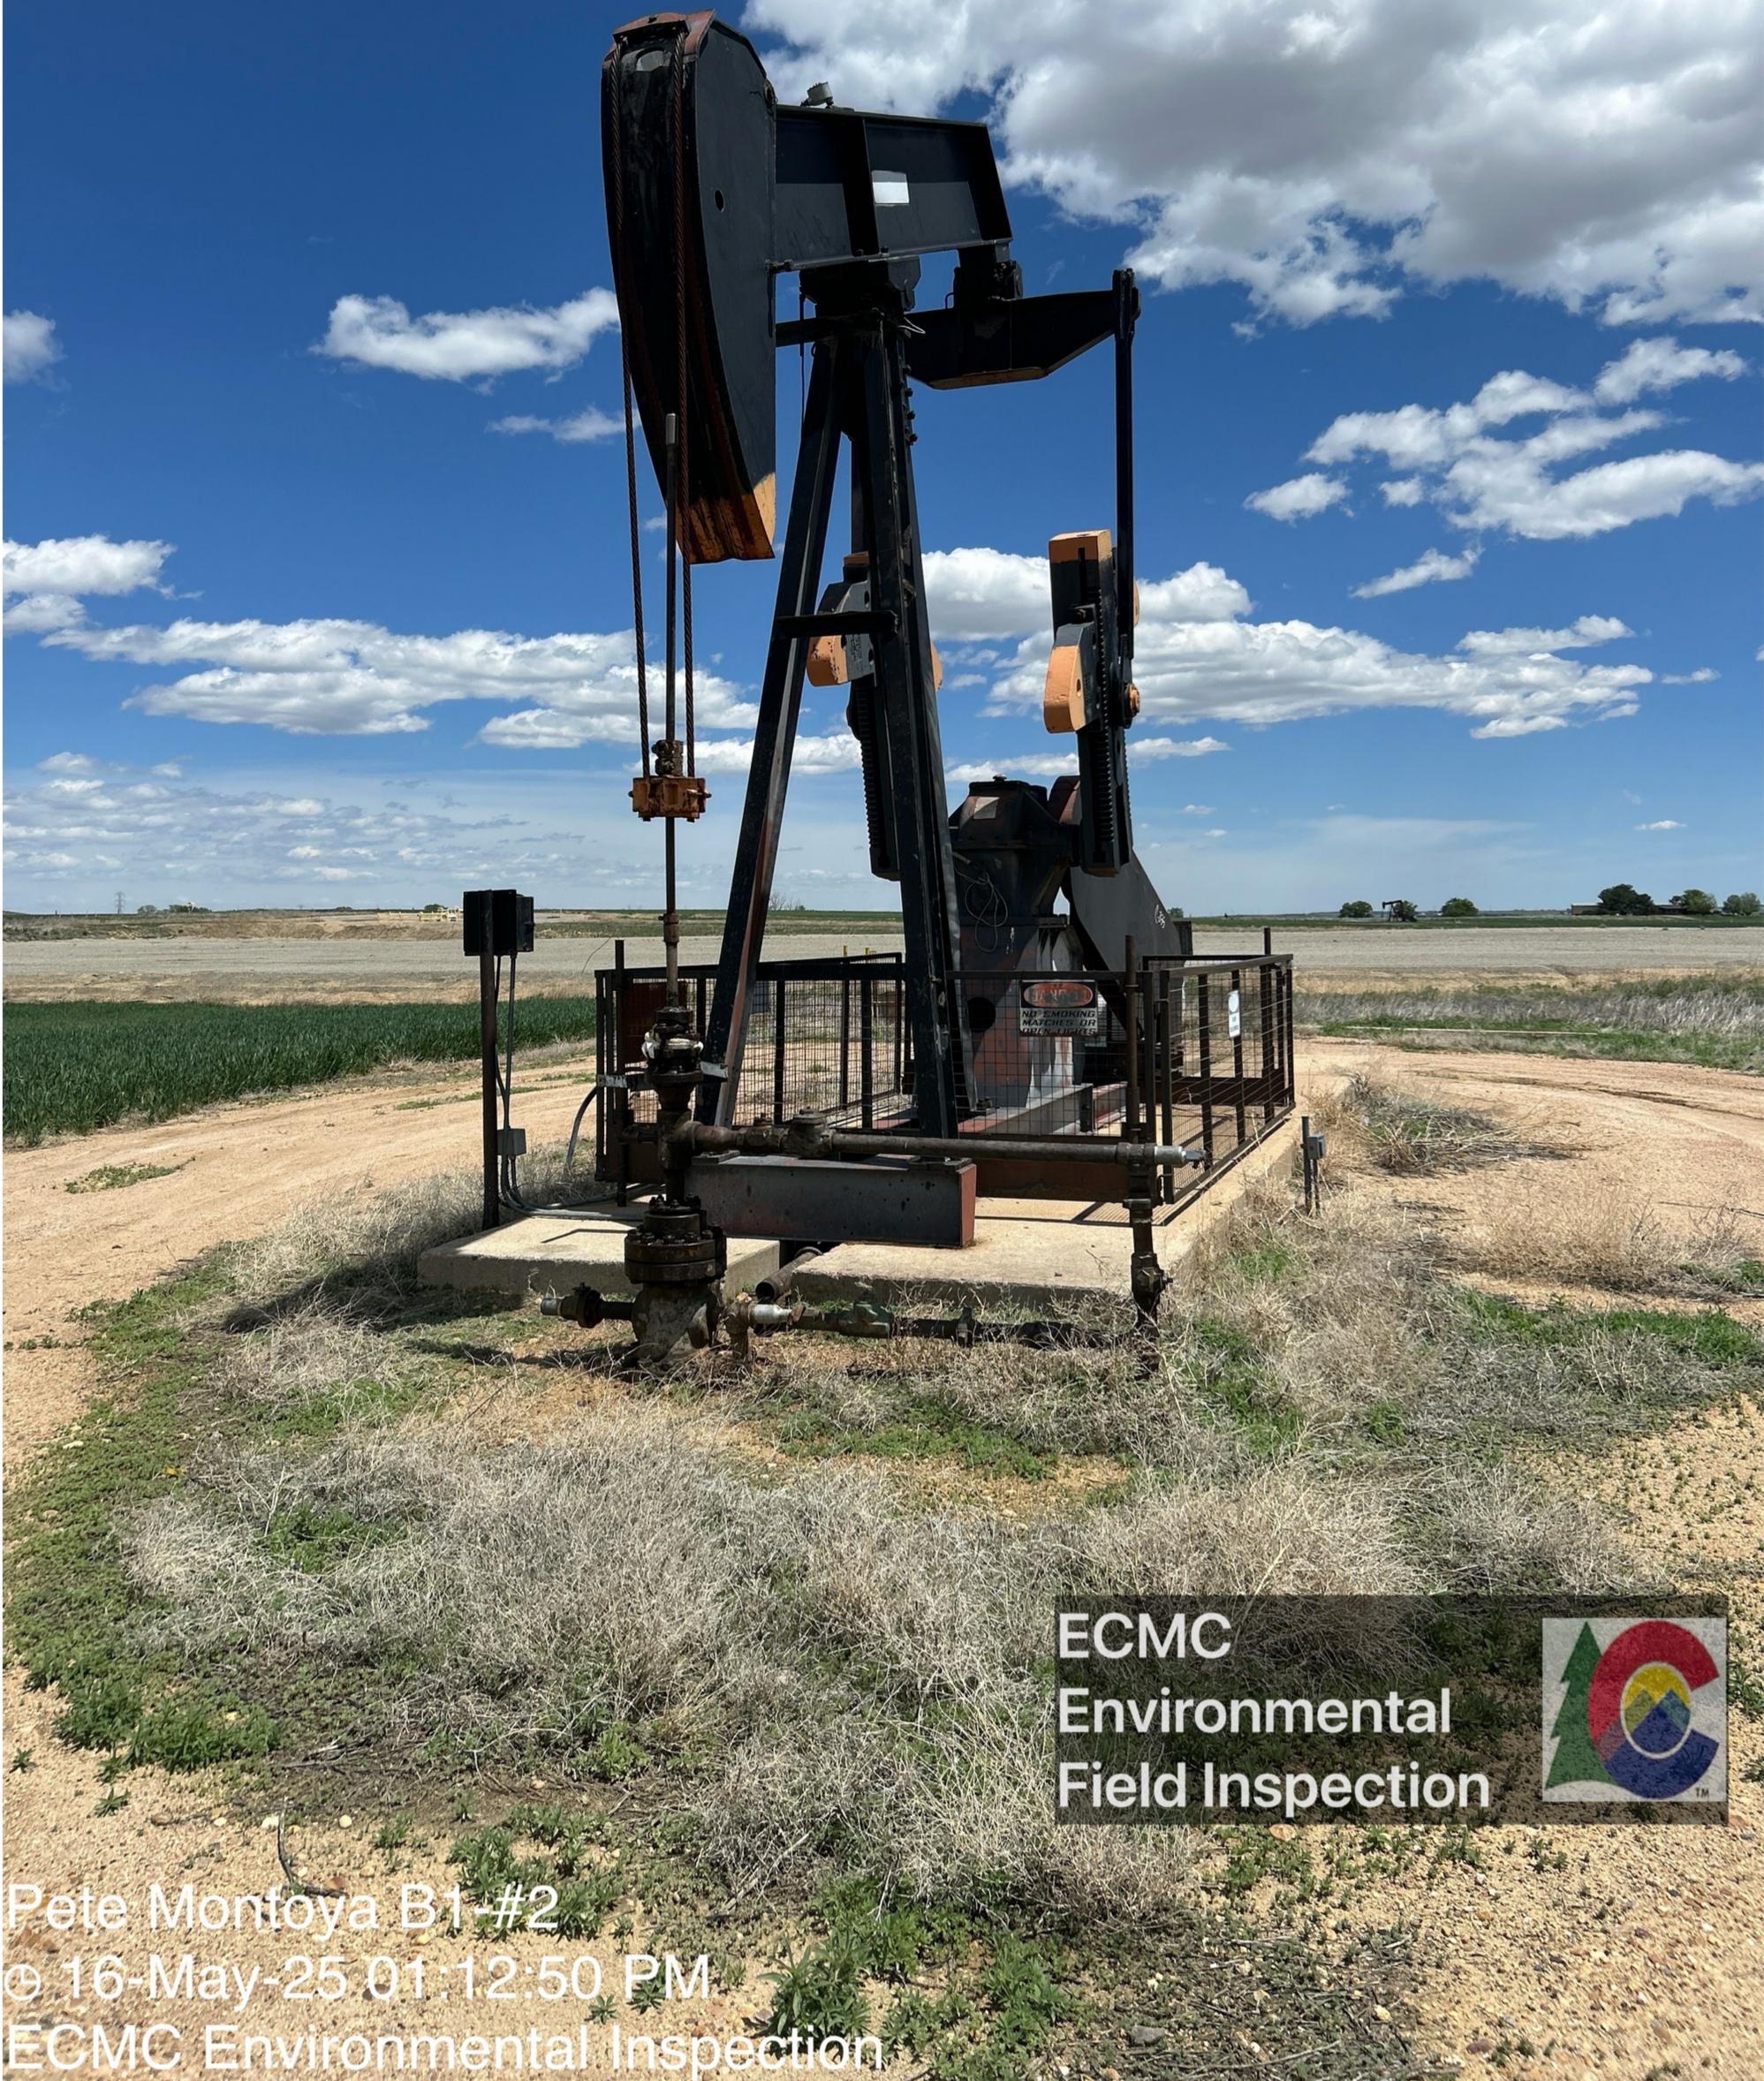
Weeds are visible adjacent to the wellhead.

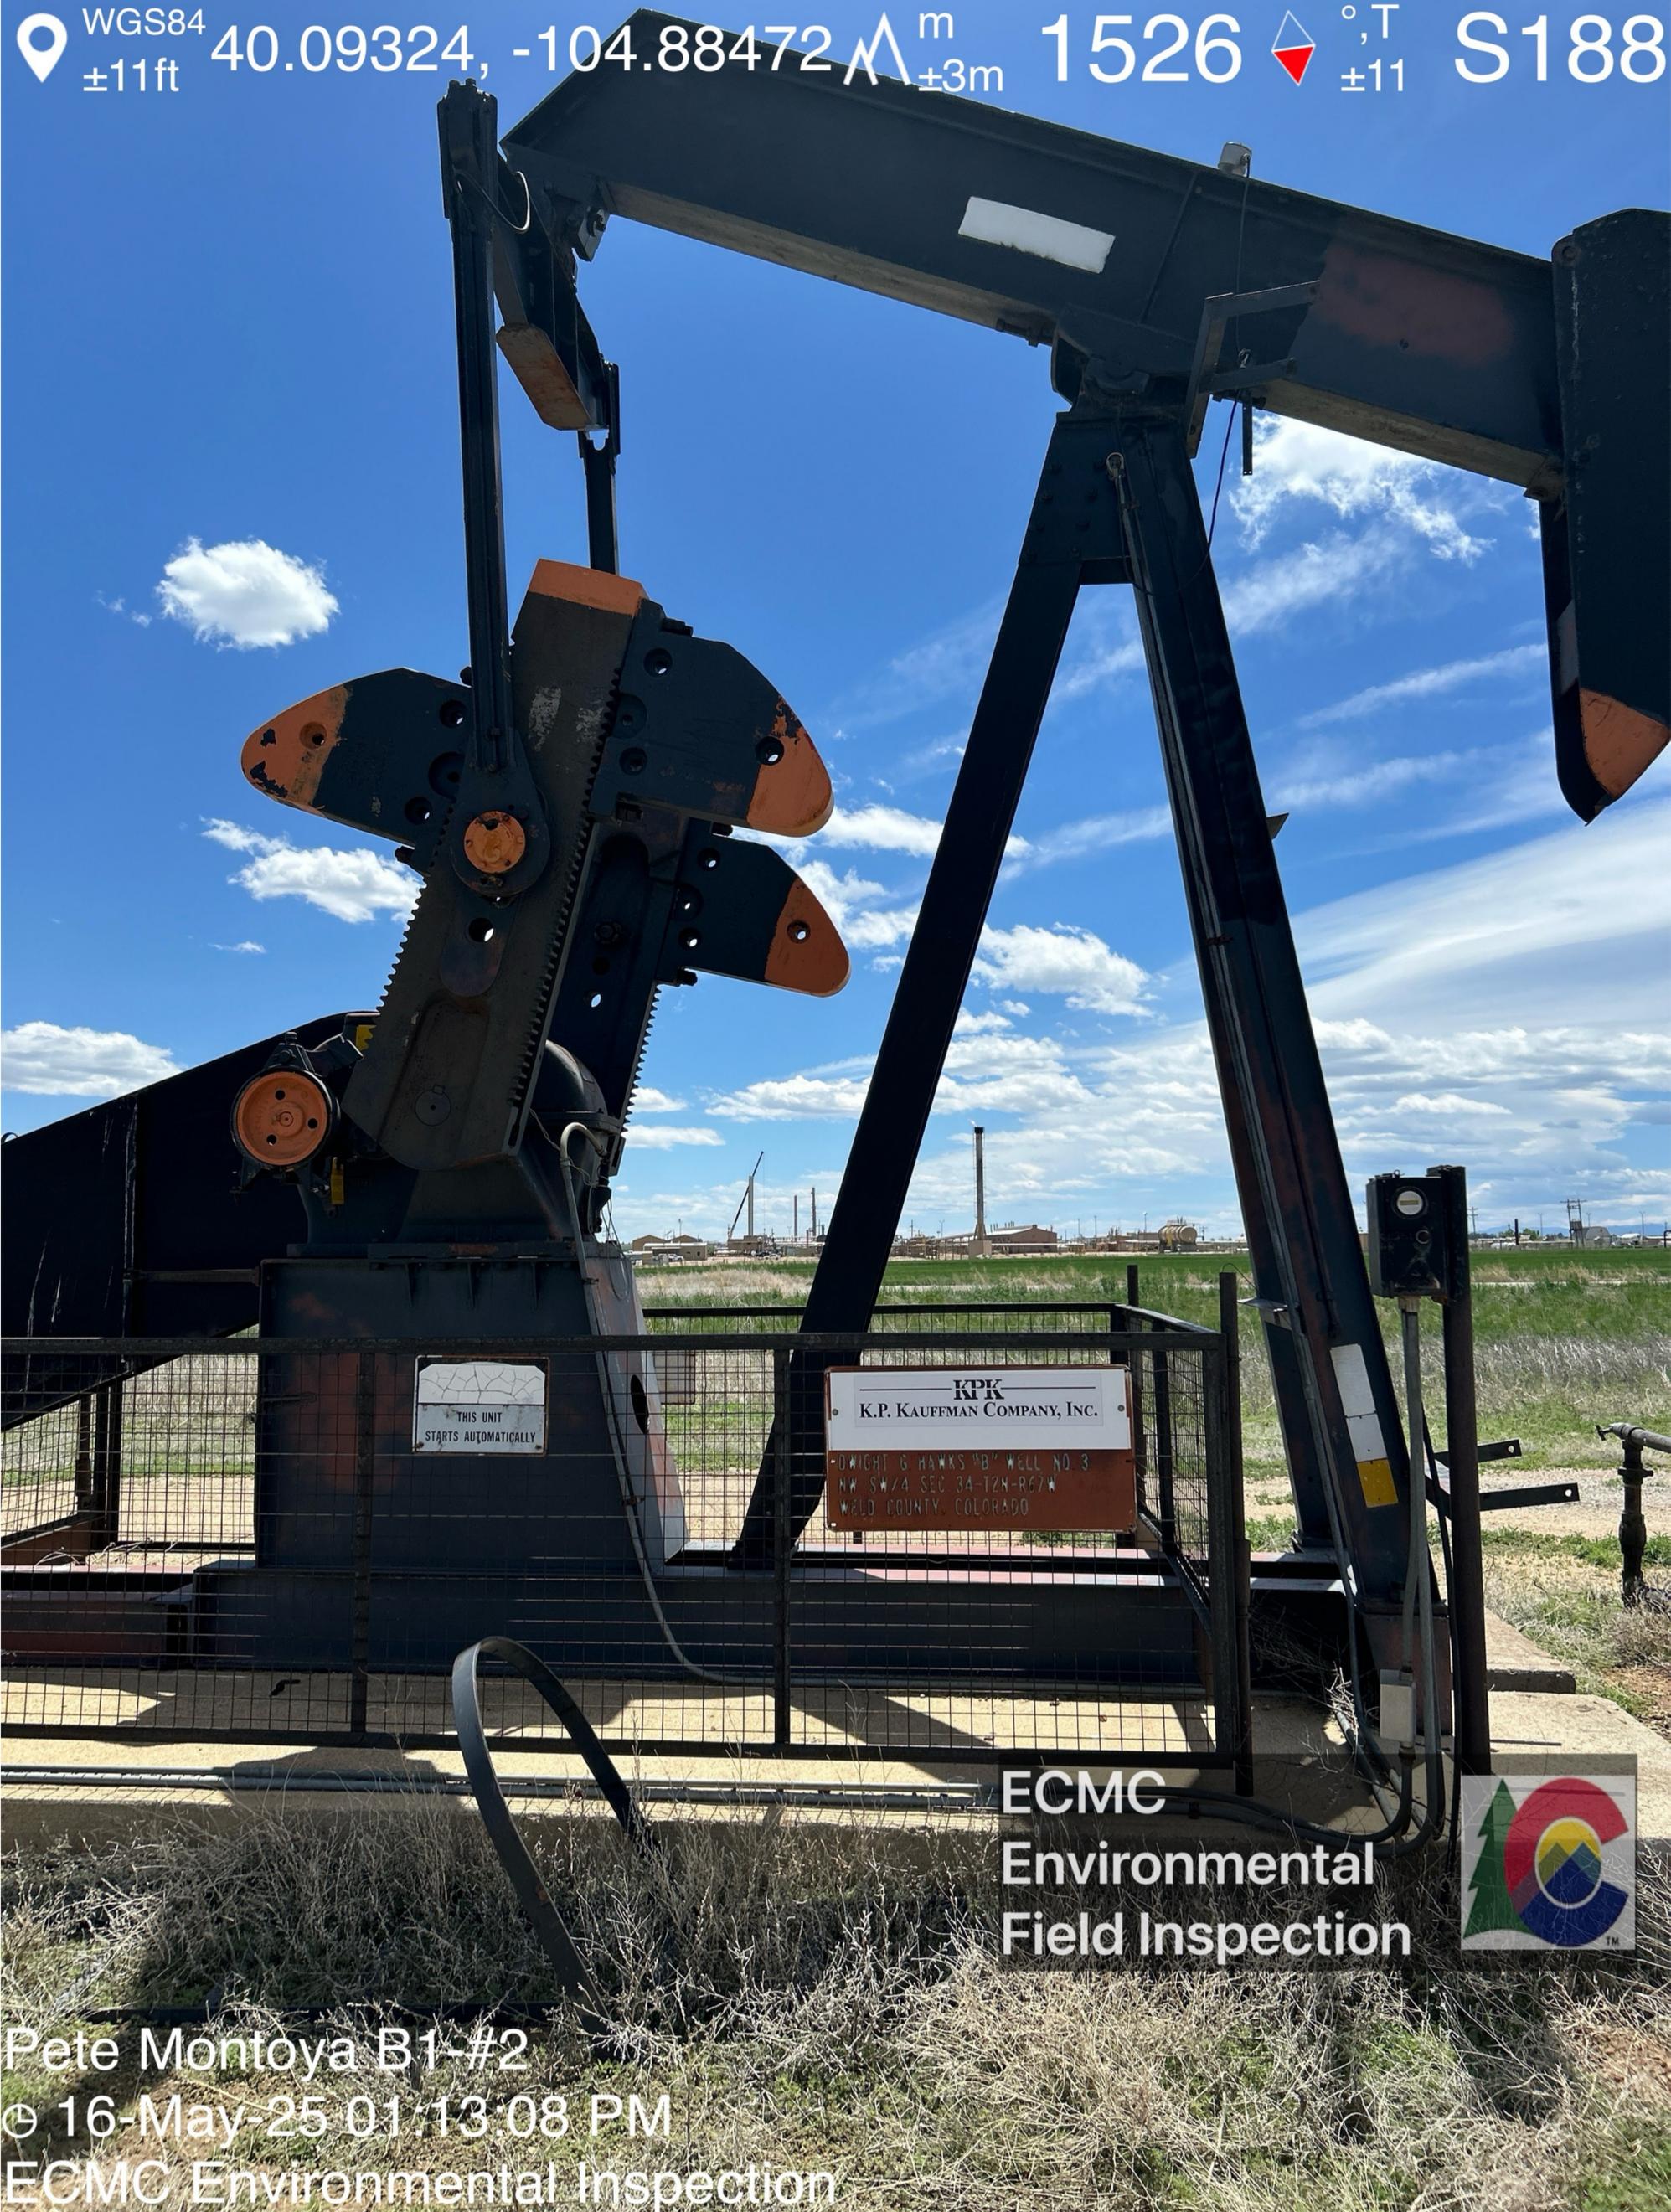
Emergency contact number is not visible on the signage.
