ECMC  
Environmental  
Field Inspection

Pete Montoya B1-#2  
© 16-May-25 01:09:00 PM  
ECMC Environmental Inspection

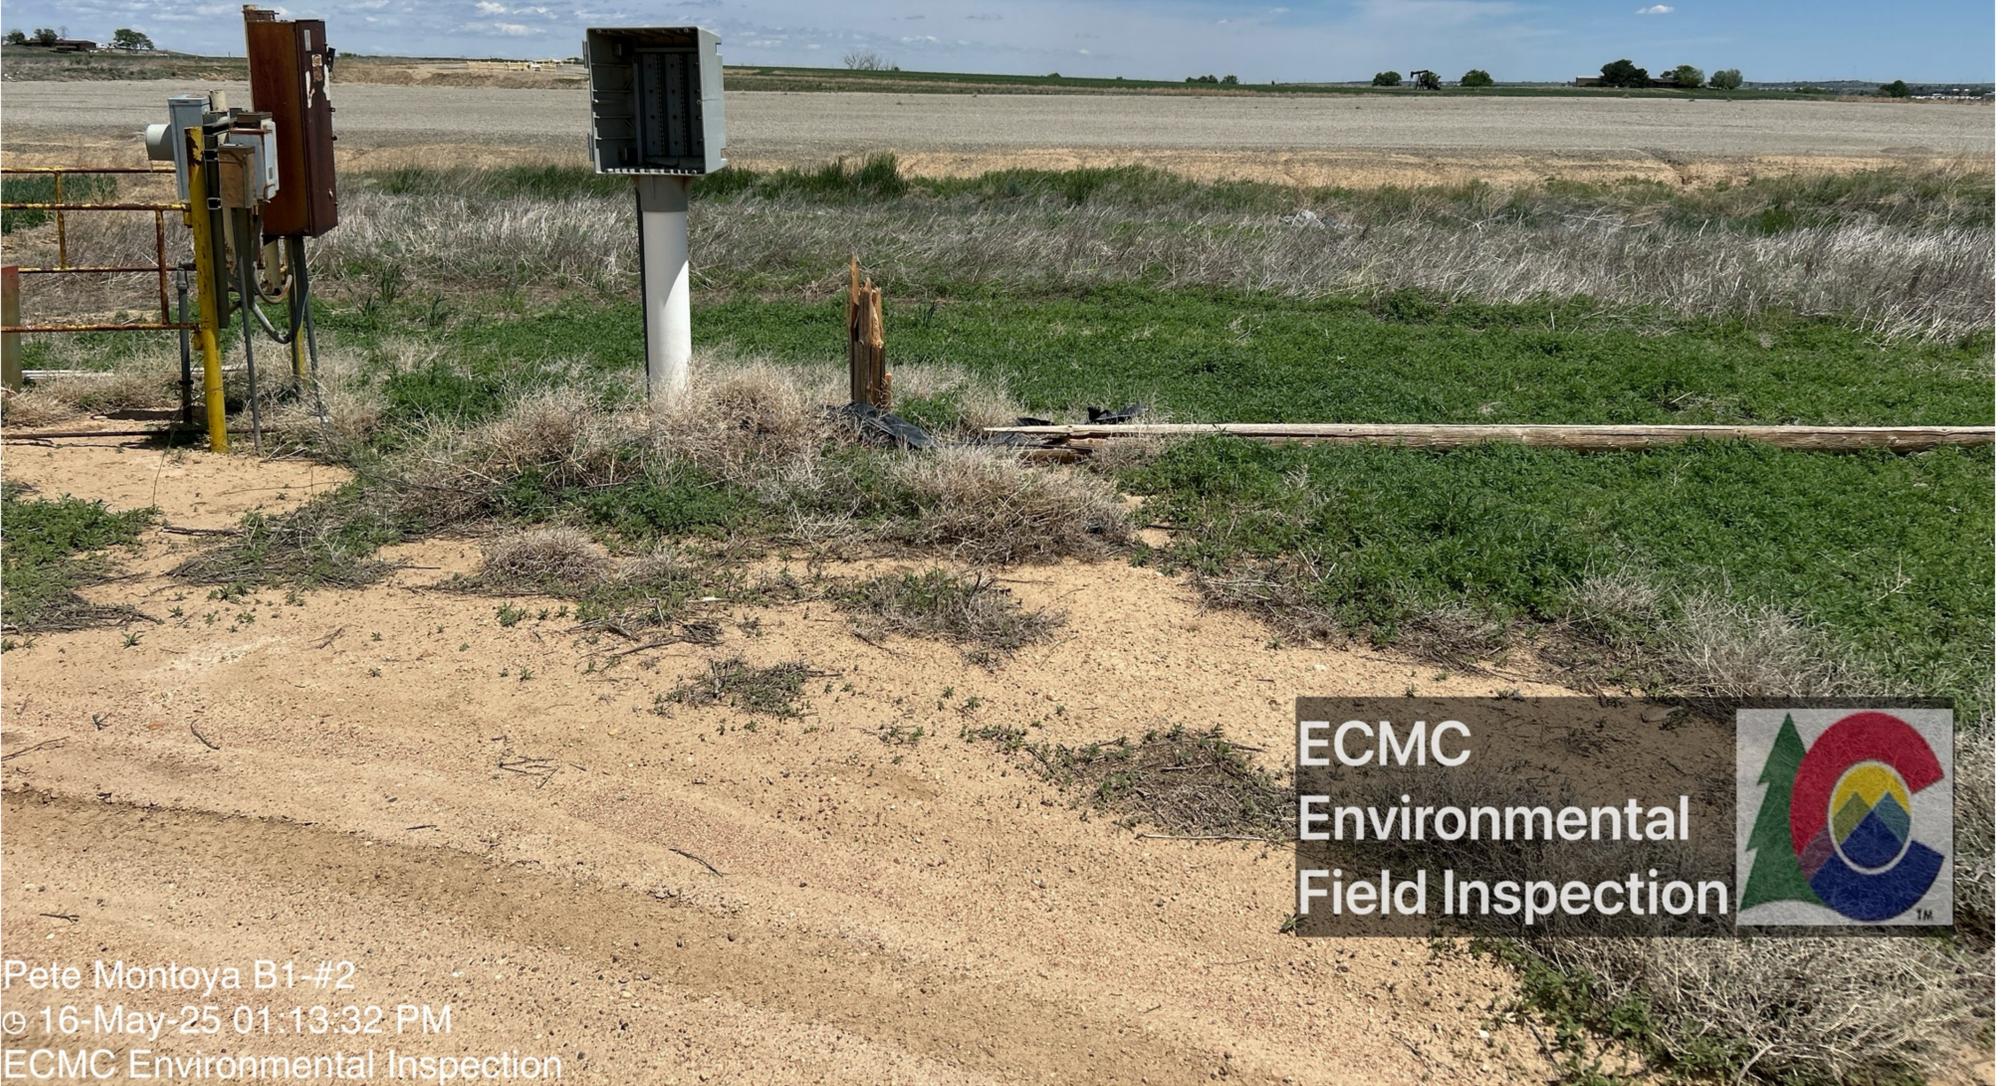
Debris/unused equipment is visible adjacent to ancillary equipment.
