ECMC
Environmental
Field Inspection

Adler 22-34 Wellhead
© 22-May-25 10:02:07 AM
ECMC Environmental Inspection

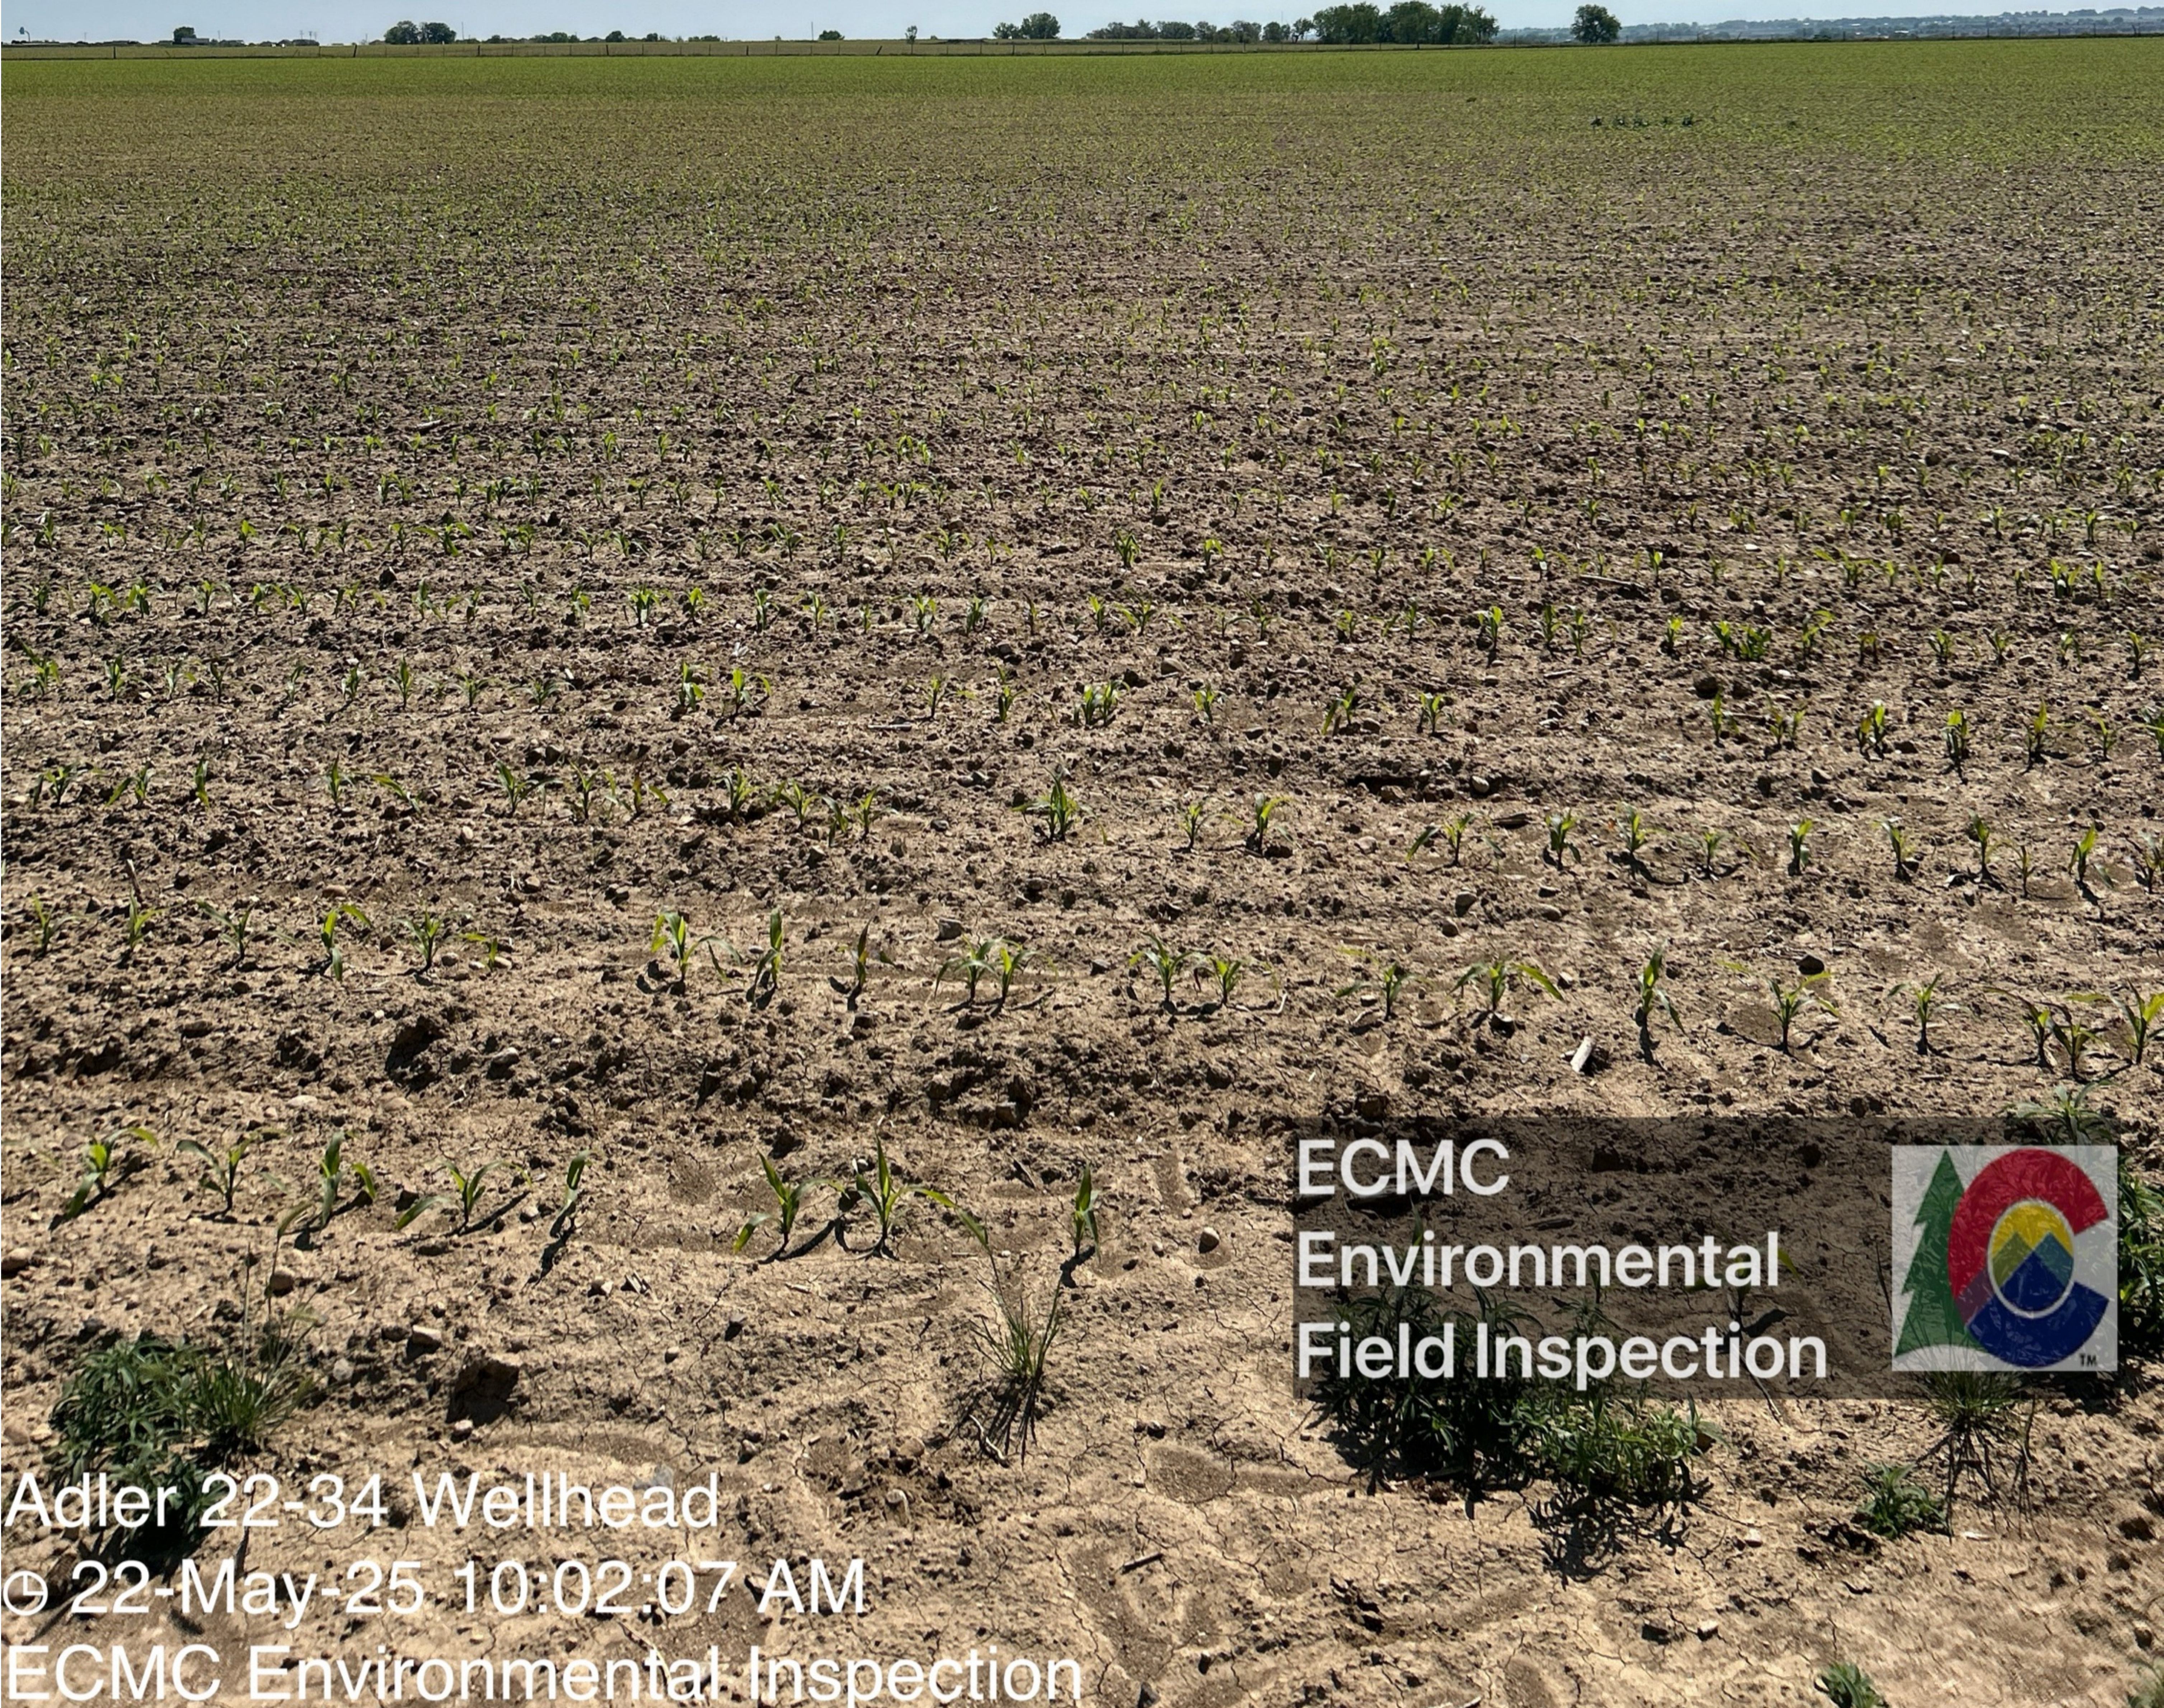
Looking at the former spill location from the end of the partially remaining access road. The excavation has been backfilled. Crops appear to have been planted.
