Inspection Photos
Location: Red Rocks 35-15
Location ID: 481116
API # 05-071-09919

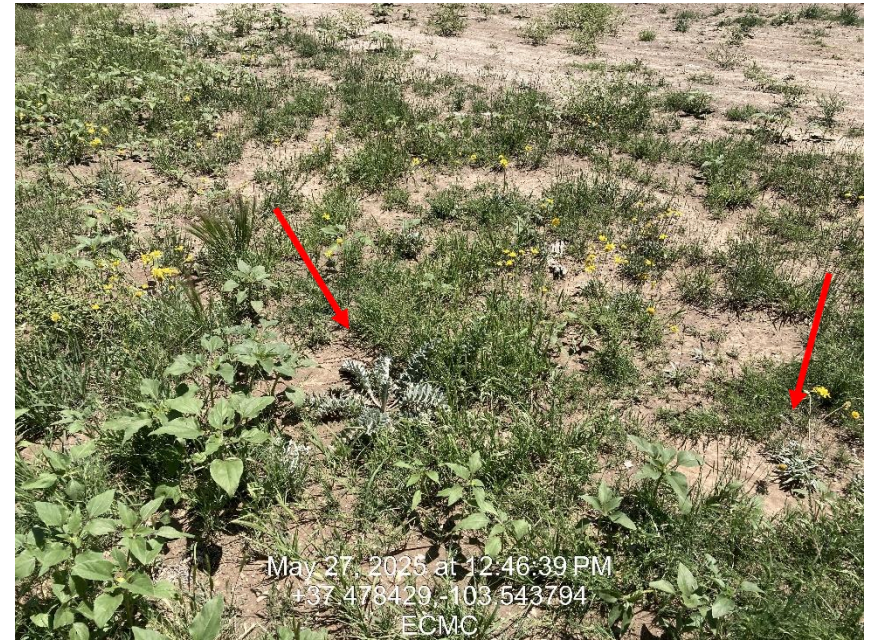
Photo 2 – Noxious weeds and undesirable plants observed at the time of inspection

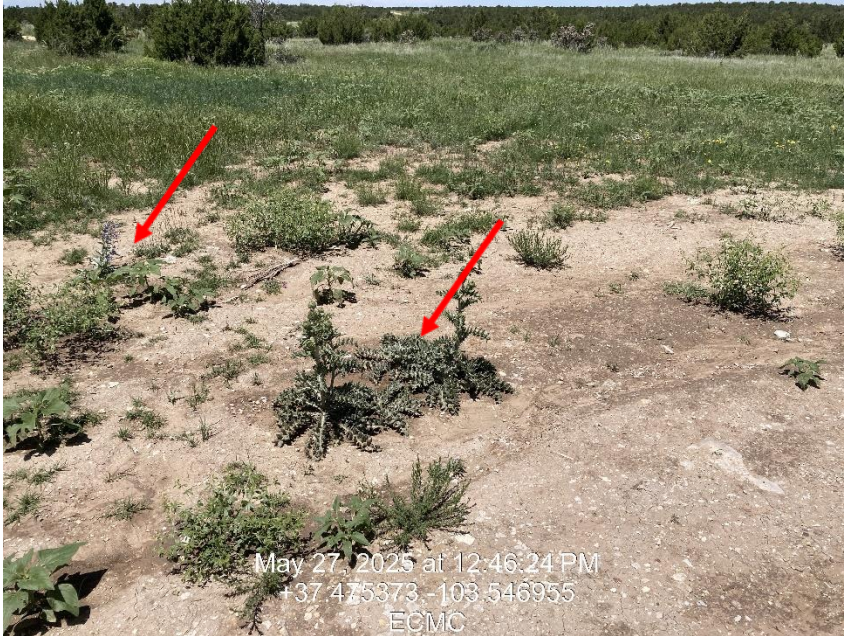
Photo 3 – Noxious weeds and undesirable plants observed at the time of inspection

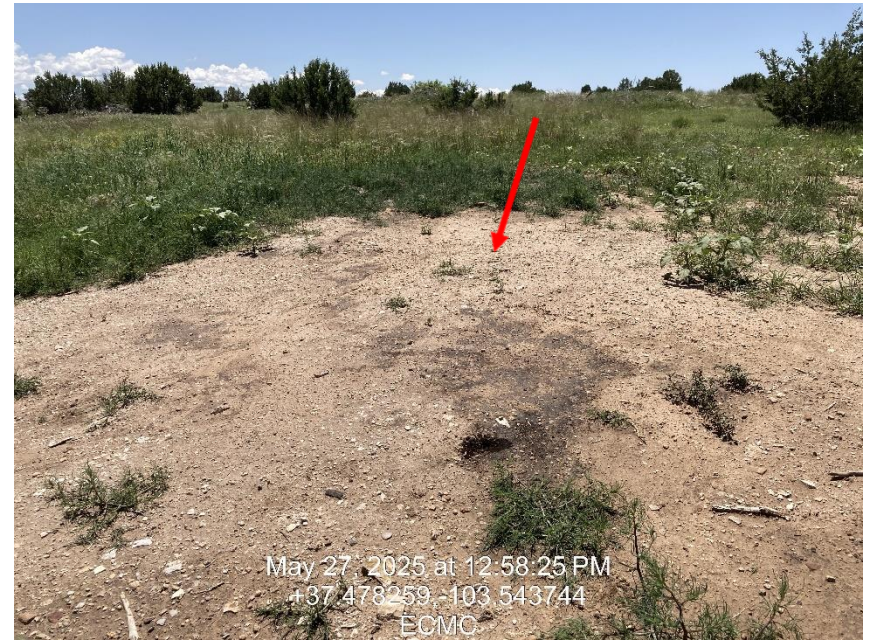
Photo 4 – Oil stained soils observed on location at Long 37.478259 Lat -103.543744

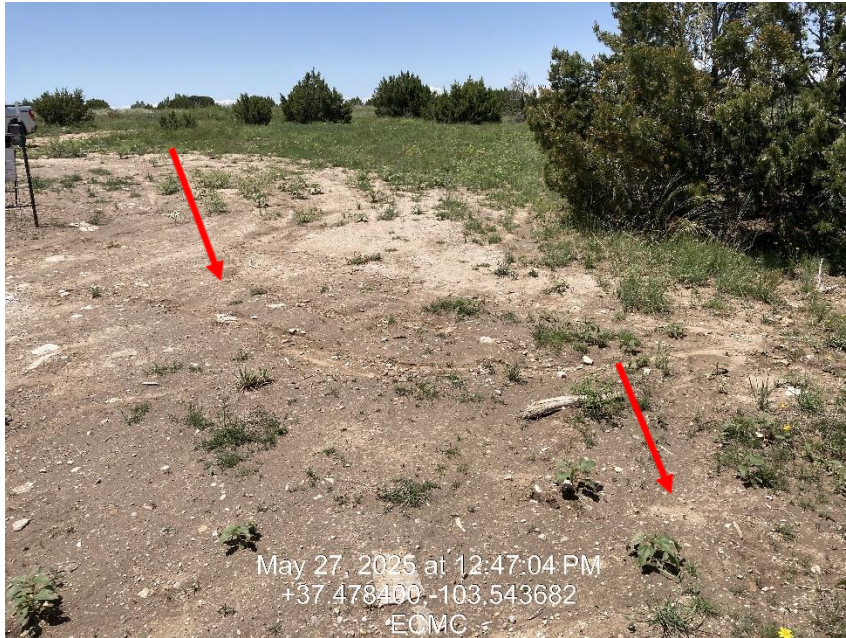
Photo 5 – Stormwater/erosion

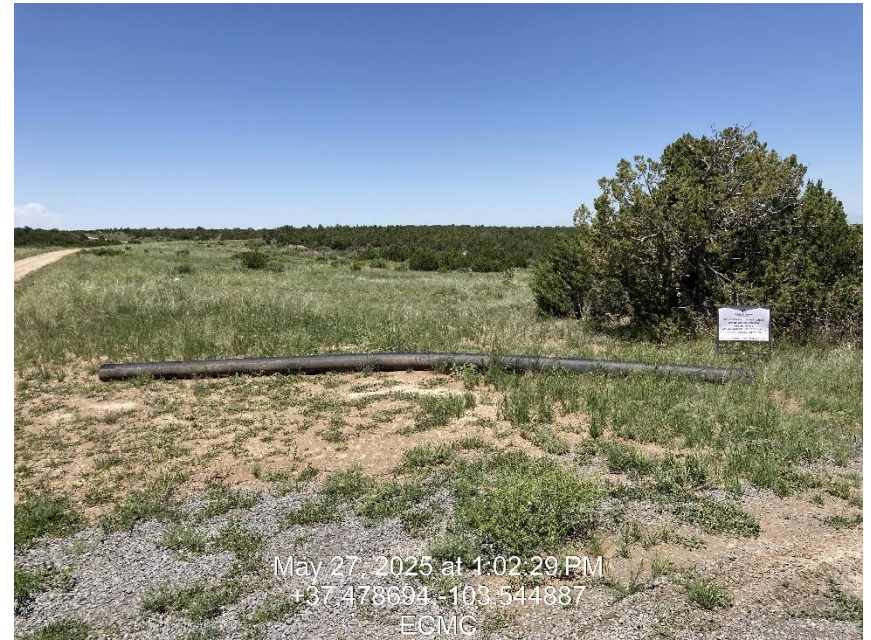
Photo 6 – Unused poly pipe at entrance to location
