Inspection/Audit Photos

Location Name: QB ENERGY OPERATING LLC ROSE RANCH 23-4D (A22W) Pad

Location #: 334755

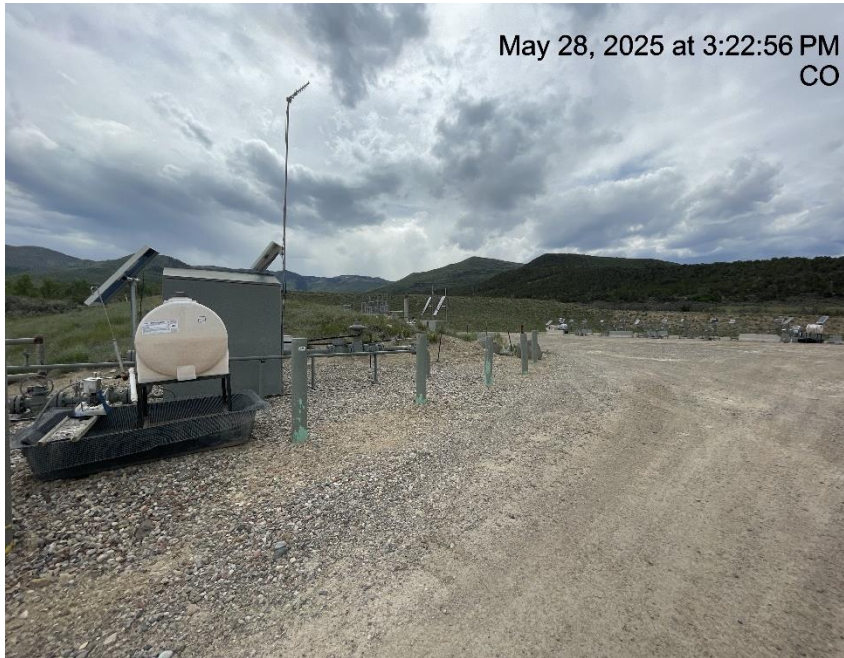
Photo # 3762 From entrance to location

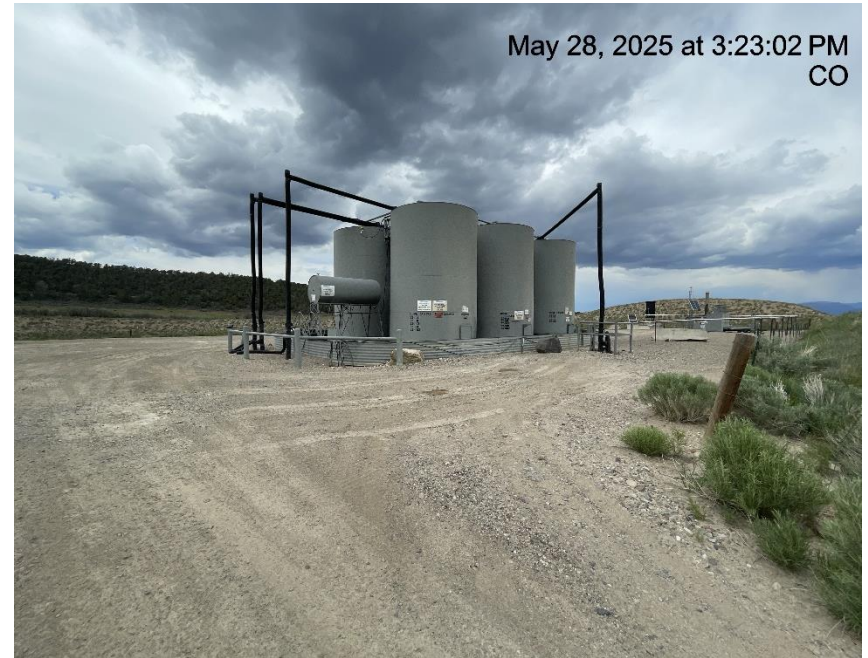
Photo # 3763 From entrance to location

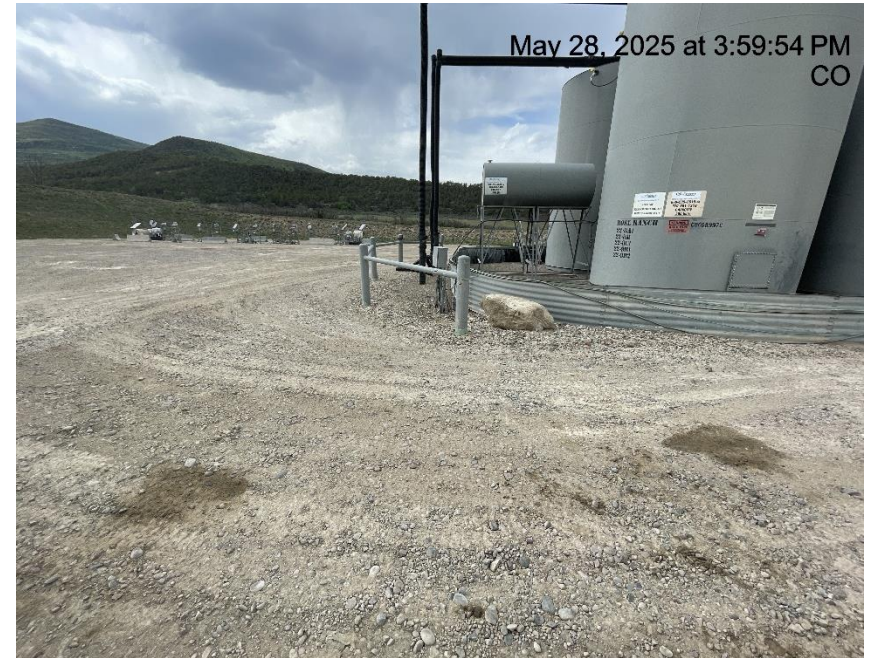
Photo # 3779 Staining near tank battery

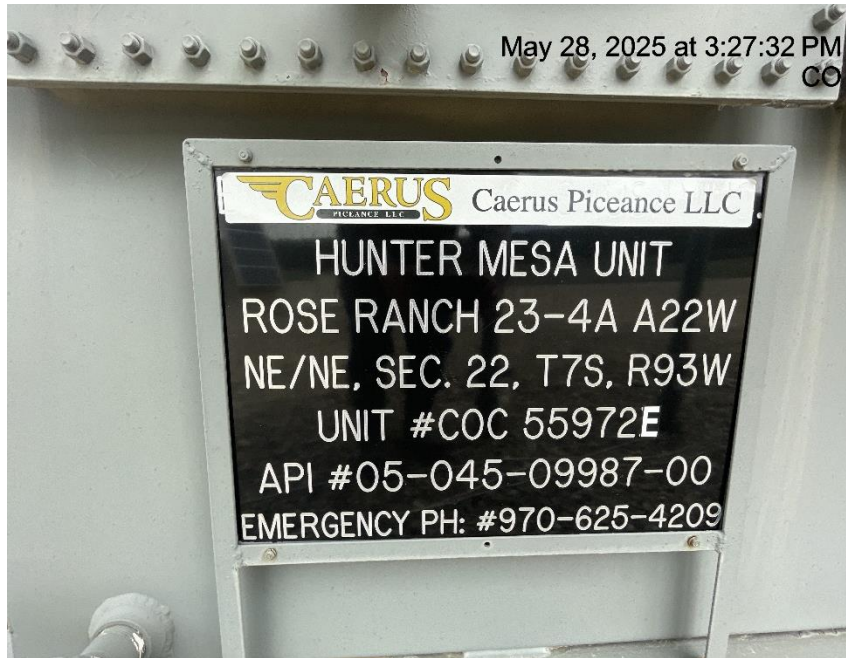
Photo # 3780 Emergency contact # on wellhead sign incorrect/# is disconnected & not in service

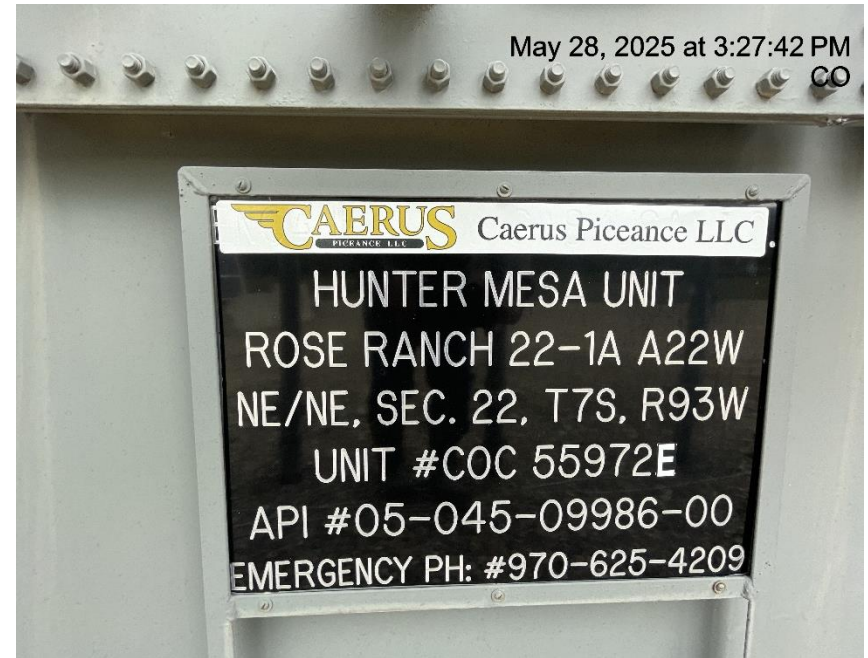
Photo # 3781 Emergency contact # on wellhead sign incorrect/# is disconnected & not in service

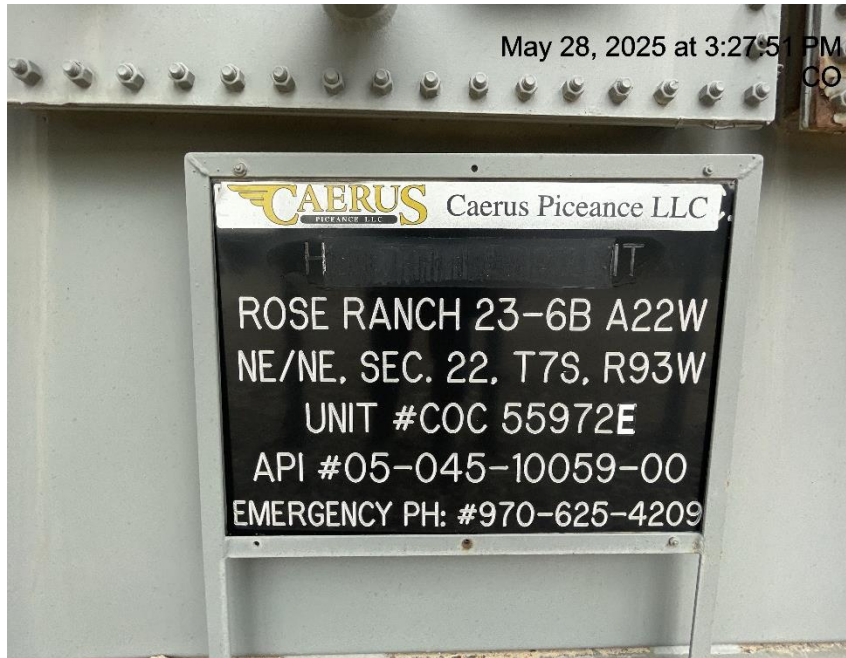
Photo # 3782 Emergency contact # on wellhead sign incorrect/# is disconnected & not in service
