# Inspection Photos

**Operator:** BLACK HILLS PLATEAU

**Location ID:** 312407

**Inspection Doc:** 718100535

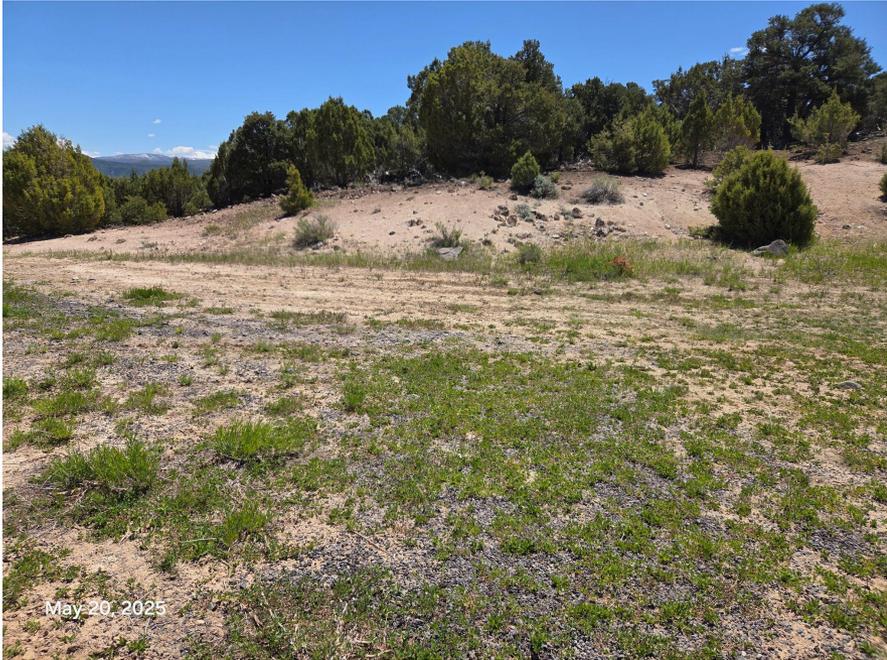
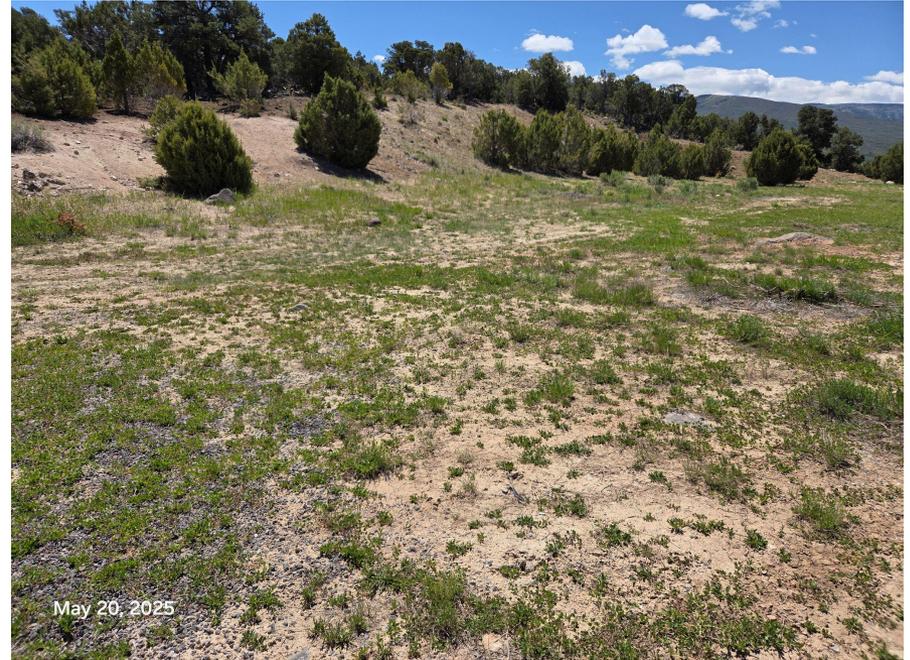
**Photo 1:** Photos 1-2 taken from the north end of the Location. Photos provide an overview from east, southeast, southwest to west. Location and access road has not been recontoured/regraded and reclaimed.

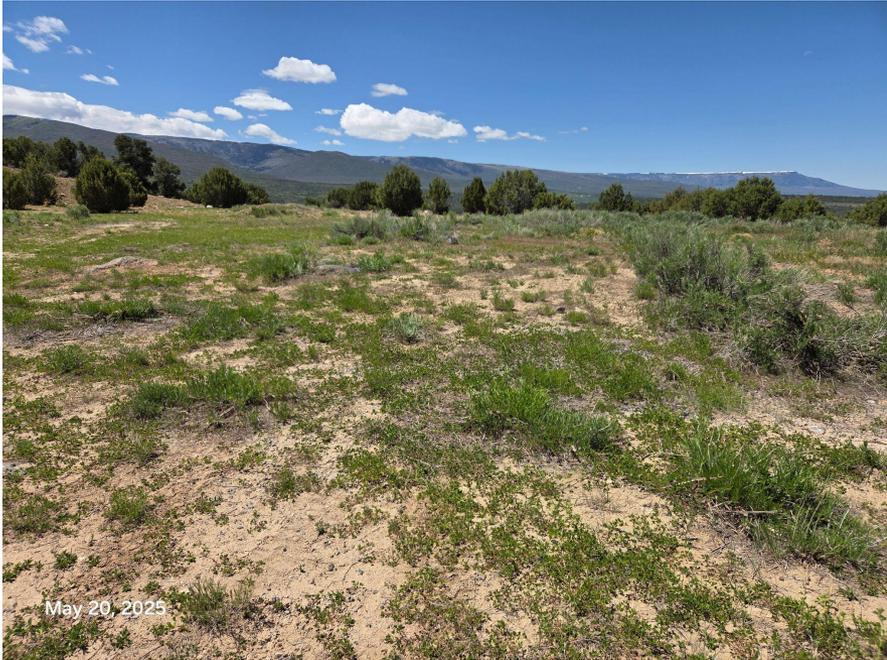
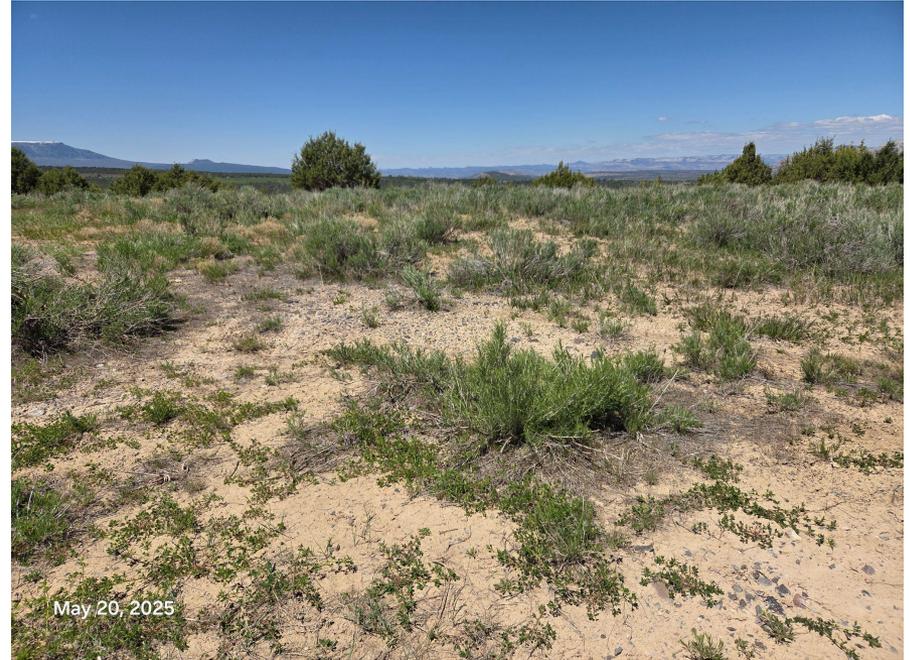
**Photo 2:** See comments under photo 1.

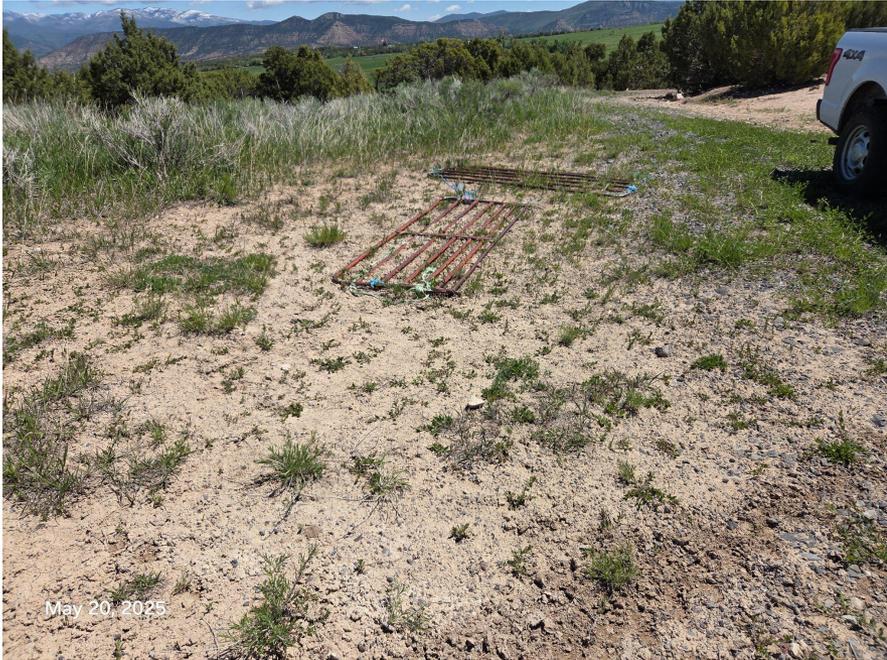
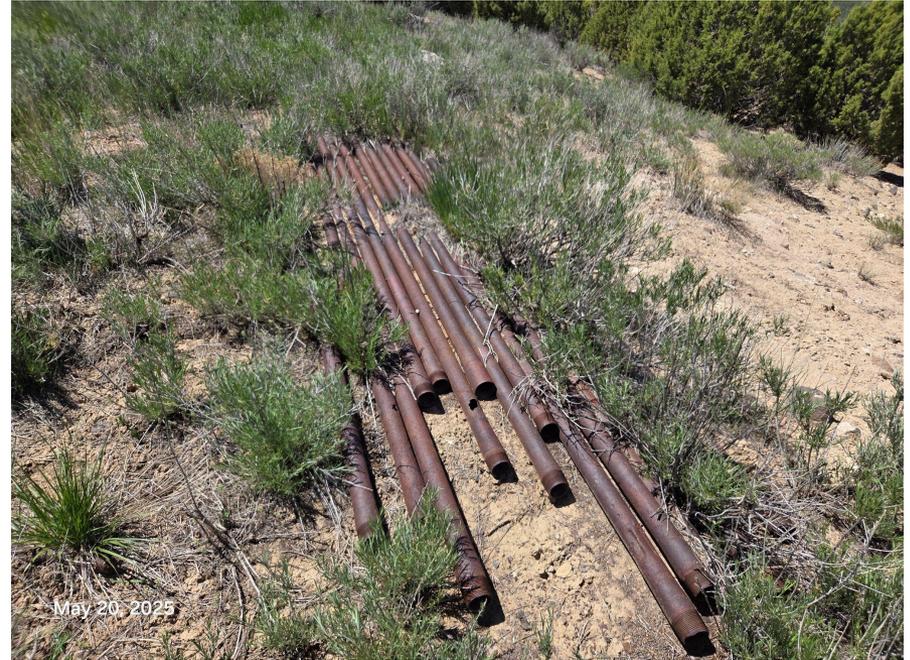
**Photo 3:** Pipe/equipment remaining on the Location.

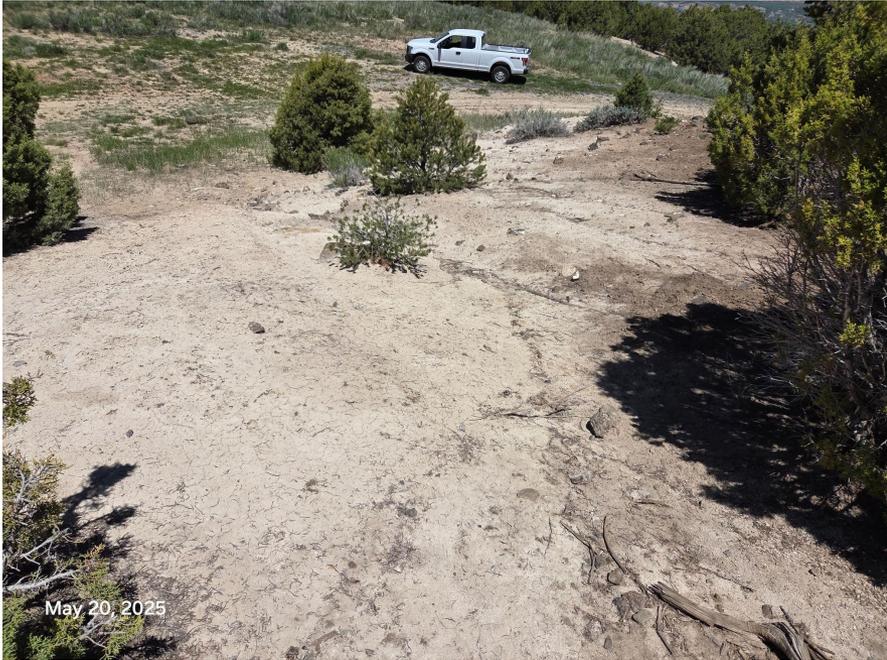
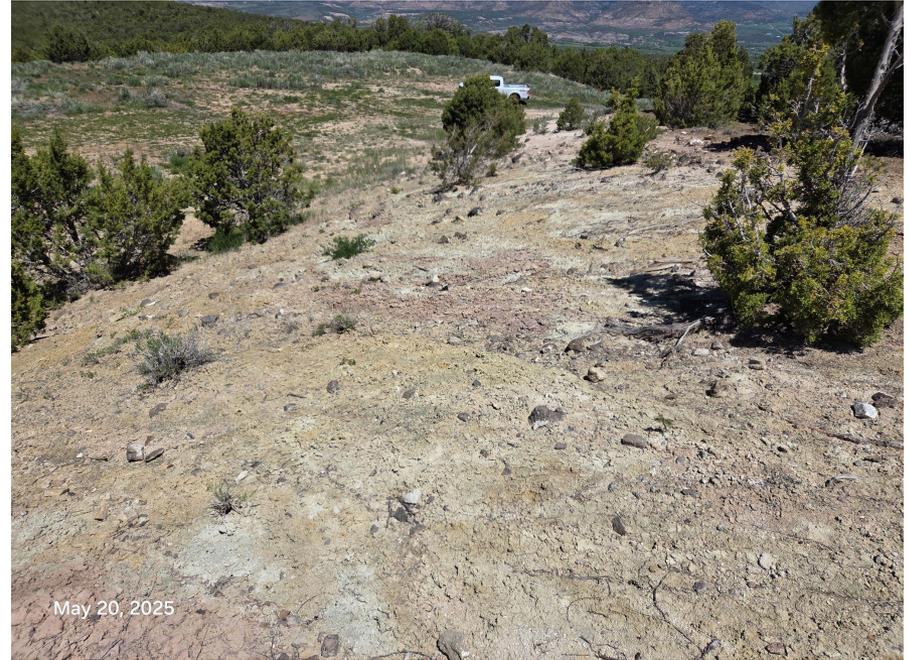
**Photo 4:** Photos 4-5 taken from the cut slopes on the south and east end of the Location. Photos examples showing BMPs to manage stormwater runoff remain missing or insufficient; slopes remain bare and erosion degradation has persisted.

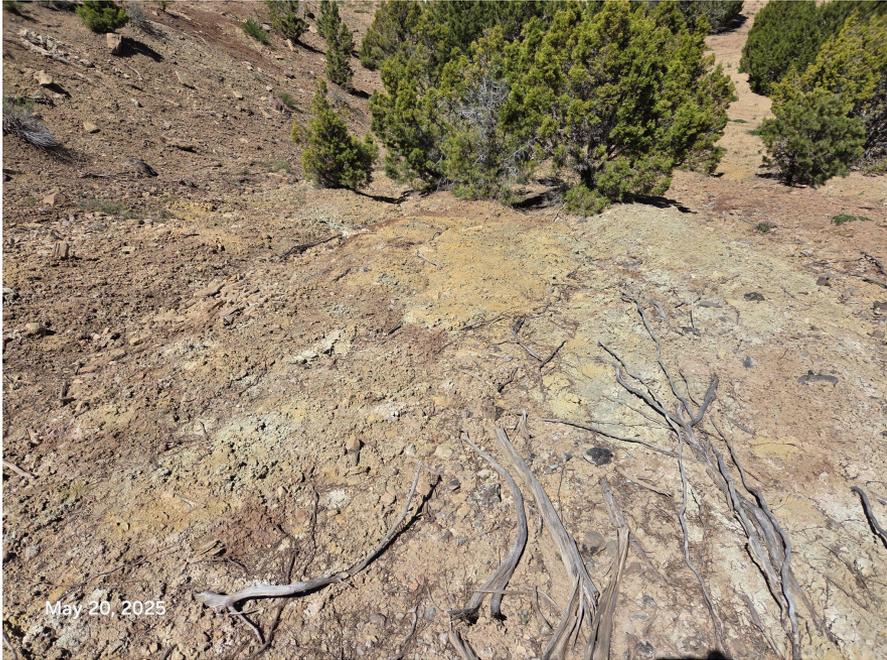
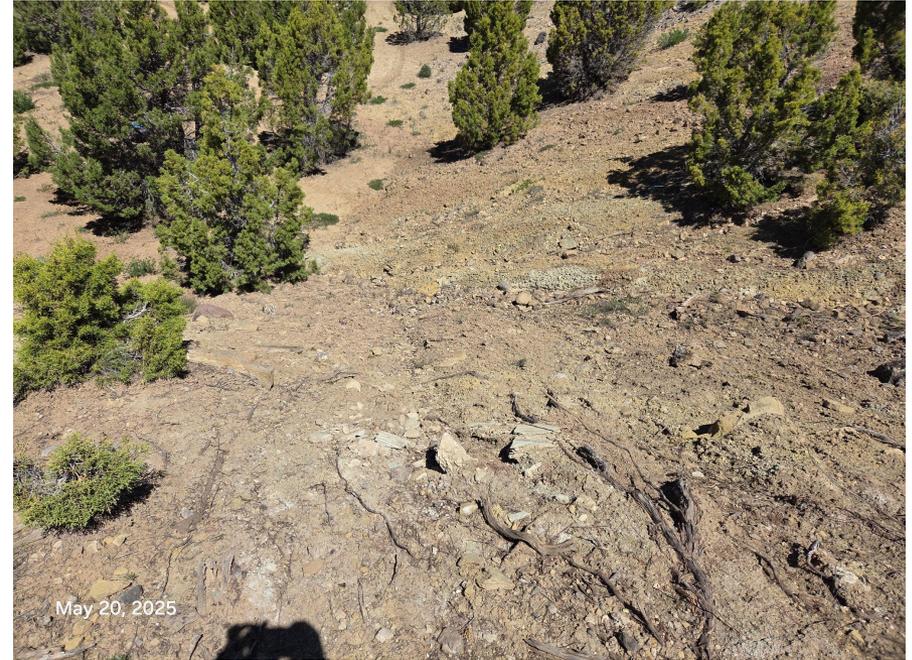
**Photo 5:** See comments under photo 4.

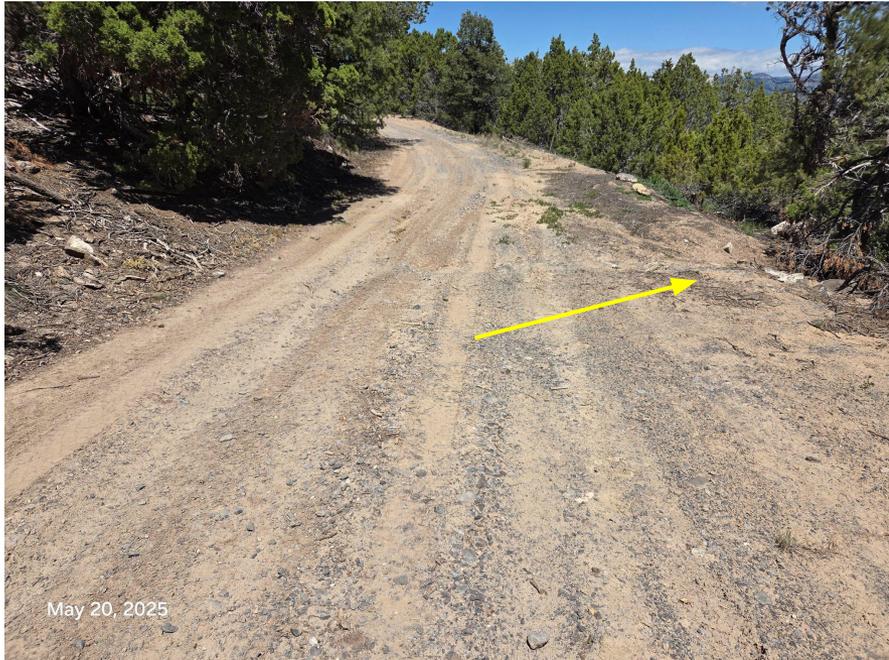
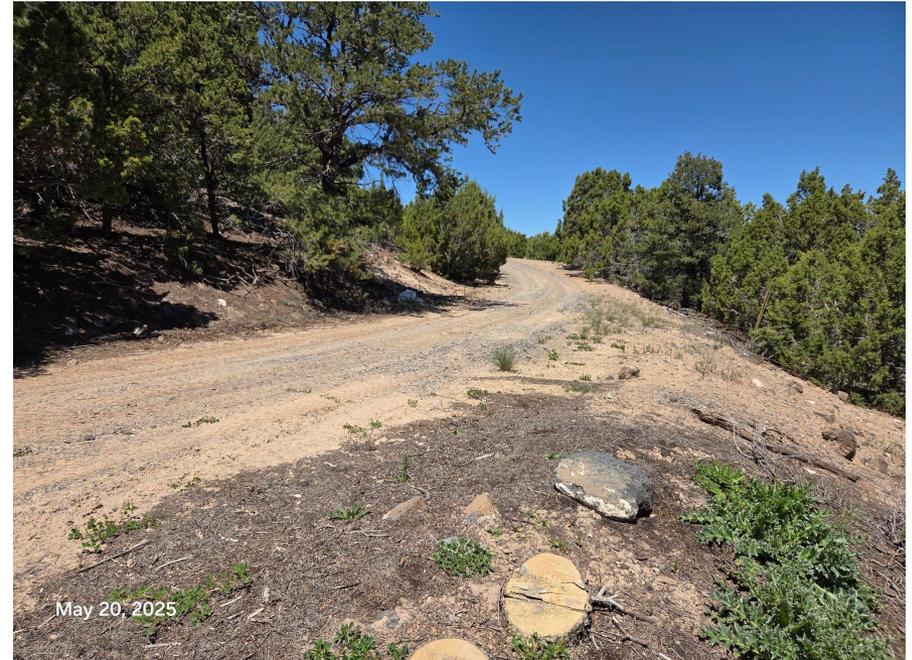
**Photo 6:** Photos taken from the access road; photos examples showing access road has not been reclaimed in accordance with 1004 requirements. Arrow in photo left shows areas where stormwater is running off from the road resulting in erosion, degradation and sediment transport.

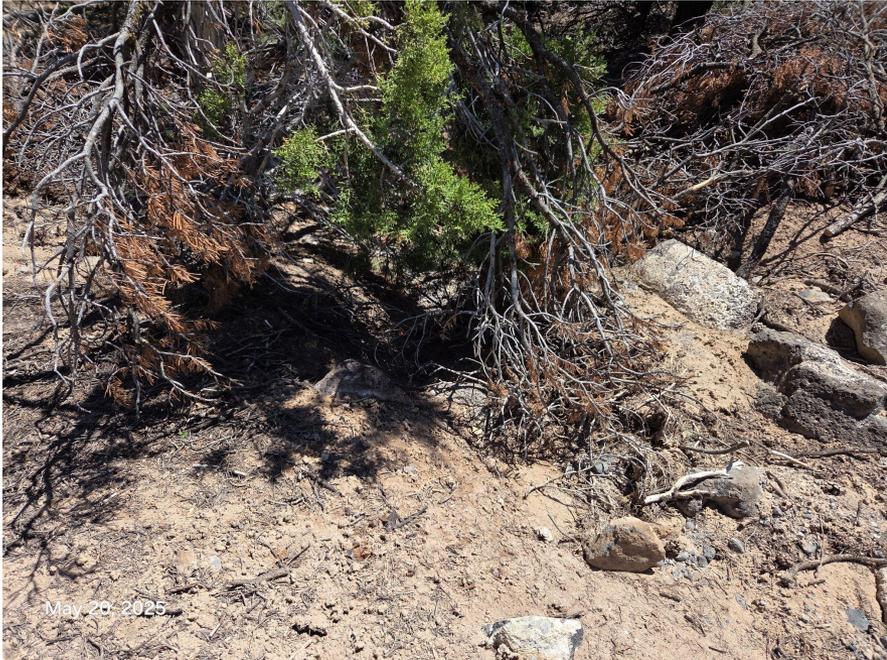
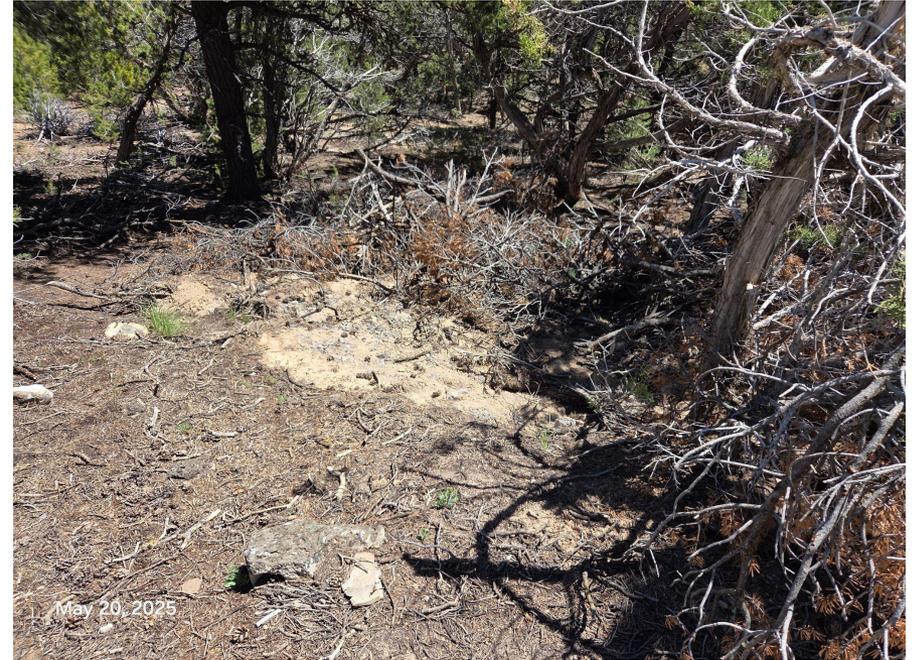
**Photo 7:** Continued from (left) photo 6. Erosion degradation and sediment transport/deposition due to runoff from the road observed.

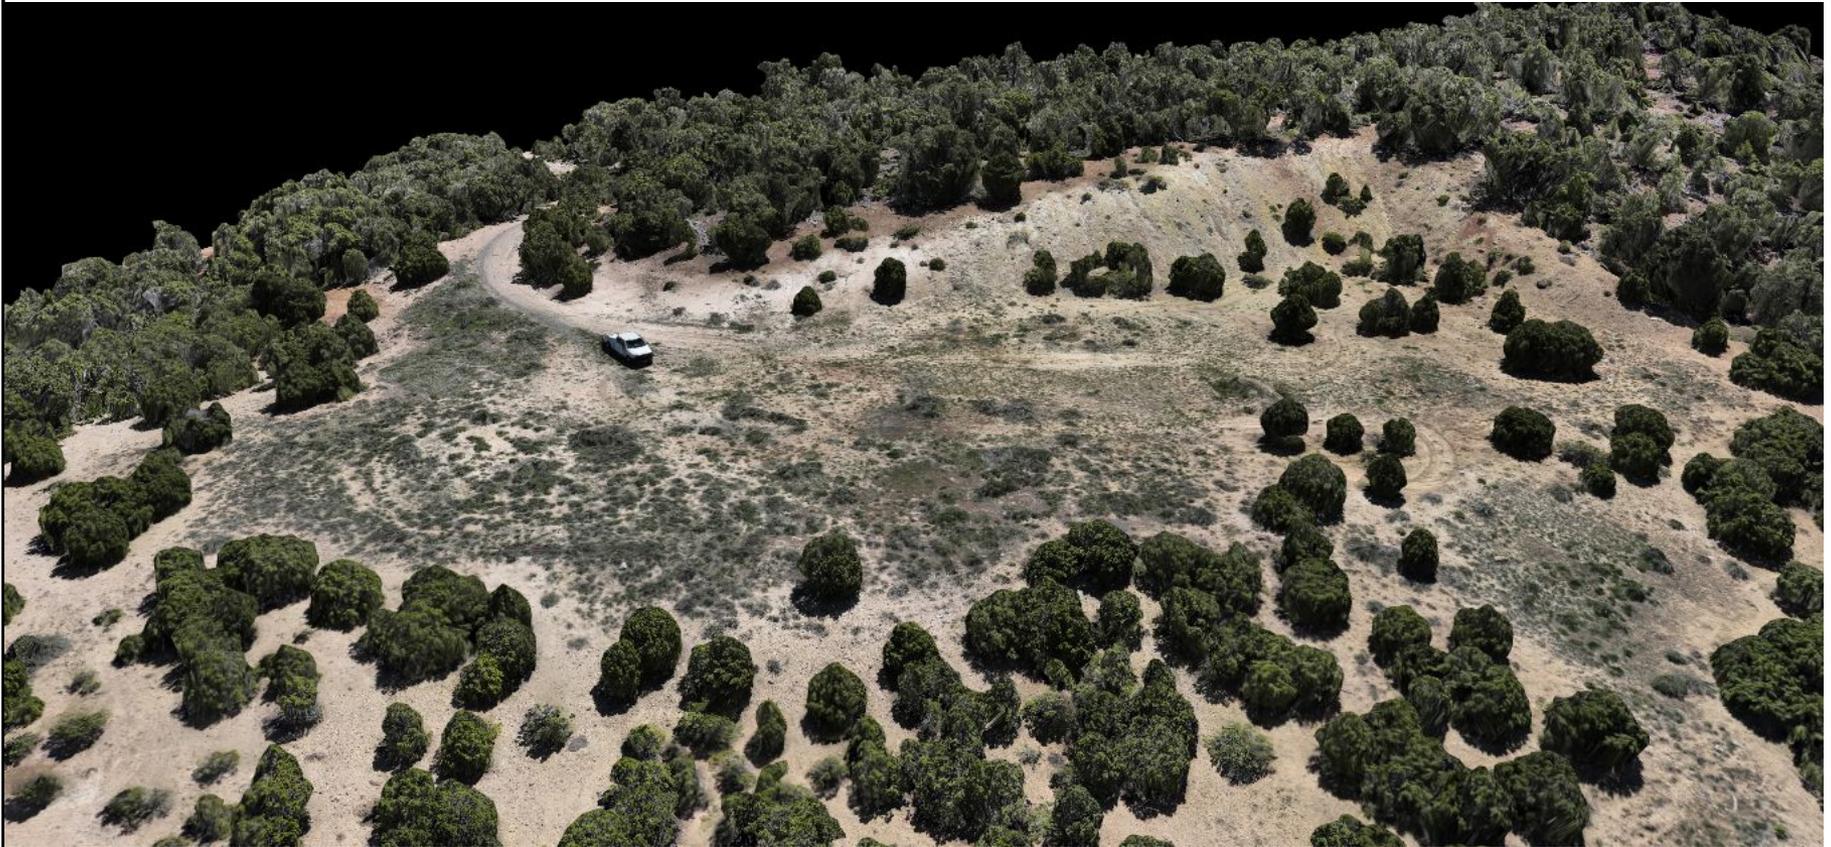
**Photo 8:** Photo a 3D model of the Location developed with use of a sUAS. Imagery dated 5/20/2025. Photo provides an aerial overview of the Location.

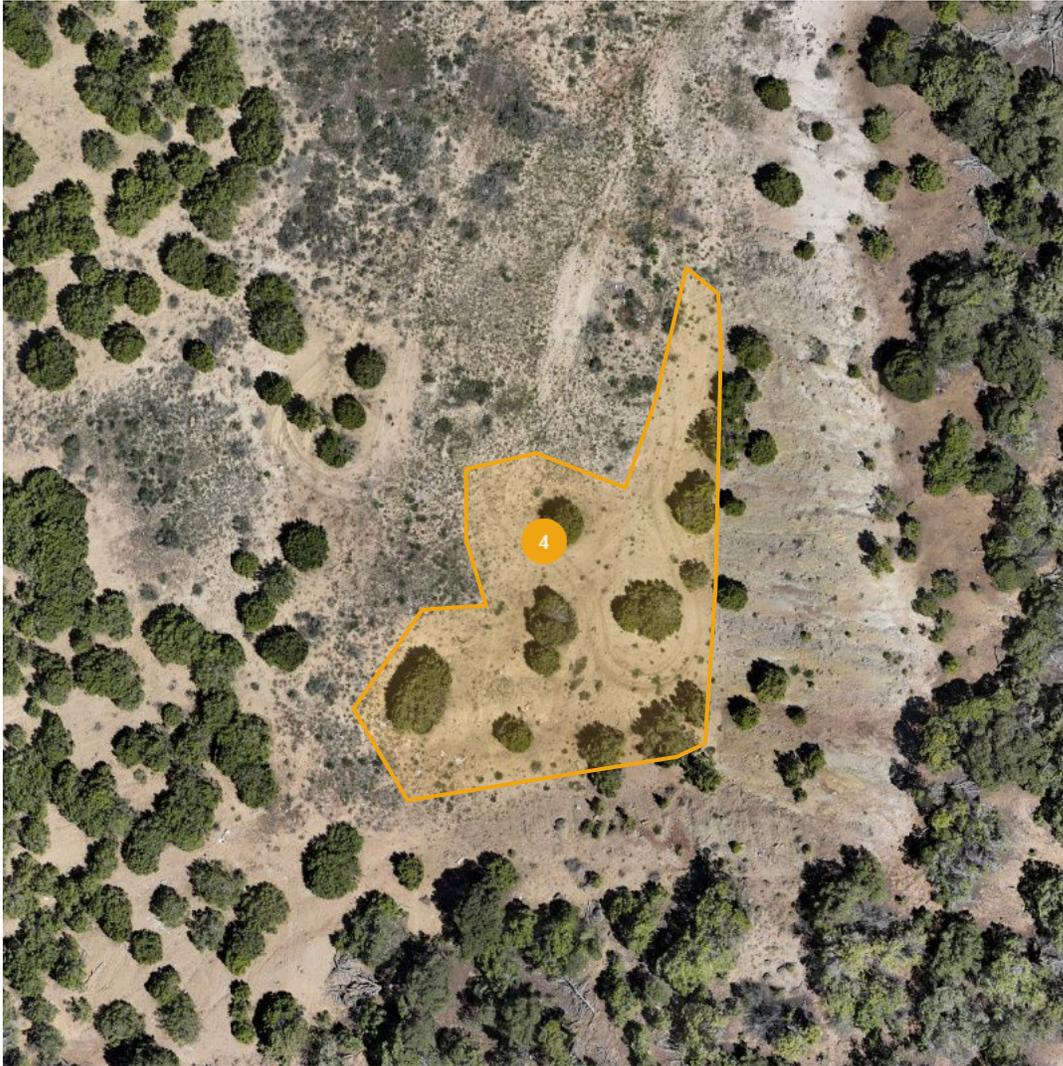
Summary:	Polygon represents areas of sediment deposition over time due to unstabilized cut slopes.
Created:	May 29, 2025, 2:38pm by Aaron Trujillo
Cost of Repair:	—
Lat/Long:	39.18566, -107.97568
Area:	8277.09 ft <sup>2</sup>
Surface area:	0.26 acres

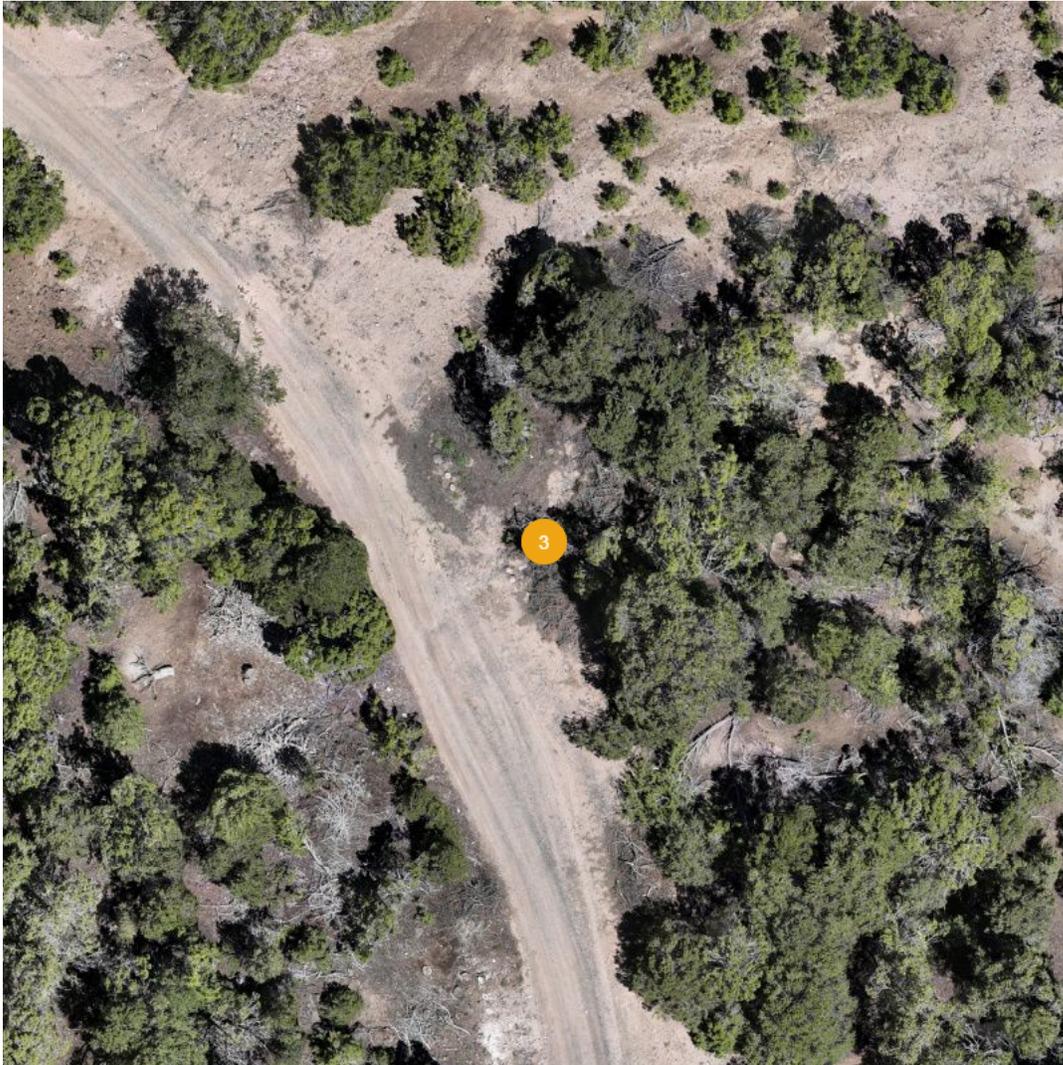
### 3 - Observation

Erosion degradation due to runoff from the road.

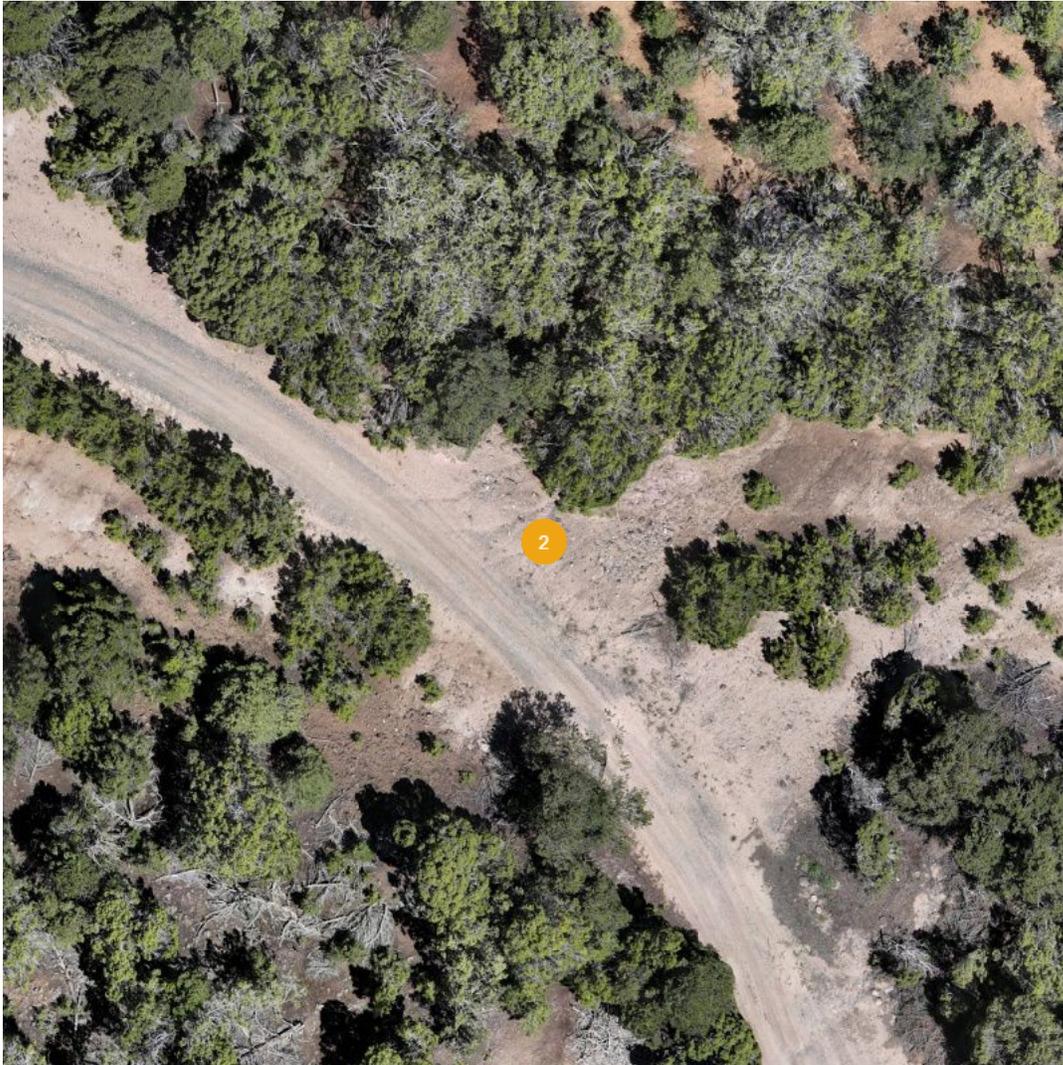
2 - Observation

Erosion degradation due to runoff from the road.

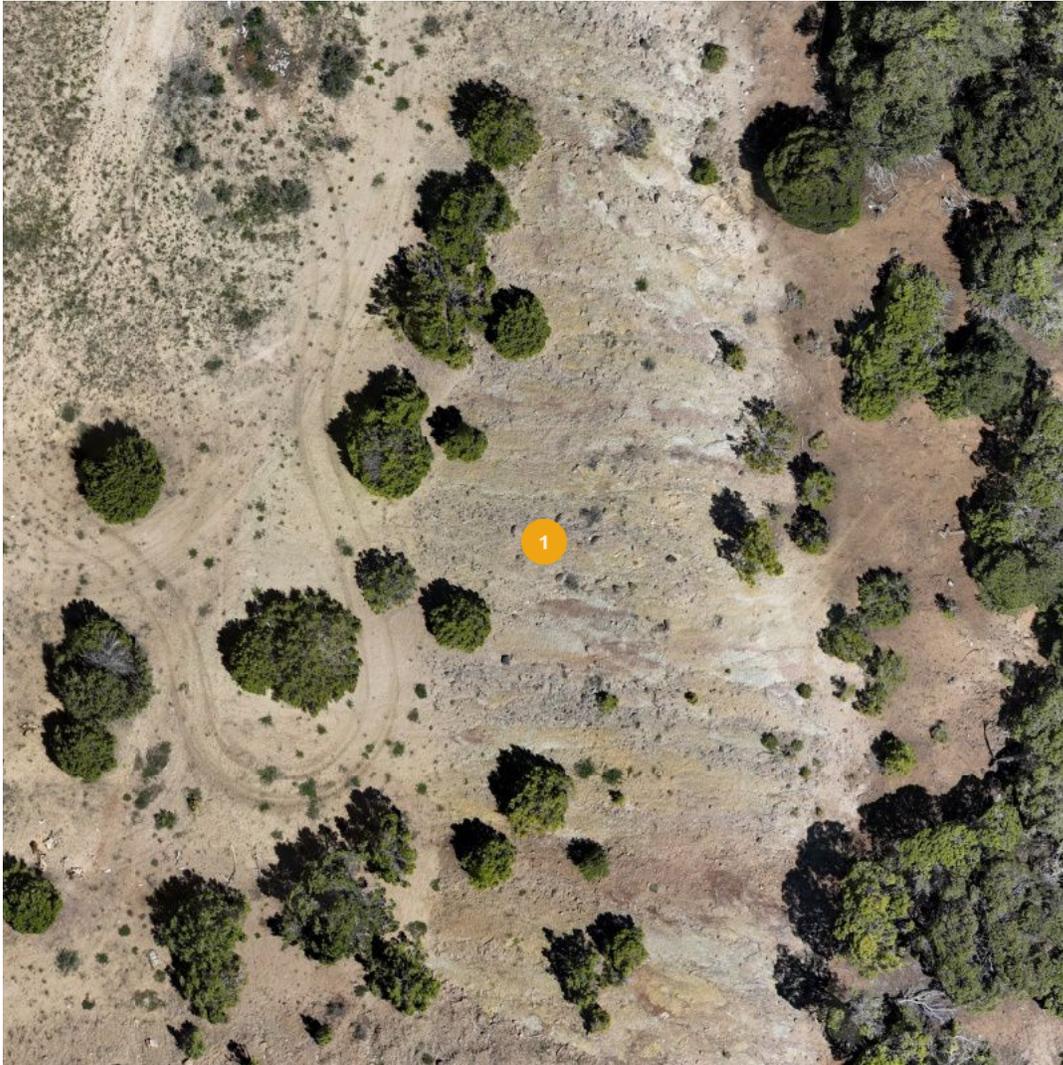
1 - Observation

Summary: Cut slope remain bare. BMPs to manage runoff remain missing or insufficient; erosion degradation has persisted.
