# Inspection Photos

Loc: 321831

Operator: **P O & G OPERATING LLC**

Inspection Date: 5/28/2025

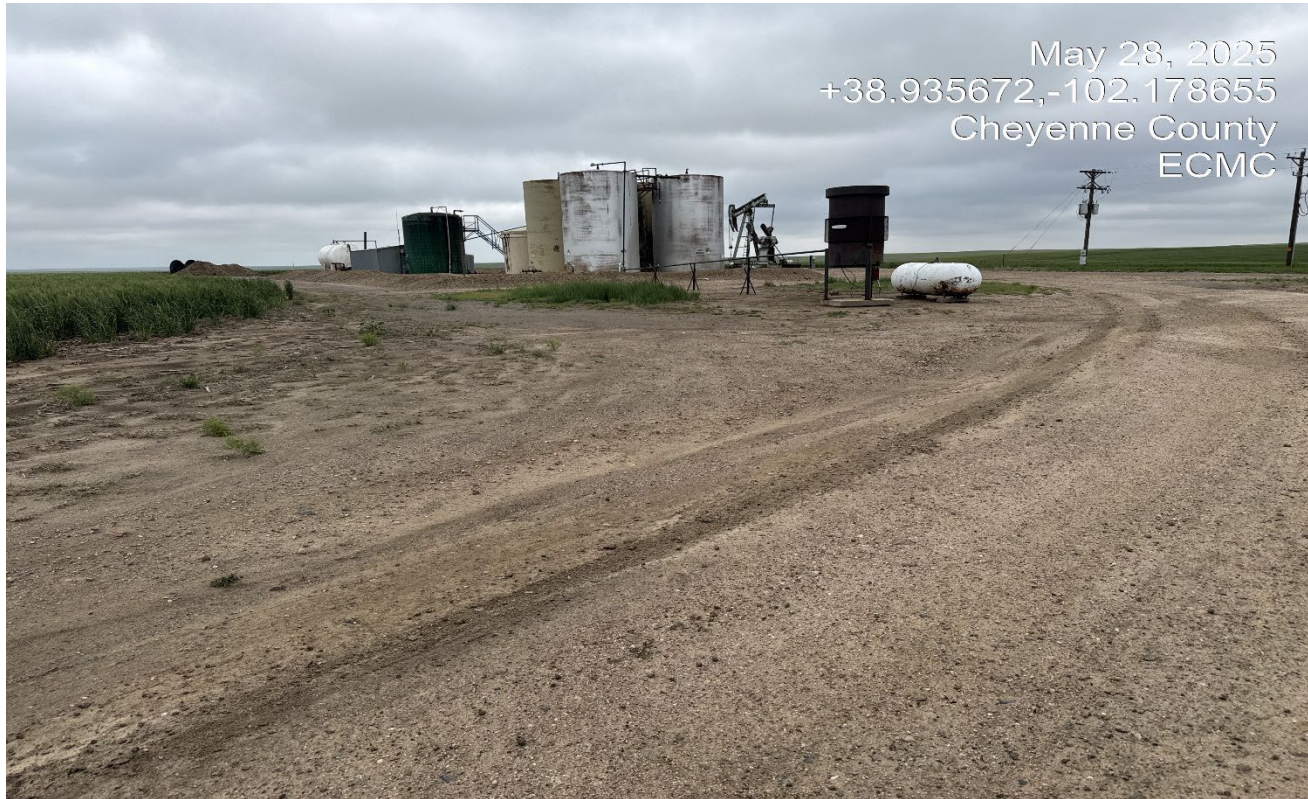
**Photo 1.** Facing southeast toward the tank battery.

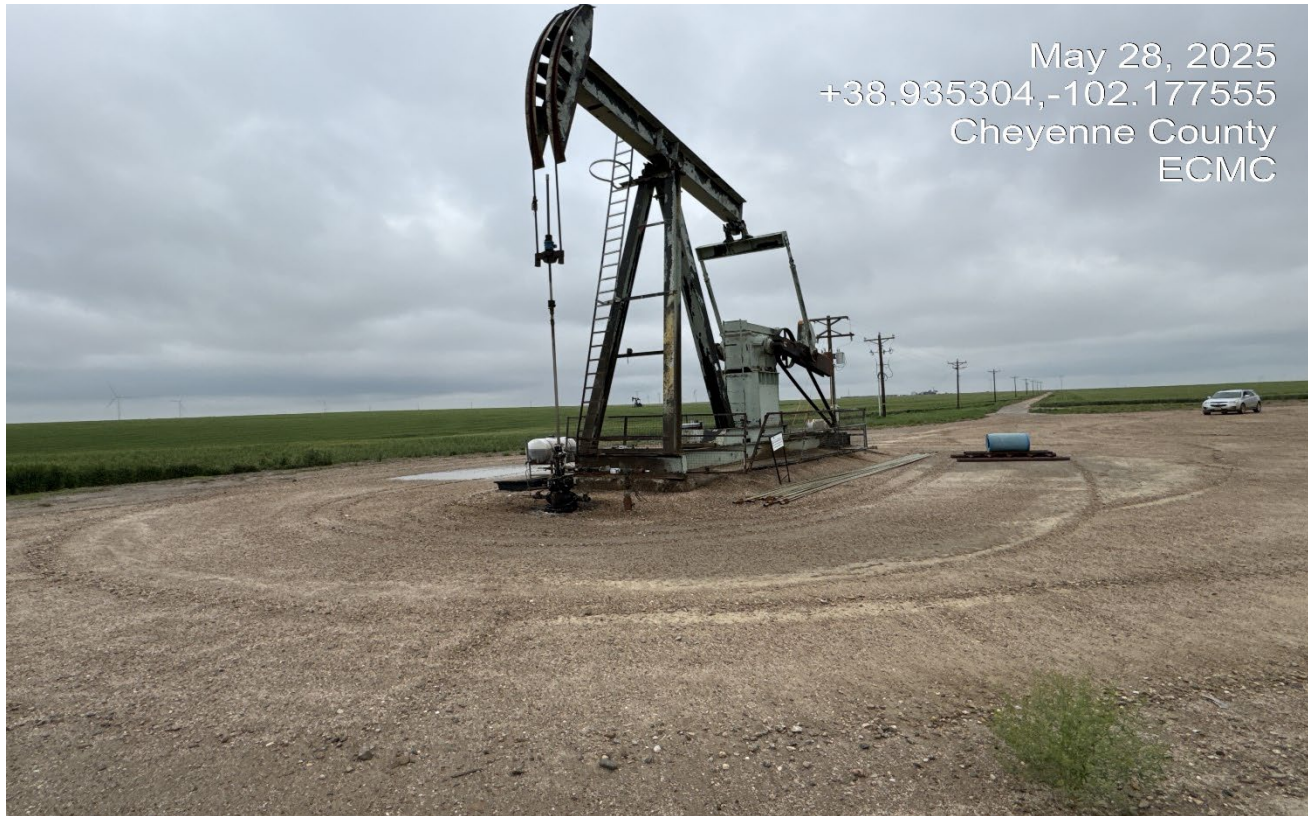
**Photo 2.** Facing southwest toward the well site and pumpjack.

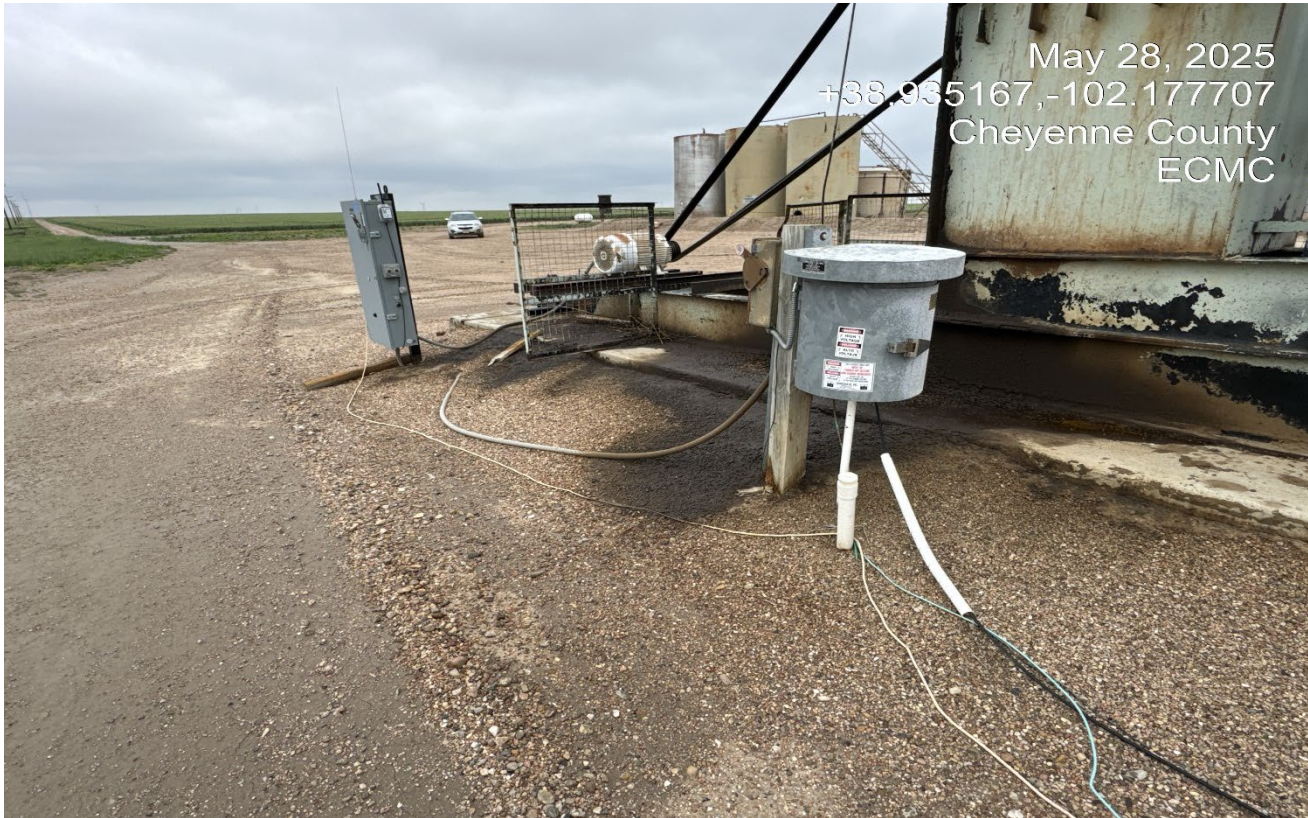
**Photo 3.** There are oil stained soils at the base of the pumpjack that need to be cleaned up and properly disposed.

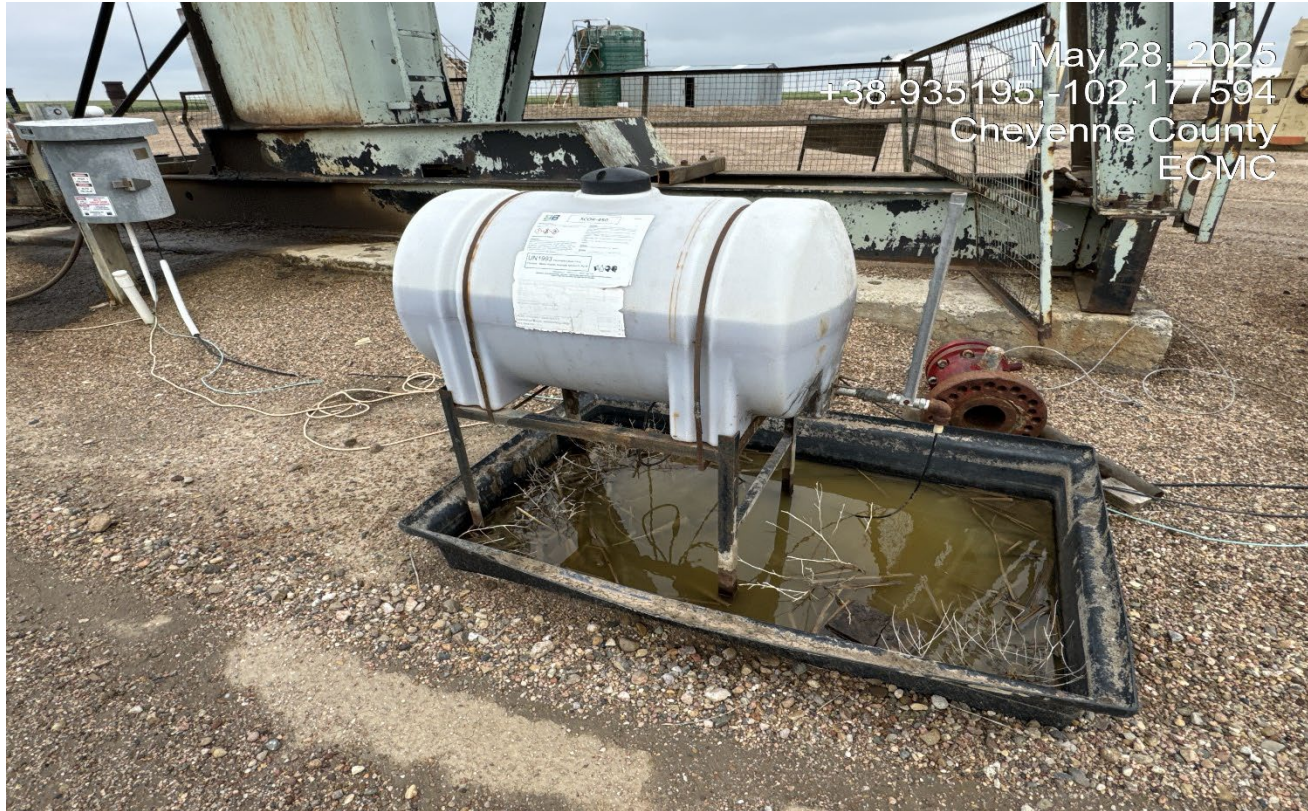
**Photo 4.** There is oily fluid in this secondary containment of the chemical barrel with no wildlife protections. This needs to be netted to prevent wildlife entry.

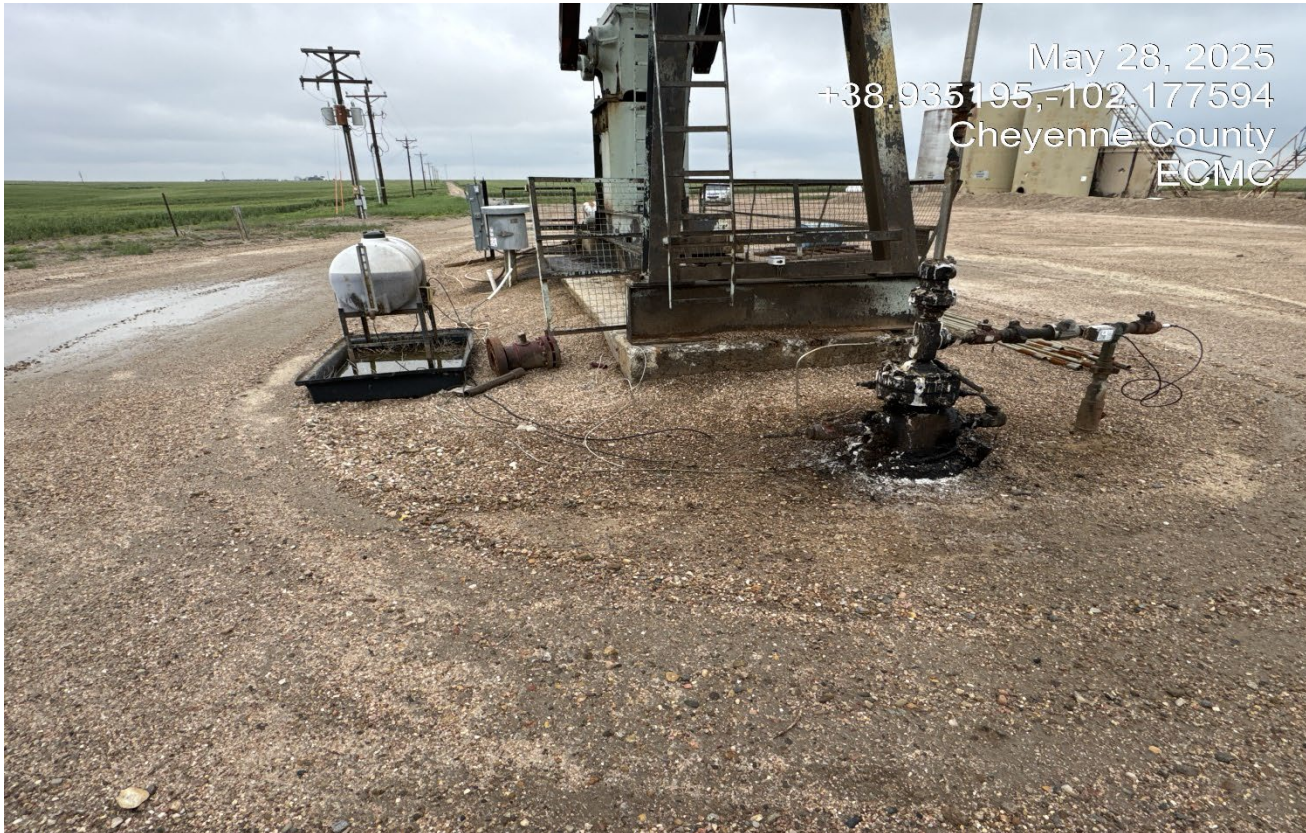
**Photo 5.** There is stained soils at the wellhead that need to be cleaned up and properly disposed. There is a leak at the wellhead that needs to be fixed.

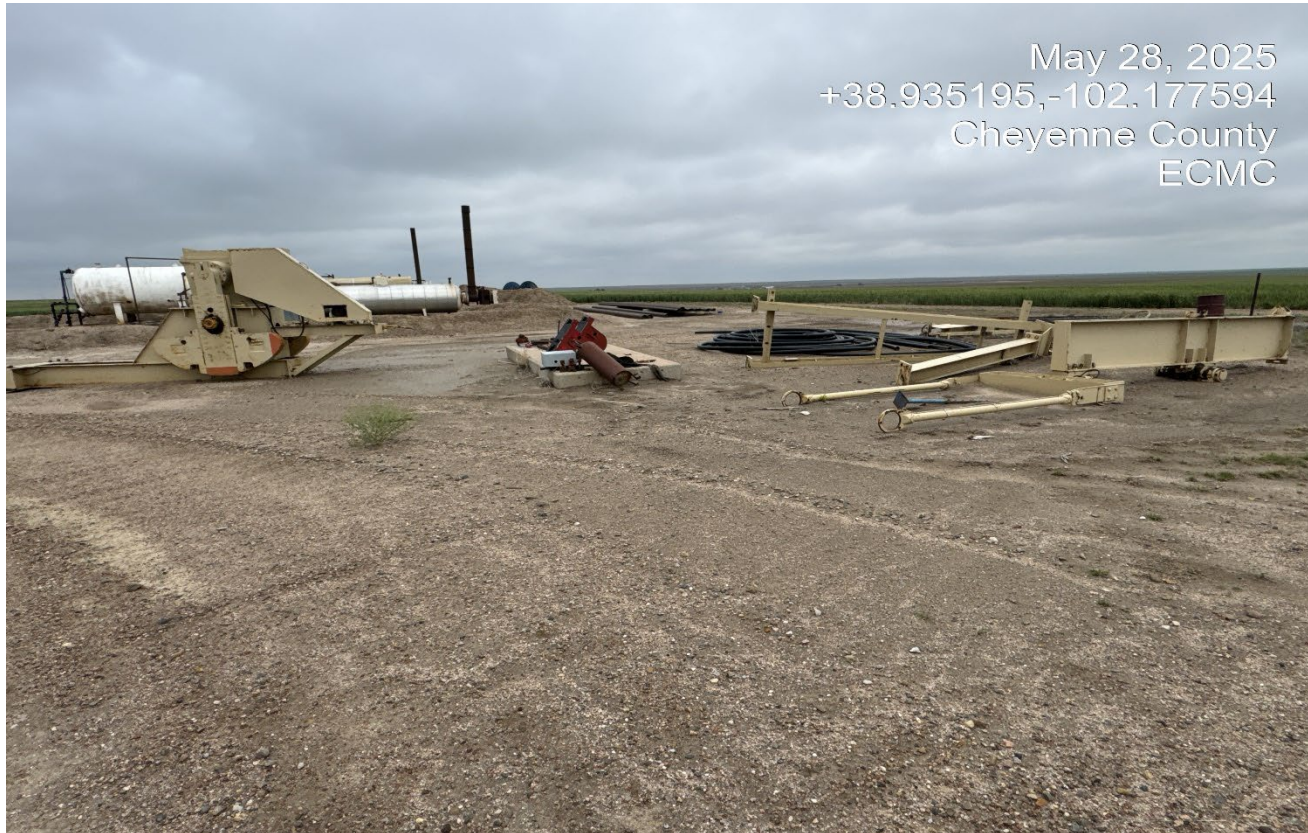
**Photo 6.** Unused equipment stored on location needs to be removed.

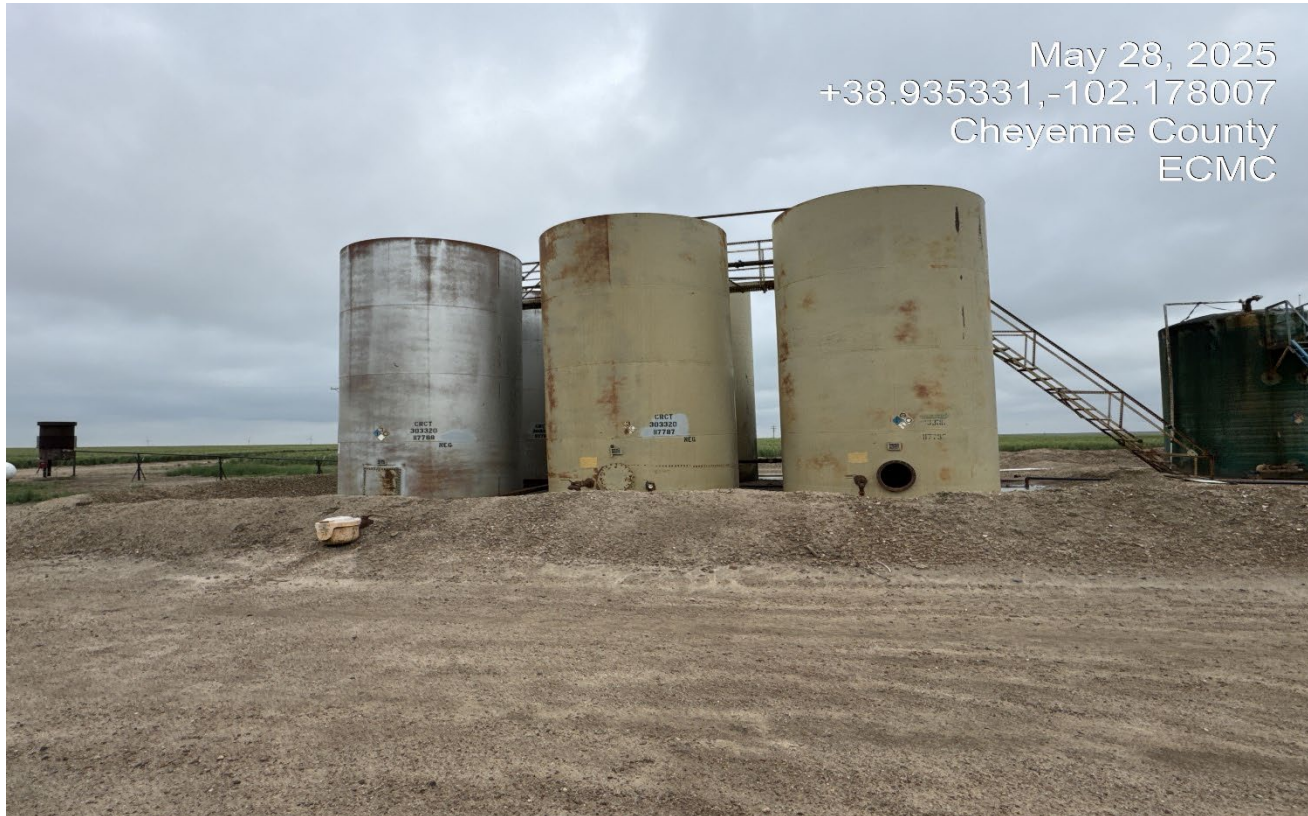
**Photo 7.** Facing toward the tank battery. Some of the labels are faded and missing information.

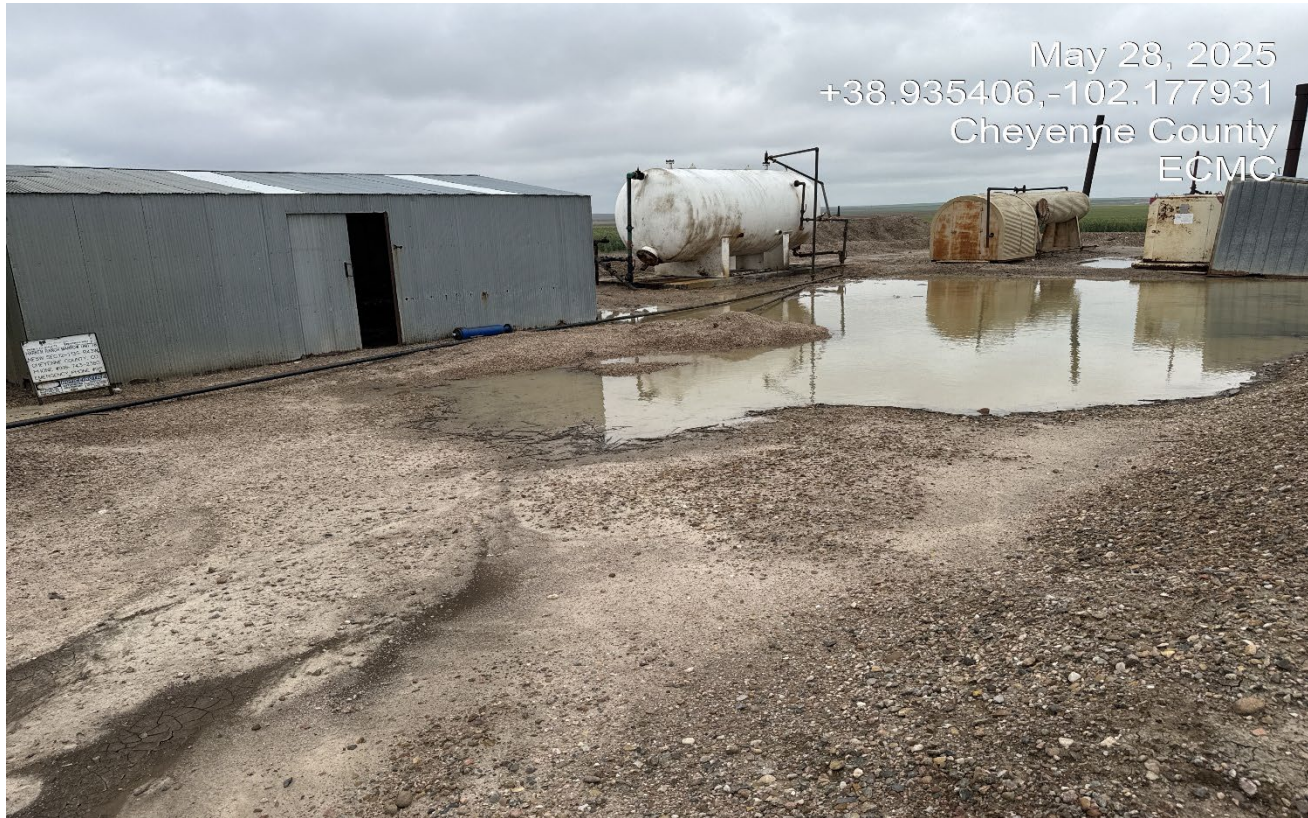
**Photo 8.** Facing northeast at the tank battery facility. Sign has been installed.

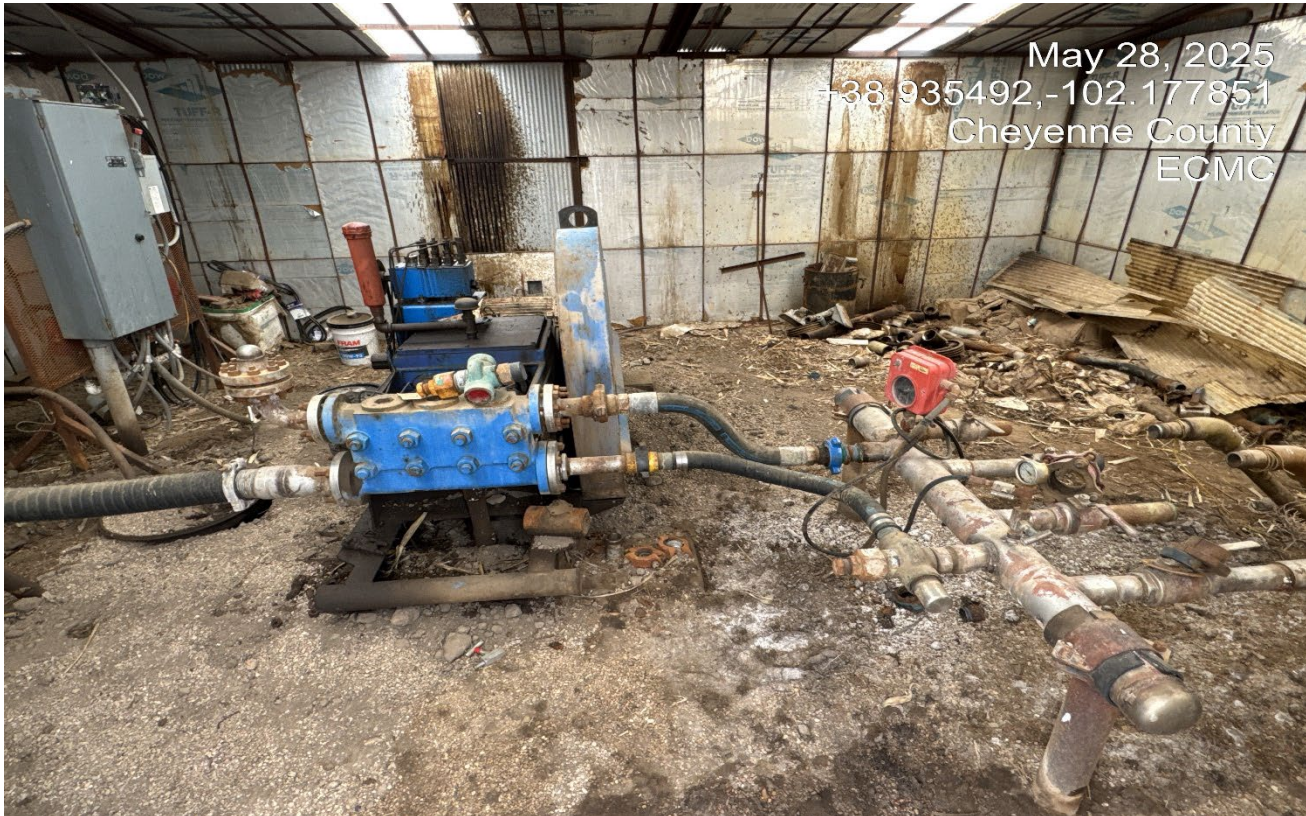
**Photo 9.** View of inside the shed shows oil stained soils and improper spill containment.

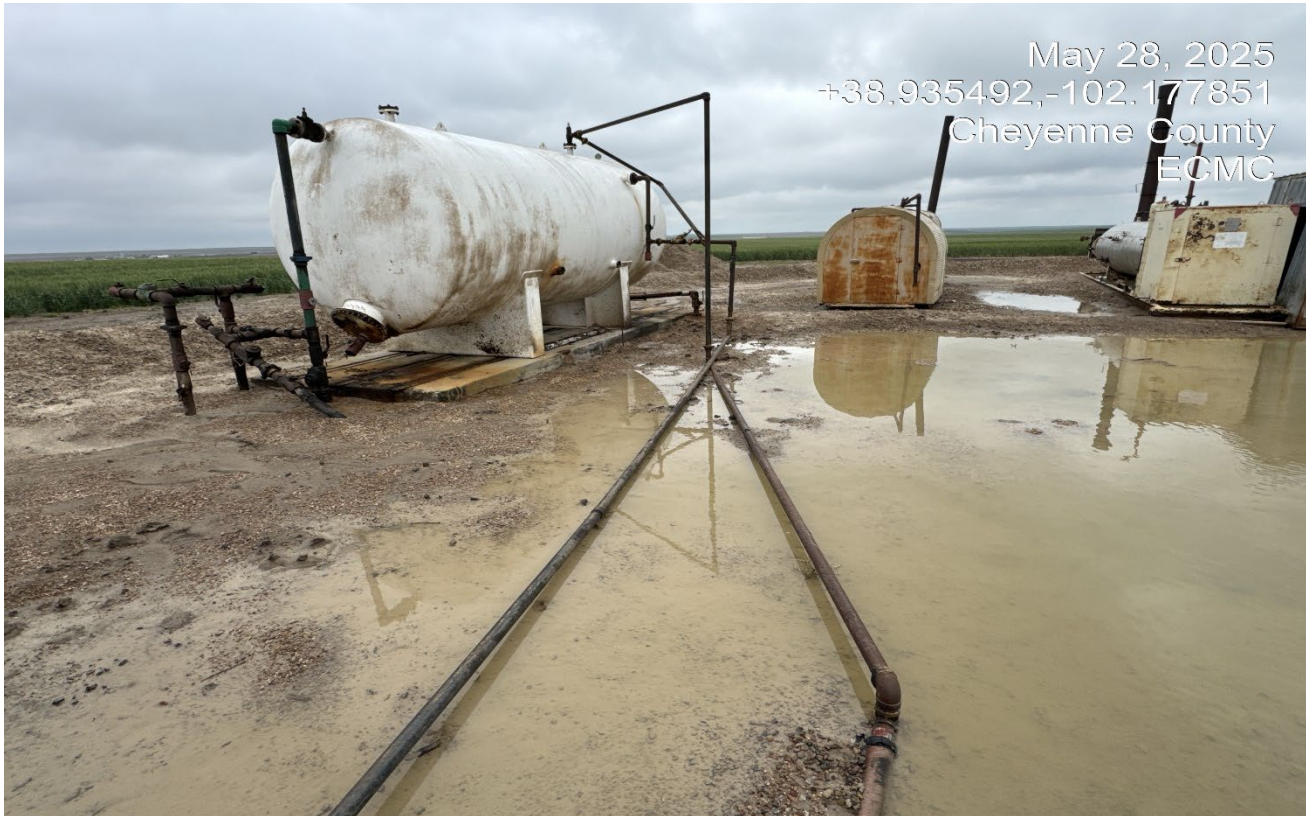
**Photo 10.** Facing northeast past the shed. There was a spill that occurred which leaked out both inside and outside of secondary containment in this area. There is now water pooling in this area.

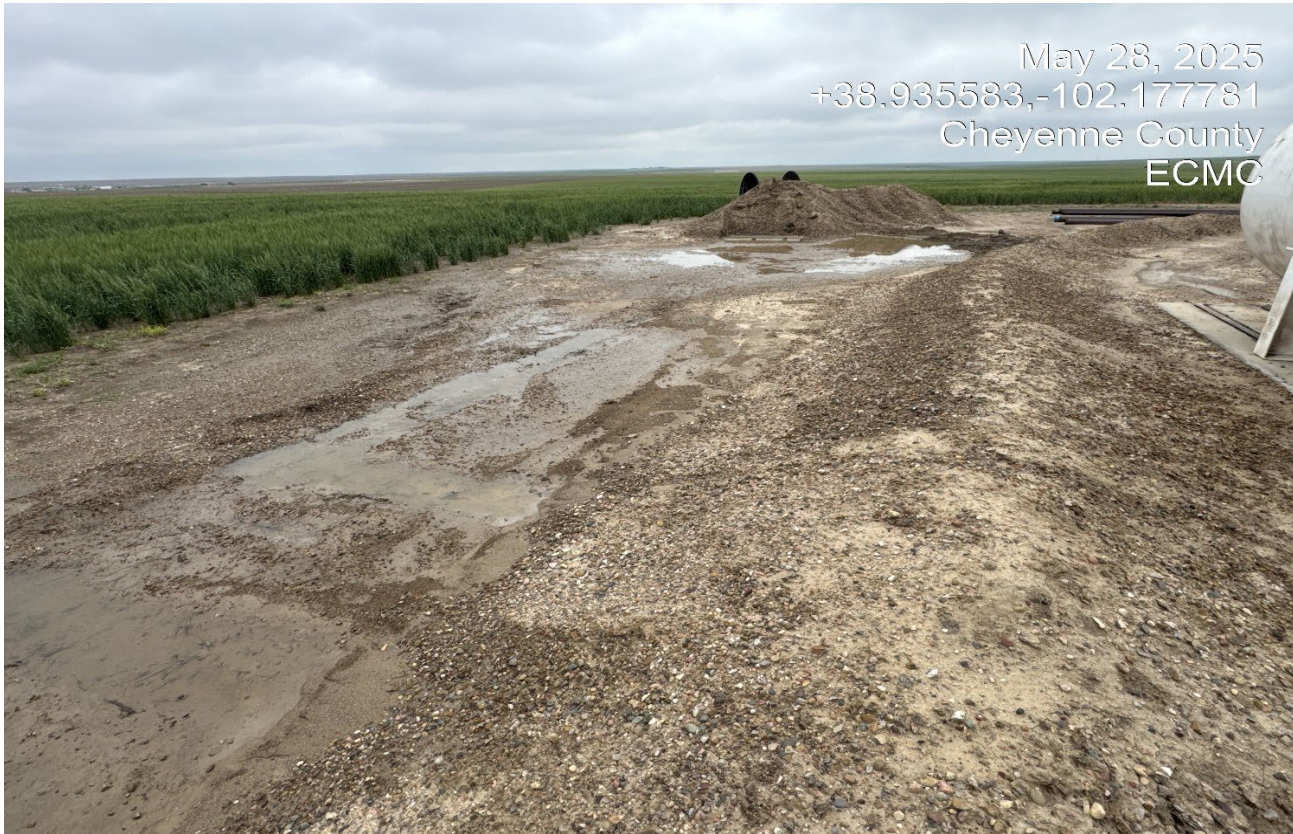
**Photo 11.** Facing northeast. It appears more impacted material was pushed out to the northeast corner pile.

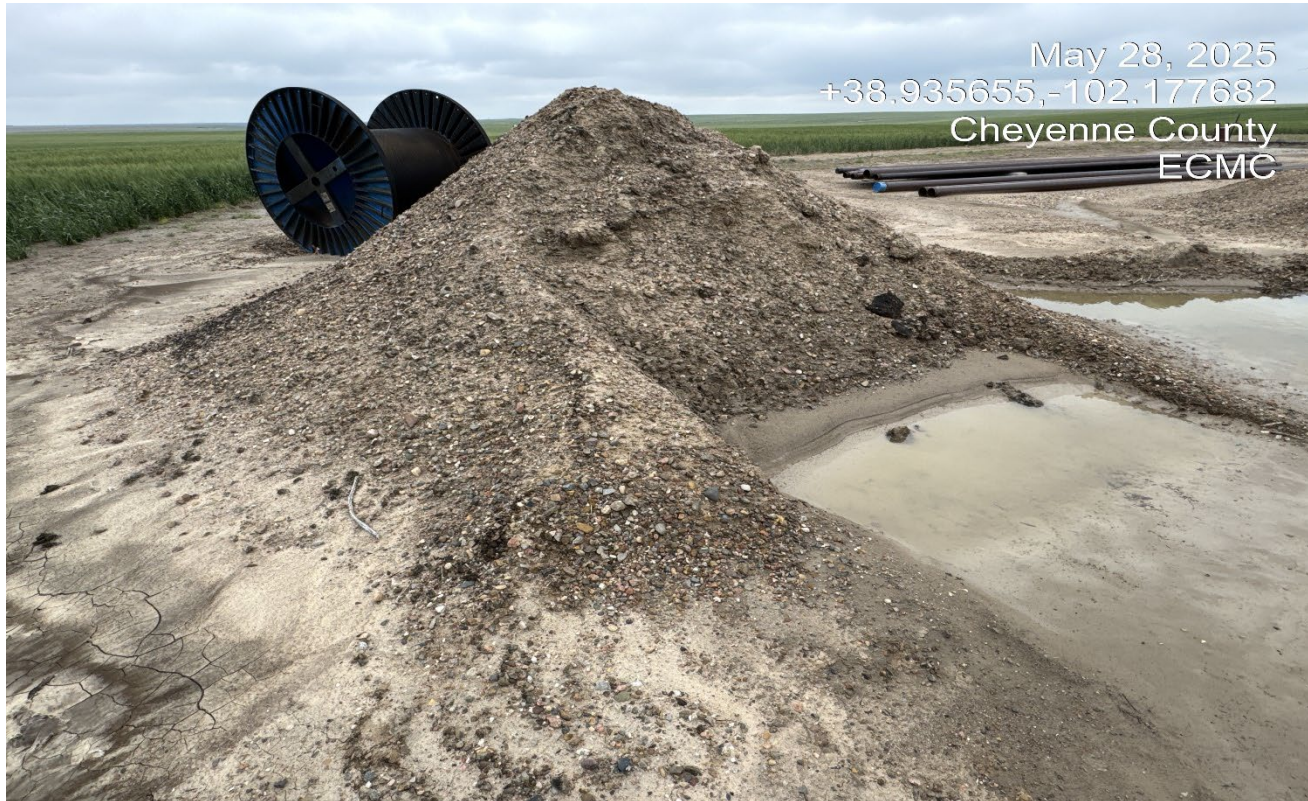
**Photo 12.** There is a pile of gravelly sand material stored at the northeast corner of the location. There is stained material incorporated into the pile. E&P waste must be stored with containment and liner.
