TEP
KP 23-16
Location ID: 335447

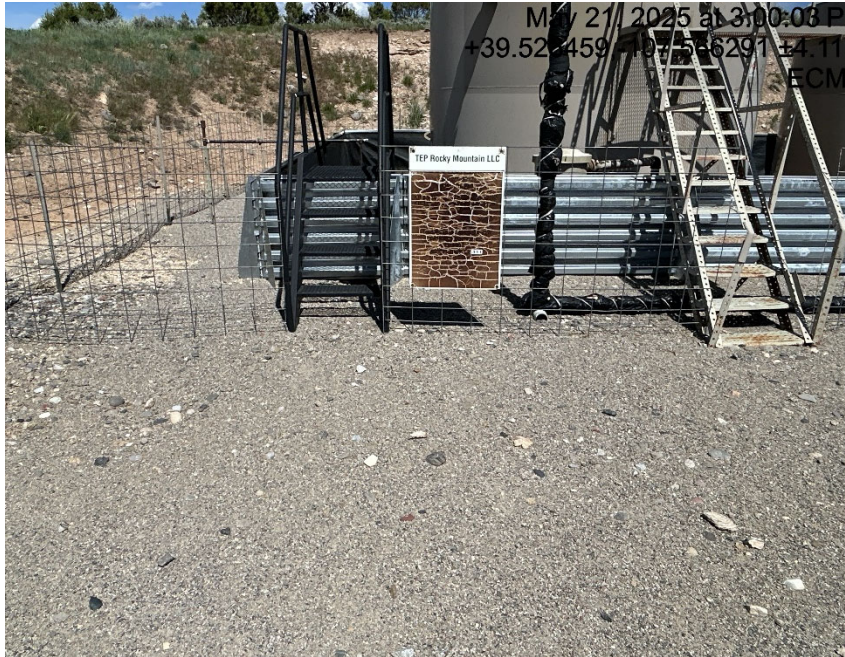
Recent inspection of tank battery signage still illegible.

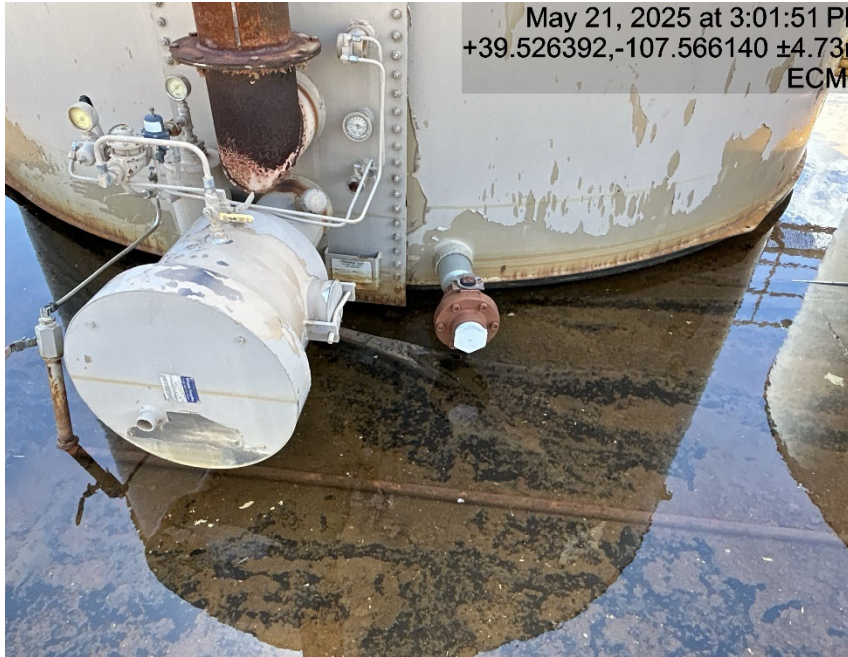
Recent photo of cap on tank load line

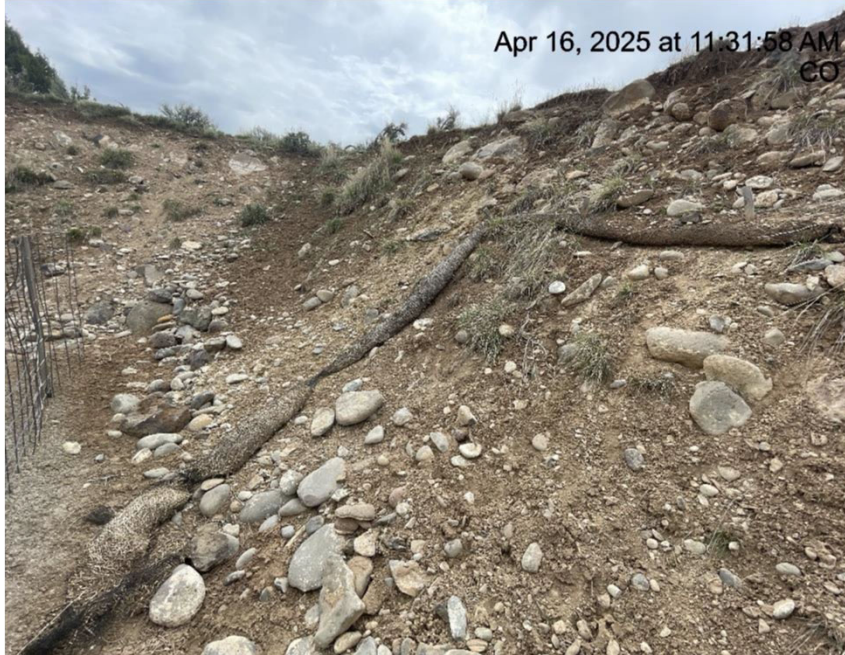
Previous inspection of lack of stabilization and waddles failing

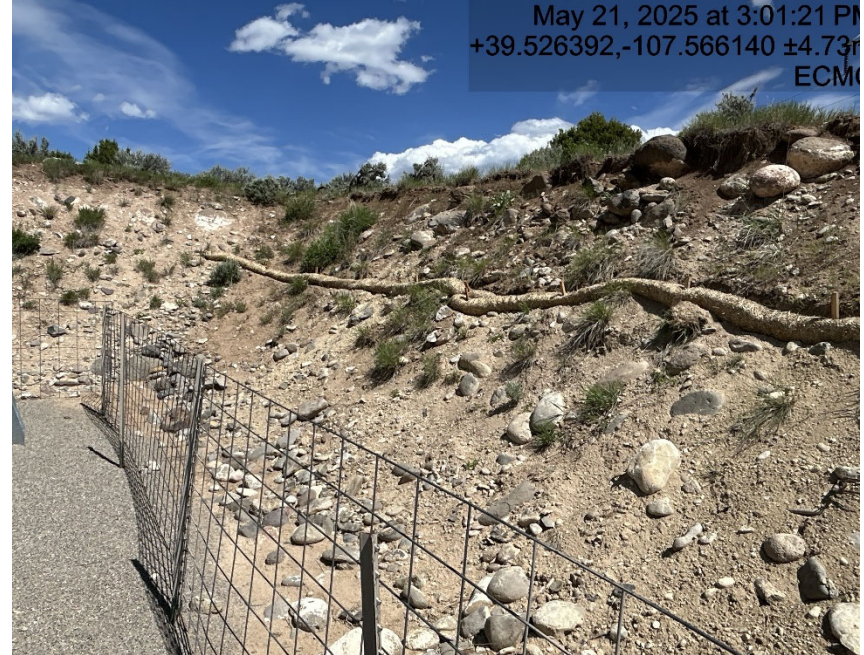
Lack of stabilization on cut slope/BMP's need maintenance

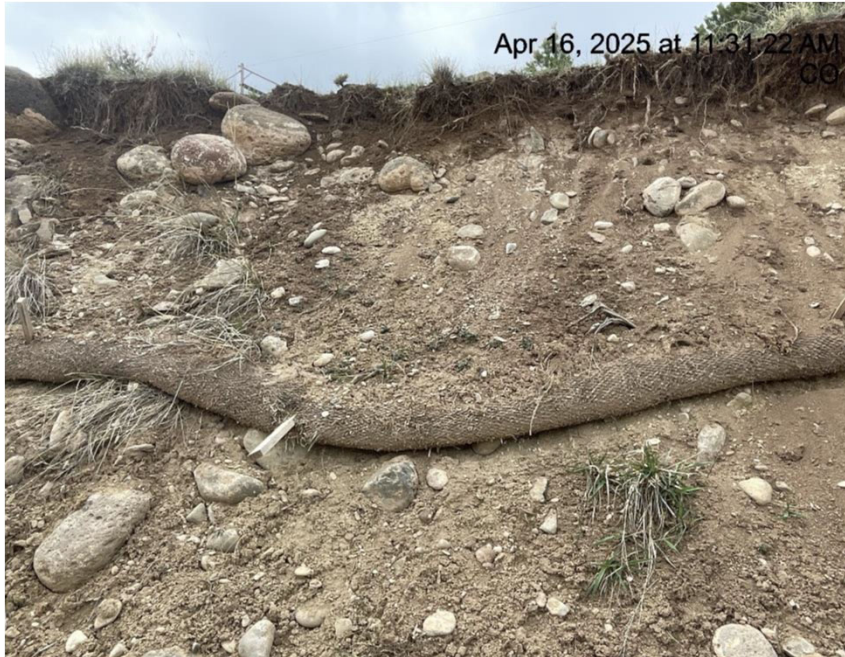
Previous inspection of lack of stabilization and waddles failing

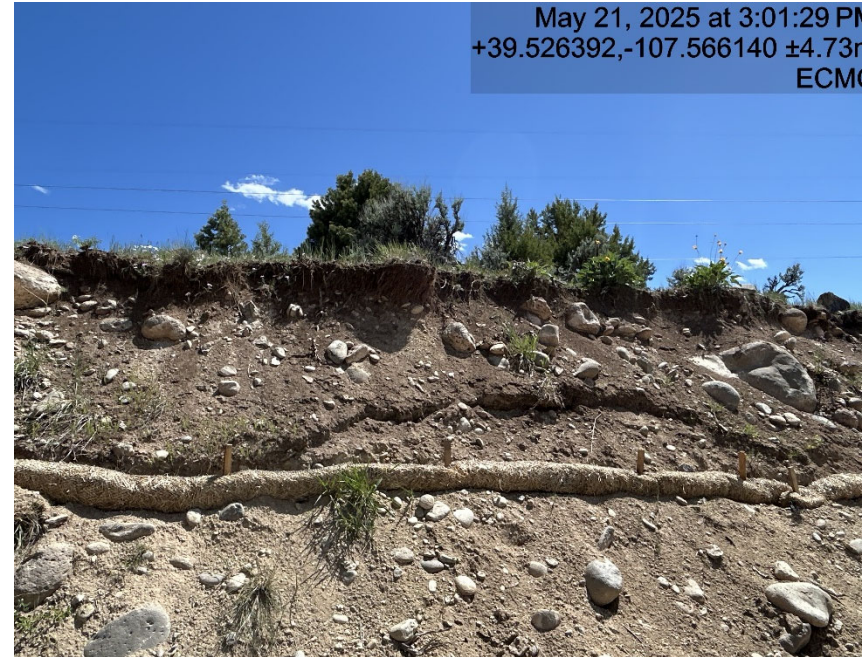
Lack of stabilization on cut slope/BMP's need Maintenance. Top of cut slope is under mining with vegetation roots exposed.

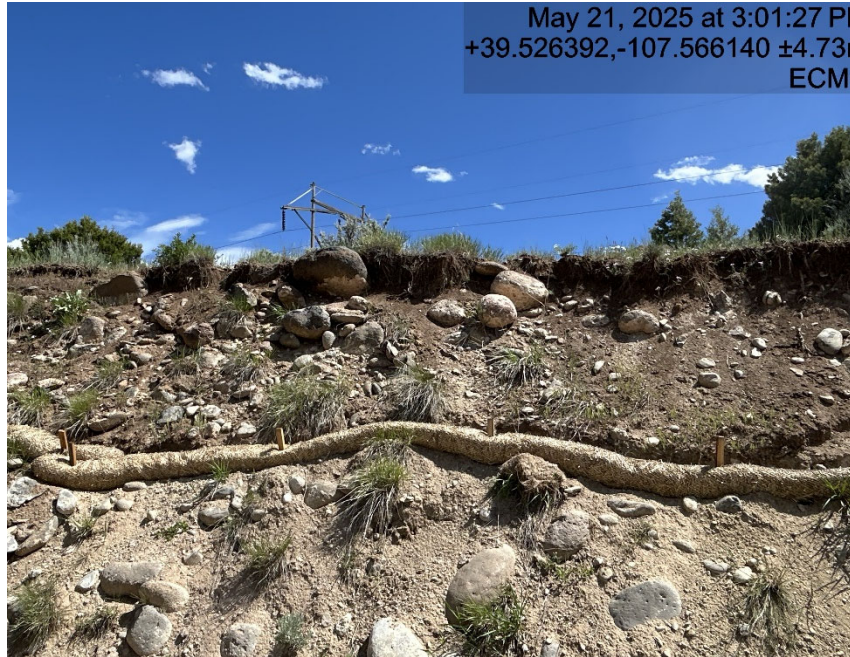
Lack of stabilization on cut slope/BMP's need maintenance

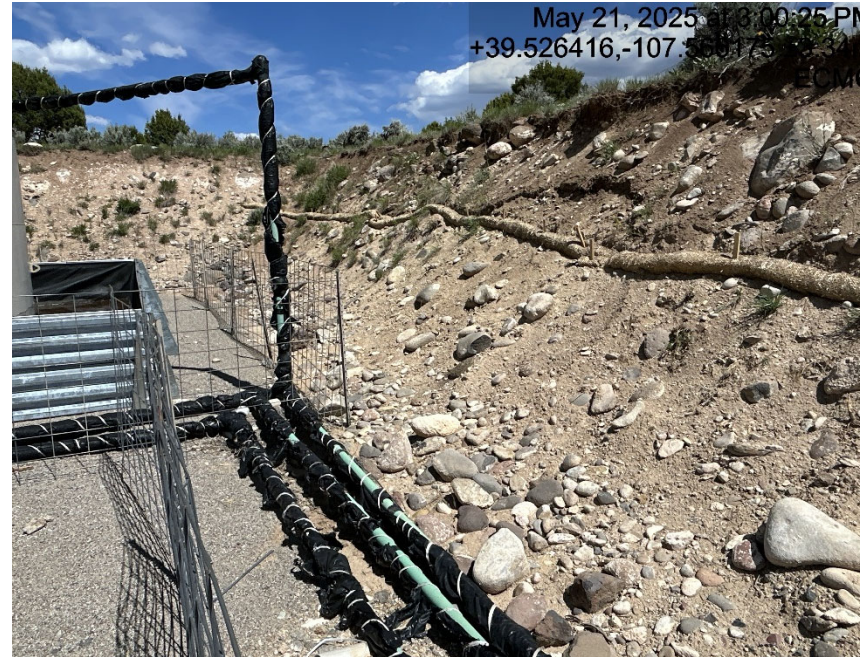
Lack of stabilization on cut slope/BMP's need maintenance

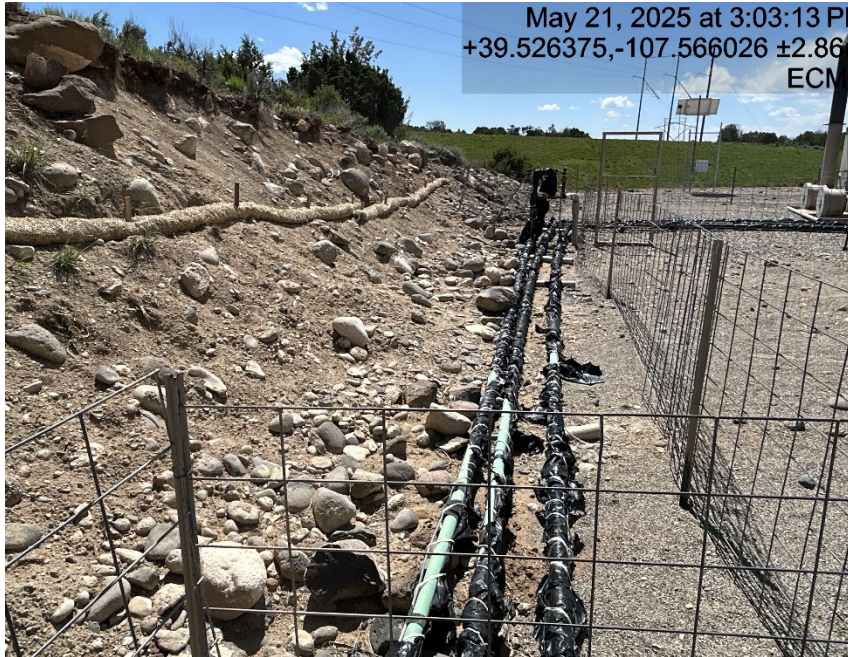
Lack of stabilization on cut slope/BMP's need maintenance

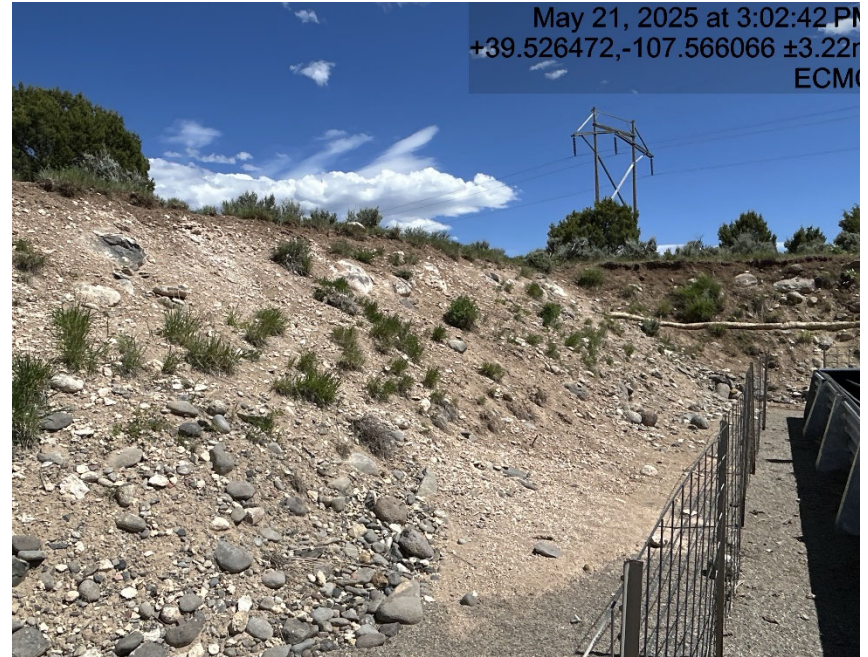
Lack of stabilization on cut slope/BMP's need maintenance

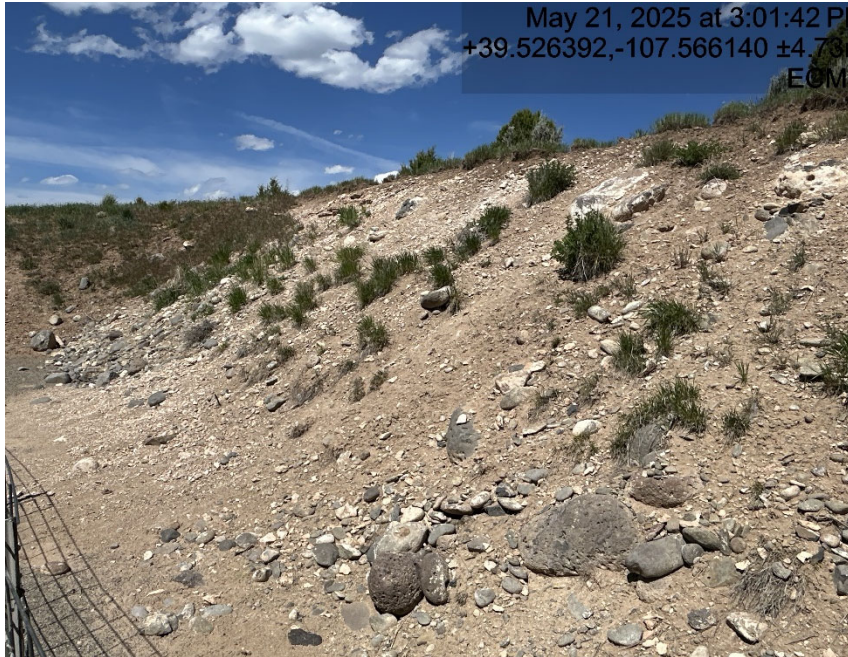
Lack of stabilization on cut slope/BMP's need maintenance

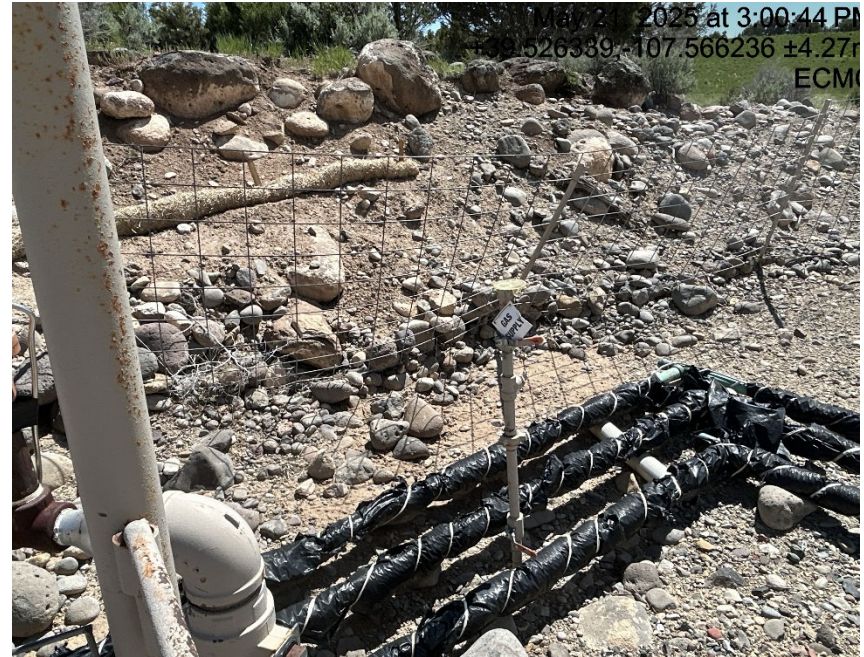
Lack of stabilization on cut slope/BMP's need maintenance
