Inspection Photos
Location: Stavely 1-26
Location ID: 324837
API # 05-061-06394

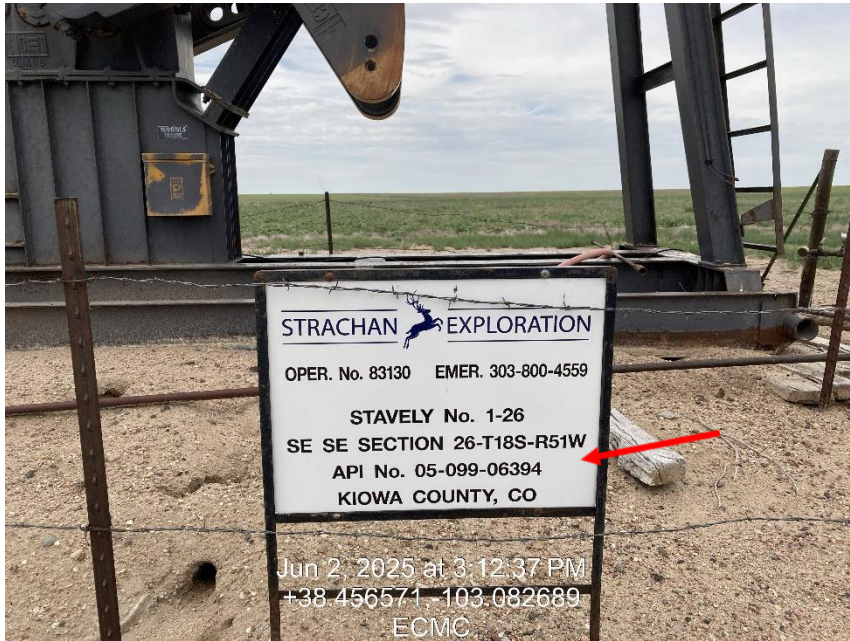
Photo 1 –Well placard, Wrong API # listed on well placard, second CA for API #

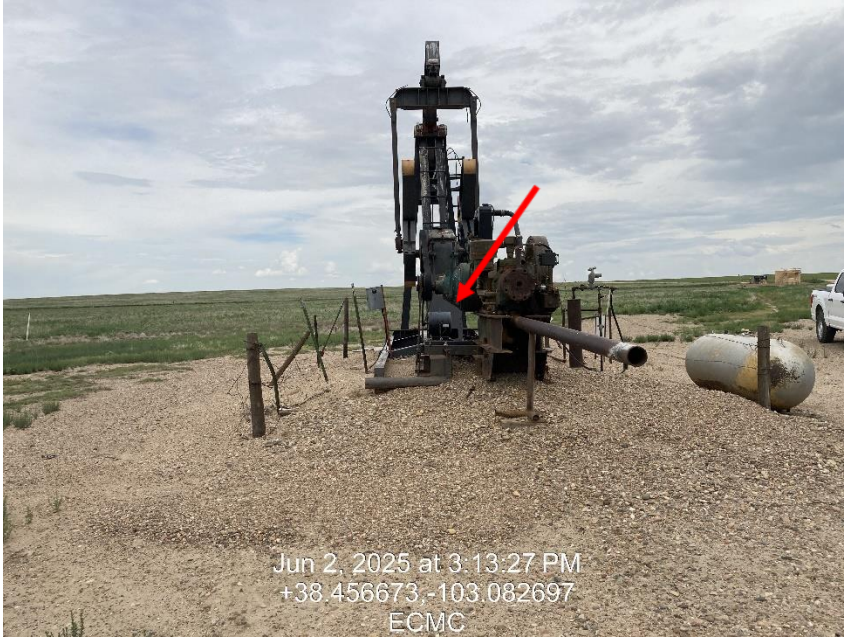
Photo 3 – Impacted soils at rear of pumping unit

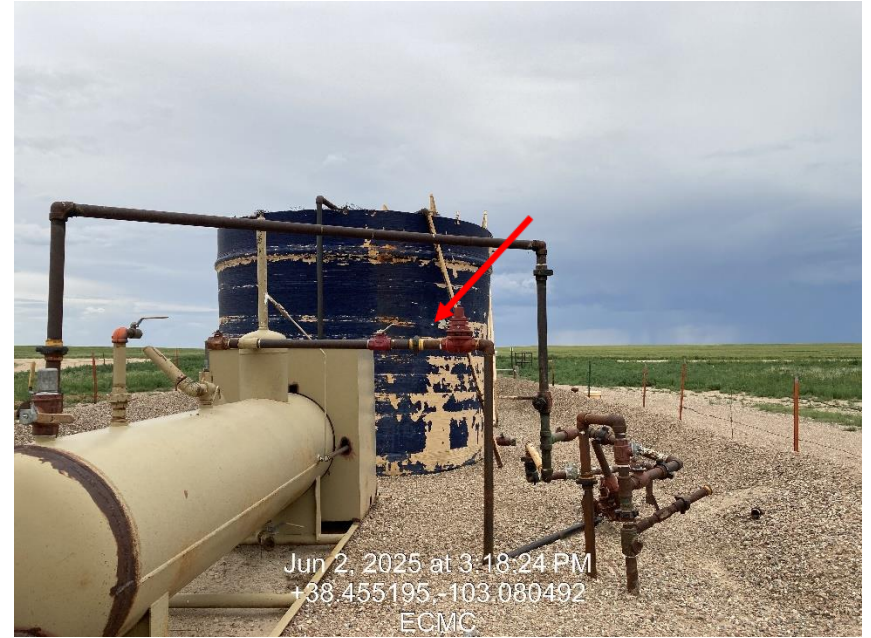
Photo 6 – Leaking valve repaired
