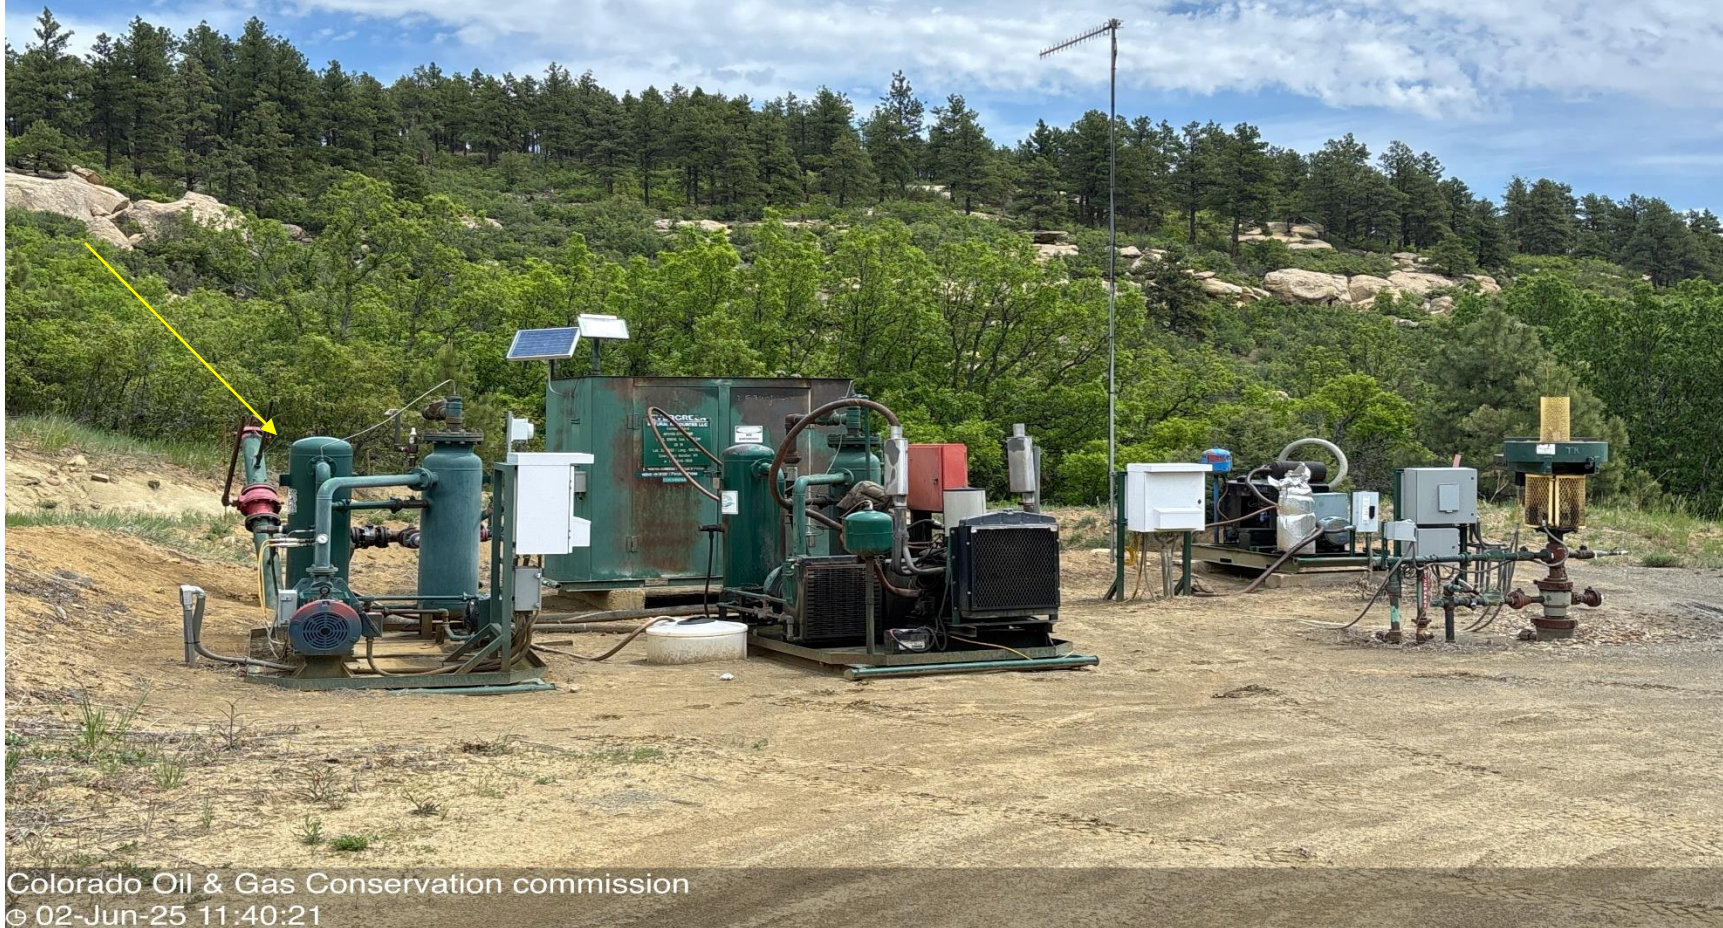
**PHOTO 4: UNUSED EQUIPMENT STORED ON LOCATION (AT TIME OF INSPECTION THE ELECTRIC COMPRESSOR IS NOT IN USE).
REMOVE THE COMPRESSOR NOT IN USE PER RULE 606. CA DATE 6/13/2025.**

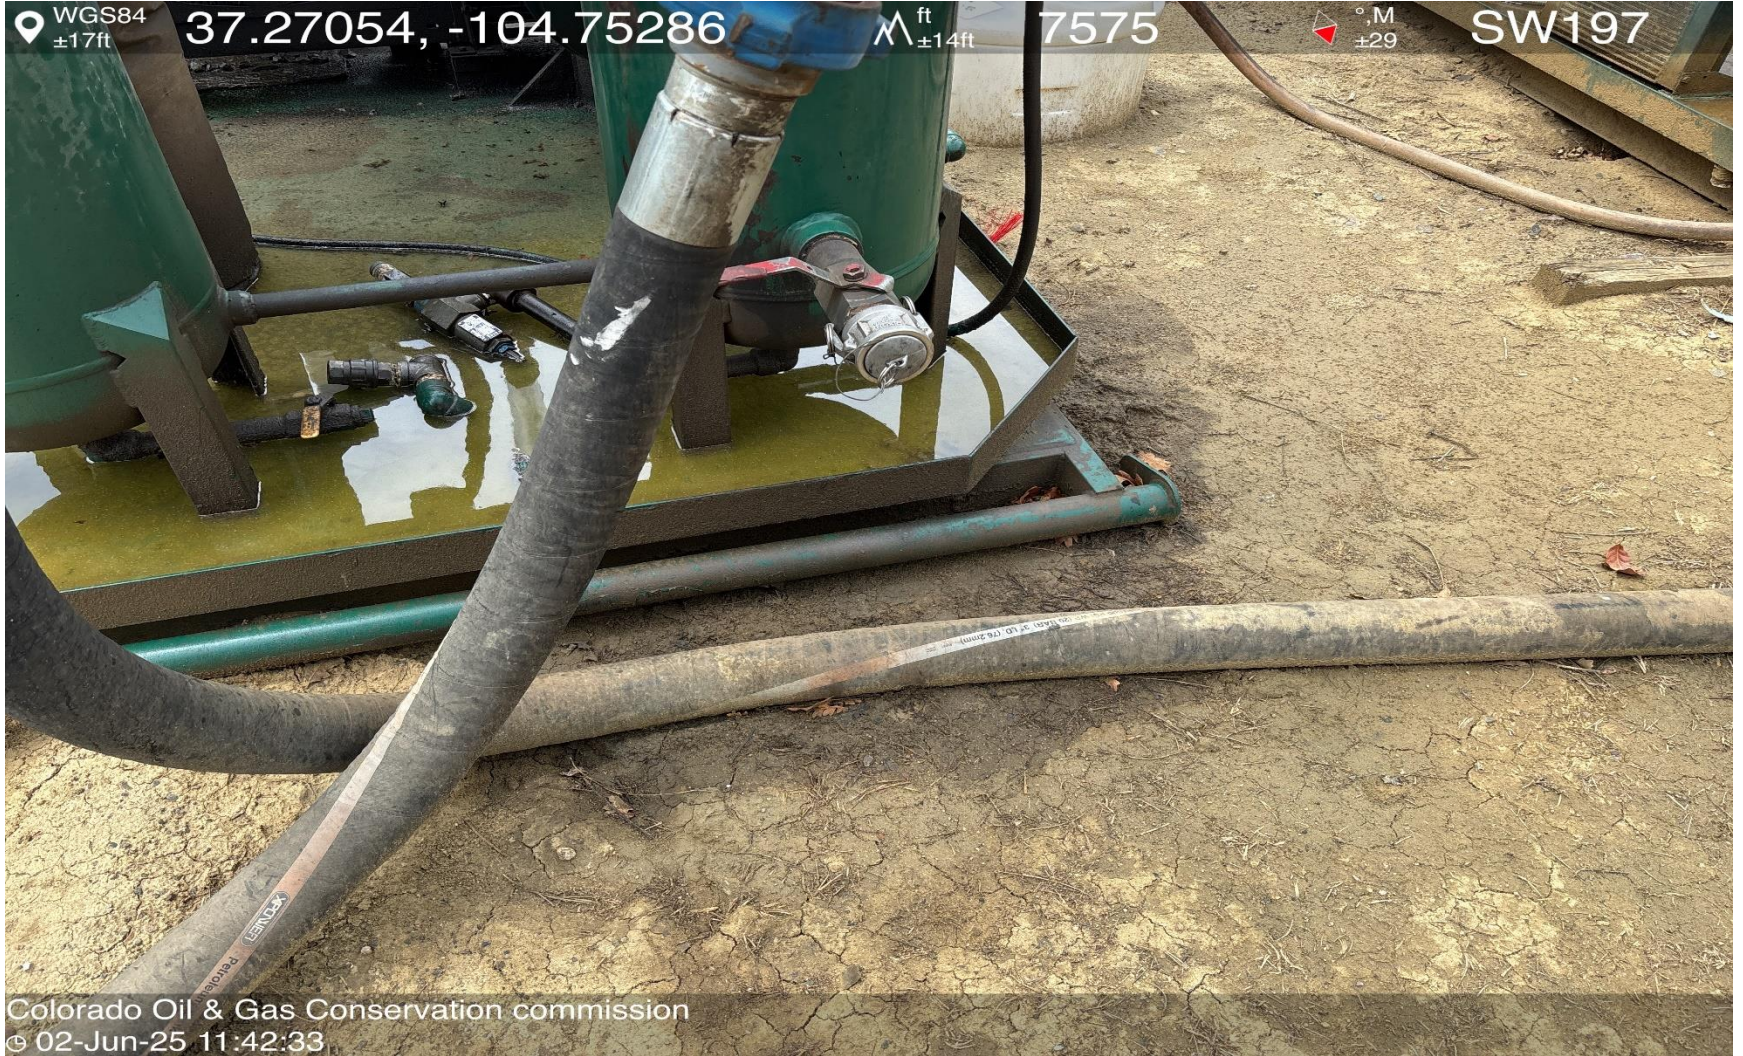
PHOTO 5: AREA OF IMPACTED SOIL NEAR GAS ENGINE COMPRESSOR APPEARS TO BE CAUSED BY STORMWATER MIXING WITH OILY WASTE INSIDE COMPRESSOR SKID. Conduct maintenance on equipment (REPAIR LEAKS), cleanup stained material and review self inspection processes. COMPLY WITH RULE 1002,(2).D CA DATE 6/13/2025.

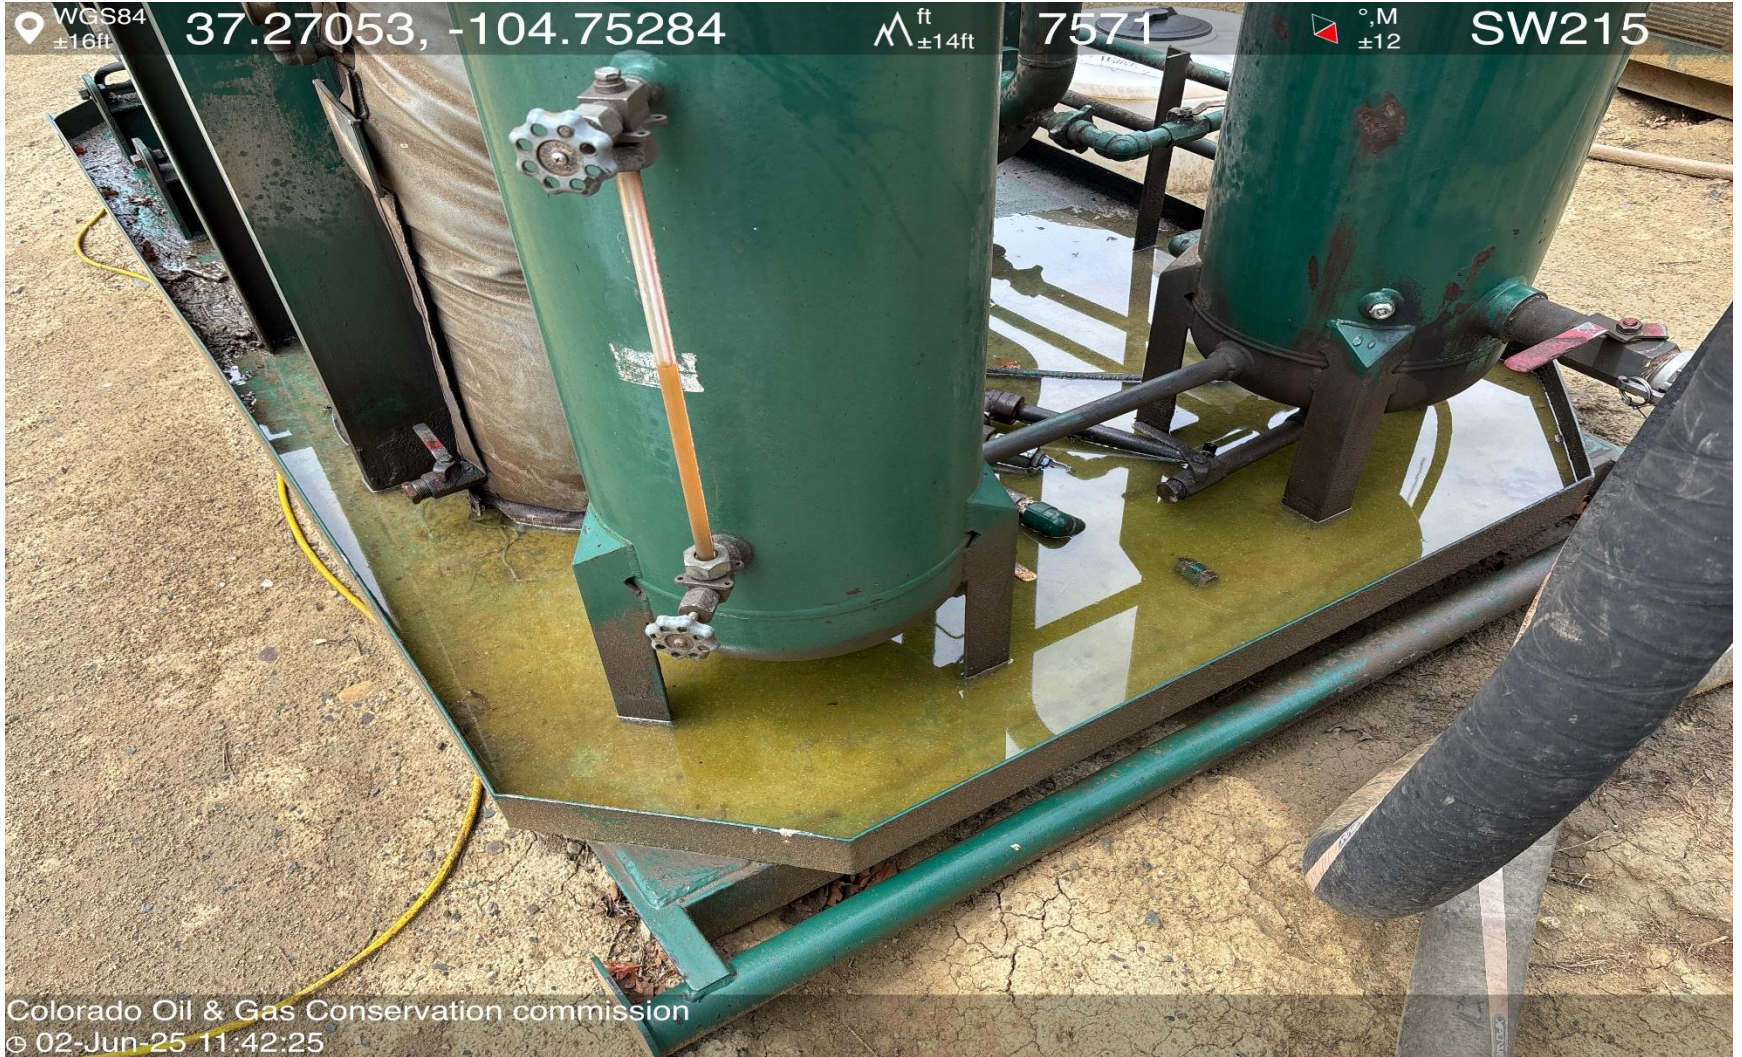
PHOTO 6: OILY WASTE INSIDE COMPRESSOR SKID. OILY WASTE FROM LEAKING COMPRESSOR EQUIPMENT HAS MIXED WITH STORMWATER AND HAS OVERFLOWED COMPRESSOR SKID AND SPILLED ON LOCATION CAUSING IMPACT SOIL NEAR SKID. DRAIN OILY WASTE REPAIR ALL LEAKS AND REMOVE IMPACTED SOIL PER RULE 1002..(2).D & 1002.f.(2)B, Comply with general provisions of the oil and gas act for wildlife protection AND SB-181. CA DATE 6/3/2025.

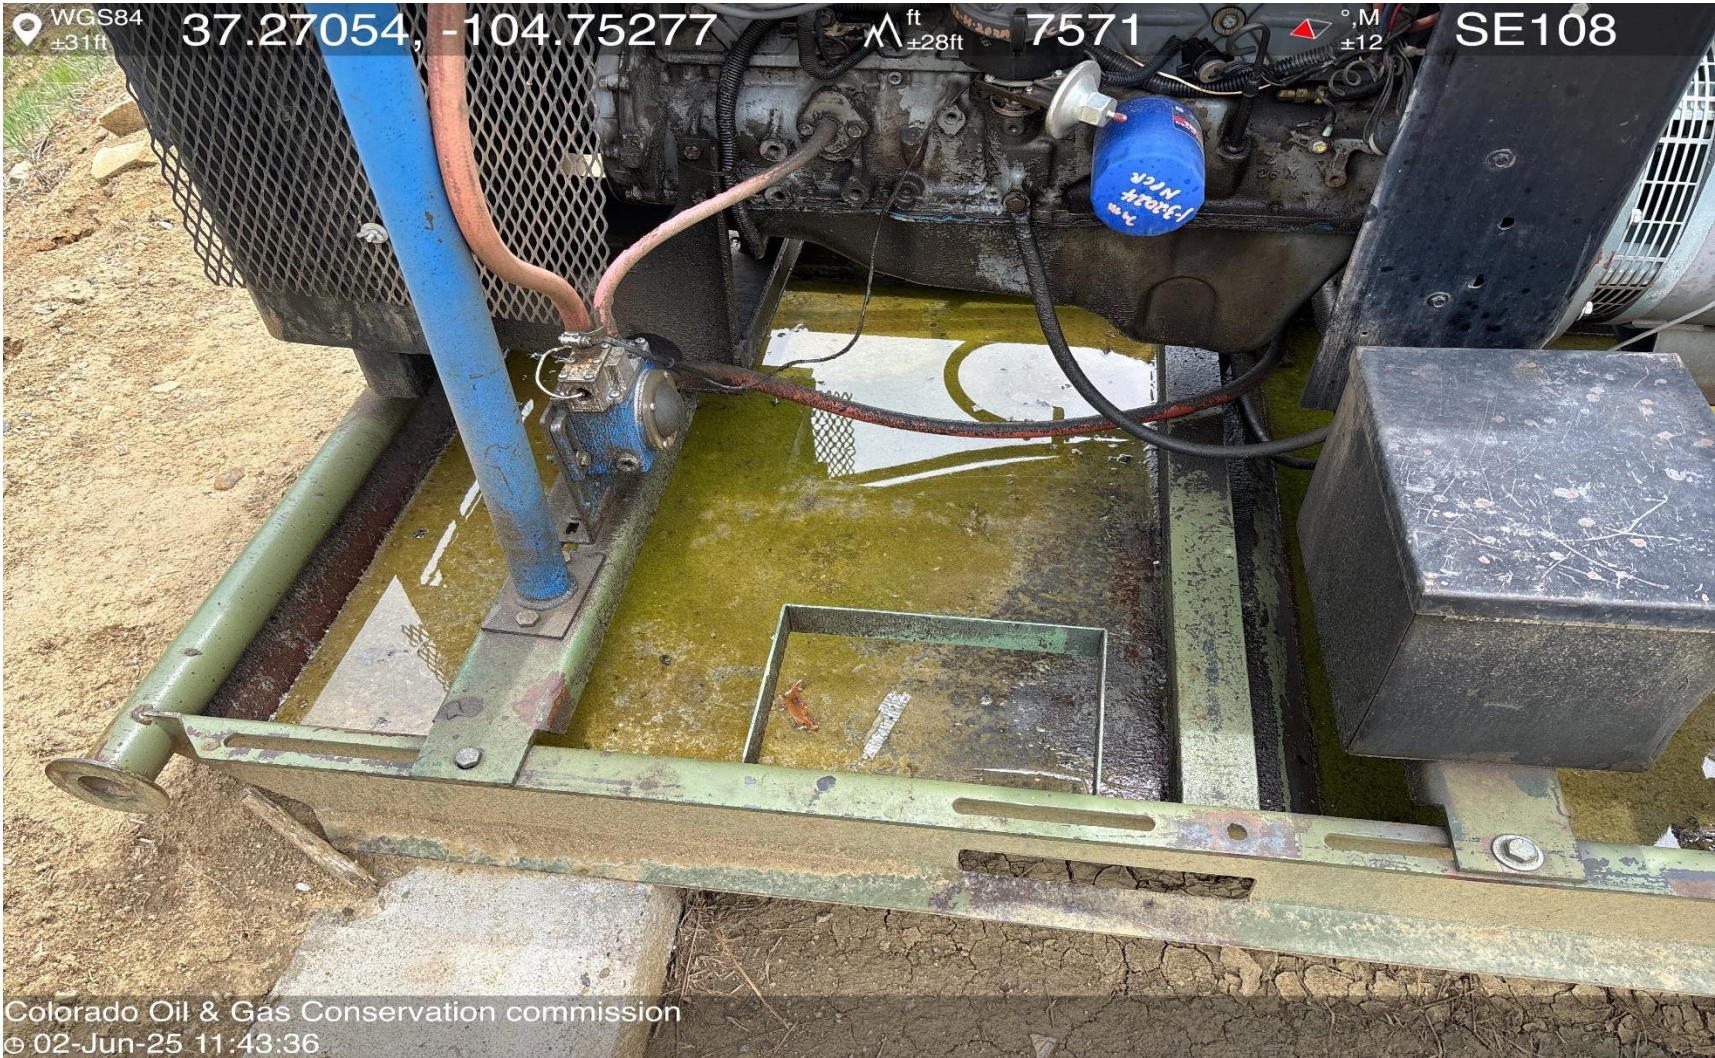
PHOTO 7: OILY WASTE INSIDE PRIME MOVER SKID. DRAIN OILY WASTE REPAIR ALL LEAKS AND REMOVE IMPACTED SOIL PER RULE 1002..(2).D & 1002.f.(2)B, Comply with general provisions of the oil and gas act for wildlife protection AND SB-181. CA DATE 6/3/2025.
