# Inspection Photos

## 05/07/2025

**Operator:** FULCRUM ENERGY OPERATING- #10805

**Location ID:** 463987

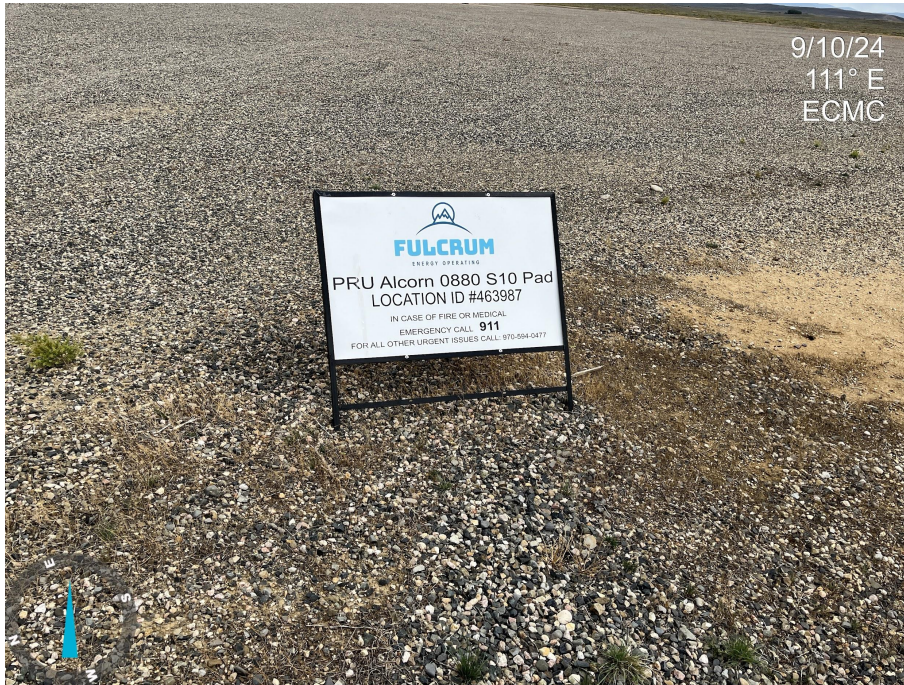
**Photo 1.** Photo taken from entrance of the Location. Photo illustrates signage.

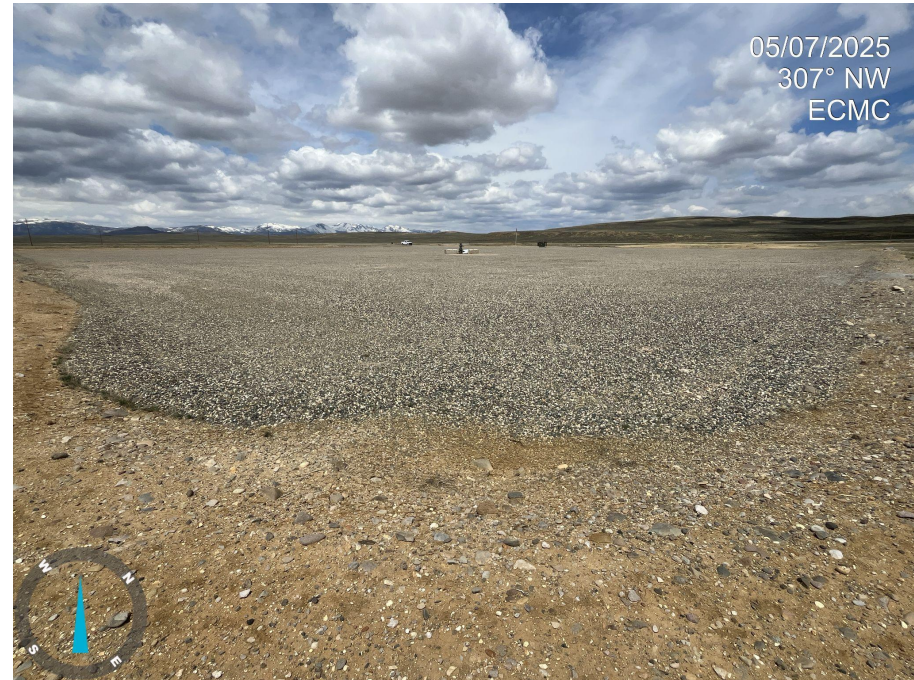
**Photo 2.** Photo taken from southwestern portion of the pad, facing northwest. Photo shows overview of location. A new OGDG for this Location is currently "in process" at time of inspection. The reclamation status of this Location is also considered "in process" pending the Commission's decision regarding the OGDG."

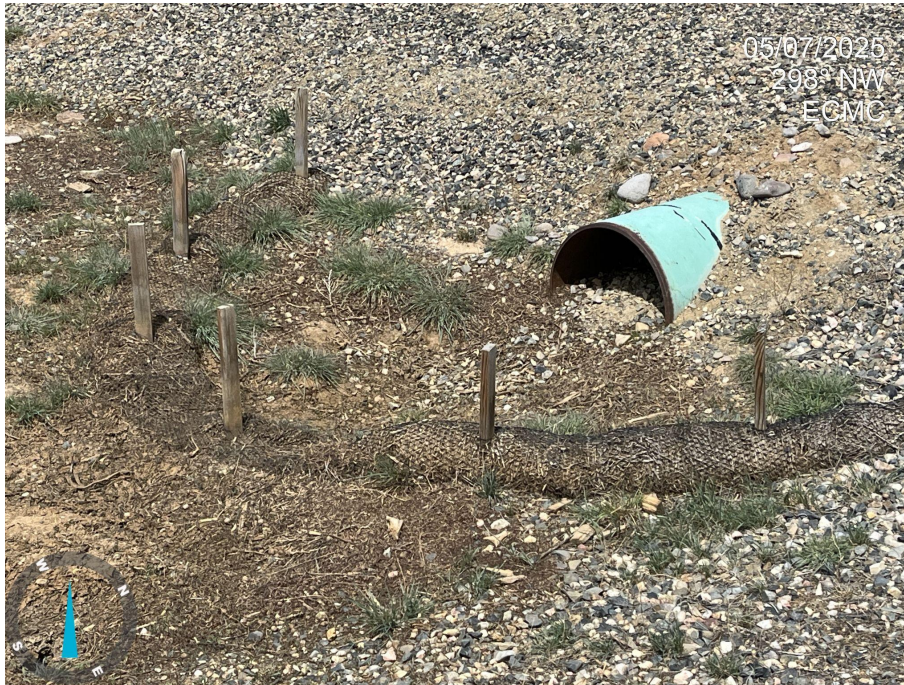
**Photo 3.** Photo illustrates culvert at the entrance of the Location. No erosion issues observed at this time. However, the culvert does not appear to have been installed with inlet/outlet protections per good engineering practices.

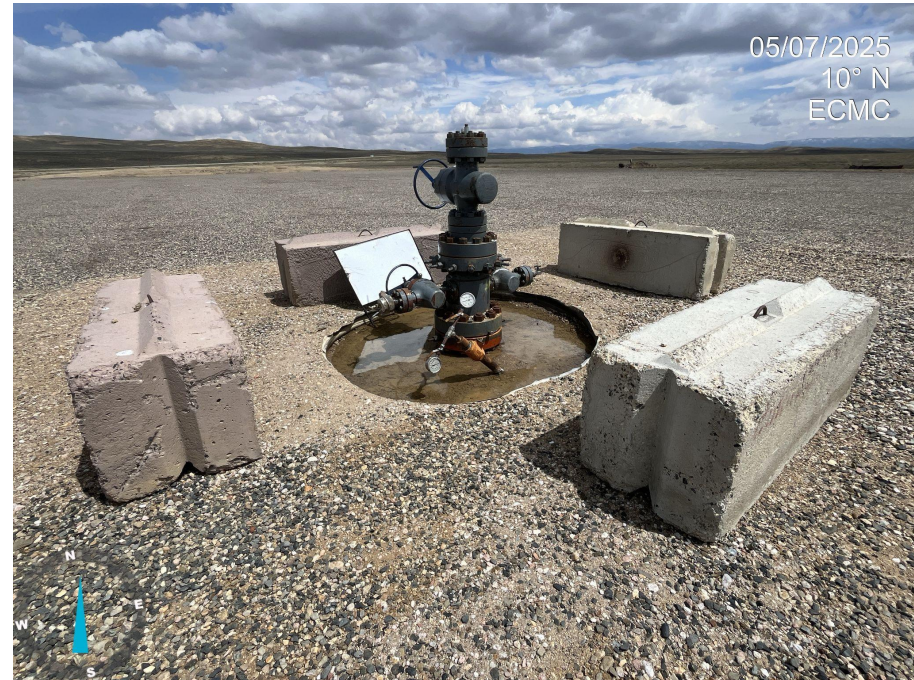
**Photo 4.** Photo taken at the wellhead. The photo illustrates ponding water in the wellhead cellar.

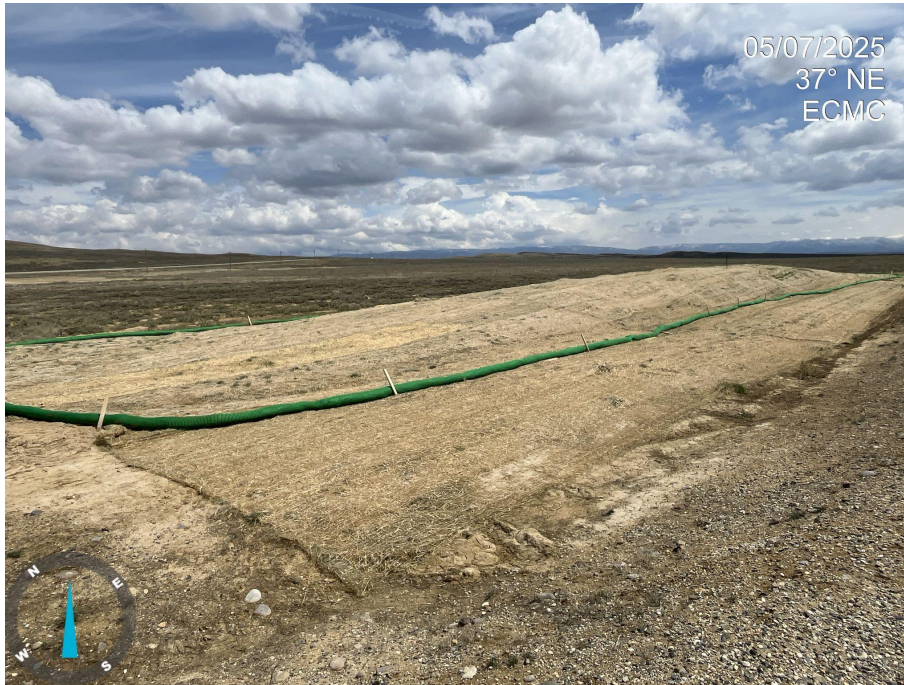
**Photo 5.** Photo taken of the topsoil stockpile. At this time, it does not appear enough topsoil was salvaged at the time of construction per 1002.b.

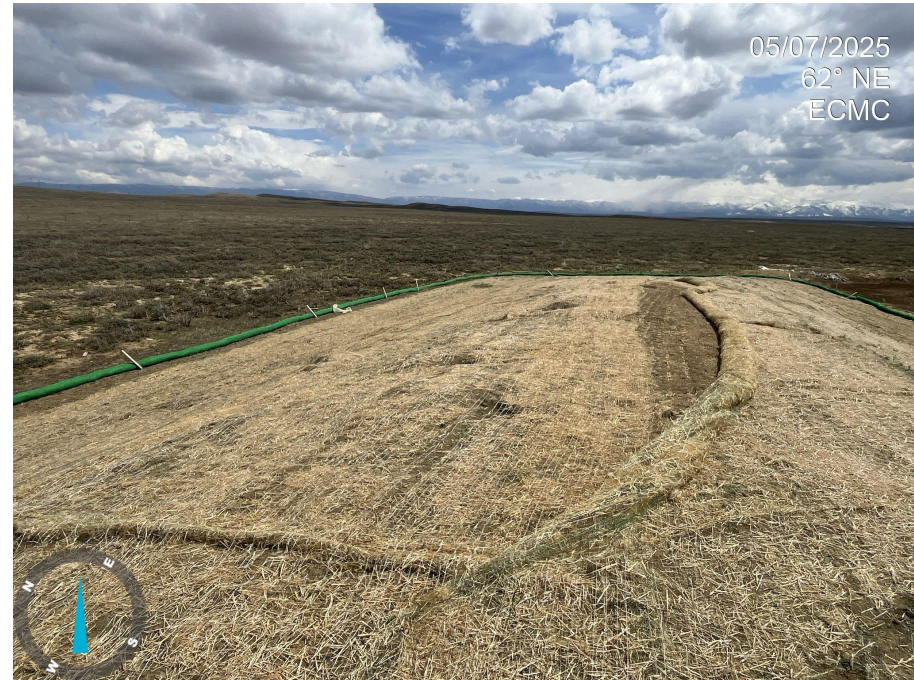
**Photo 6.** Photo taken of the topsoil stockpile. Maintain erosion matting to prevent degradation of the topsoil stockpiles.

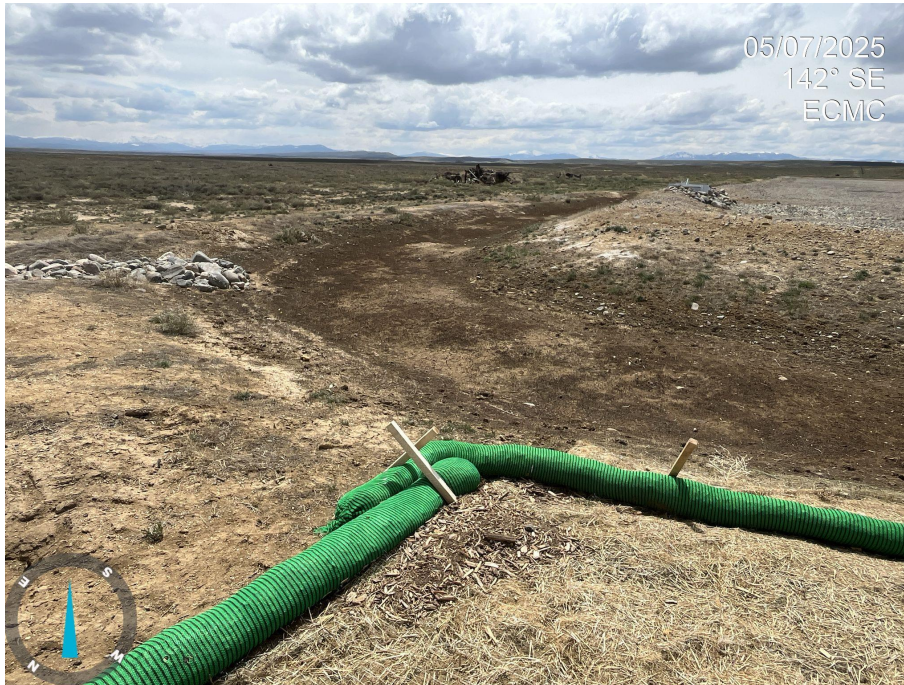
**Photo 7.** Photo taken at the northeastern portion of the pad, facing southeast. Photo illustrates the perimeter ditch. It is unclear if areas were included during previous reclamation/revegetation efforts conducted on the Location.

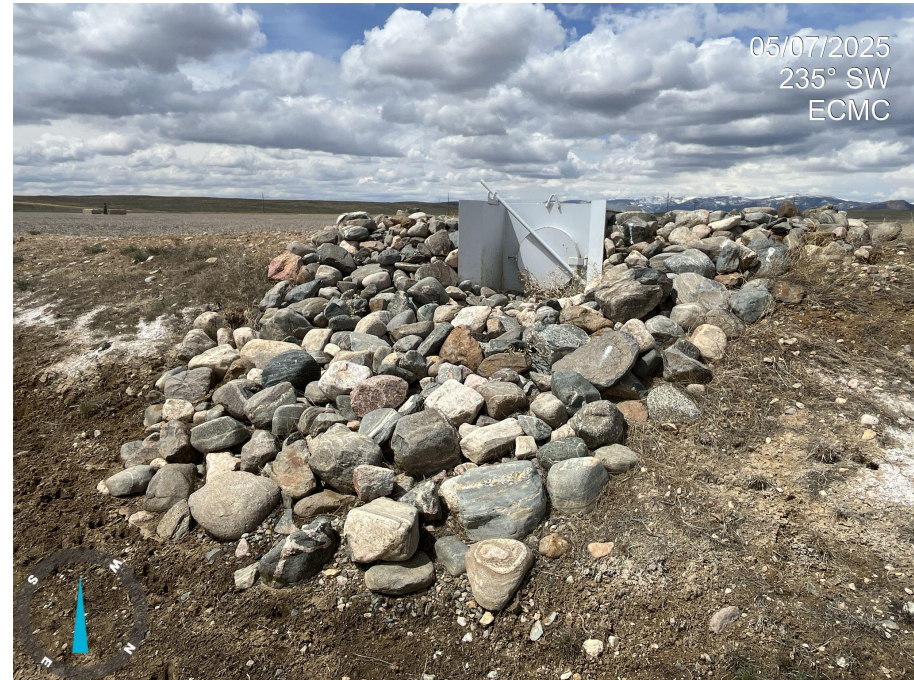
**Photo 8.** Photo taken at the eastern portion of the Location, facing the stormwater outlet. It is unclear if geotextile lining has been installed under the riprap per good engineering practices.

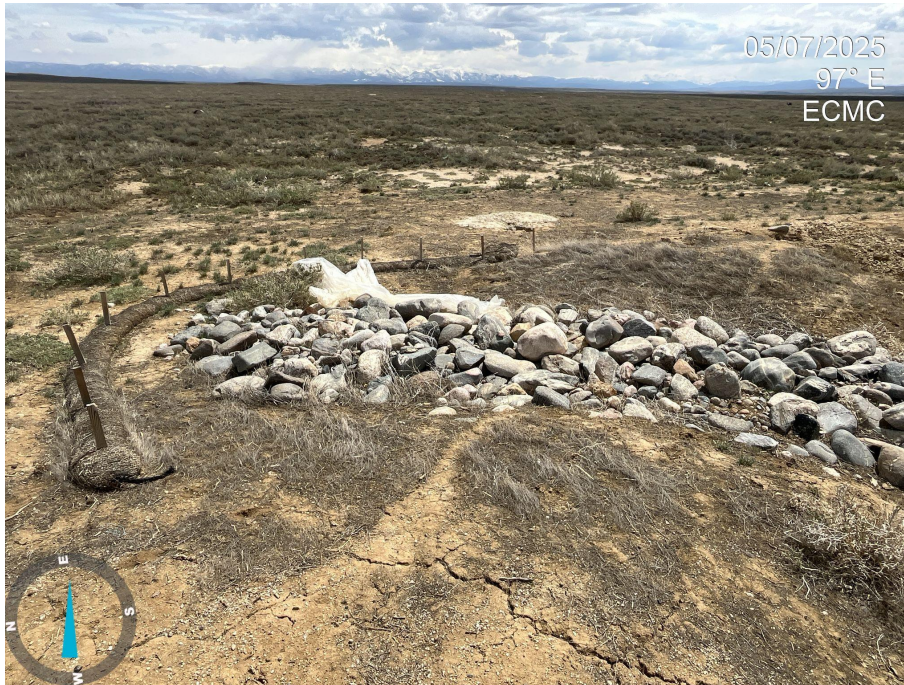
**Photo 9.** Photo taken at the eastern portion of the Location. Photo illustrates an example of trash observed at the Location.

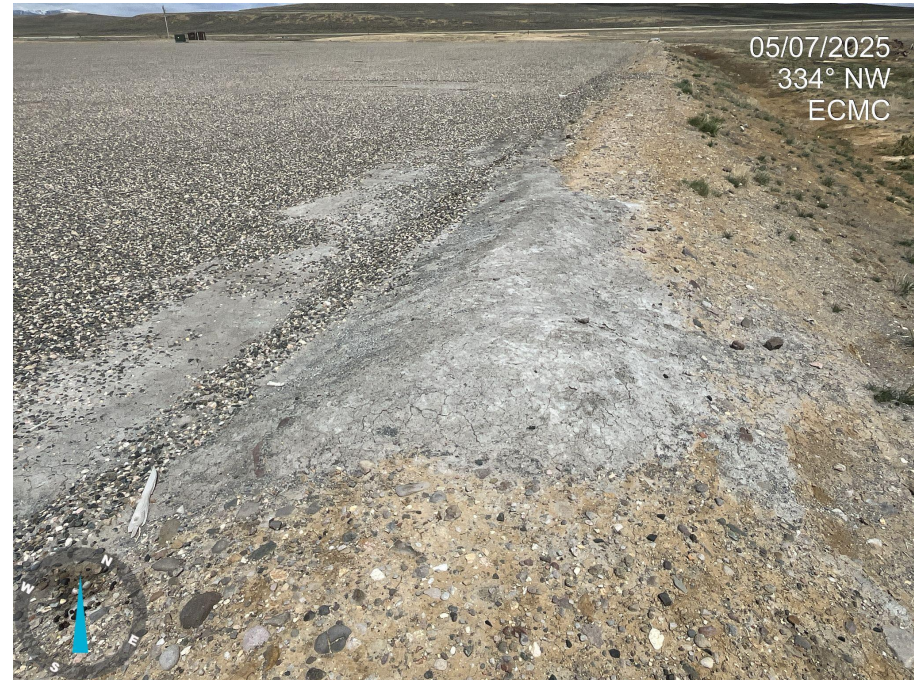
**Photo 10.** Photo taken at the southeastern portion of the Location. What appears to be cement waste has spilled on the location and perimeter berm.

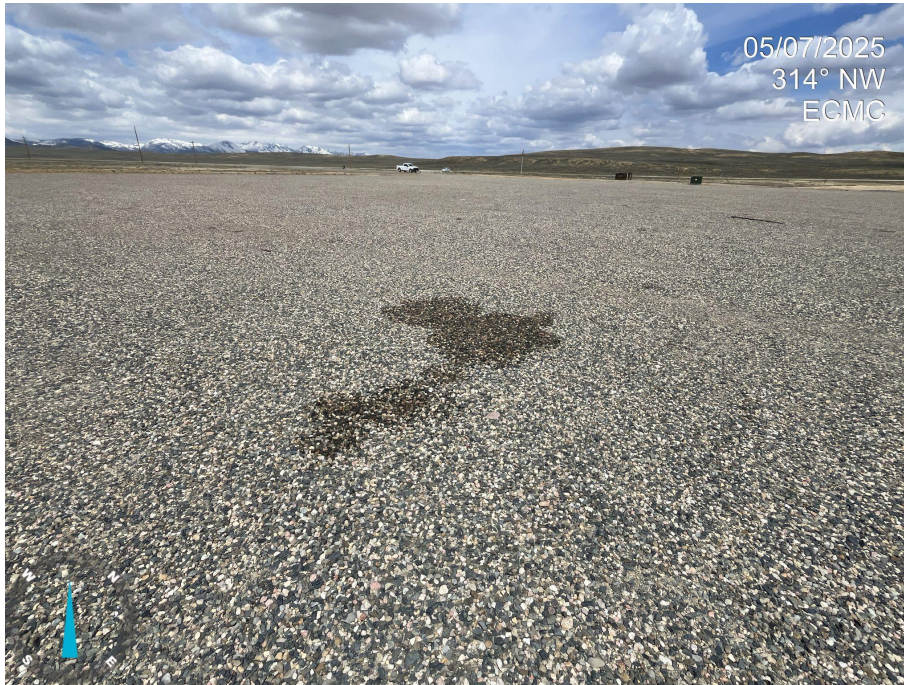
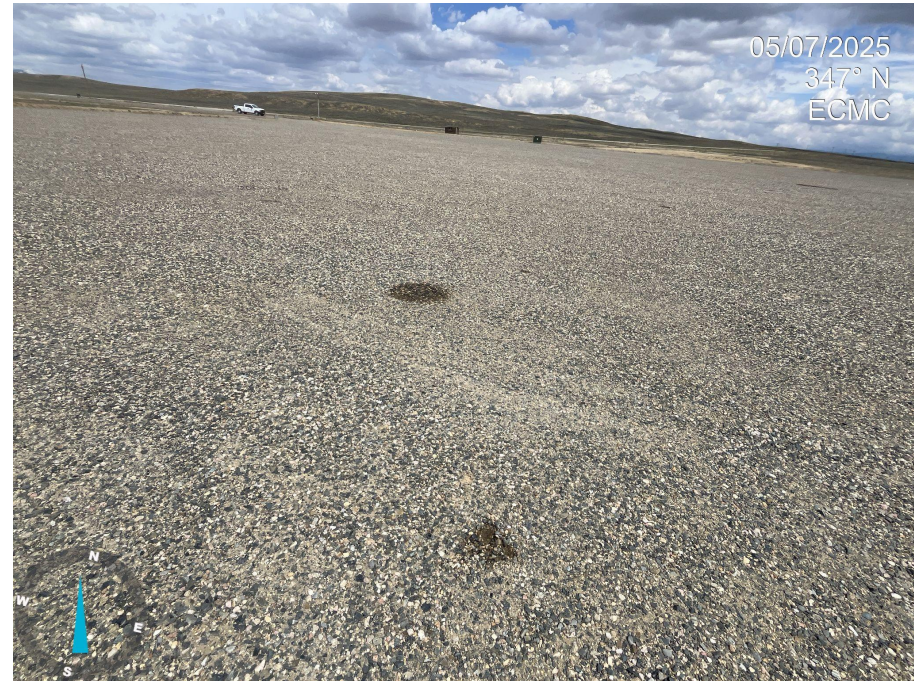
**Photo 11.** Photos 11-12 illustrate stained/impacted soils observed throughout areas on the pad. Remove and properly dispose of impacted material.

**Photo 12.** See comments on Photo 11.
