# Inspection Photos

**Operator:** FULCRUM ENERGY OPERATING- #10805

**Inspection Document #:** 712300119

Inspection Photos  
Location Name: Spicer Annex S32 Pad  
Location ID: 467526

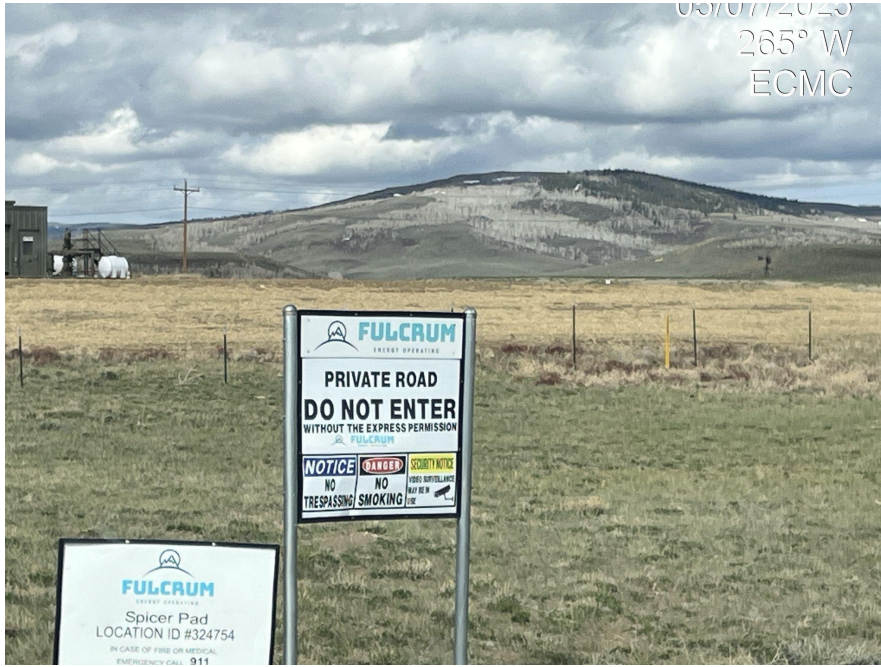
**Photo 1.** Photo taken from the entrance of the access road.

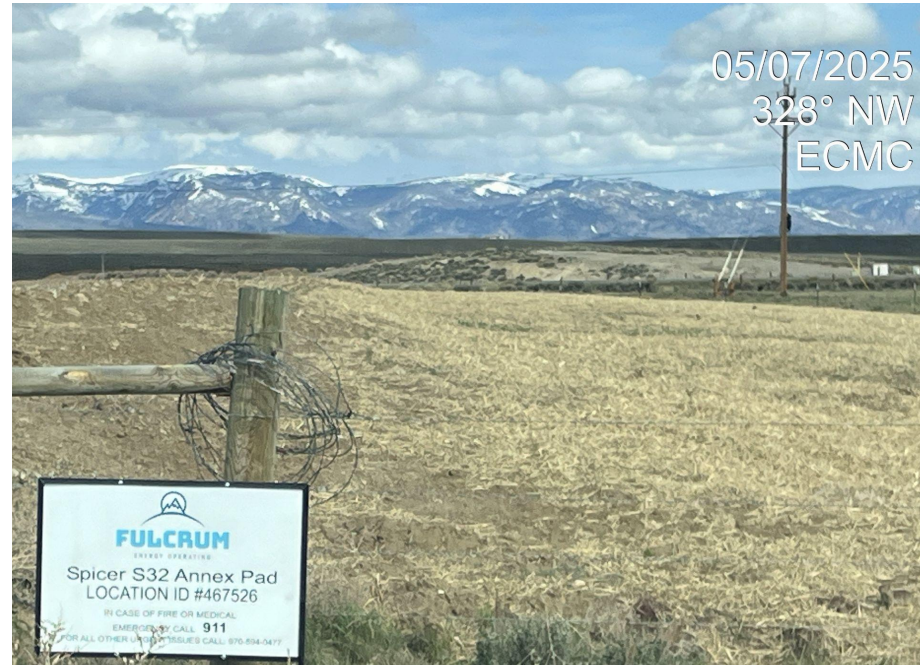
**Photo 2.** Photo taken from the entrance of the pad.

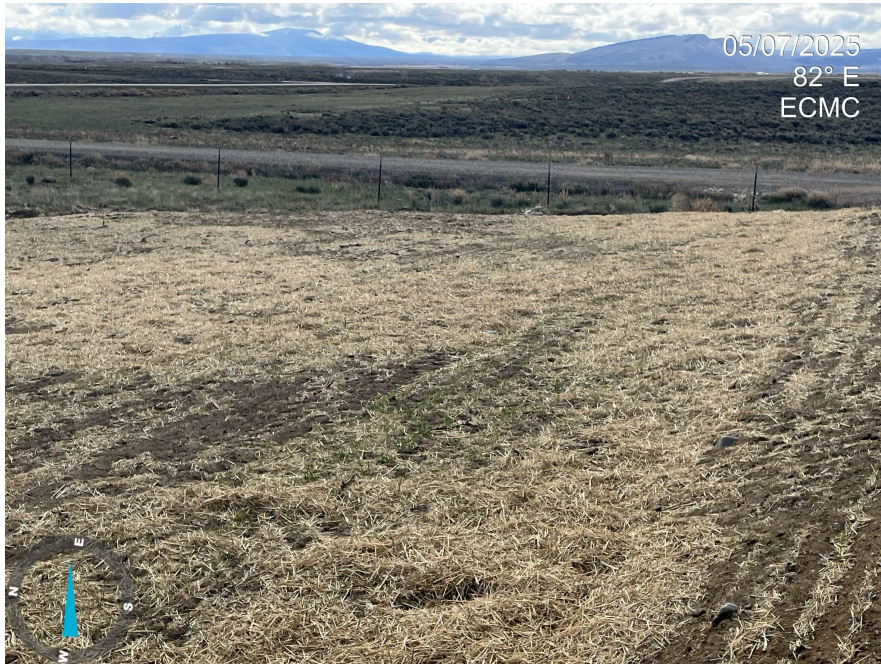
**Photo 3.** Photo taken from the northeastern portion of the pad, facing the eastern interim reclamation area. Photo illustrates seeding has occurred and straw mulch has been applied. It appears that straw mulch has densely accumulated in some areas. It may prevent early germination.

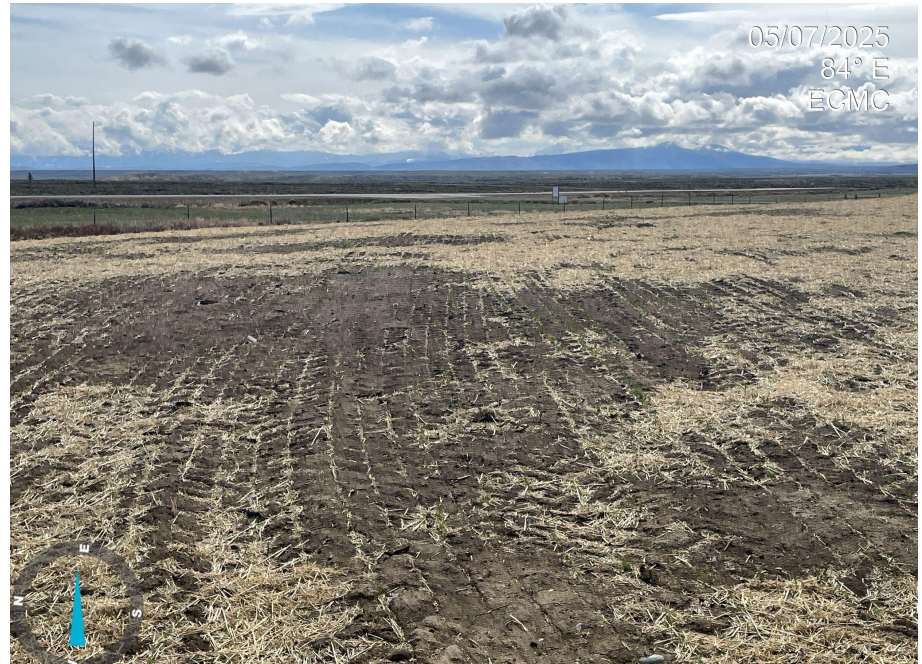
**Photo 4.** Photo taken from the northeastern portion of the pad, facing the eastern interim reclamation area. Photo illustrates seeding has occurred and straw mulch has been applied. Observed are areas where mulch does not appear to have been sufficiently anchored and has blown off.

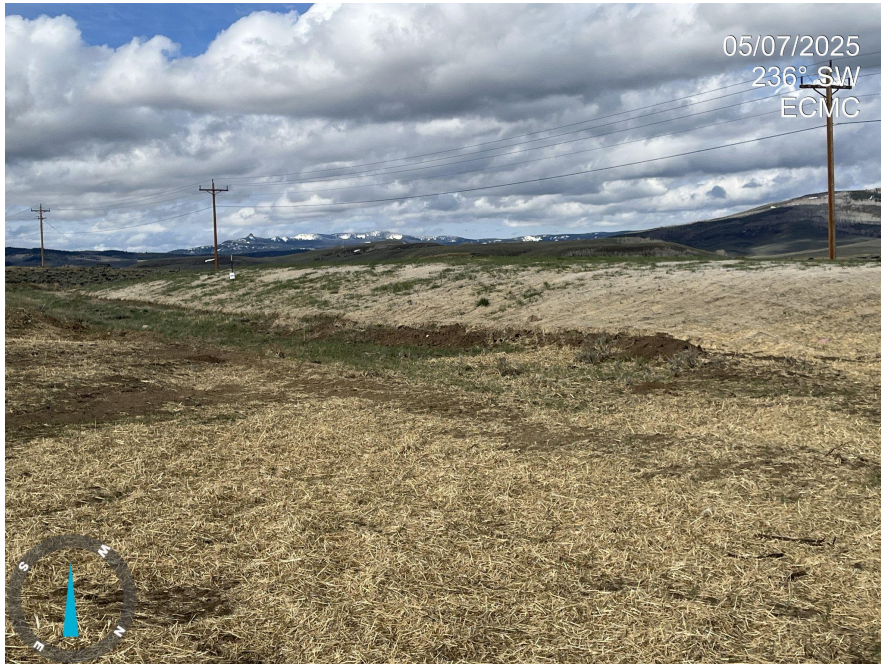
**Photo 5.** Photo taken from the northwestern portion of the location, facing topsoil stockpile. Topsoil has been stabilized with erosion matting.

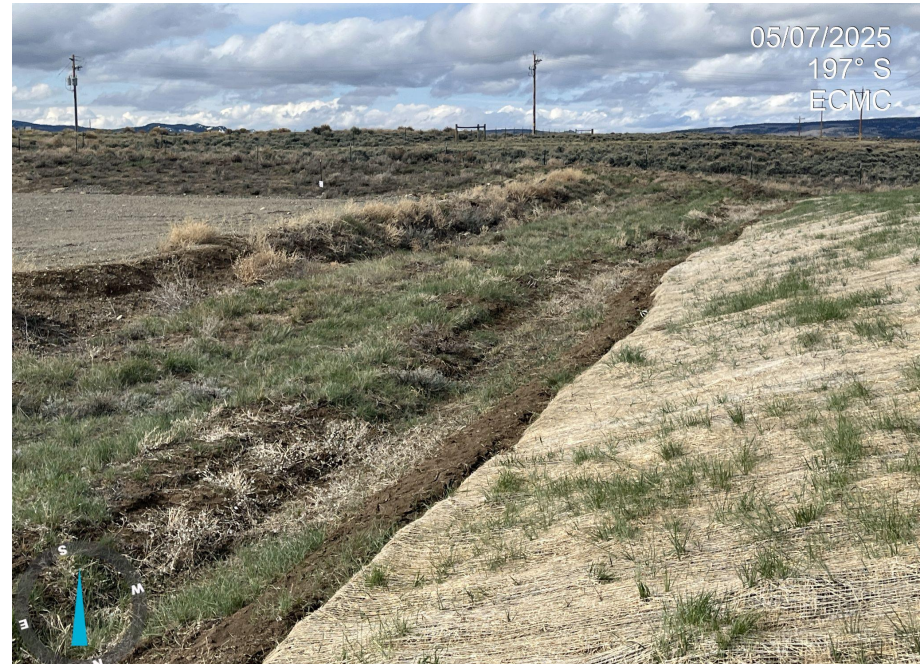
**Photo 6.** Photo taken from western portion of the location, facing south towards stockpiled soil. Erosion matting has been applied to soil stockpile.

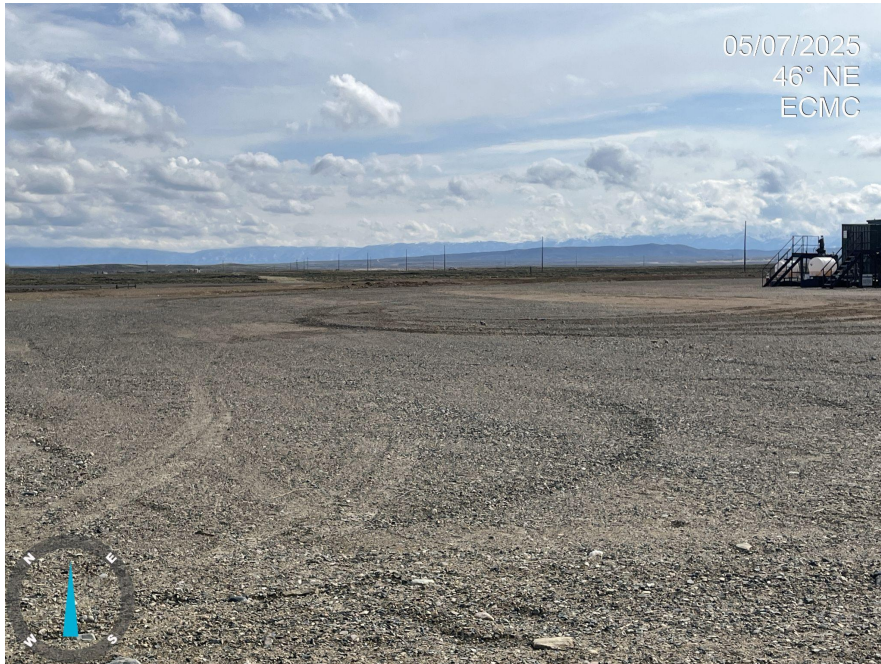
**Photo 7.** Photo taken from western portion of location, facing northeast. It is unclear if all areas not needed for production have been reclaimed.

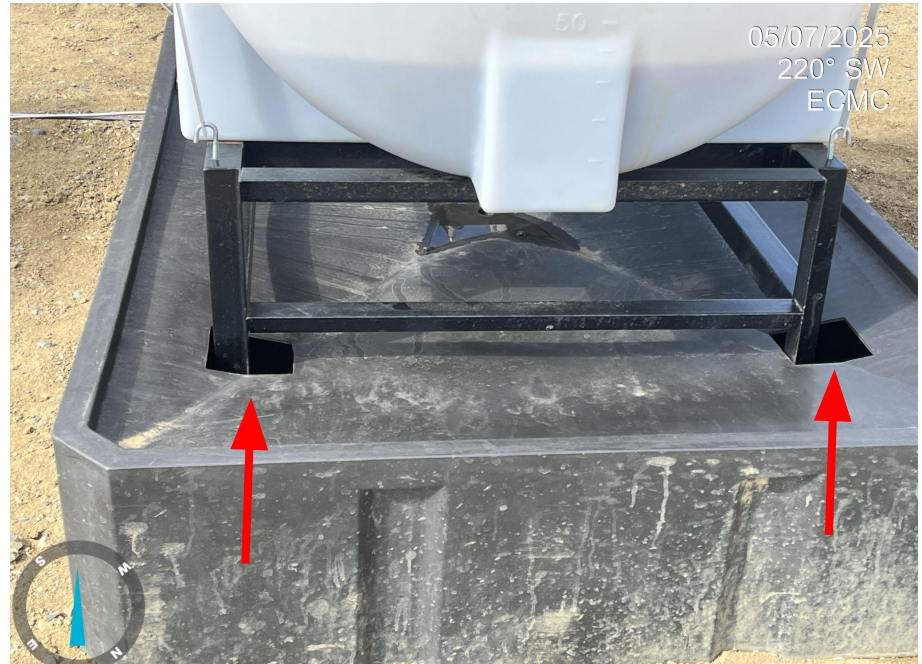
**Photo 8.** Photo taken from southeastern portion of Location of the tanks. Photo illustrates an example of missing caps/covers that prevent access to wildlife.
