Inspection Photos
Location: Rhoades Unit Gas Injection Flowline
Location ID: 476172
Spill ID # 489565

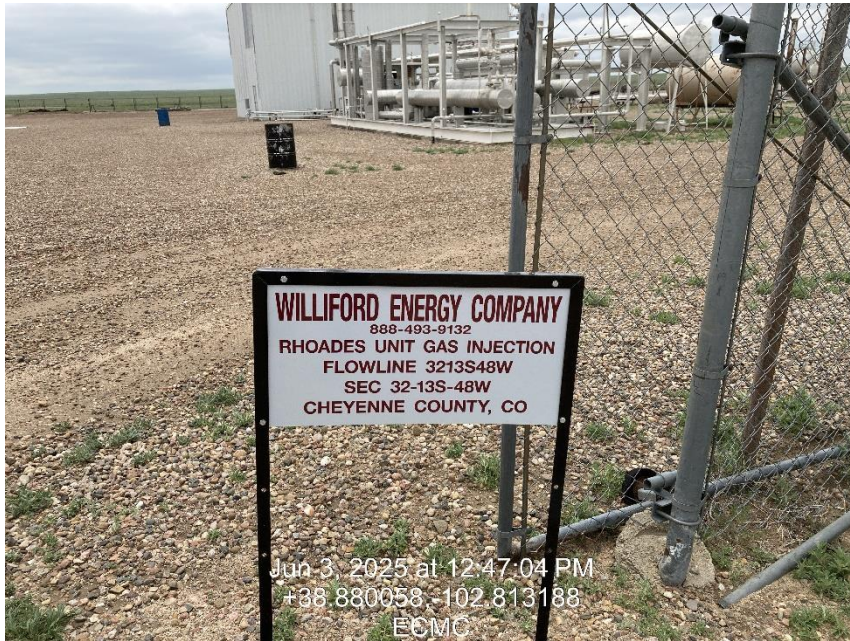
Photo 1 – Placard at facility

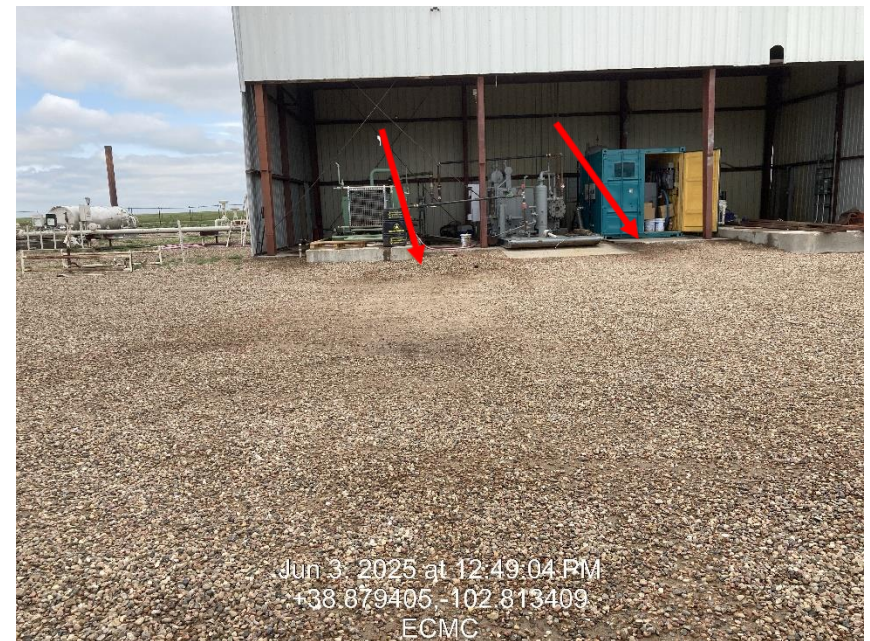
Photo 2 – Stained ground

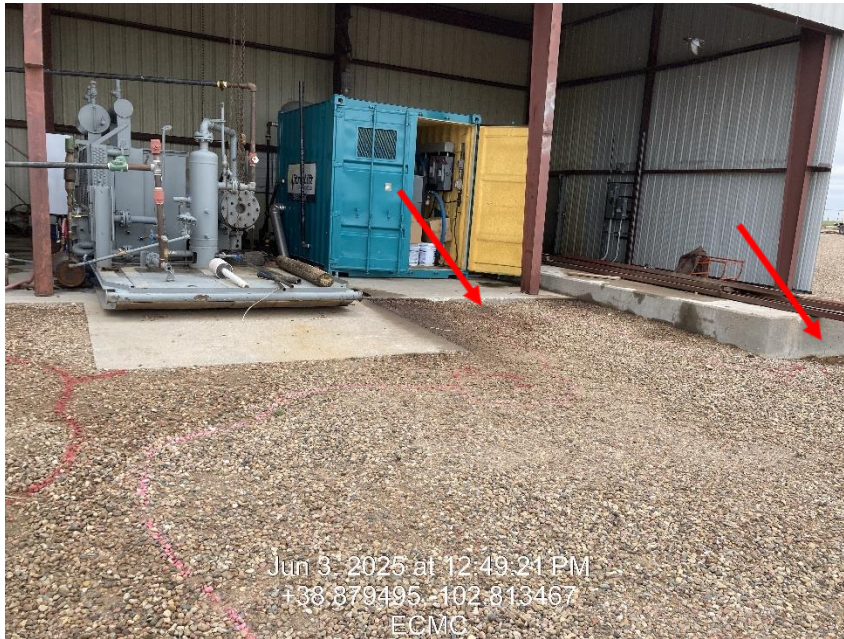
Photo 3 – Stained Ground

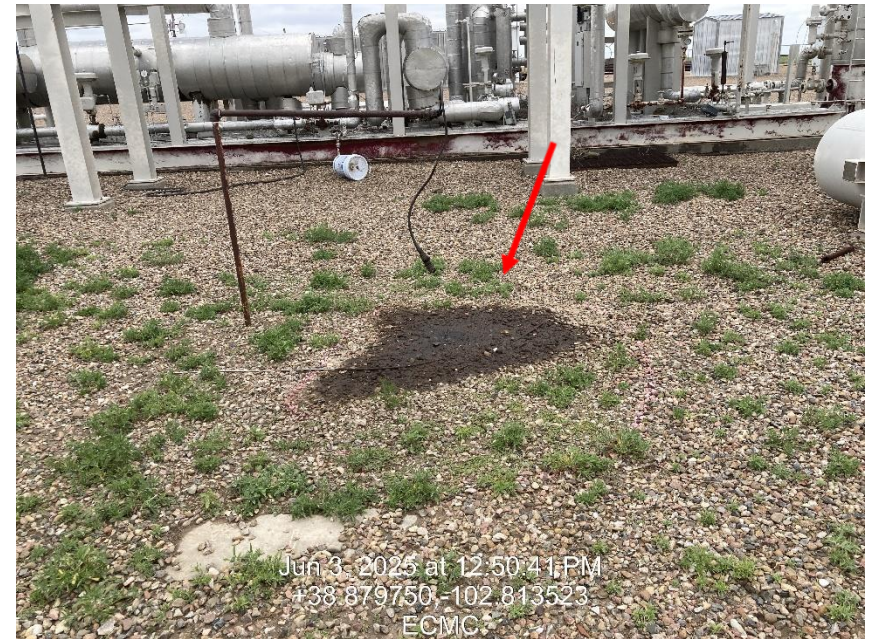
Photo 4 – Impacted soils identified at Latitude 38.87975; Longitude -102.813523

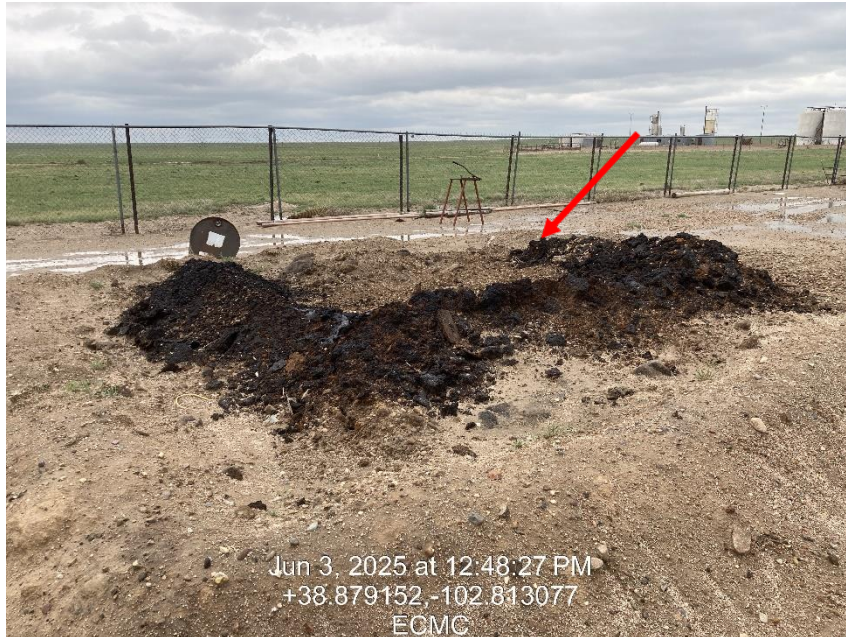
Photo 5 – Impacted materials

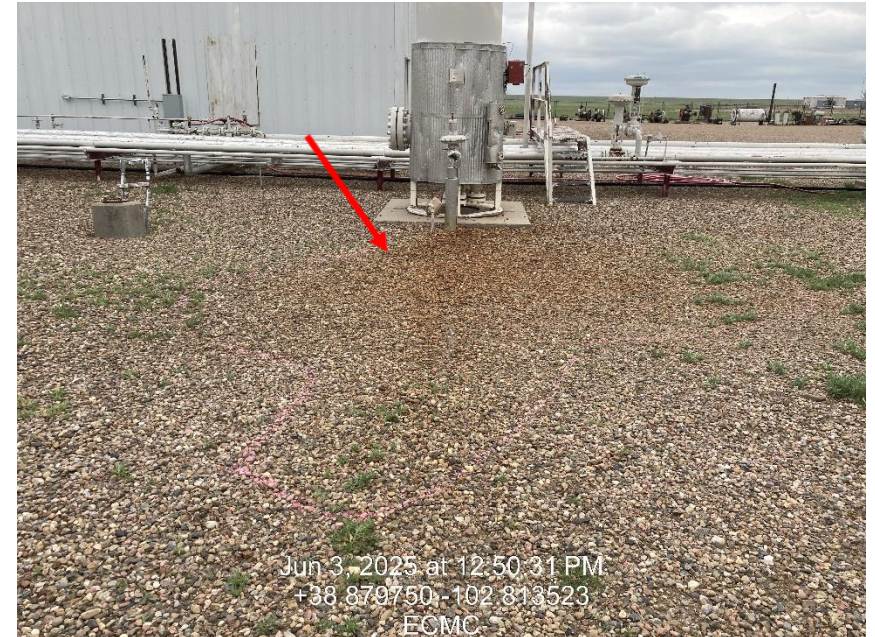
Photo 6 – Impacted materials
