Inspection Photos  
Location: RHOADES UNIT TUBING FLOWLINE  
Location ID: 476137  
Spill ID(s) 486490, 489566, and 490098.

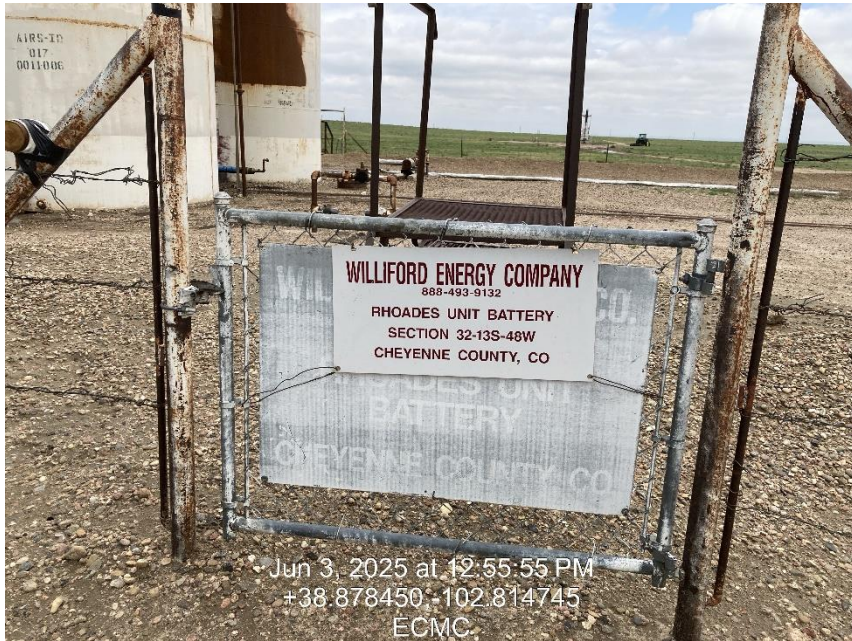
Photo 1 – Placard at facility

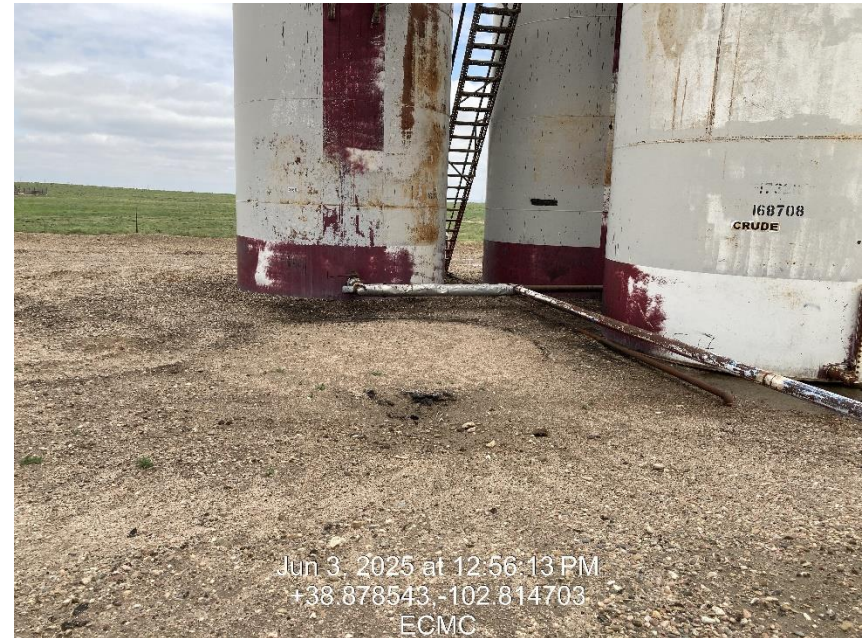
Photo 2 – Impacted Soils

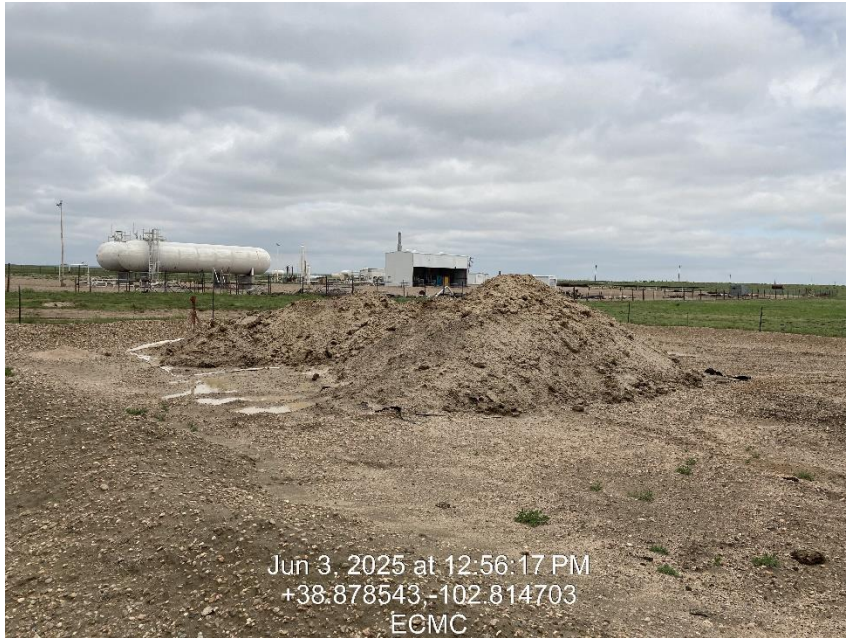
**Photo 3 – Impacted Soils**

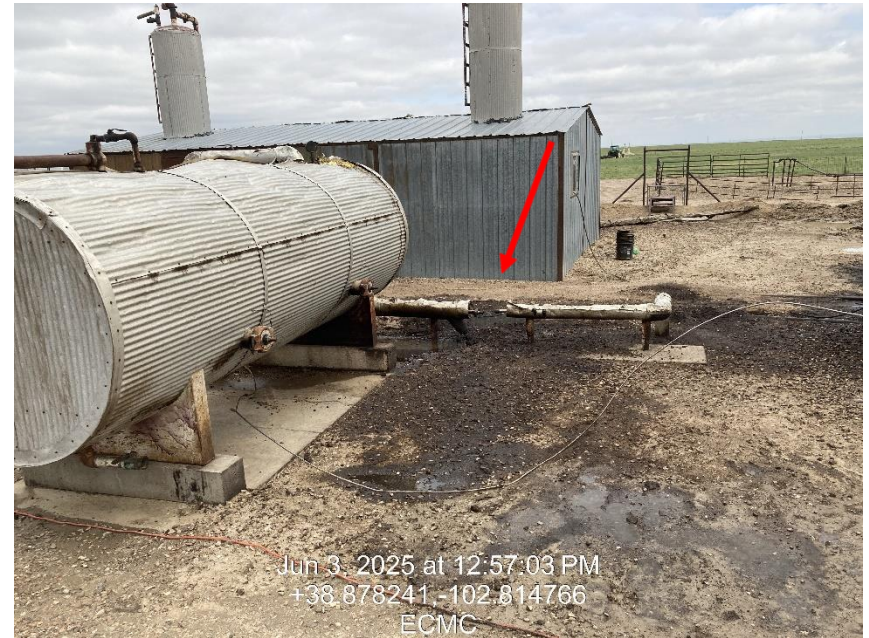
**Photo 4 – Impacted Soils**

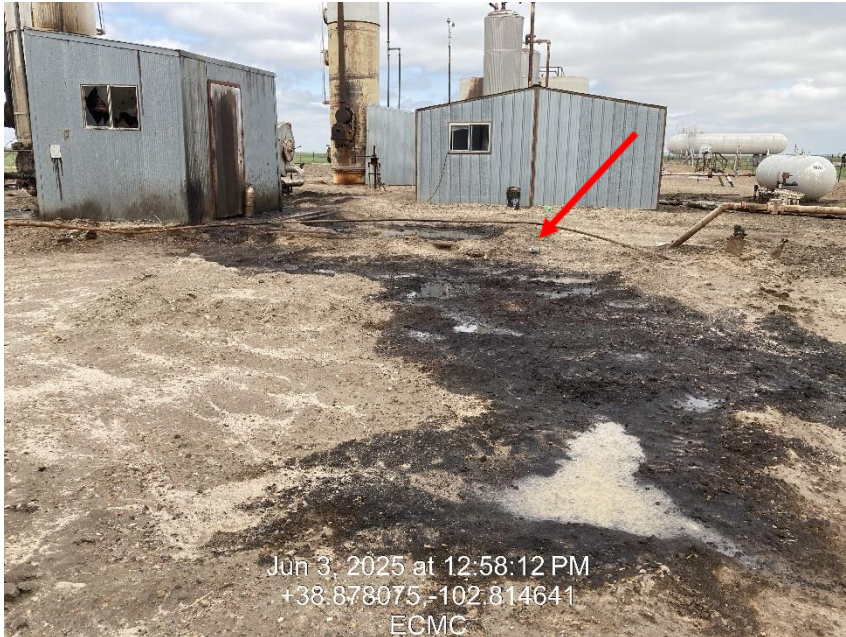
Photo 5 – Impacted Soils

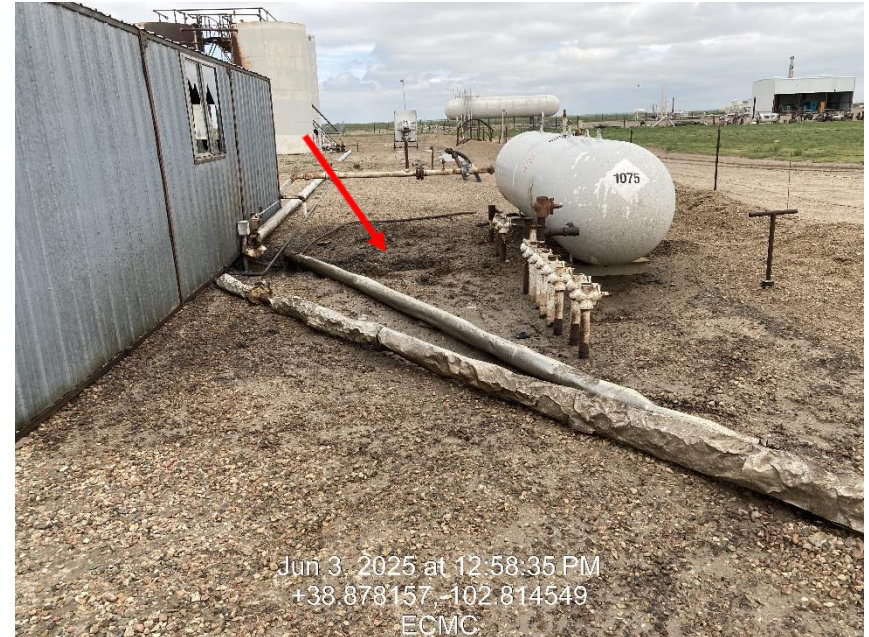
Photo 6 – Impacted Soils
