Inspection Photos
Location Name: UPRR 42 Pan Am F#4
Spill ID: 480343

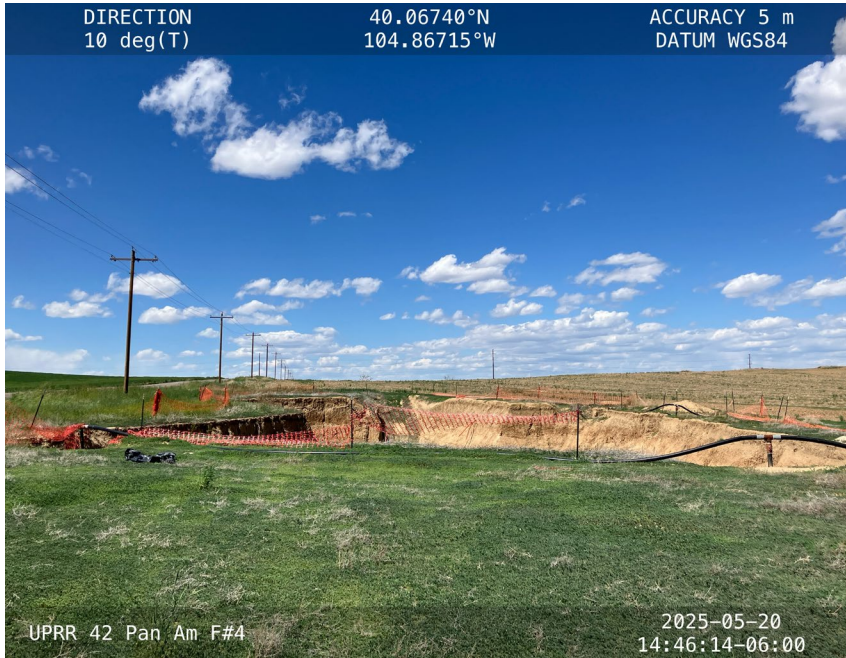
Remedial excavation. Fencing is down, trash observed

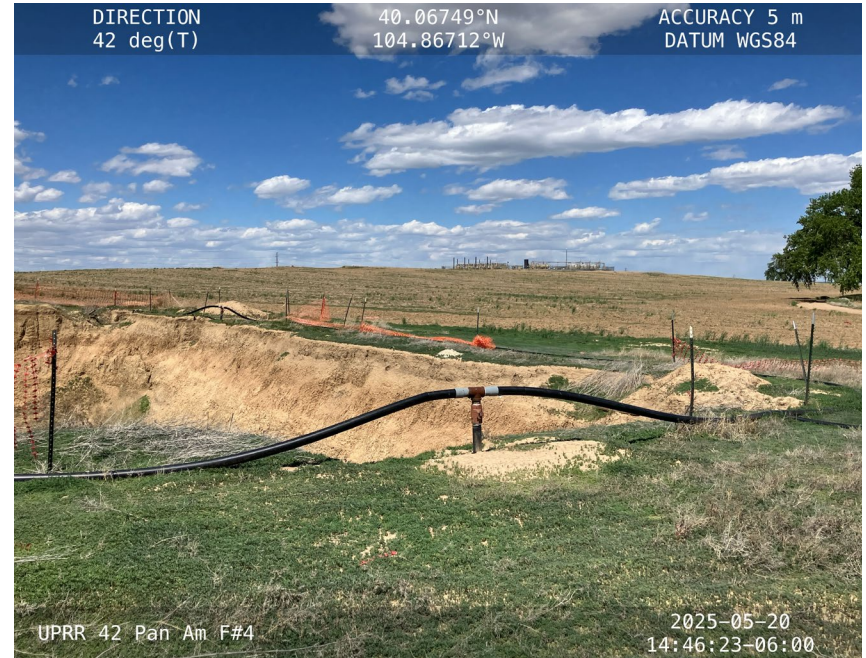
Flowlines appear to have been replaced with ~3" HDPE flowline pipe at the surface.

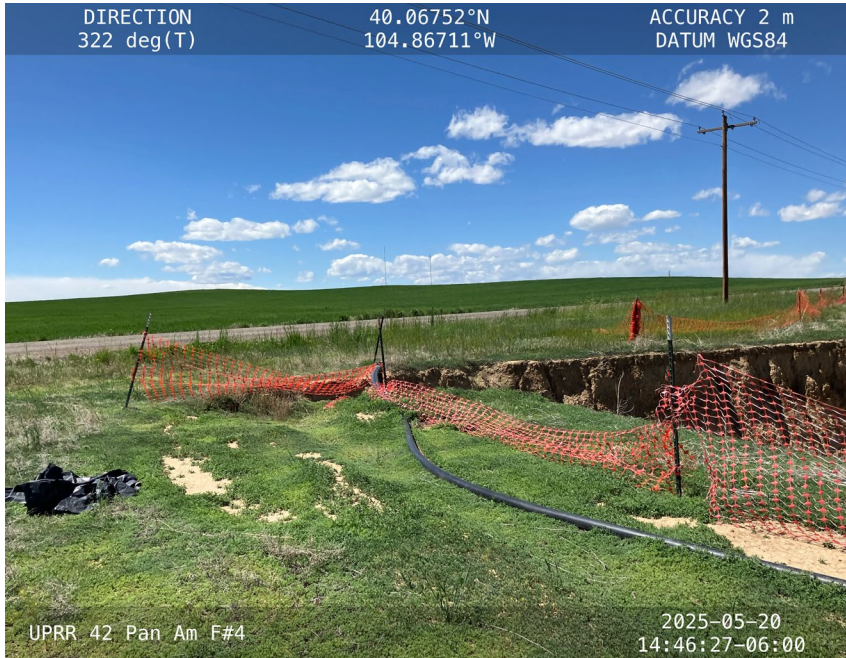
Torn fencing

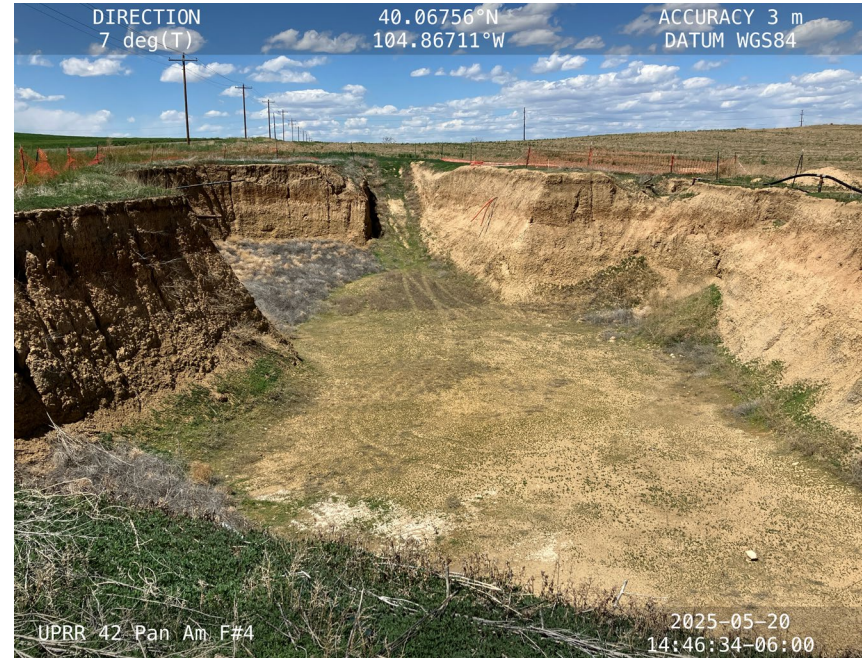
Excavation

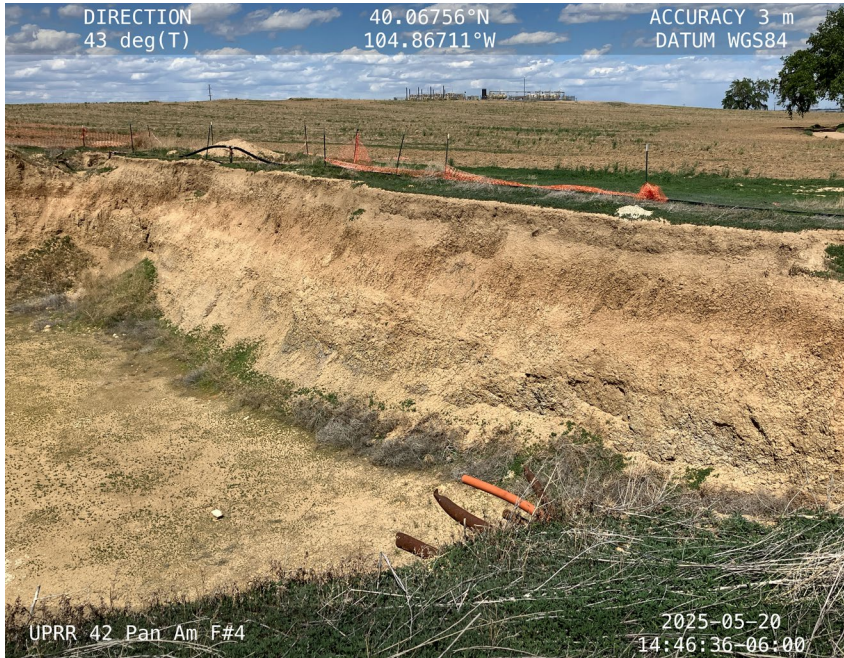
Excavation. Torn fencing. Multiple flowlines of unknown status were observed exposed within the open excavation.

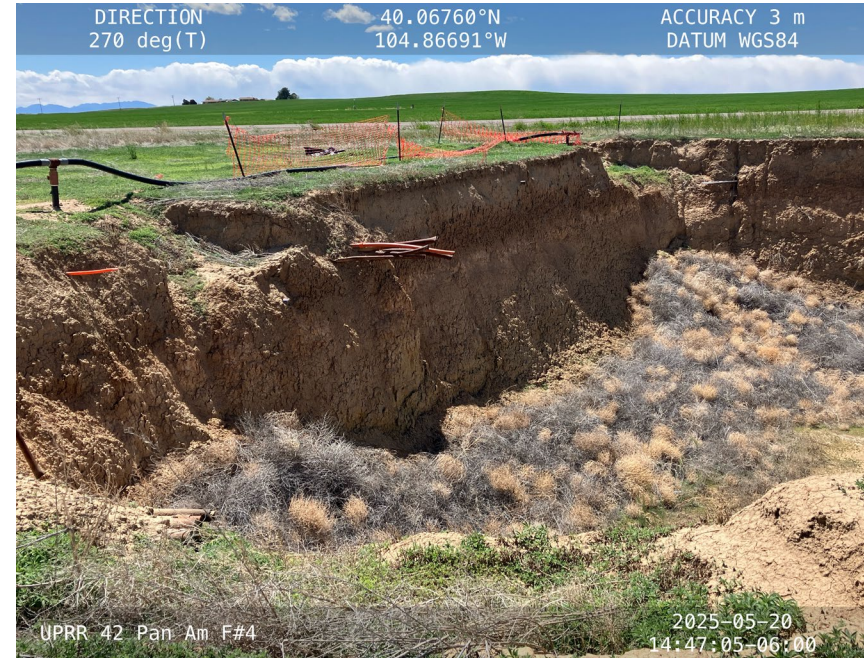
Excavation. Weeds. Torn fencing. Multiple flowlines of unknown status were observed exposed within the open excavation.

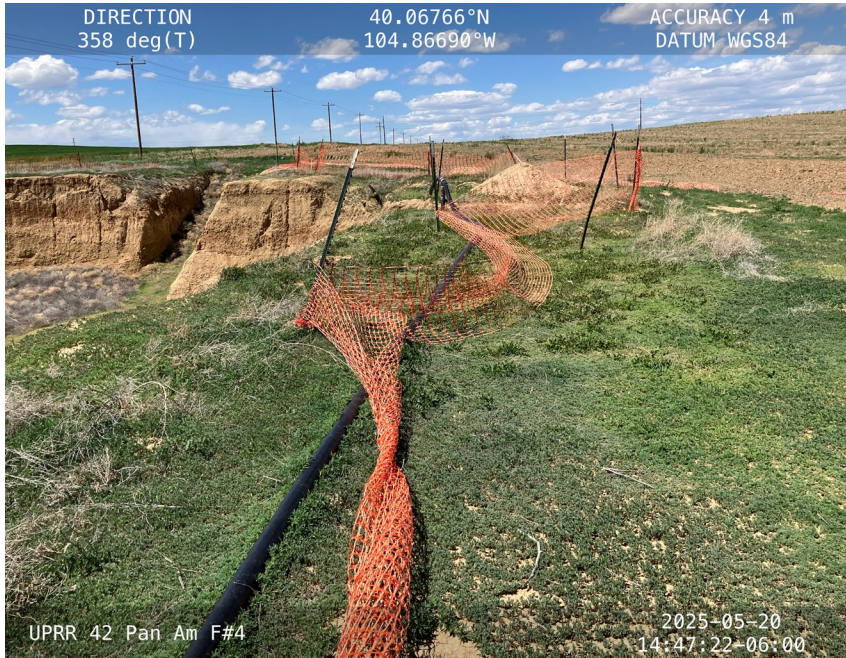
Torn fencing

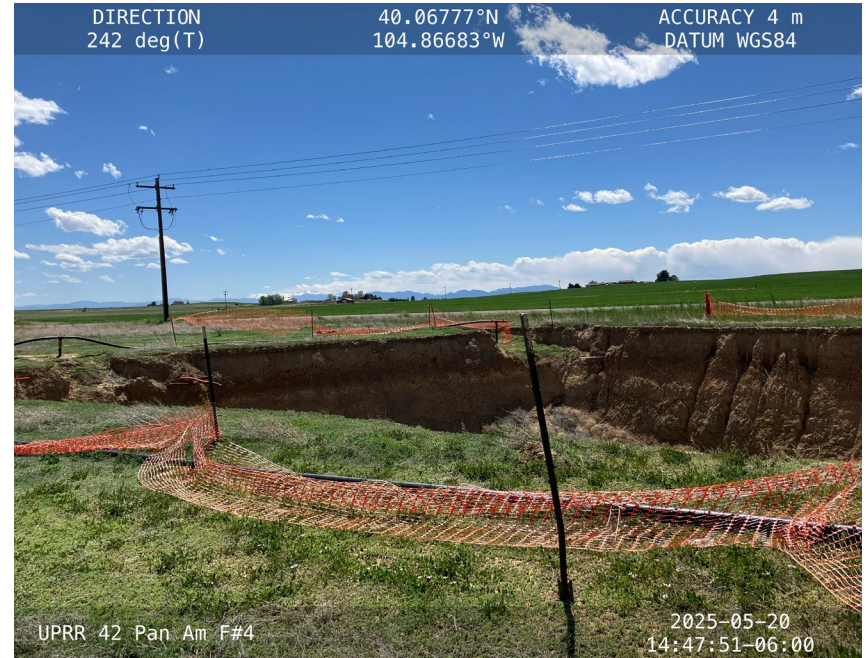
Torn fencing

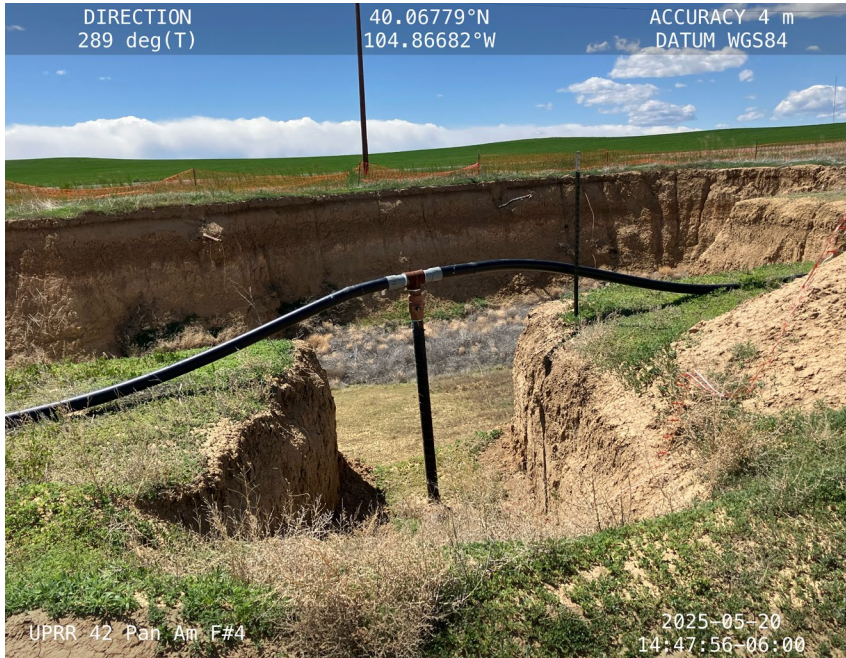
Flowlines appear to have been replaced with ~3" HDPE flowline pipe at the surface.

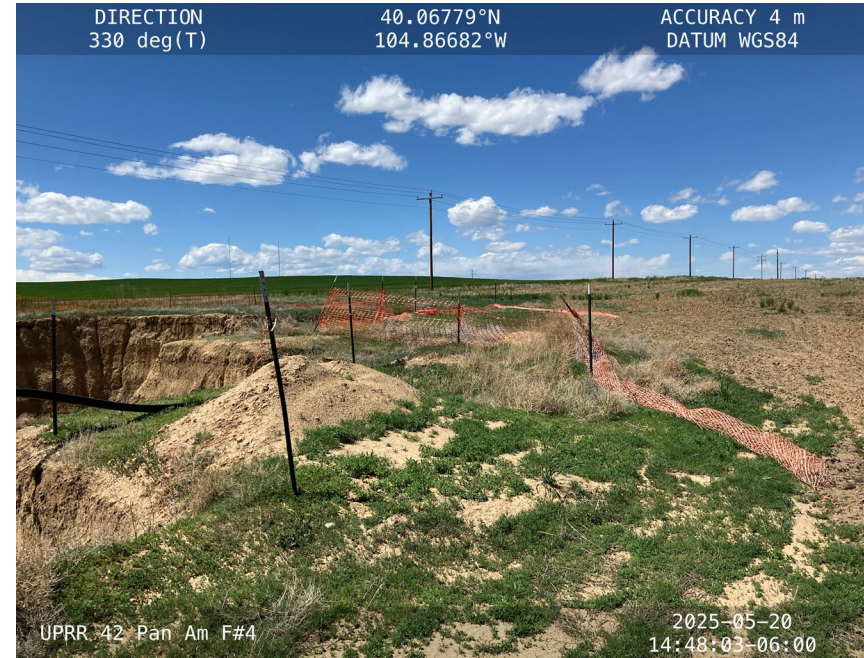
Torn fencing

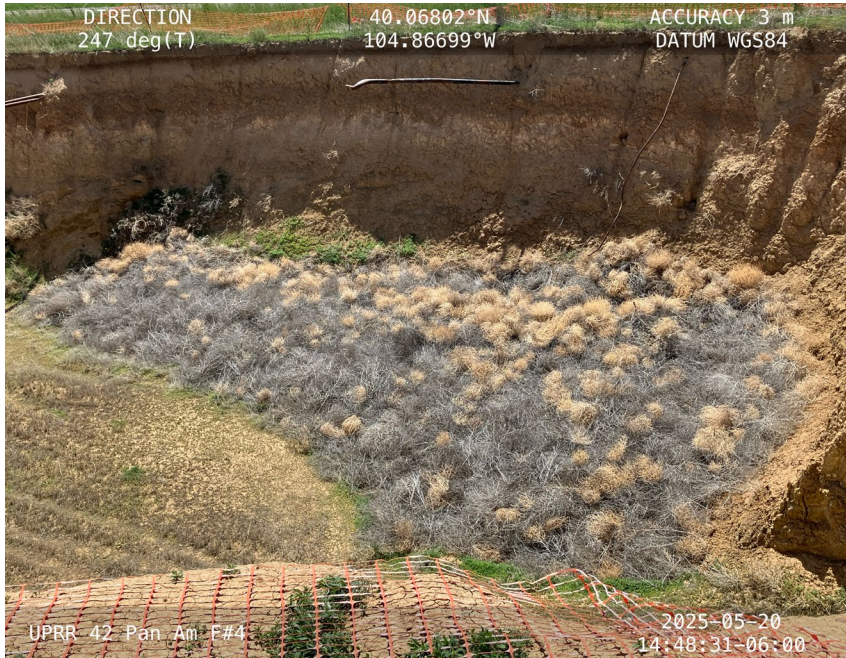
Weeds within the excavation

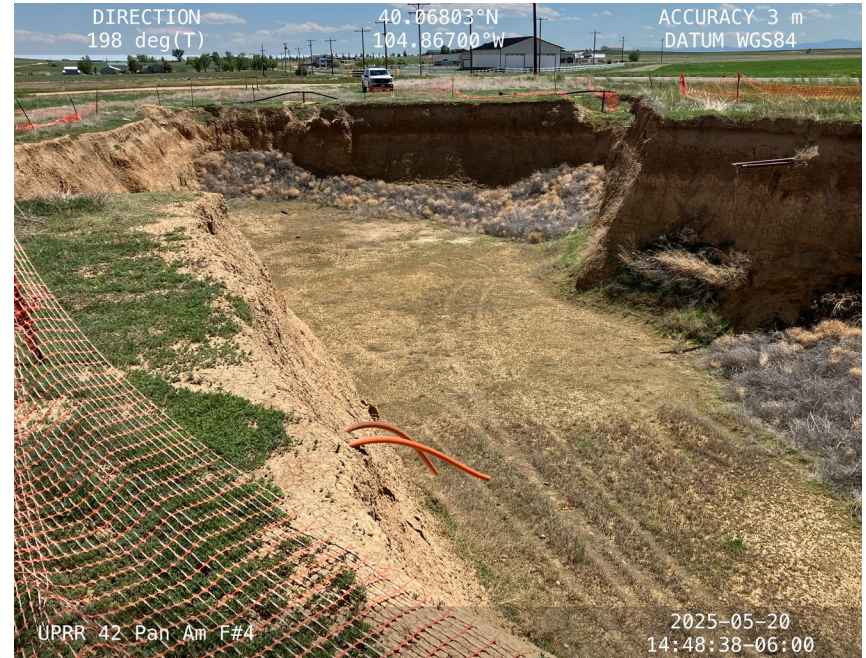
Multiple flowlines of unknown status were observed exposed within the open excavation.

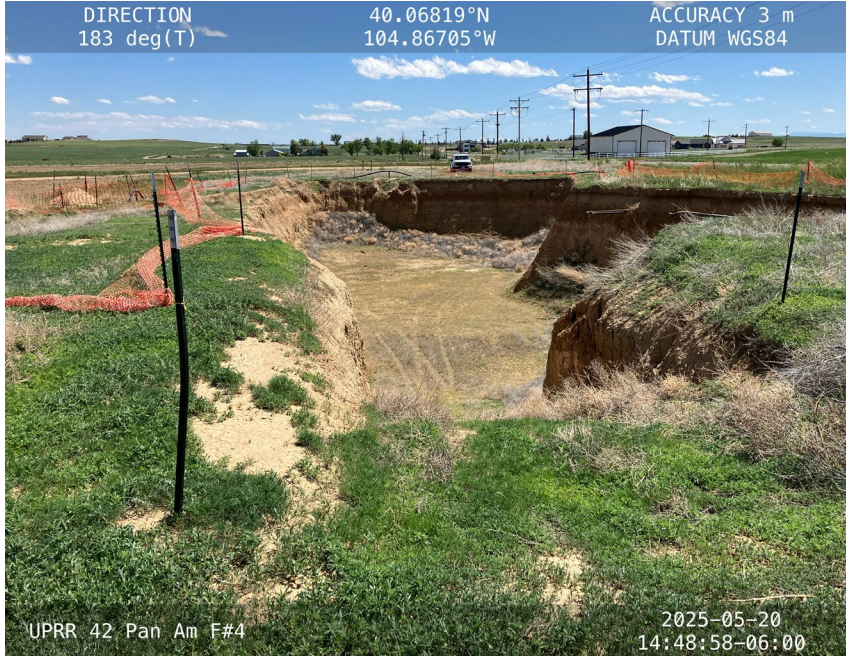
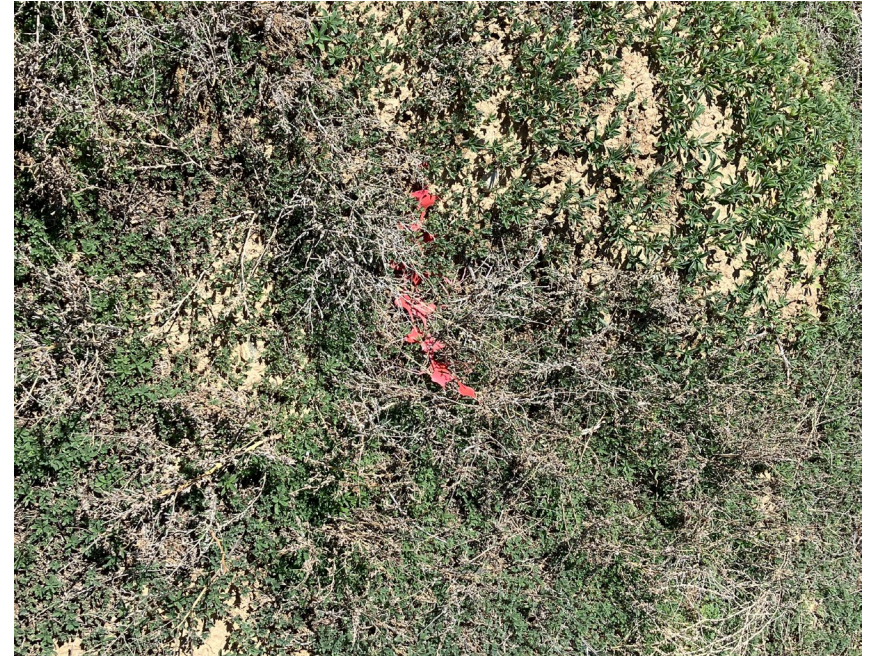
Trash

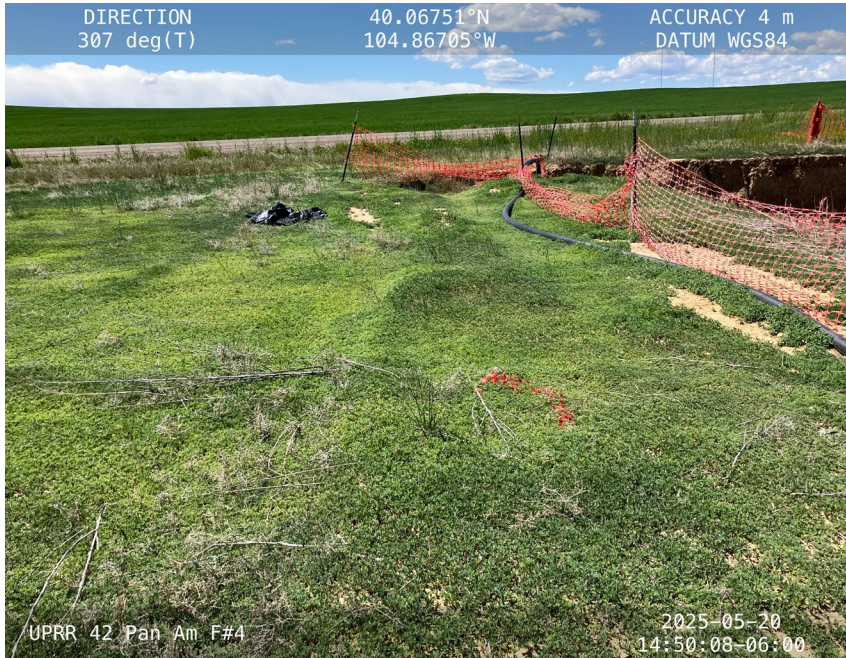
Trash

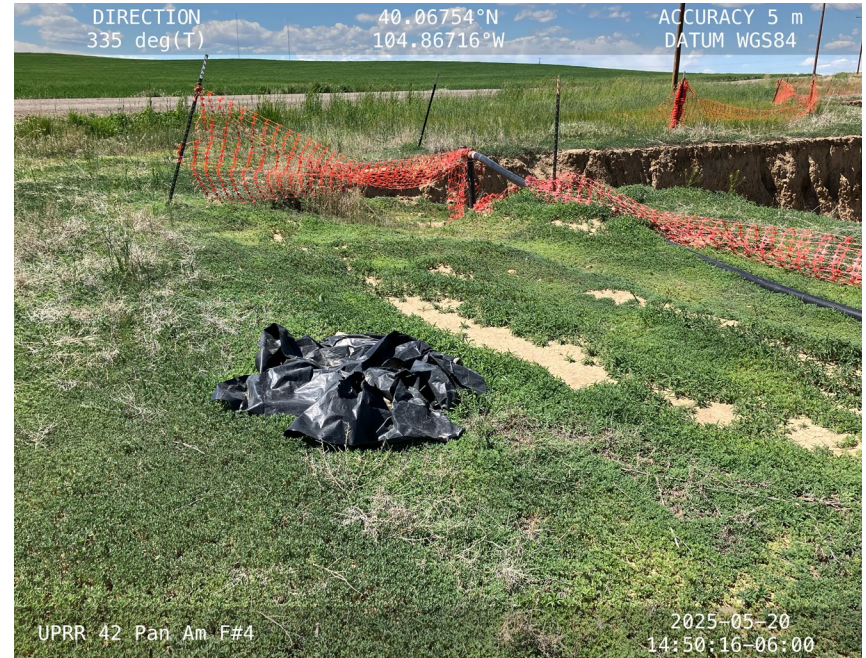
Trash
