Inspection/Audit Photos

Location: TEP ROCKY MOUNTAIN LLC GM 24-1 PAD

Location ID: 334878

Date: 05/28/2025

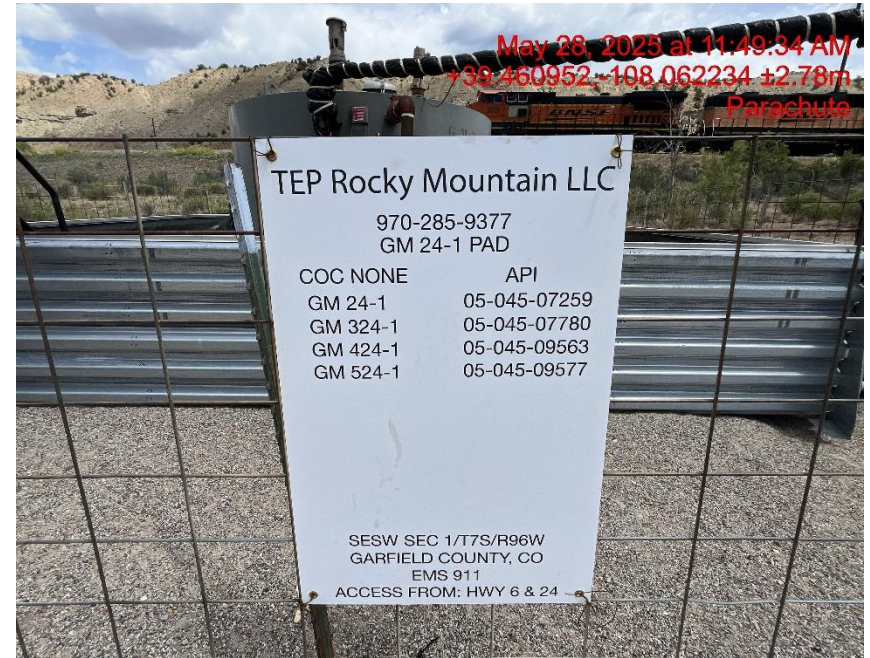
Photo # 7439 New battery sign has incorrect access information/not in compliance with CECMC rules

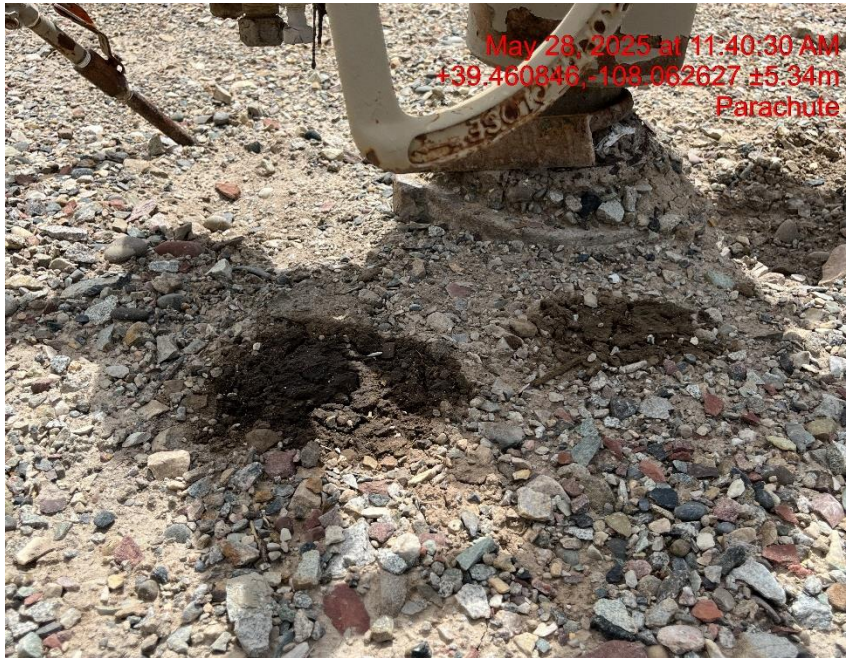
Photo # 7432 Small amount of staining at GM 324-1 wellhead

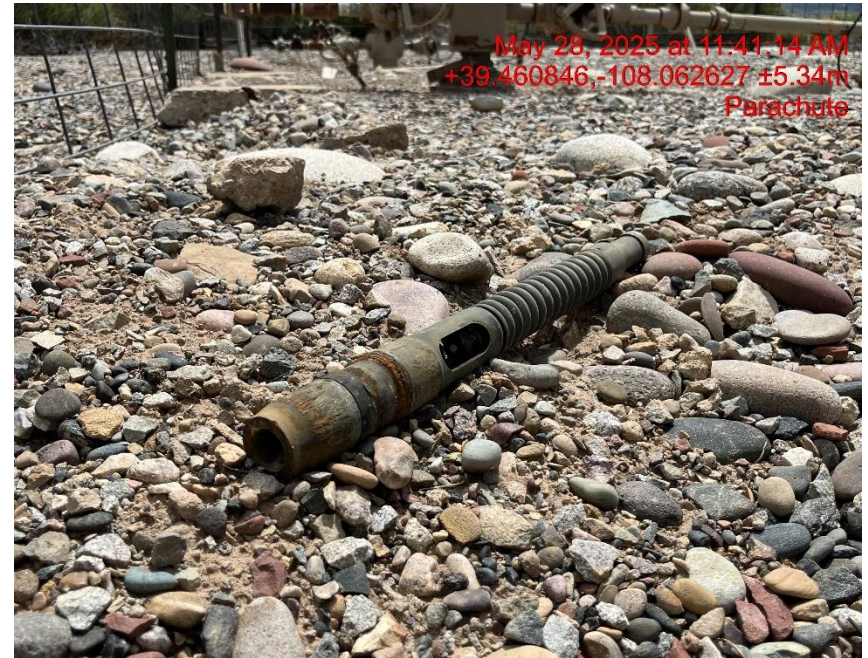
Photo # 7435 Debris near wellheads
